## On the Ground Deformation and Phenomena Forerunning Natural Disasters (Earthquake, Rock-falling and Landslide)

By Michio TAKADA

### Abstract

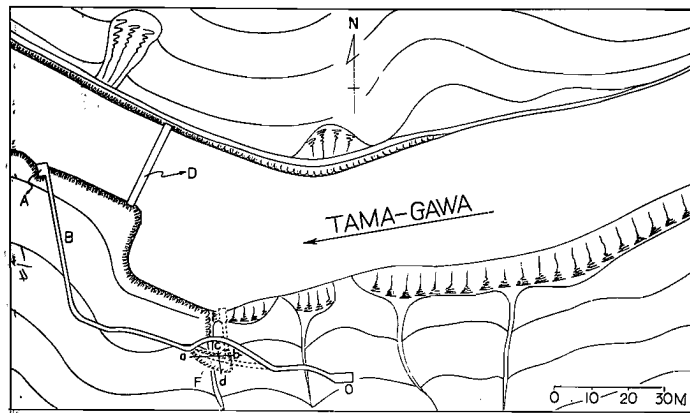
Fig. 2. Illustration of the Ide Observatory and location of rock-falling.  
 A : -Recording room, B : -Drift, F : -Part of rock-falling,  
 O : -Observing room, D : -Sabo-dam

On Dec. 24, 1954, a part of the drift was broken and rock-falling occurred about 15 m in the length at the Ide Observatory. (See Figs. 2 and 7.) Repair work was begun immediately but the workers were inexperienced. Fragments of fallen rocks were carried out of the drift until interrupted by an opening which came in the hillside on Jan. 17, 1955. During this work, the amount of rocks carried out was about 450 m<sup>3</sup>. After this difficult repair, the observing room could safely be entered on Jan. 31 for the first time since rock-falling. Fortunately the records before and

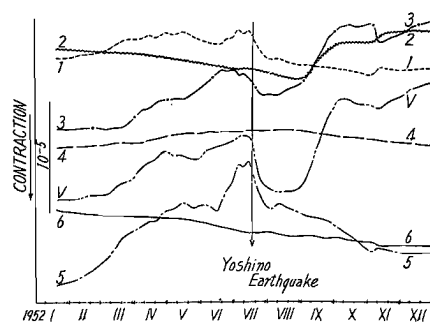
Fig. 3. Variations of linear strains and volume dilatation of which eliminated annual variations and variations caused by rainfall at Ide.

1 : -Vertical, 2 : -Horizontal·N88°E, 3 :  
 -Horizontal·N2°W, 4 : -Dip 50°·N88°E,  
 5 : -Dip 66°·N2°W, 6 : -Horizontal·N77°W,  
 V : -Volume dilatation (1+2+3)

the Ide Observatory are shown as in Fig. 3. As this figure shows, peculiar variations were found several months before and after the earthquake-occurrence. Especially, the peculiar change is shown in the variation of extensometer-5 set up toward hypo-centre. The ground-strain gradually became large about March and it suddenly increased from the middle of June. Soon after, on July 13, just 5 days before the earthquake-occurrence, the direction of variation turned to the contrary direction, and the earthquake occurred on July 18. After that the variation of strain continued in the same direction for several months and the ground-strain recovered to some extent. The same remarkable variations of ground-strain were observed by extensometers 1 and 3 (set up nearly toward hypocentre) and shown in volume dilatation-V calculated from the record observed by extensometers 1, 2 and 3 (which were set up rectangular co-ordinate axis). The peculiar changes were not shown clearly in the other components orthogonal in the direction of hypocentre. On the other hand, the peculiar change of ground-strain before and after the Yoshino Earthquake was also observed by Prof. I. Ozawa at the Osakayama Observatory about 20 km distance from the Ide Observatory.

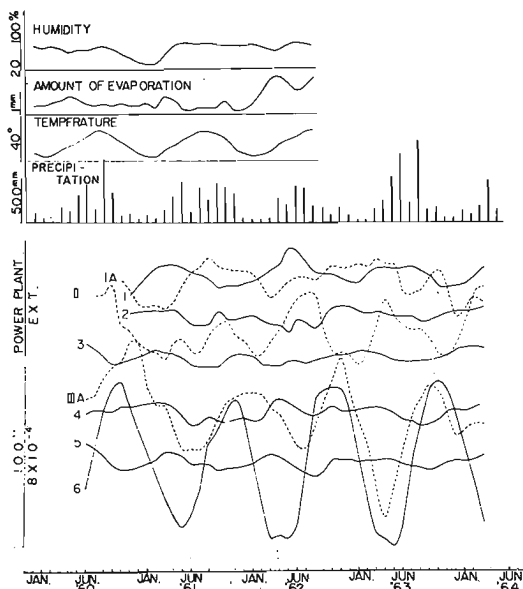
Fig. 12. Annual variations of the ground-strains (—) and the ground-tilts (---).

The annual variations of ground-strain and -tilt obtained from the observations by six extensometers and three tiltmeters which have been used from the start are as shown in Fig. 12. Generally, these variations are periodic, and the extension and contraction of the secular variation make the phase of annual variation contrary. In order to clear up the cause of the annual variation, we investigated the relationship of the meteorological

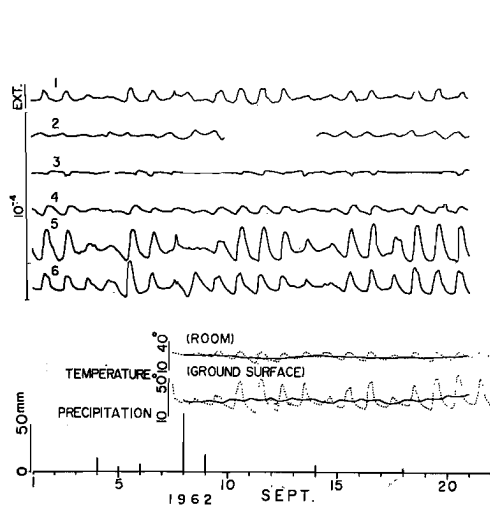
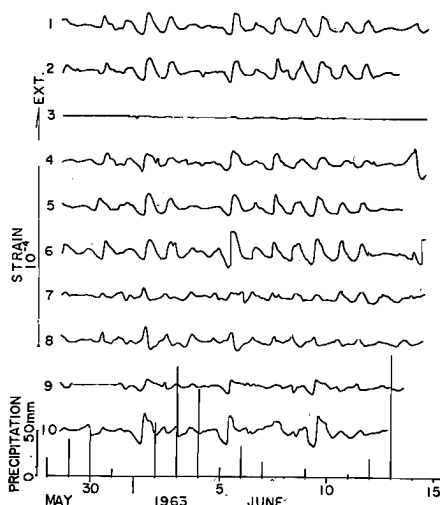
Fig. 15. Daily variations of the ground-strain, temperature and precipitation.

variations of ground deformation, it seems that they are identified with the temperature on the ground surface. Above all, it is believed that where daily variations are large secular variations are also large. It means that the ground deformation in this place is changable.

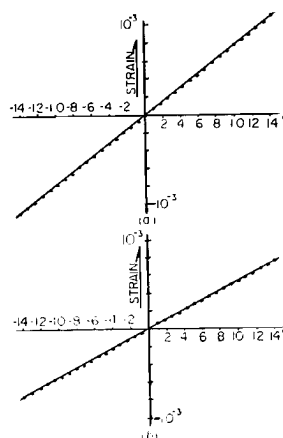
Fig. 21. Sensitivity of the portable underground inclinometer.  
(Relation between the angle of inclination and strain)

strain) is shown. Where (a) is the sensitivity on upper spring and (b) is that on lower spring which directs right-angle to upper spring. In this experiment, the tilting motion in any direction was just the same to that obtained by resultant of two components.

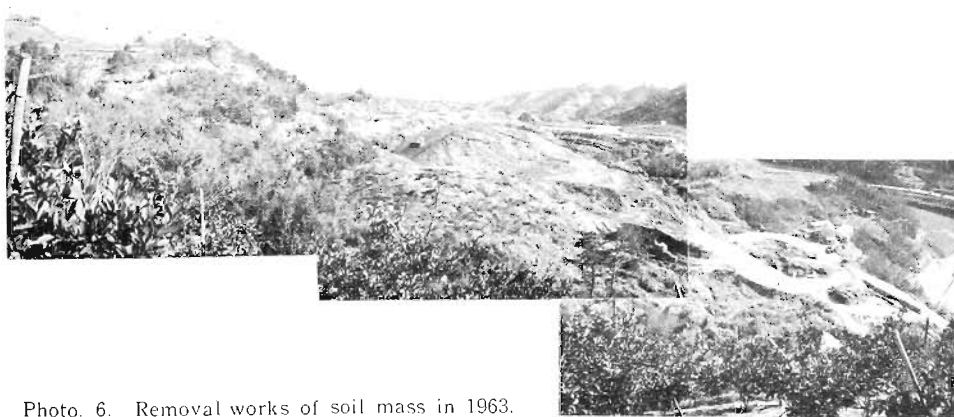
Photo. 6. Removal works of soil mass in 1963.

extensometer 3 to extensometer 1 was a compressive zone which checked the landsliding of the higher block. So much care, was taken in the removal works which have been carried on since the middle of September. The first construction was to make a transporting road which led to the National Road and the next was to cut off the slope to expand the city road near the shaft No. 1. These projects removed about 5,000 m<sup>3</sup> soil mass to the east along the city road until the beginning of November. From the end of December to the middle of February, 1964, about 30,000 m<sup>3</sup> soil mass in the western slope of Umanose, and from the middle of February to the end of March, about 25,000 m<sup>3</sup> soil mass in a little hill on the east of shaft No. 2 were removed. A total of 60,000 m<sup>3</sup> soil mass was removed. (See Photo. 6.)

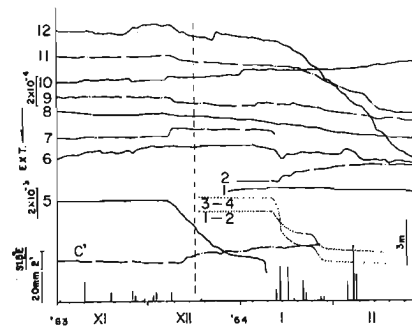
Fig. 25. Variations of ground-strain and ground-tilt before and after the crack-occurrence and the precipitation.

each other across a main crack in order to observe the variation of gap of crack. The result of these observations is shown in Fig. 25. The distances 1-2, 3-4 between these posts were suddenly extended on January 12 and they moved about 3 m during the next 5 days and increased about 1 m during the 3 days after January 25, showing the change of about 4.5 m horizontally, about 2 m vertically (See Photo. 8.), but the change has gradually decreasing since then. In Fig. 25, the variations of ground-strain and -tilt observed by extensometers and tiltmeters are shown in addition. From these variations the forerunning phenomena before the occurrence of crack (i.e. the occurrence of landslide) were observed. The extensometer 5 which crossed over the crack changed to the extension from about December 7, 10 days before the occurrence of the cracks and then the cracks occurred. After that it still continued to be tensile, but the rate of variation decreased at the end of the year. From about January 3, the rate again increased and on January 9 the observation became impossible because of the great extension. After that the gap of crack opened suddenly on January 12. Extensometer 6 set up in the compressive zone which is above to the crack showed the compression till about December 7, and after that the variation stopped for a while, but from about January 5 it changed to the extension. Extensometer 7 also showed the compression from about December 9 and after that from about January 6 it showed the extension. In these variations observed by other extensometers and tiltmeters the variation of changing rate was found before December 7 and after January 6. The ground surface was gradually deformed from about December 7 and it was broken on 17th making cracks. From about January 6, the deformation became large and was enlarged on 12th. The variation of ground-strain and -tilt occurred long before the occurrence of the landslide. So from the observations of ground-strain and -tilt the key for the prediction of landslide-occurrence may be found. In conclusion, it also seems that the landsliding of the higher block was checked

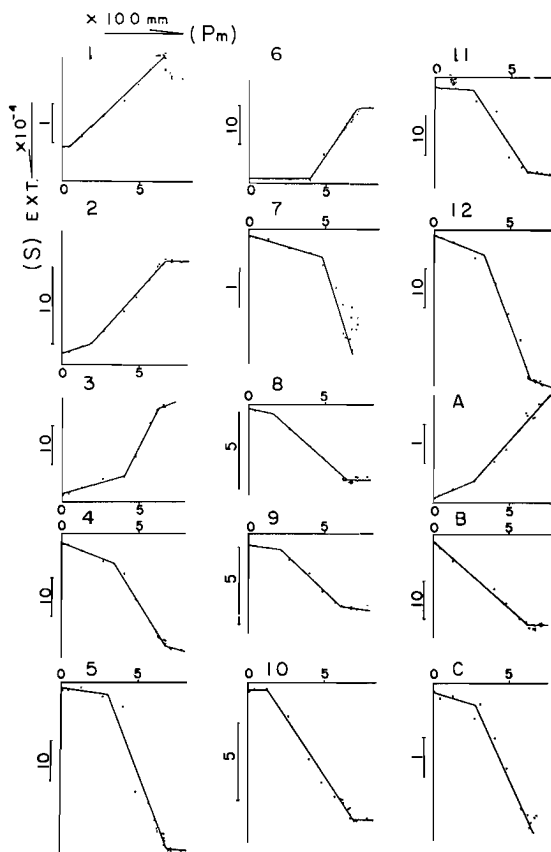
Fig. 27. Relation between the ground-strain and the successive accumulation of weekly precipitation.

the rainfall. Next, in order to study the ground-strain caused by rainfall, the relations between the successive accumulation of weekly precipitation and the ground-strain is shown in Fig. 27. From these figures we find that the ground-strain increases or decreases with the increase of the successive accumulation of precipitation. Afterward when the successive accumulation of precipitation amounted to a definite value, the variation rate of the ground-strain suddenly decreased or its variation stopped. It is believed that this phenomenon is due to the increase of the water content ratio in the soil with the permeation of water, but at last the water content quantity amounts to the saturation point. G. Kajikawa has tried to obtain the relationship between the moisture ratio (%) and the internal frictional angle ( $\phi$ ) and between the moisture ratio (%) and the cohesion ( $c$ ) on the soil in that area. (See Fig. 28.) According to this report, after the water content ratio increased more than some value,  $\phi$  and  $c$  became suddenly small and the soil inherited the plasticity. So it is believed that the results of the variation in the water content ratio of soil, (caused by rainfall) and the form of slip surface etc. complicate each other. At this point a landslide occurs and the ground strains. Accordingly, it is considered that the ground-strain does not change much when there is not as much rain as in the rainy season of 1964.

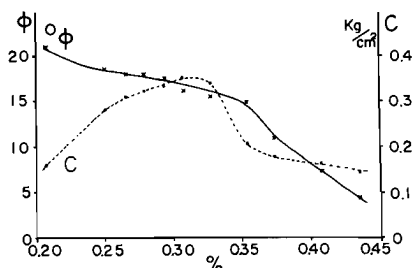
Fig. 28. Relation between the moisture ratio (%) and the internal frictional angle ( $\phi$ ) and the moisture ratio and the cohesion ( $c$ ) on Kamenose soil. (after G. Kajikawa)
