# 大谷崩一の沢での土石流観測

静岡大学大学院M1 高橋英成

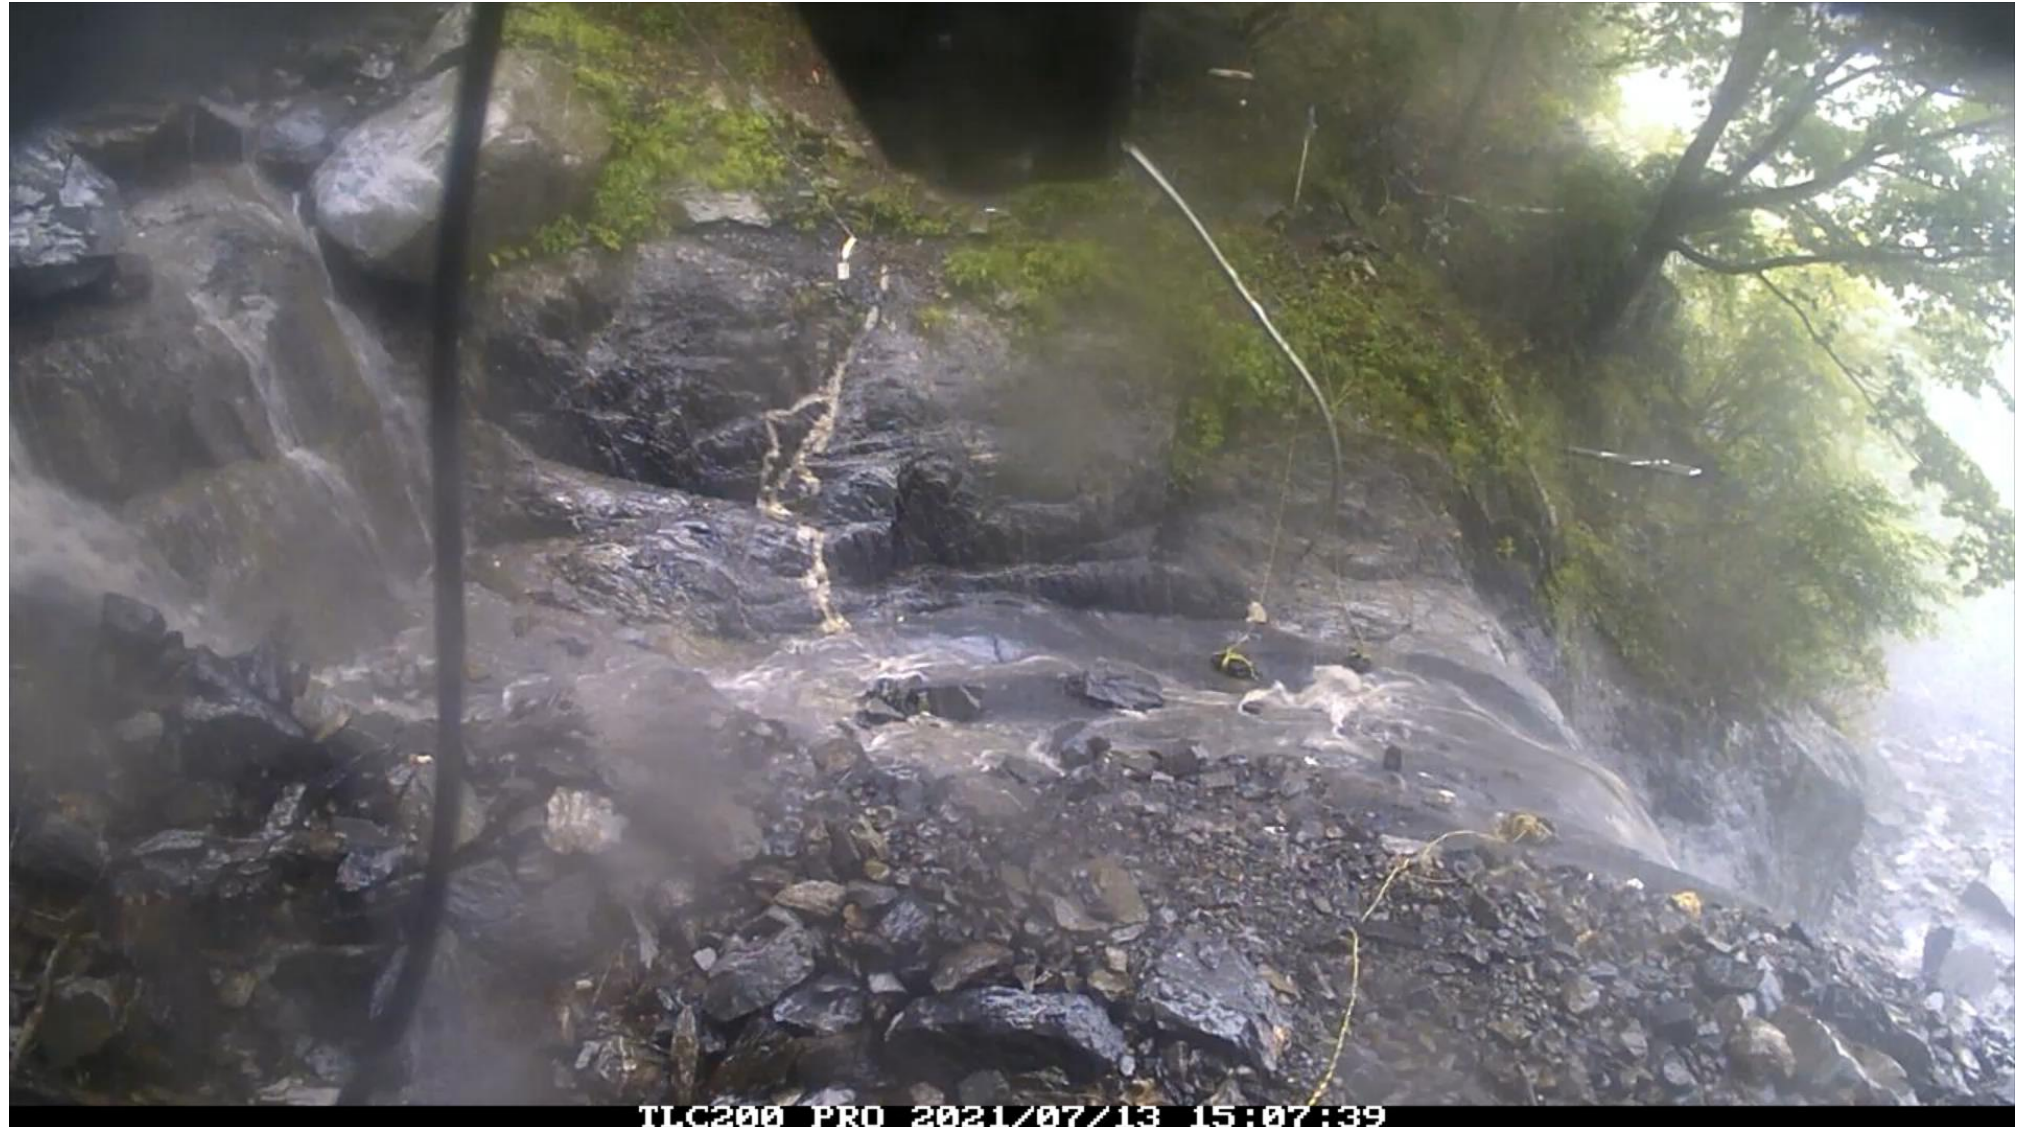
# 不飽和土石流の映像

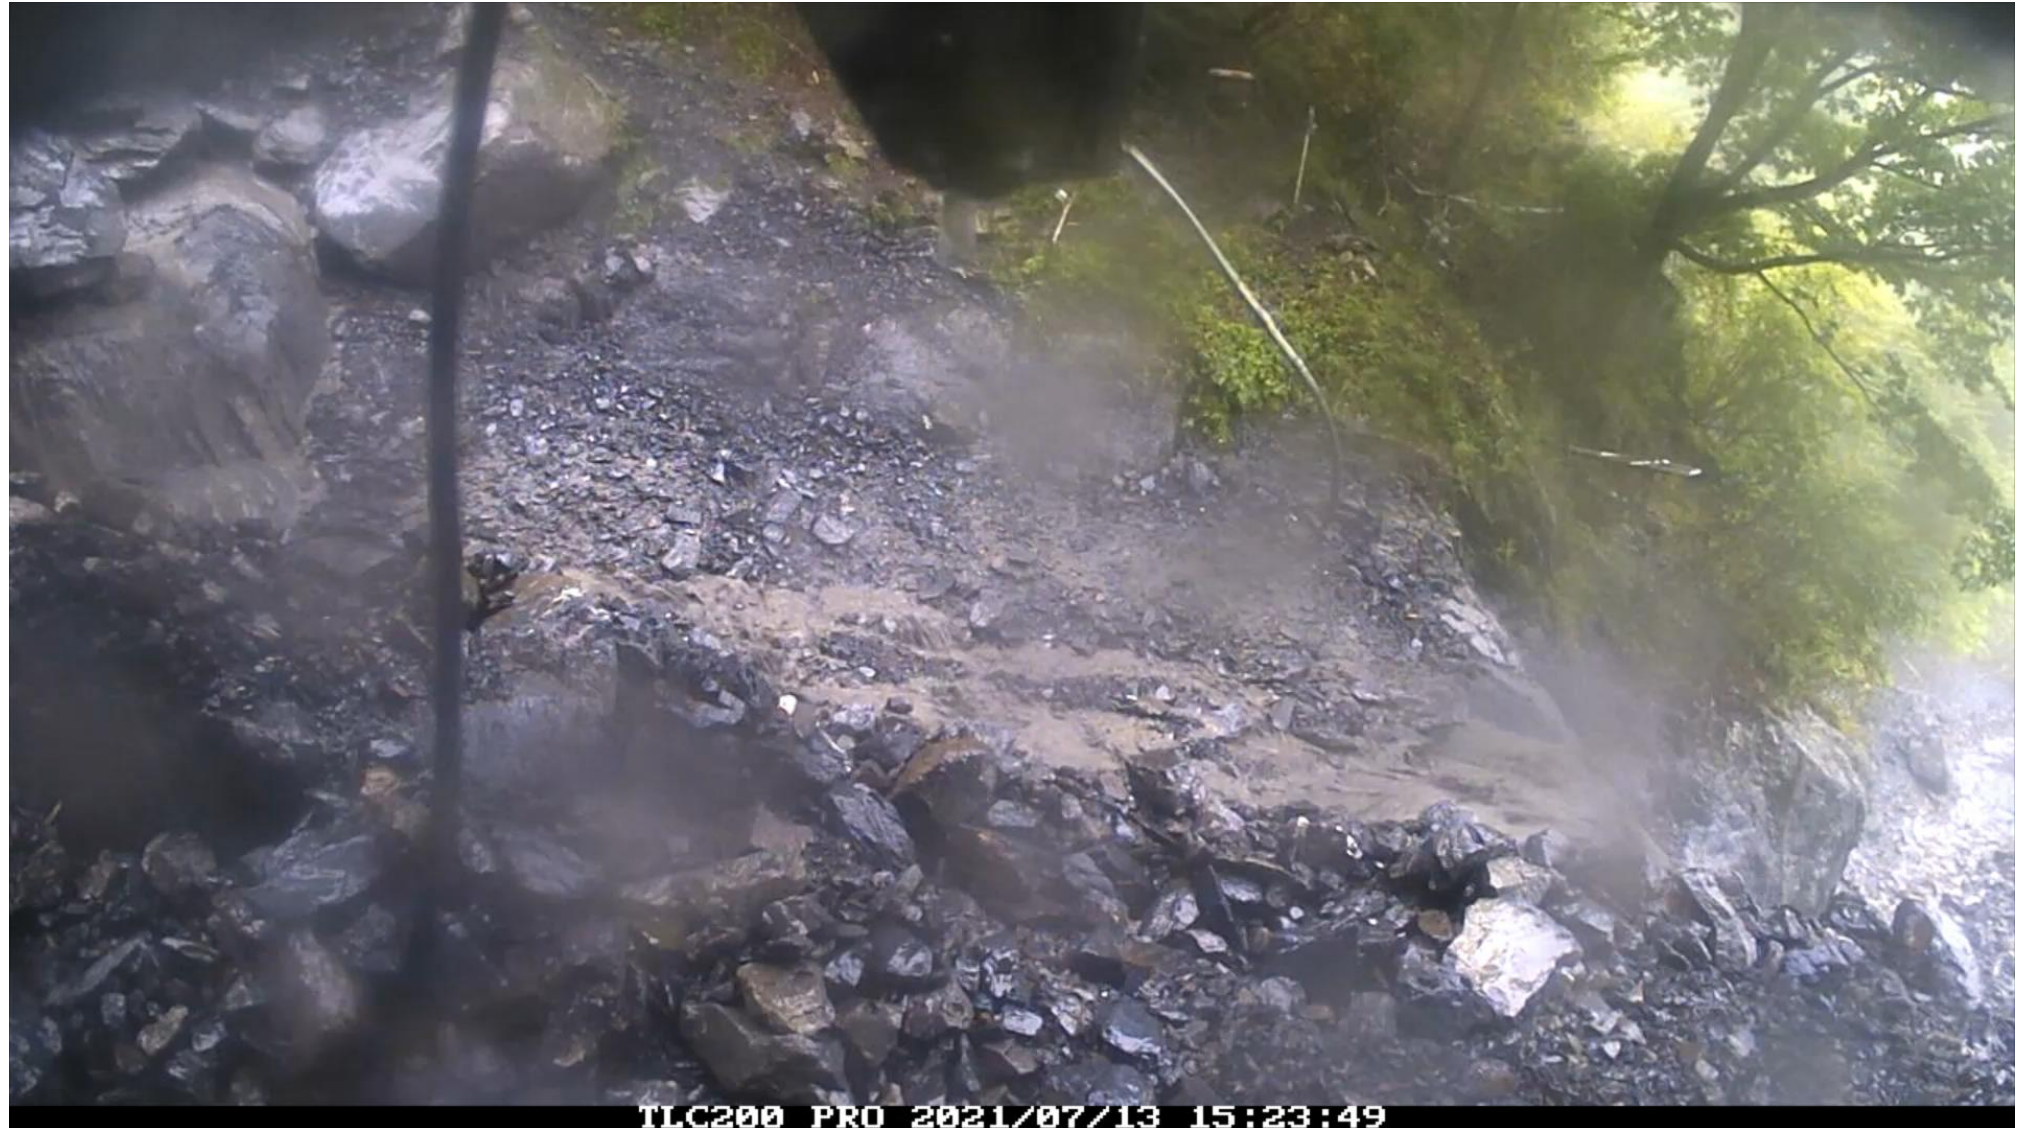
# 飽和土石流の映像

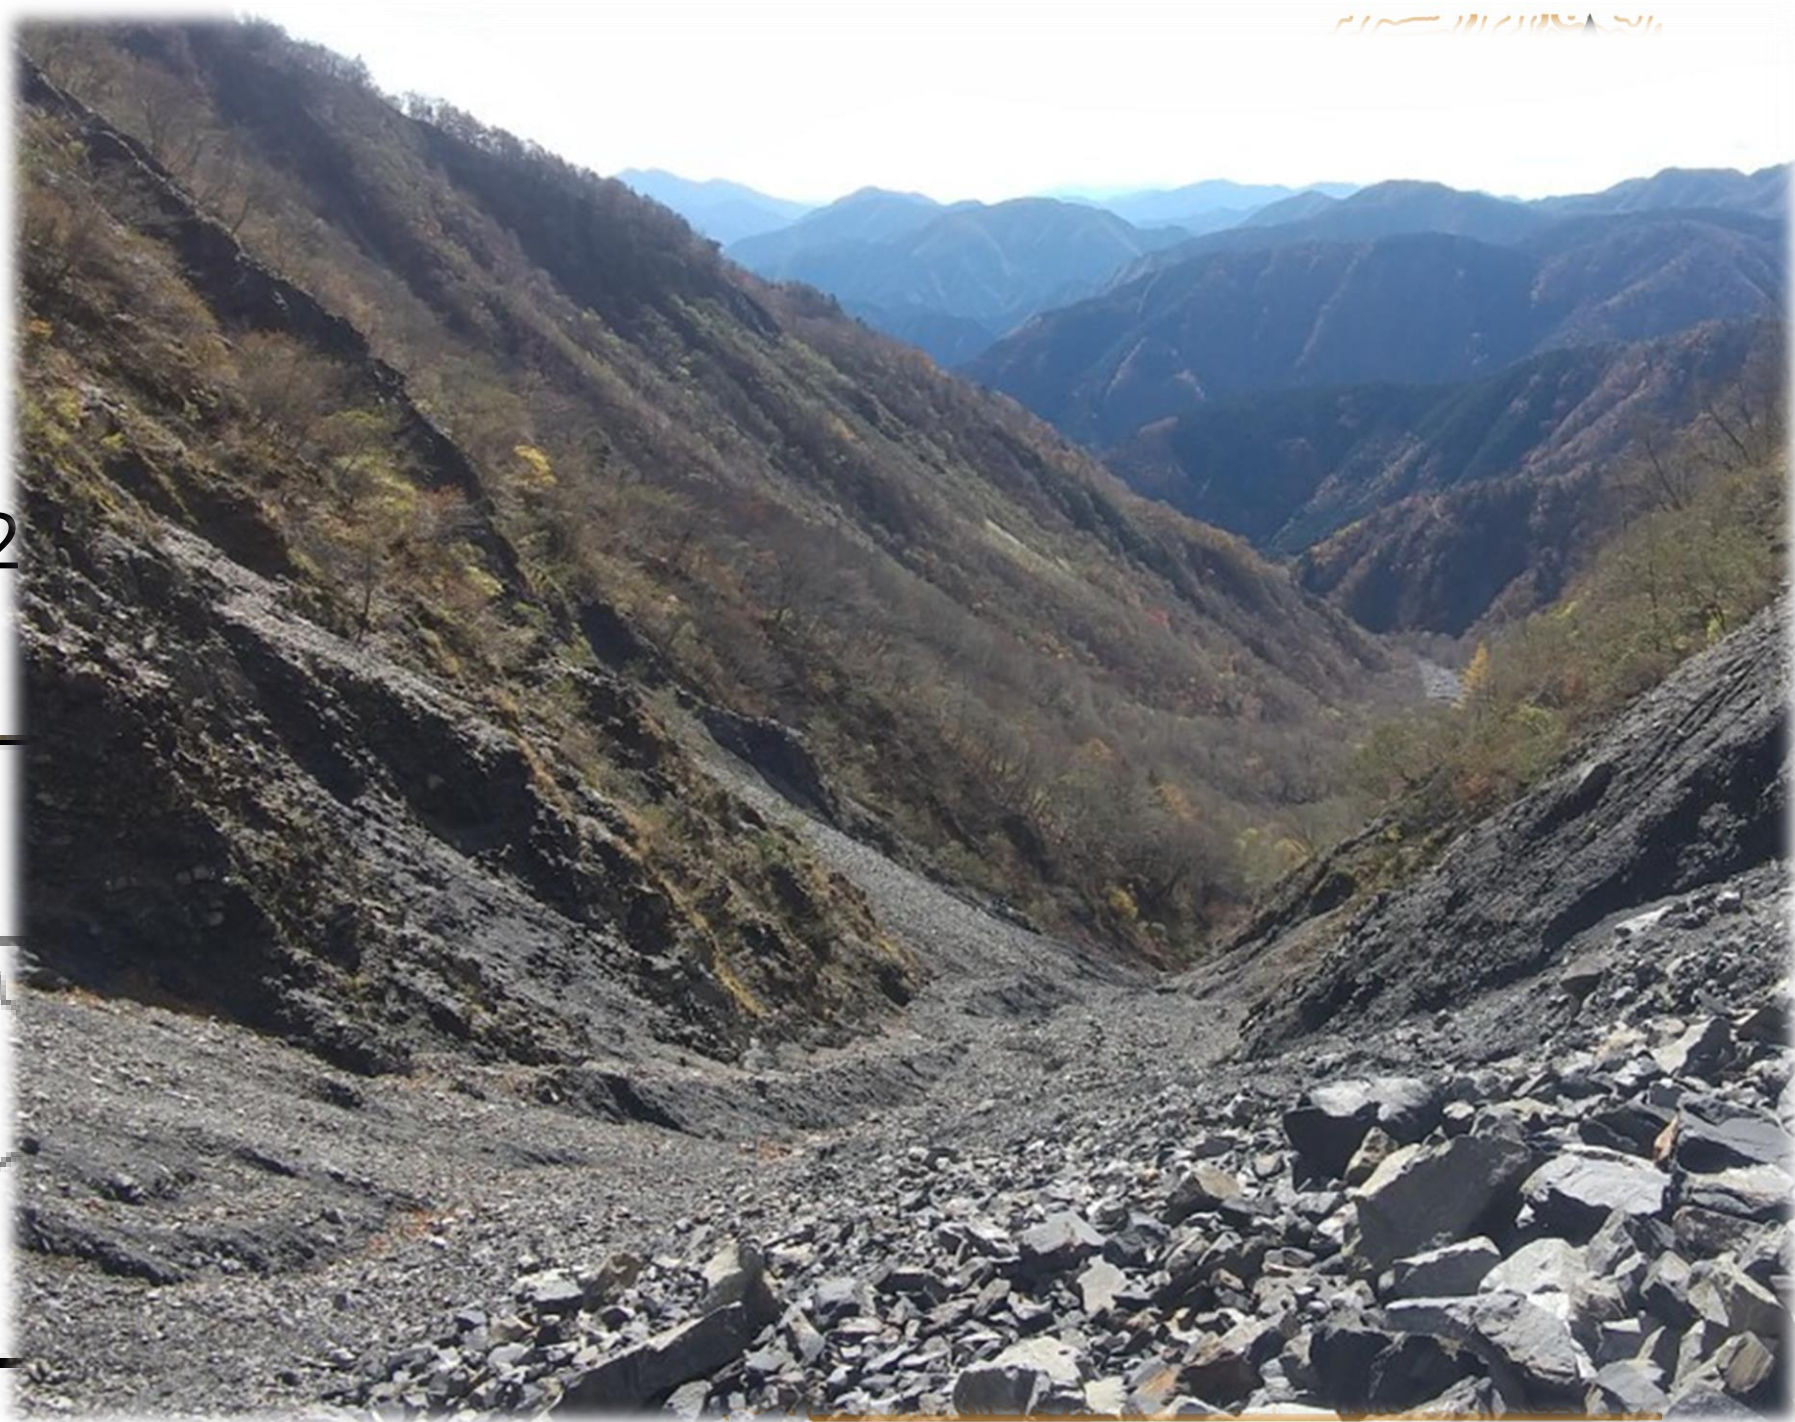
## 大谷崩一の沢

面積：約0.22km<sup>2</sup>

平均溪床勾配：約2  
人為が介在しない。

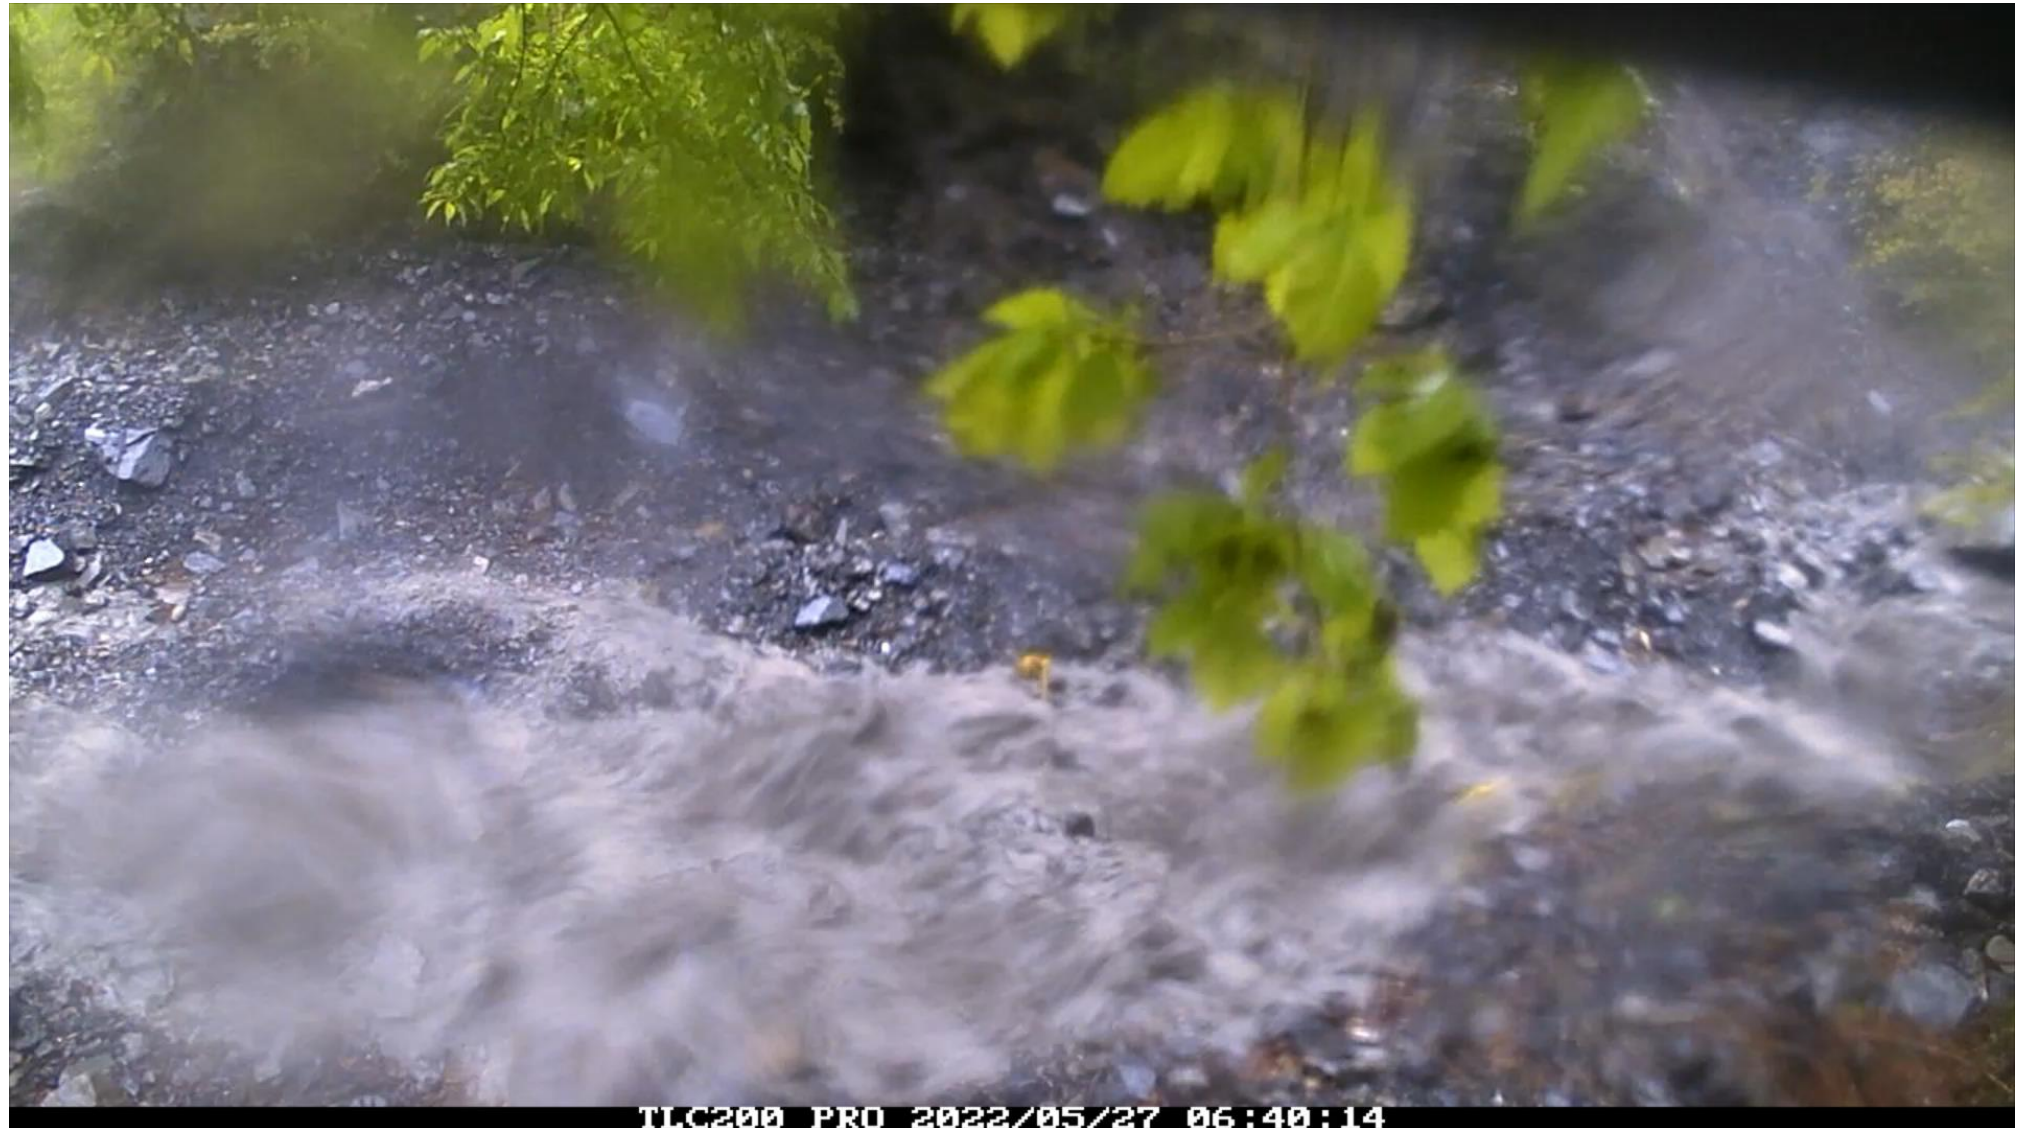
TLC200 PRO 2022/05/27 06:40:14

# 5月27日の土石流の映像

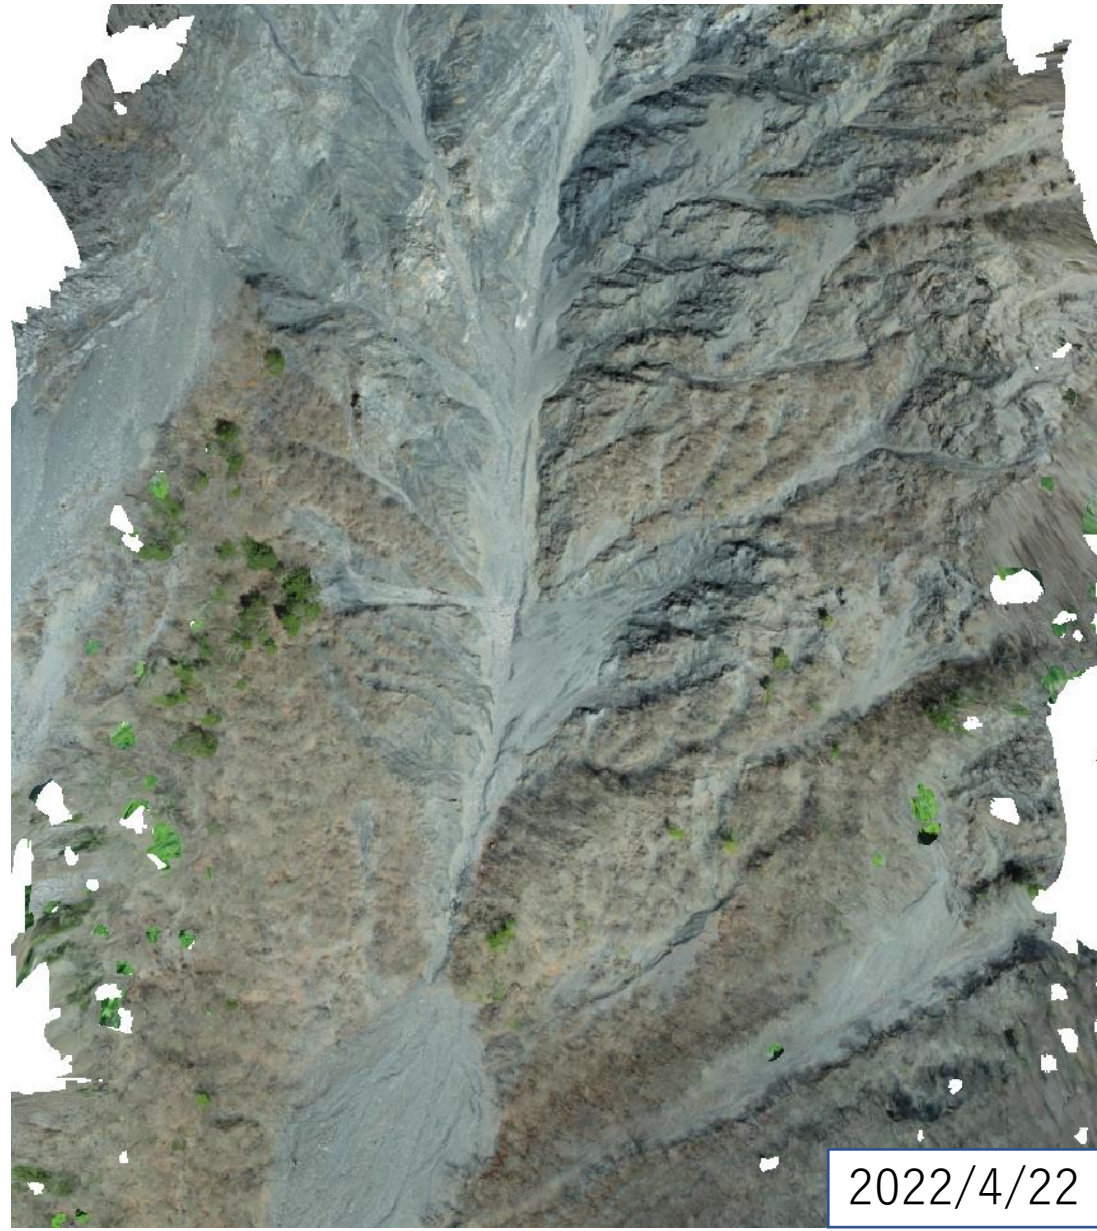
# 5/27の土石流（発生前後のオルソ画像）

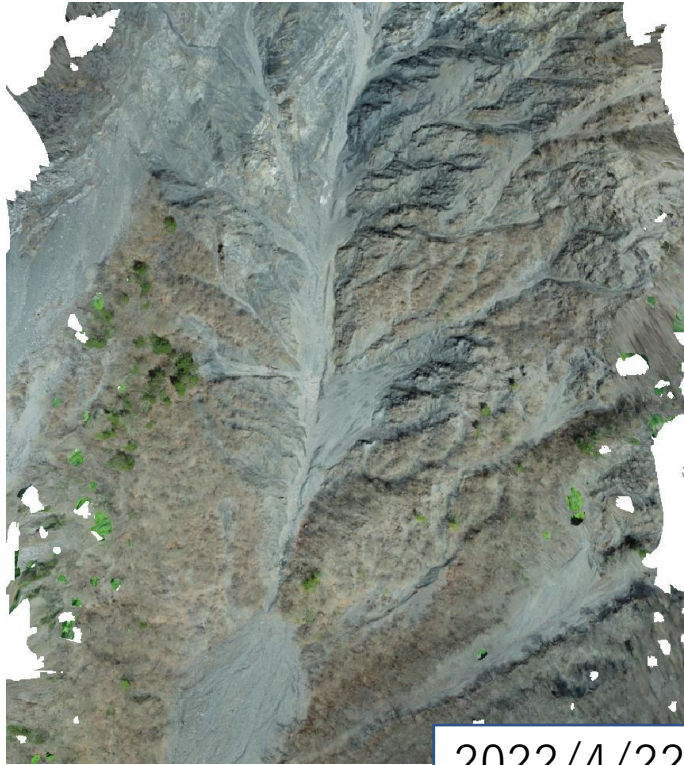
2022/4/22

# GISから分かる地形変化
