# DPRI Newsletter

No.14 1999年11月

## 1999年コジャエリ地震報告

# Chichi, Taiwan Earthquake (Mw 7.7)

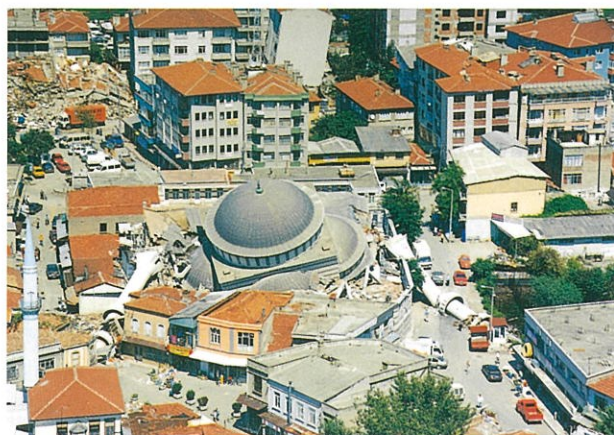
アダバザルの倒壊したモスク（8月31日撮影）

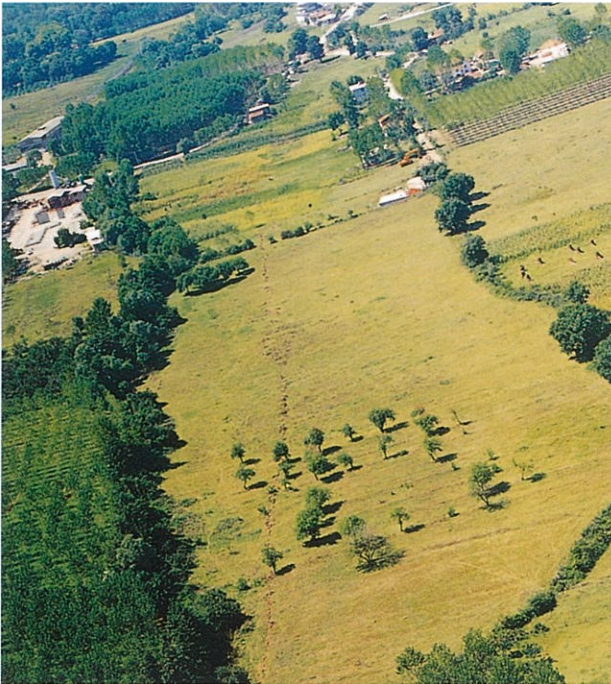
イズミット市の東隣に位置するキョセキョイ市を走る地震断層  
(8月31日撮影)

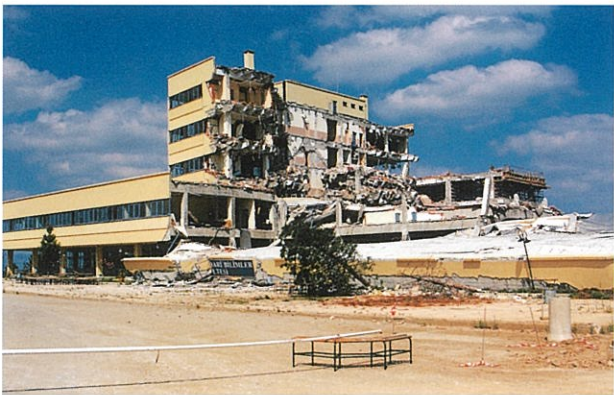
コジャエリ (イズミット) 大学の造営中の新キャンパス内の建物の被害 (7月17日撮影)

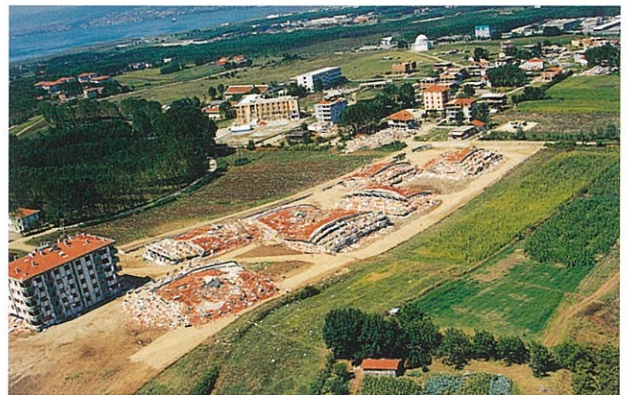
イズミット市での被害の例。このアパート群の建っていた敷地内を断層が走っている (8月31日撮影)

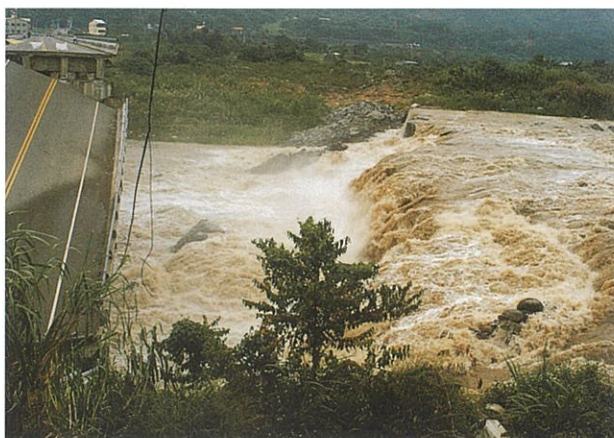
There were spectacular vertical offsets in the river northeast of FengYuen. At one site near a collapsed bridge, a new waterfall formed from an estimated 8 meter vertical fault offset (Photo 1). About a kilometer from

New waterfall created by fault offset. The vertical displacement is estimated to be about 8 m. (Photo1)

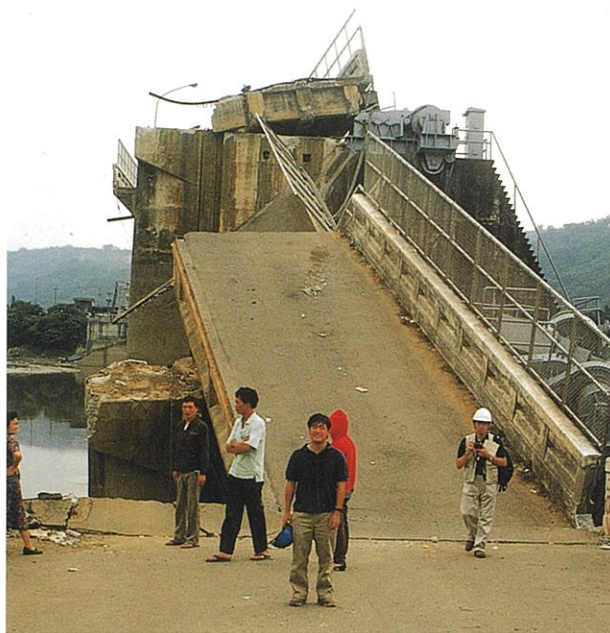
Road along the top of a dam that is vertically offset by fault. (Photo2)

this site, a dam was cut by the fault. The road running along the top of the dam was vertically offset by 8 meters (Photo 2). These displacements are some of the largest surface fault movements observed for earthquakes world-wide.

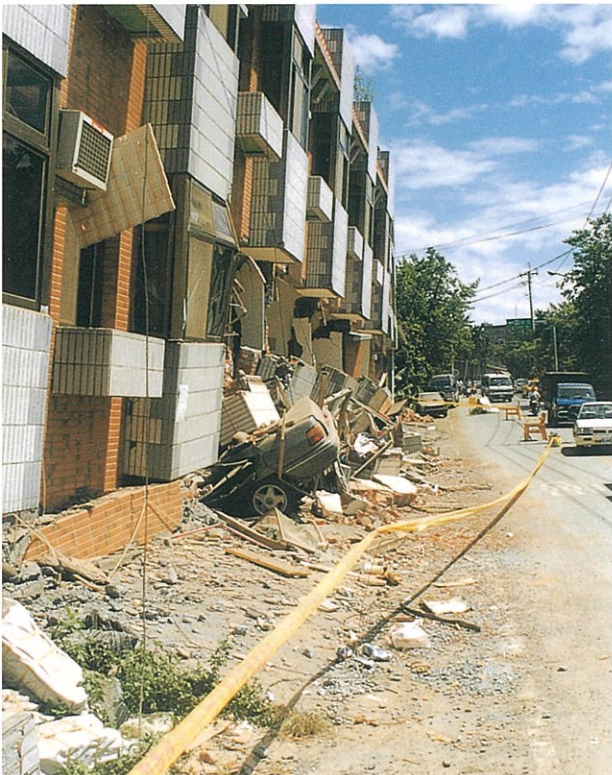
In the southern region, there were many collapses of the first story in 2 to 4 story buildings. This was largely due to a soft first story. The first floors had fewer walls with more open areas and were used for parking or businesses. There were many of these collapses in ChungLiao (Photo 3).

Collapse of the 1st floor in a 3 story building located in Chungliao. (Photo3)
