# Diagnosis of Production Facilities of Bandsaw Mills by Sawing Accuracy

—Investigative report at Norwegian bandsaw mills—

Nobuaki HATTORI

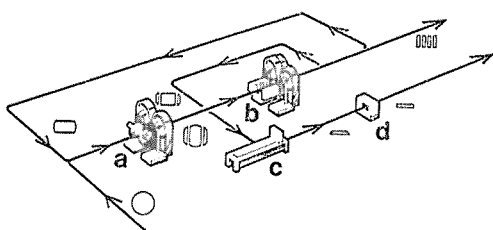
Fig. 1 Typical layout of modern Norwegian sawmill. (a) chipper canter and twin saw, (b) triple saw, (c) optimizer and (d) double edger.

Figure 1 shows an example of a layout of production facilities at one of the seven bandsaw mills. A log enters from lower left of the figure after barking and is converted to a cant by the chipper canters and the twin saw in group (a). The cant is fed back again to the starting

point and cut into two or four boards by machines of groups (a) and (b). The side strips derived from the primary sawing and resawing are edged to boards by the double edger (d) after positioning of the strip by the optimizer (c). The average yield of lumber and chip per log was 55 % and 35 %, respectively. Mills B and F have only one single bandsaw machine with carriage, but the remaining five mills have more than two machines among from single to quad saws and an automatic feeding system. Mills A, D, E and F have a log sorting line. Mills C, D and E convert mostly spruce (*Picea abies* Karst.), Mills A, B and G 60-80 % spruce and 40-20 % pine (*Pinus sylvestris* Linn.) and Mill F pine only. Typically the bandsaws used at the mills were 180 mm in width and 1.47 mm in thickness, had teeth (2.4 mm kerf width) spaced at 40 mm and were driven at 40 m/s. Average feed per tooth in winter, 0.688 mm was 13 % lower than that in summer, 0.790 mm.

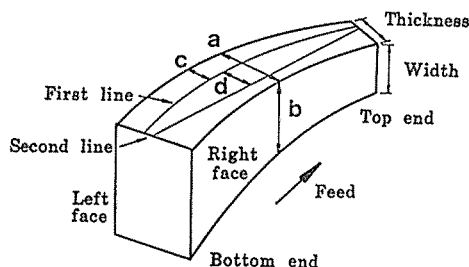
Fig. 2 Measurement locations method on board. (a) thickness, (b) width, (c) distance between left face and the first line and (d) distance between both the lines.

along the first line as shown in Figure 2. The thickness (a), the distance between the left face and the first line (c) and the distance between the two lines (d) were measured by a digital caliper at twenty one points at equal intervals from top end to bottom. The width (b) was measured only at the outside face of the two outer boards.

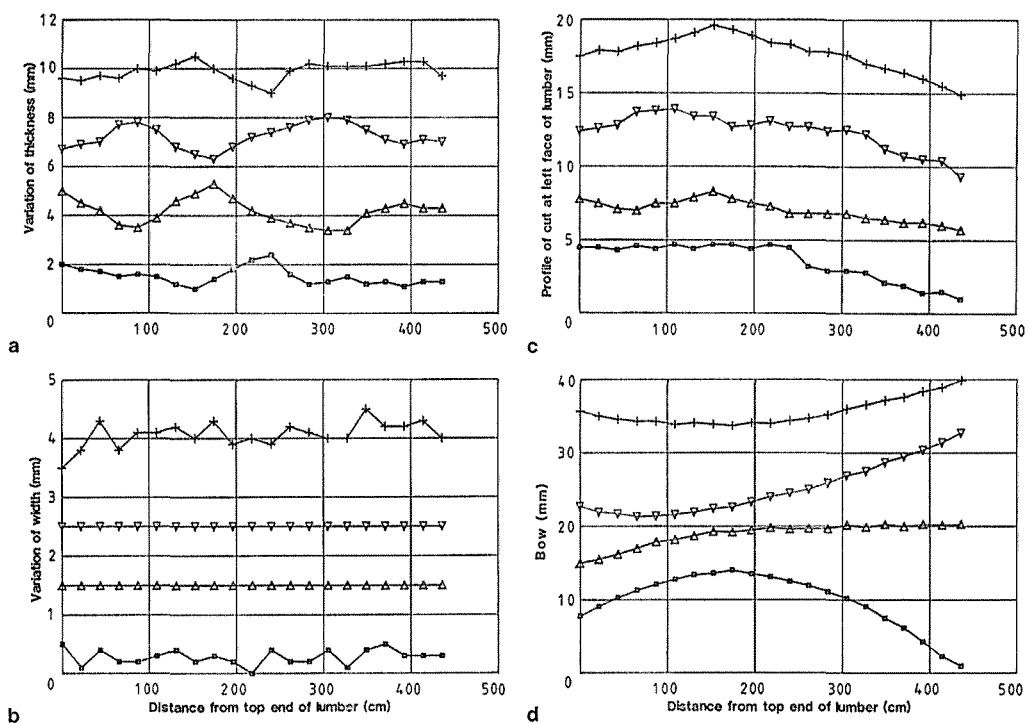
Fig. 3 Typical figures made from data sets of a board. (a) variation of thickness, (b) variation of width, (c) profile of cut on left face of board and (d) bow.  $\square$  left side board,  $\triangle$  middle left board,  $\nabla$  middle right board and  $+$  right board.

Figure 3 gives an example of the values measured on boards cut from the same cant. These figures show variations of thickness (a) and width (b), profiles of cut along the left face of the boards (c) and bow (d). The abscissa indicates the distance from the top

end of the boards in cm and the ordinates indicate the variation of variables in mm. The raw values of each ordinate plotted on Figure 3 contain an arbitrary offset which is removed in the data processing. With the data in this form, the following matters were analyzed at each mill: variations of thickness and width, straightness of sawn surface, size difference from target size and contact pressure distribution between sawblade and wheel.

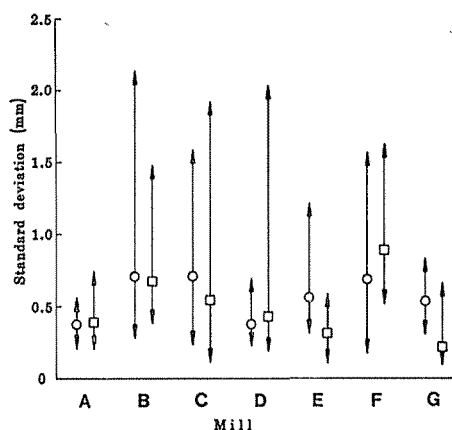
Fig. 4 Variation of thickness and width indicated by standard deviation at each mill. ○ mean of standard deviations for thickness and □ mean of standard deviations for width. A line with arrow heads indicates range of standard deviations.

Figure 4 shows the mean value of the standard deviations for the thickness and

width at each mill and their ranges. Mills E and G had significant differences (5 %) between the mean values of the standard deviations for thickness and width. Mill C also appeared to have the same tendency, but the mean value of the standard deviations for the thickness variation at Mill F was greater than that for the width. Furthermore, Mills B, C, D and F seemed to produce lumber with larger variations for thickness and width. Therefore, the difference of variation between thickness and width is considered to differ with mills. It is very difficult to find the main cause but it seems to come from the adjustment of individual machines and the global adjustments between groups of machinery.

It may safely be said from this figure that mills using single bandsaw machines with carriage belong to the group with relatively larger variations of thickness and width and the age of mill had no statistical connection with the variation.

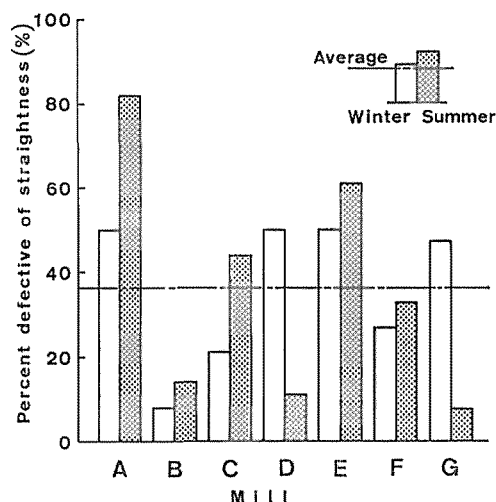
Fig. 5 Percent defective of side faces of boards from the point of straightness of profile of cut at each mill. A face was judged bad if three times of the standard deviation is over 5 % of the width.

The first step is to check percent defectives of straightness of both faces of boards at each mill, and the results were obtained in Figure 5 judging from the value of 5 % of target thickness as the criteria. Comparing this figure with Figure 4, Mill A with small standard deviations and narrow ranges for thickness and width produced a lot of boards with bad straightness, while Mill B had the opposite tendency. Typical profiles of cut sawn by Mill A were shown in Figure 6. It is clear from this figure that the variation of thickness of these two boards are very small even if straightness of the profiles of cut are very bad. Four mills showed worse straightness in summer than in winter. Percent defectives of Mill B and F were under the average defective of all mills. These mills are the only mills which use a single bandsaw machine with carriage.

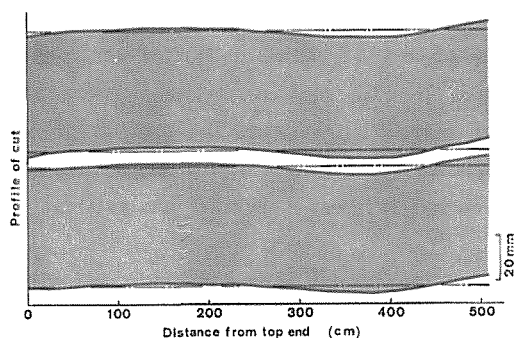
Fig. 6 Typical bad profiles of cut of two boards produced at Mill A in summer.

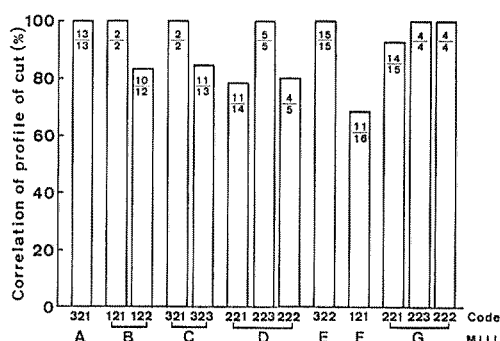
Fig. 7 Result of analysis of correlation between both profiles of cut sawn by a processing machine at each mill. A numerator in a bar graph indicates the number of cuts with 1 % significant profiles on both sides.

The second step of diagnosis is to analyze whether two profiles of cut of a board sawn by a processing machine are correlated or not. Figure 7 shows the percentage of

the number of cases with correlated profiles of cut to the total number analyzed at 1 % significant level at each bandsaw machine of the mills. The two codes of Mill B denote going and returning of the carriage of a double cutting bandsaw machine, respectively. The coefficient of correlation between two profiles of cut produced by a bandsaw machine must be almost one generally if the sawing is done normally. But there are six cases that could not reached the line of 100 % in this figure. Two profiles of cut with a low correlation suggest the vibration of a sawblade or unsymmetrical swaged sawteeth. An example of Mill F among them is shown in Figure 8 which shows the change of a kerf width along the longitudinal direction. These cases are not a serious problem because there was no such case among profiles of cut with bad straightness in this analysis.

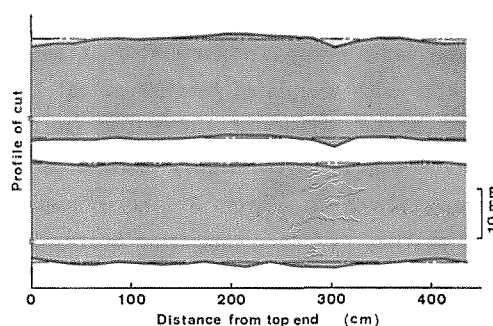
Fig. 8 Typical profiles of cut without 1 % significant profiles on both sides sawn at Mill F.

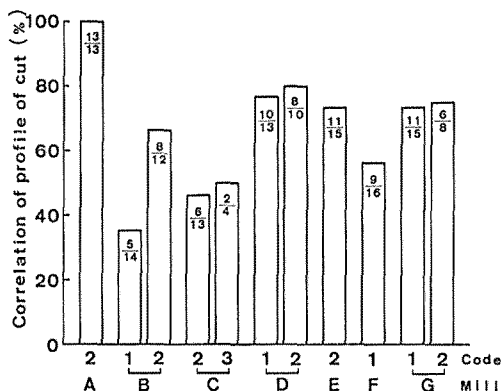
Fig. 9 Result of analysis of correlation between any two profiles of cut among boards sawn by processing machines in the same group at each mill. A numerator in a bar graph indicates the number of 1 % significant result.

in the same group are correlated or not. Figure 9 shows the percentage of the number of cases with correlated profiles of cut to the total number analyzed at 1 % significant level at each group of the mills. Only the machines in the second group of Mill A produce boards with highly correlated profiles of cut of which a typical example is already shown in Figure 6. An example of Mill E with low correlation between any two profiles of cut among two boards and high correlation between the profiles of cut produced by a sawing is shown in Figure 10. The cause of bad straightness in this case may come from bad feeding and bad processing on outer faces. A further analysis can be executed by FFT analysis.

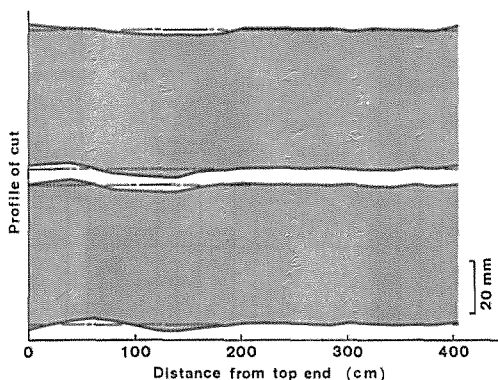
Fig. 10 Typical profiles of cut without 1 % significant profiles among boards sawn at Mill E.

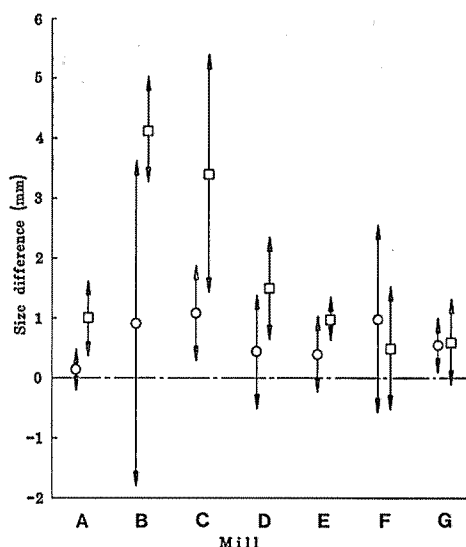
Fig. 11 Size difference from target size at each mill.  $\circ$  mean of size differences for thickness and  $\square$  mean of size differences for width. A line with arrow heads indicates  $\pm 1$  standard deviation.

Information about size difference from target size is shown in Figure 11 where mean values of size differences from the target thicknesses and widths are indicated with their standard deviations. Each data set was recognized to have a normal distribution. An F-test to compare variances of size difference for thickness and width from the target sizes found that all mills except Mills D and F had differences between the two variances. Two kinds of t-tests were performed in order to compare the mean values of thickness and width differences from the target sizes. As a result, Mills F and G were recognized significantly (1 %) to produce lumber with the same grade of size difference

from the target size for thickness and width. Other mills seemed more or less to produce lumber with different size difference. In particular, Mills B and C seemed to produce lumber which have widths much more oversized than the thickness. Because of this large variation, the machines in the mills have been adjusted to produce oversized lumber in order to insure acceptable finished sizes. Only Mill F could be evaluated to produce lumber with the same grade of size differences between thickness and width from the standpoints of the mean value and the standard deviation. From these results, it became clear that machine adjustments are set with larger oversize for the primary sawing (decision of width) than for resawing (thickness) at all bandsaw mills which were judged to produce lumber with different size variations of thickness and width.

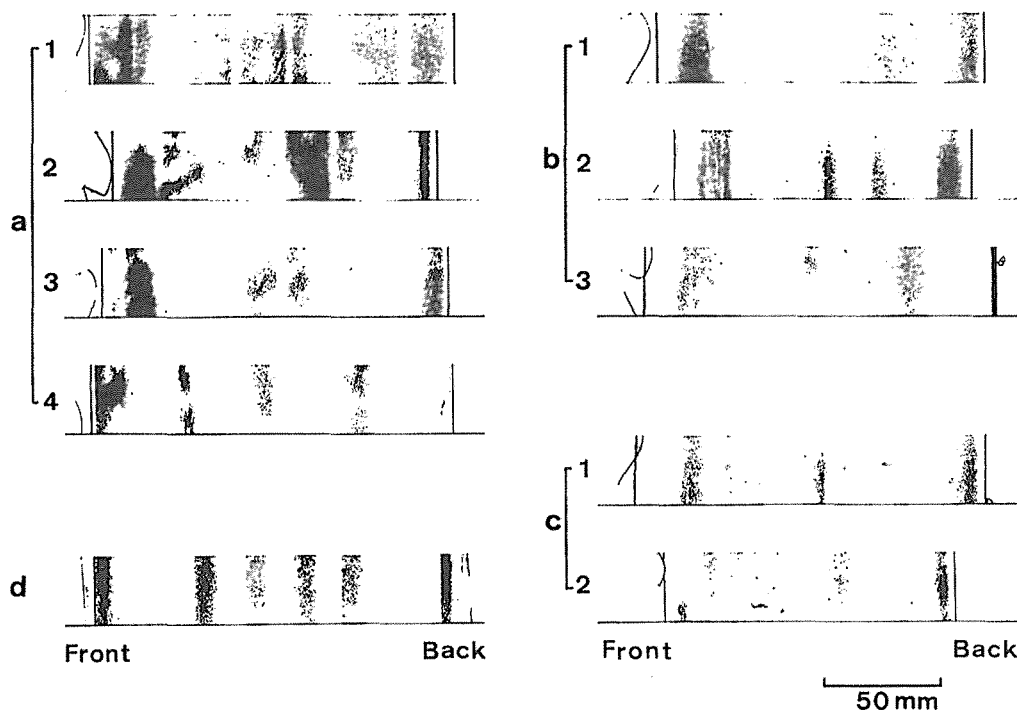
Fig. 12 Some examples of pressure distribution between sawblade and upper wheel of bandsaw machine. (a) quad saw, (b) triple saw, (c) twin saw and (d) special type of single bandsaw.

Pressure distributions between the sawblade and upper wheel were measured on most of the bandsaw machines at the seven mills with the prescale paper. Most of the wheels had a small curvature on their surfaces. Figure 12 shows a few examples of the measurements. The darker parts mean higher pressure in this figure. From this figure, it was recognized that the highest pressure part is not at the front edge of the contacting area but a little inside of the front zone as shown in the case of a-1, a-3 and so on or middle zone (a-2 and b-2) or back zone (b-3, c and d). If a sawblade is only a belt that transfers force to the other wheel, this pressure distribution is acceptable. But if this blade has teeth at the front edge and is tensioned to stabilize the blade especially in the teeth zone, the highest pressure part should be at the front edge of the contact area, somewhat lower pressure part should be in the back zone and the least pressure in the middle according to the shape of cross section of a sawblade on the wheel as shown by Sugihara<sup>11)</sup>. Furthermore, it became clear that there are irregular pressure distributions in the front zone along the longitudinal axis of the blade as shown in a-2 and a-4 and that the teeth are in the contact area (b-3 and c-1). The first undesirable situation is considered to be caused by poorly tensioned sawblades or wear of the wheel while the second was caused by incorrect inclination angles of the upper wheel which also caused irregular pressure distributions. From these results of the contact pressure distri-

bution, it may be suspected that a wheel with some curvatures or special grooves on its surface demands stronger tensioning than that with flat surface and that such wheels are not suitable to stabilize the front side of a sawblade between both saw guides.
