## Geological and Geomorphological Factors at some Landslide Areas in Shikoku

By Takahiko FURUYA

From a geological and geomorphological point of view, the writer described some landslide areas, and pointed out their characters.

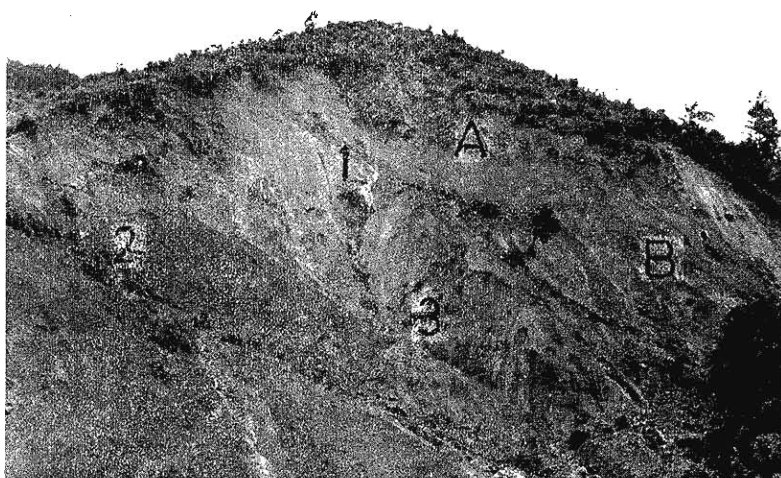
Photo 1. The upper part of Shigeto landslide area.

1~3: Gushed water A: Chert B: Slate

The landslide area is geologically composed of a slate layer and, in places, blocky sandstone layers. The rupture surface cuts the rock formations and is uneven. It is weathered strongly in the upper part, but little in the lower part. No clay is found around the landslide scarp. Much water gushes out of three fissures on the scarp (see photo 1). Detrital materials are deposited at the foot of the scarp, keeping trees tilted on the surface (see photo 2). Around the boundary of rupture surface and slid mass there were many blocks about 50 cm in diameter composed of sandstone and slate. Many cars and people were pushed away to the toe of the landslide, which reached as far as the river (see photo 2). On the basis of these facts, Shigeto landslide may have occurred along weaker fissures inside the rock formations.

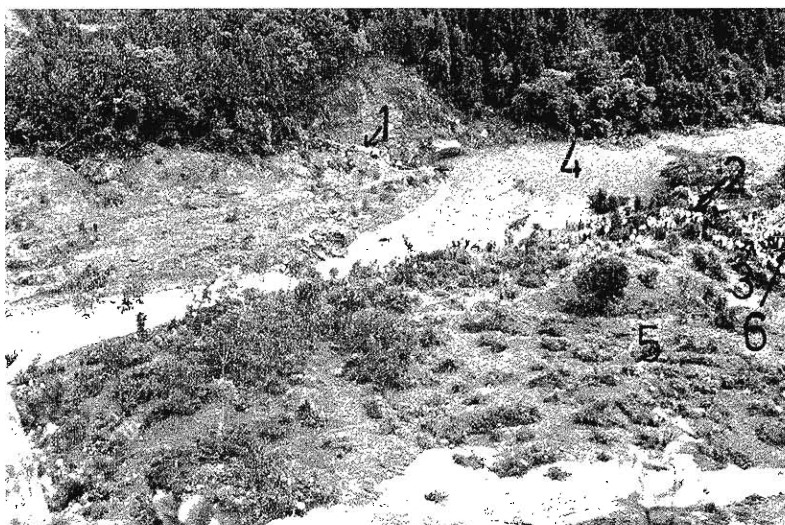
Photo 2. The lower part of Shigeto landslide area.

1: Car 2: Train 3: People 4: The Ananai River 5: Debris 6: Railway

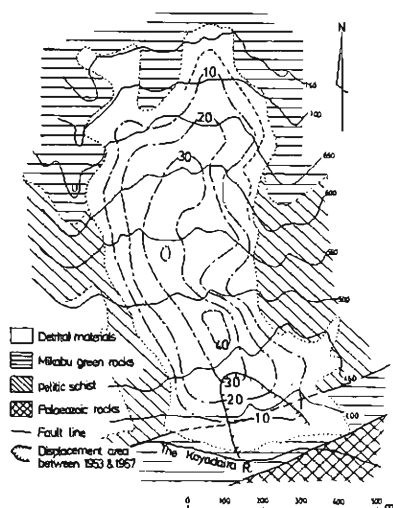
Fig. 5. Bedrock surface under a detrital materials at Morito landslide area.

Investigations by means of boring revealed thick detrital material deposits covering the bedrocks (Fig. 4,5). They are mainly composed of angular boulders of basic and pelitic schist supplied from the bedrocks. The openings between angular boulders are filled up with clayed or loamy soil. The depositional structure is composed of debris, clay and loamy soil, which lie side by side in an alternative order, showing the depositional structure of talus deposits. A buried beech gave the radio-carbon date of 15,400 yrs. B. P. (Lin & Yamaguchi, 1970), which was buried at the landslide. Other samples from Taira-shimo landslide area, Tokushima prefecture were dated older than 37,800 yrs. B. P. (N-1652, N-1692).

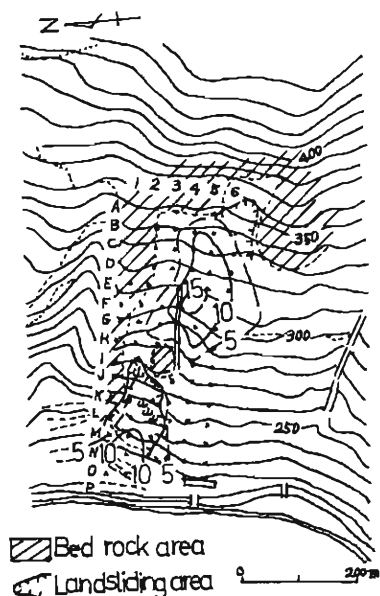
Fig. 9. The map showing a buried topographical surface, measured point of electric prospecting, and active landslide area.

This is a potential landslide area. When farming road was enlarged in 1968, a small landslide occurred at the lower part of the area. The geological investigation by means of drilling, electric prospecting and surface observation brought the following results. Electric prospecting detected a valley-like irregularity under the detrital material by showing a low value of specific resistance (Fig. 9, 10). As a result of boring and field investigations, a subsurface valley buried under the ground is expected. The active landslide is situated at the outlet of the subsurface valley and the slip surface is supposed to exist around the boundary between the bedrocks of pelitic schist and the detrital material deposits. Moreover, the percolation of ground water is observed under the main scarp at the upper end of the moving mass, hence the moving mass seems to be highly water soaked. As above, landslide activities seem to be related to detrital material, subsurface valley and groundwater.

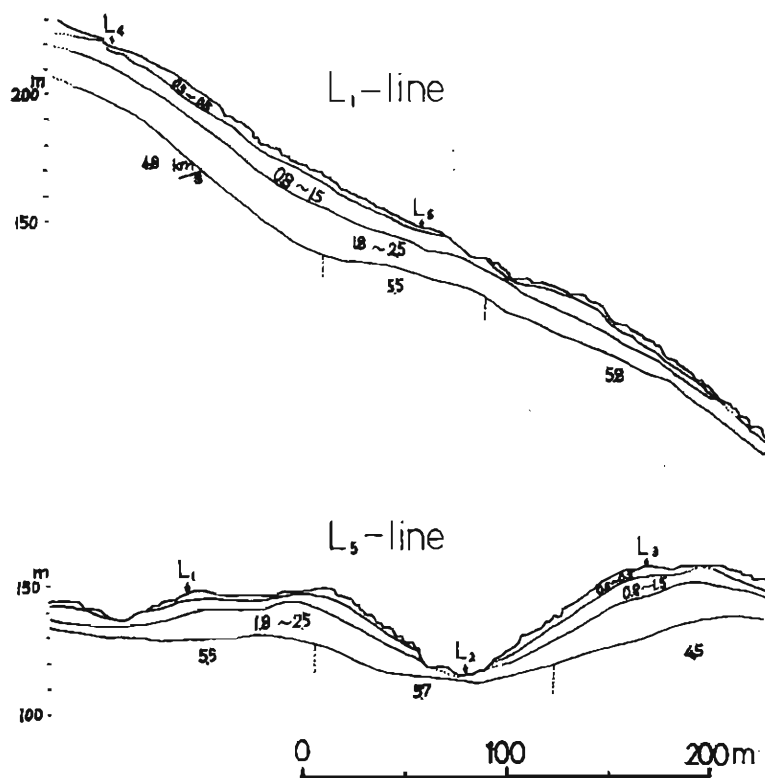
Fig. 12. Underground profile by seismic prospecting at Hiura (Iitani-cho) landslide area. Measuring lines are shown in Fig. 11. (after Tokushima Pref., 1973).

This landslide area is located at the left bank of the Hiura River, a tributary flowing into the Katsuura River. The drainage basin is geologically composed of sandstone, mudstone and diabase, which belong to the Chichibu zone, and the area is covered with detrital materials. The seismic prospecting distinguished four kinds of layers with seismic wave velocities of 0.3~0.6 km/sec, 0.8~1.5 km/sec, 1.8~2.5 km/sec and 3.8~5.8 km/sec (Fig. 11, 12). The low velocity layers of 0.3~2.5 km/sec are in

general detrital materials and weathered layers. The high velocity layers of 3.8~5.8 km/sec are hard bedrock based on these facts and possibility of landslide, the layers are divided into two groups: low velocity group (0.3~2.5 km/sec) and high velocity group (3.8~5.8 km/sec). By careful examination of underground structure down to the bedrock debris or weathered bedrock are certain to the depth of 30 m, sometimes of 60 m. The surface features such as convexity of ridge-like are related only to low velocity layers not to bedrock.

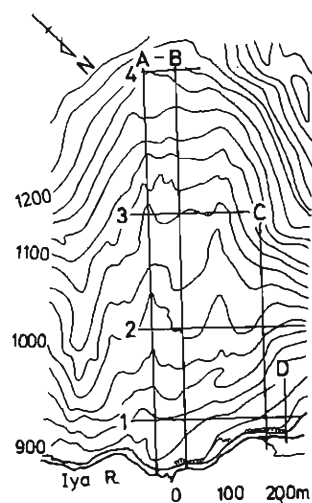
Fig. 15. The map showing the topography of Tairadani landslide area.  
A — D, 1 — 4: Measuring lines of seismic prospecting.

Seismic prospecting gave five layers: surfacial soil (0.3 km/sec), detrital material (0.6 km/sec), wet detrital or upper weathered layer (1.0~1.5 km/sec), lower weathered layer (2.0~2.5 km/sec) and unweathered bedrock (4.5~5.5 km/sec) (Fig. 15, 16). The layers between 0.3~2.5 km/sec, which seem to be related to landslide is 20 m to 50 m thick in general, however it measures 70 m at the thickest and rather thinner at the valley. The seismic wave velocity of 2~3.2 km/sec observed at many points within bedrock may indicate shattered or fractured zones.

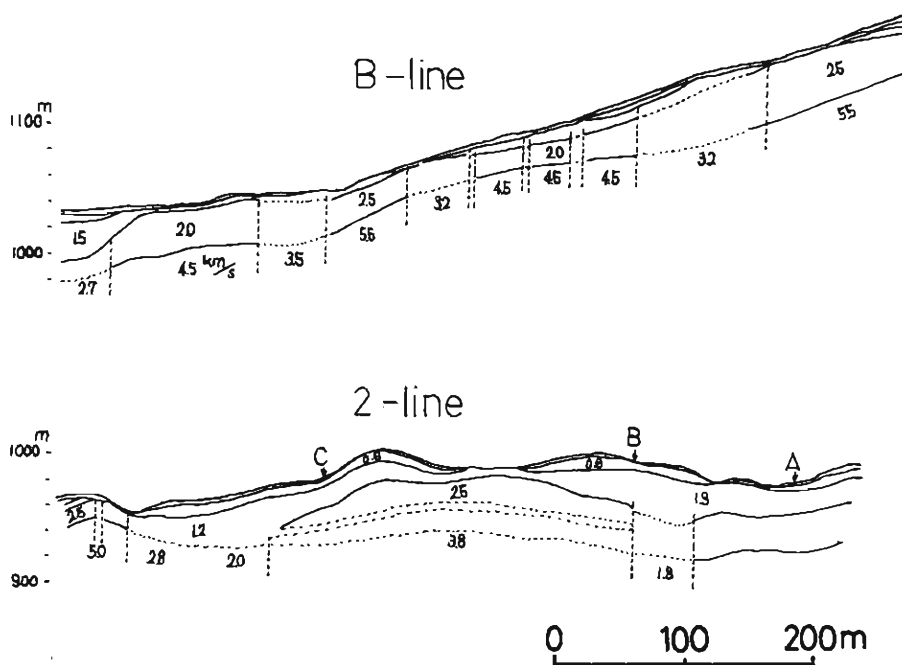
Fig. 16. Underground profile by seismic prospecting at Tairadani landslide area. Measuring lines are shown Fig. 13. (after the Forestry Agency 1965).
