# Electron Microscopic Images of Crystals Observed with 300 kV Electron Microscope

Hatsujiro HASHIMOTO\*, Kenzo TANAKA\*\* Keinosuke KOBAYASHI\*\*\*  
and Eiji SURTO\*\*\*

(Institute for Chemical Research, Kyoto University)

Resolution of the electron microscopic images of crystalline films with certain thickness is discussed and some of the features observed in electron micrographs of crystal films taken at 250~300 kV are illustrated.

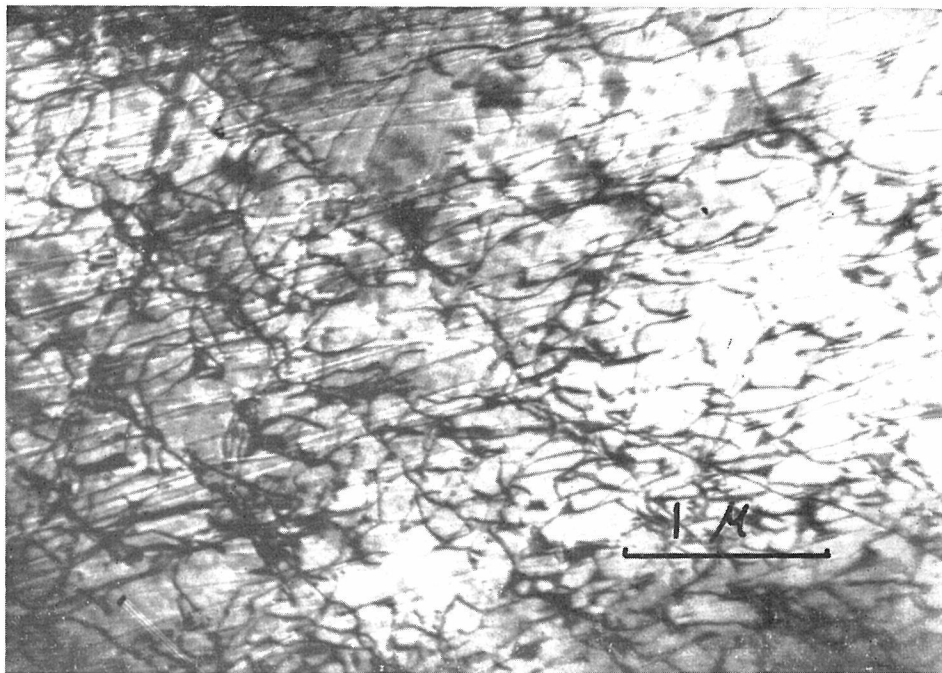
Fig. 9. An electron microscopic image of piled-up dislocations in stainless steel film. The film seems to be thicker than  $1\ \mu$ . (300 kV)

Figures 8 and 9 are the images of stainless steel films with larger thickness than those shown in 4, 5, 6 and 7. Complicated dislocation structures are seen.
