## A Preliminary Report on the Landslides and Other Ground Surface Movements Induced by 1999 Chichi Earthquake, Taiwan

Kazuo OKUNISHI, Makoto MUSASHINO\* and Miekko SONODA

### Synopsis

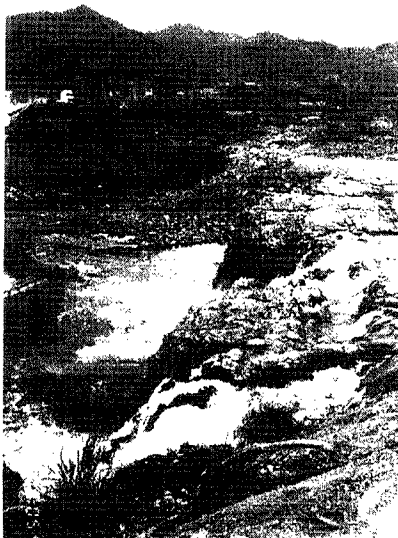
Photo 1 A water-fall created by the earthquake fault in the Dachia-shi River near Fengyuan. Crushed rock is left on the high-water bench beyond the river. Erosion by running water is already in progress in the central part of the river.

girders. The outcrop of the earthquake fault was at high angle when it crossed the bedrock (Photo 1) and at low angle when it crossed a soft stratum, presumably reflecting the difference in friction angle. An anticlinal uplift was observed on a soft and cohesive stratum (Photo 2).

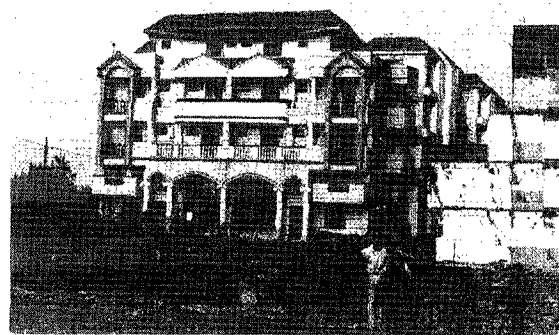
Photo 2 A building in Fengyuan tilting towards the uplifted side of the fault due to an anticlinal ground deformation. The river on this side also suffered from this deformation.

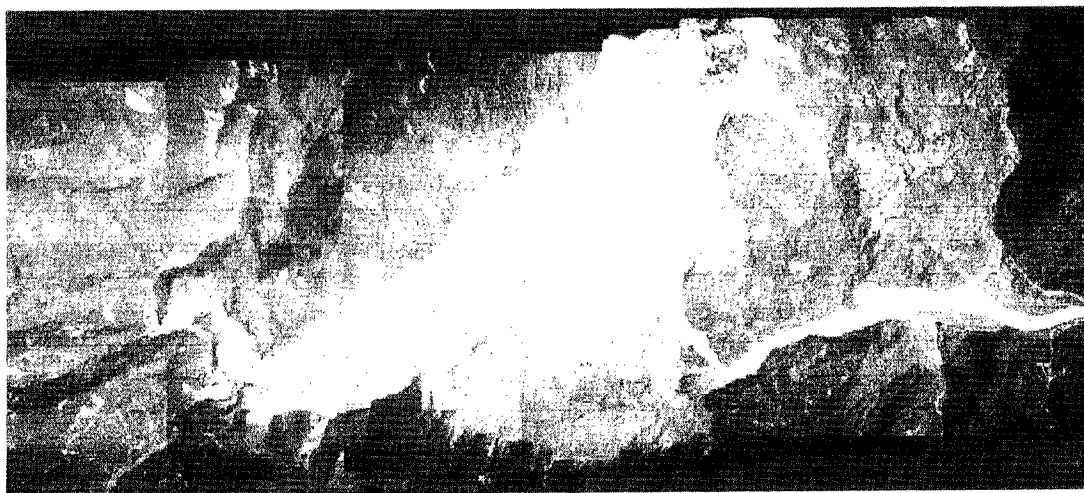
Photo 3 Aerial photograph of the Tsaolin landslide (from the home-page of National Cheng Kung University)

landslide mass was  $120,000,000 \text{ m}^3$  and the affected area is 698 ha with a distance of about 4 km between the top of the slip surface and the snout of the debris avalanche. There were only small casualties because the landslide area was off the village center of Tsaolin. The aerial photograph and the topographic map of this landslide area are shown in Photo 3 and Fig. 2, respectively.

The side block on the eastern side has more complicate in structure. There is a block at the northeast corner of the landslide area where trees are left with enlarged interval with one another (Photo 3 and Photo 10). It is interpreted that a block of shallow transitional slide of highly weathered soil was divided into many zones by cracks expanding towards the downslope direction as suggested by Photo 11. The mobility of the lower part of this block seems to have been larger than the upper parts since the arrangement of the left trees was more irregular. To the lower-left of Photo 11 (Photo 12) is a hummocky zone similar to that in the western side block. It is associated with two small slumps at its upslope part (see Photo 3).

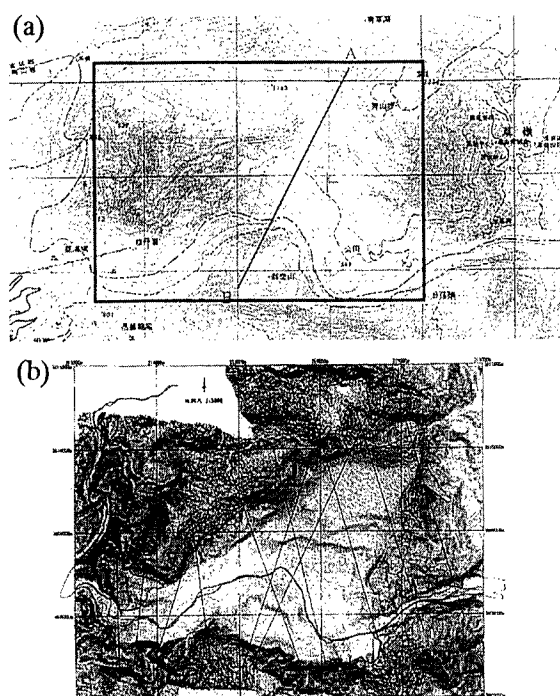
Fig. 2 Topographic map of the Tsaolin Landslide Area before the earthquake (a) and after it (b), after Lin (2000). Grid interval is 1 km.

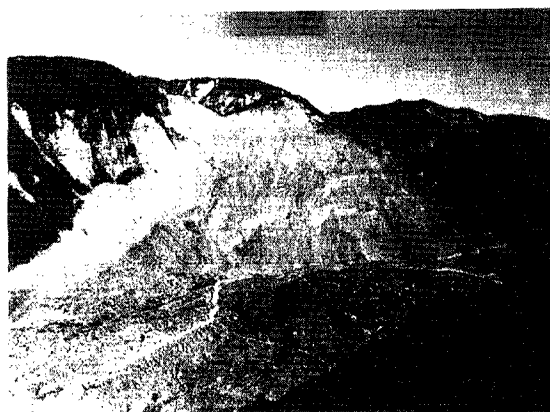
Photo 4 The denudational area and the area of former channel of the Qingshui-shi river of the Tsaolin Landslide.

There is a main scarp of horseshoe type at the center of the top part. It was accompanied by two shallow landslides on its right and left side at a little higher position (Photo 4). The main block extends to

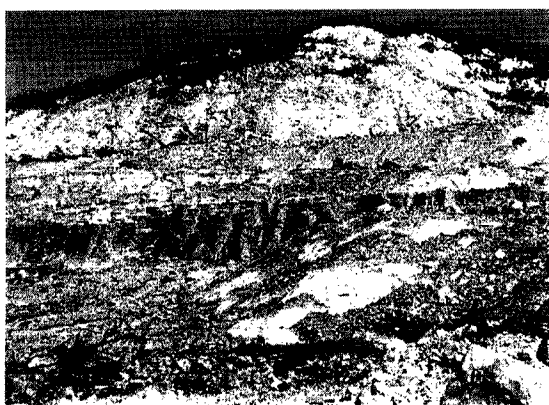
Photo 5 Outcrop of the bedding plane at the secondary landslide scar of the Tsaolin Landslide.

southwest from the main scarp and there are two steps of the secondary scarp. Viewed from the bottom, the upper one represents a cross section of layered strata and the other does not present obvious lamination (Photo 5). Such structure is characteristic of the sliding along the bedding plane of a gentler angle. The denudation area and the transport area were not easily distinguished, since many landslides had been repeated here. The depositional area was beyond the original channel of the Qingshui-shi River. The sliding was inferred to be caused by the intercalation of permeable sandstone and impermeable siltstone, which store perched groundwater lubricating the interface, as demonstrated at the eastern edge of the lower step (Photo 6). There, water was found to seep out of the interface between sandstone and siltstone and flow on the planar surface of the latter. The discharge was thought to have decreased from that at the time of landsliding, since the white powder (main constituent is  $\text{Na}_2\text{SO}_4$ ) was seen covering the rock pieces and debris besides the watercourse. It suggests the leaching of  $\text{Na}_2\text{SO}_4$  associated with the hydration of clay minerals (Sato and Aoki, 1990).

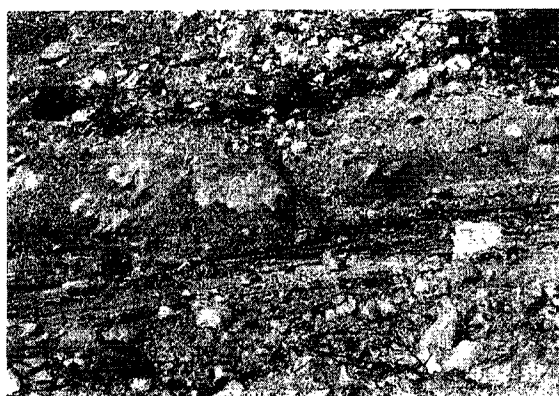
Photo 6 Water running out of spring on the bedding surface of siltstone.

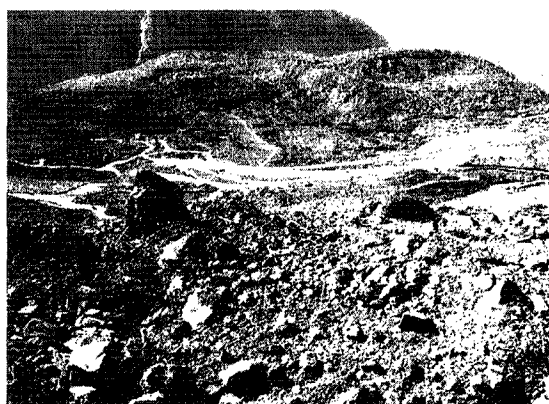
Photo 7 Depositional mound of the main block of the Tsaolin Landslide. Tong-like snout is visible at its head and slip-back scars are at its tail facing the site of the original channel.

the southern side of the original channel of the Qingshui-shi River. There are secondary scarps towards the rear side of the depositional area suggesting the back-slip according to the inverse gradient of the ground surface. A wide and shallow valley had been left along the original channel, not by the channel erosion but by the high-speed transit of the sliding mass. The snout of the depositional area is formed by sheets of debris with a shape like a tongue (Photo 7). It suggests the liquefaction by the water which was squeezed out of the sliding mass (Suwa et al., 1985). A schematic illustration of the main block in its moving state is shown in Fig. 3 according to the above consideration.

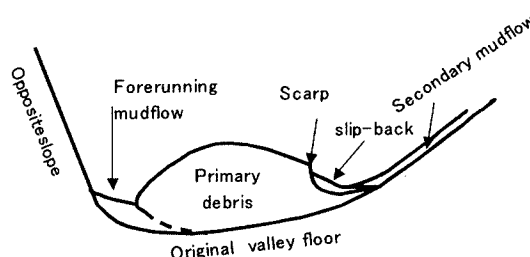
Fig. 3 Schematic illustration of the depositional features of the main block of Tsaolin Landslide

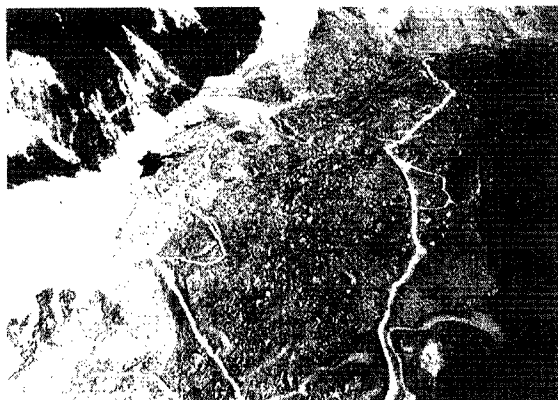
Photo 8 An overview of the western side block. It consists of two zones of different color. The black object a little at the upper left of the center is a pond.

The western boundary of the upper part of the landslide area is a rocky cliff. The debris falls on it is obviously independent of the gigantic landslide. The part of the gigantic landslide that is adjacent to the border is distinguished from the main block by its color suggesting a high mobility. A group of flow mounds form hummocky zone between this part and the main block. This zone is interpreted as the transitional zone between the main block where the sliding mass was essentially rigid, and the fluidized part. Thus these two parts should be lumped as a side block. Photo 8 shows the central part of the western

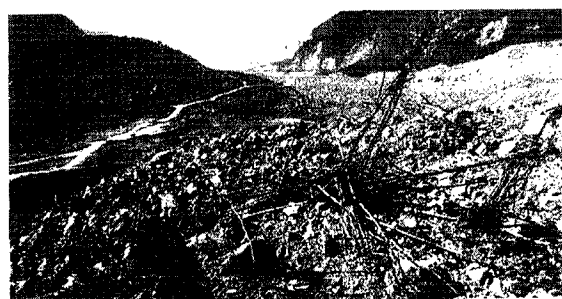
Photo 9 The debris that flowed downstream along the Qingshui-shi River (photograph was taken from the main block).

side block viewed from the helicopter. Corresponding to the main block expanding its width towards the lower end, the side block moved towards west-southwest and after reaching the channel of the Qingshui-shi River, it flowed along the channel for about 500 m (Photo 9).

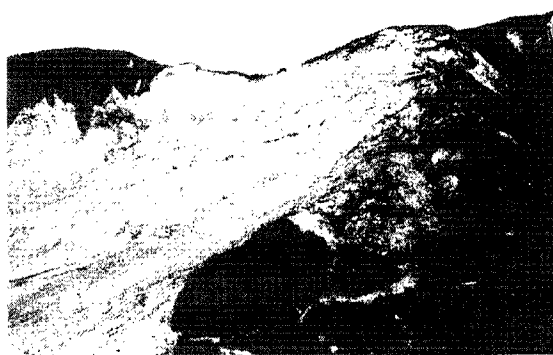
Photo 10 The upper part of the eastern side block (at the left edge of this photo).

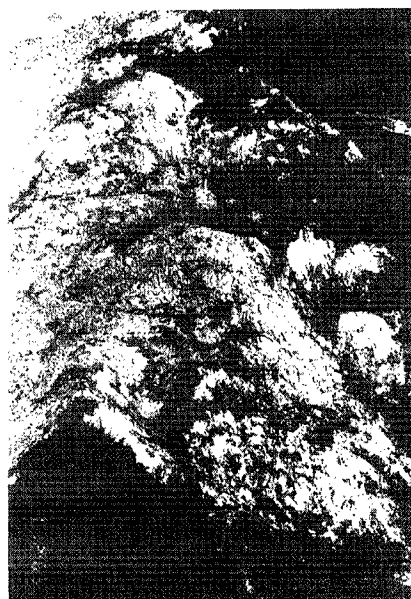
Photo 11 A close-up of the lower part of Photo 10.

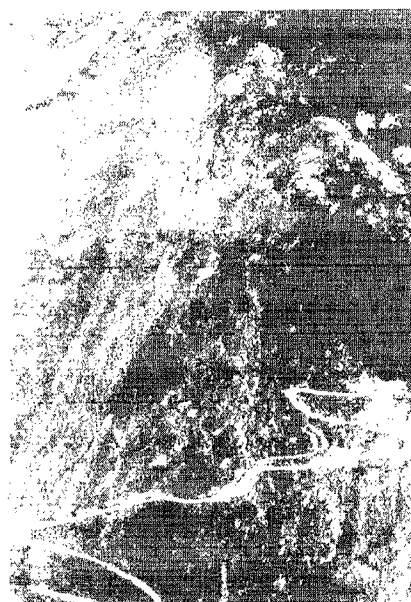
Photo 12 The hummocks in the eastern side block located at the lower left of Photo 11.

This hummocky zone continues to the original channel of the Qingshui-shi River, and beyond it, the sliding mass is bifurcated similarly to the western side block. While the western side block can be regarded as a variant of the main block due to a high mobility, the eastern side block seems to be an assembly of the regions of different dynamic properties. It includes transitional slide of highly weathered soil and slumping of the laminar formation, as well as the hummocky zone. However, these regions should be regarded as a block as a whole, since they are commonly associated with deep weathering along the eastern edge of the landslide area.

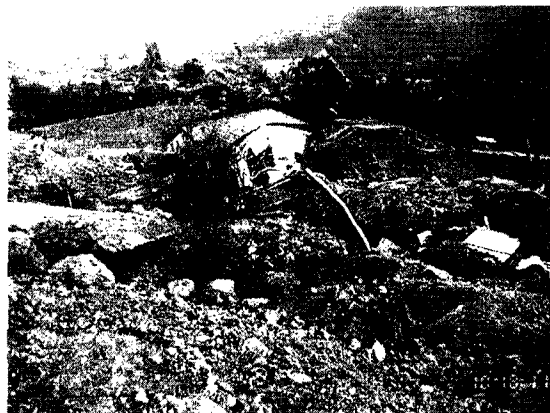
Photo 14 A house that had been near the ridge of Mt. Chiufengershan was moved along a distance of about 1 km by the landslide.

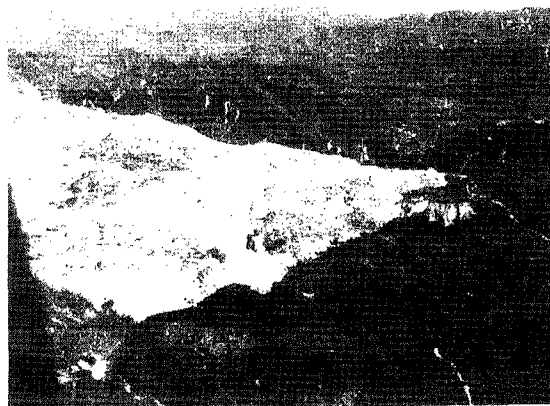
Photo 15 The lowest part of the landslide deposit that blocked a small river around its confluence with a tributary. A part of the deposit has been modified by the restoration works.

Below the denudation area is a hummocky depositional area. It is steeper on its upper part and gentler on the lower part. The lower part is underlain by the main channel of a small river and one of its tributaries, and also by a small ridge between them. The river was blocked along a distance of about 1 km (Photo 15). A small lake has been formed at the upstream side. A large construction work was in progress and the ground surface of the depositional area had been partly disturbed at the time of the field reconnaissance study.

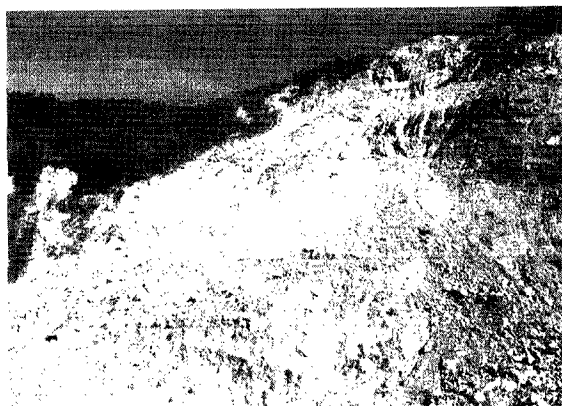
Photo 16 An example of the landslide presumably along the bedding plane (in the mountains to the east of the Qingshui-shi River).

Except for the Quaternary formations, the geology of Taiwan is zonal in the direction of the north to the south with monoclinical structure steeply dipping toward the east (although a syncline is found in the vicinity of Tsaolin where the strata dip gently toward the south on the axis of the syncline). Therefore, the geological susceptibility to the landslides along the bedding plane shows a regular geographical distribution according to the slope aspect. Hence, if a group of landslides occur collectively on the slopes of the same aspect, they can be recognized as of this type. This tendency was obvious in the mountains on the left side of the Dachia-shi River. Similar tendency was also recognized in the mountains on the both sides of the Qingshui-shi River, where larger number of landslides occurred on the south facing slopes and seemed deep-seated. Photo 16 shows an example of the landslides that seemed to have slid along the bedding plane.

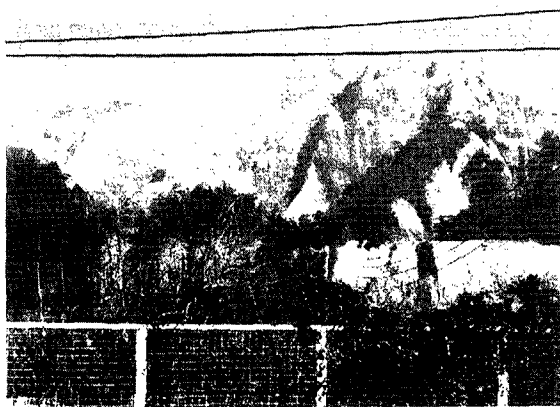
Photo 19 A view of Mt. Chiushichiu-feng denuded of vegetation due to extensive and intensive surficial landslides.

observed. In several areas, this type of landslides were connected with one another to produce a wide landslide area. An extreme example of such cases was observed on the Mt. Chiushichiu-feng (the naming came from "ninety-nine peaks") where almost all parts of the mountain slopes of conglomerate had become denuded of vegetation (Photo 19). A series of marked geomorphic changes (Okunishi et al., 1987) are anticipated in the future.
