## Case Study of Reinforced Earth Wall Failure during Extreme Rainfall

**ABSTRACT:** Recently number of reinforced earth walls had problems such as cracking on the facing wall, breakage of connection pins in the modular block, differential settlement on the foundation and collapsing facing wall. This paper describes the recent application and design for both panel type and modular block type faced reinforced walls. The failure case histories of reinforced earth wall during the extreme rainfall are also presented.

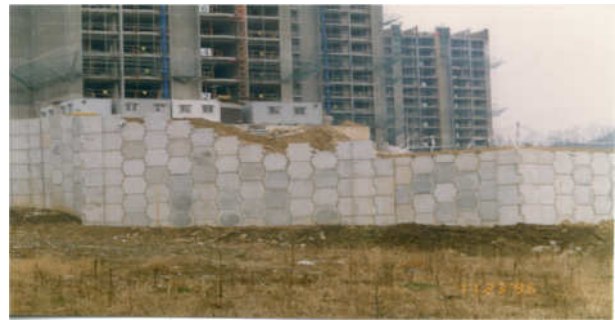
Figure 3.1 shows the construction of the reinforced earth wall to gain the extra land for the apartment complex in Youngin, Kyeonggi Province on November, 1996. This marginal land can be used for the parking space and play ground for resident. Many of these kinds of construction techniques are practiced in Korea due to the dwindling of available land in the urban area.

Fig 3.1 Reinforced earth wall for apartment complex in Youngin, Gyeonggi Province.

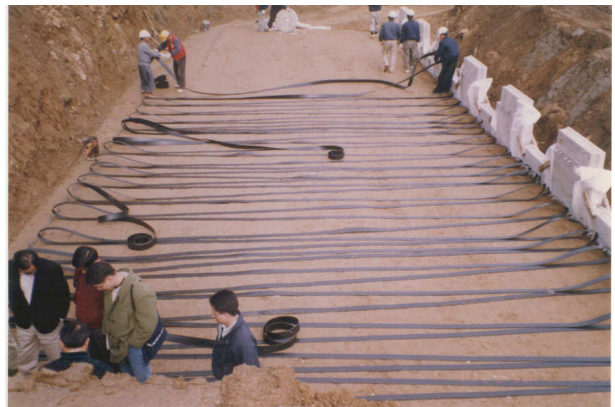
The reinforcing material in this particular project is a belt type continuous strip which made of polyester(PET) with polyethylene(PE) coating. The con-

struction sequences are shown in Figure 3.2. The reinforcement belt strip is stretched and anchored on the facing panel by using a loop attachment and carbon rod( $L=17.5\text{cm}$ ,  $D=25\text{mm}$  or  $32\text{mm}$ ). The reinforced earth wall shown in Figure 3.3 is for Sadang Dealim apartment complex in southwest part of Seoul Metropolitan area on July, 1988. The height of this reinforced wall is about 16m and consists of levels with a small beam in-between the 1st staged wall and the 2nd staged wall(E & S Eng., 1997).

Fig 3.2 Construction of reinforced earth wall with PET belt type reinforcement.

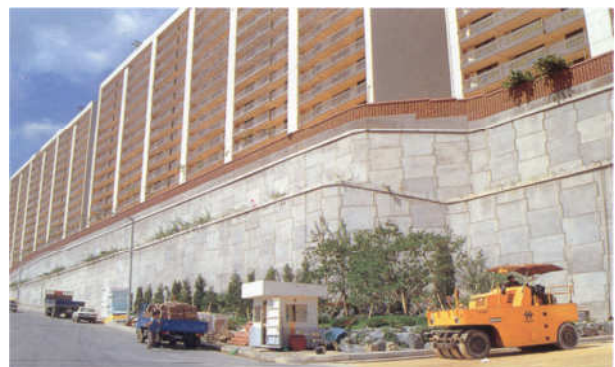
Fig 3.3 Two stages of reinforced wall in Sadangdong, Daelim apartment complex.

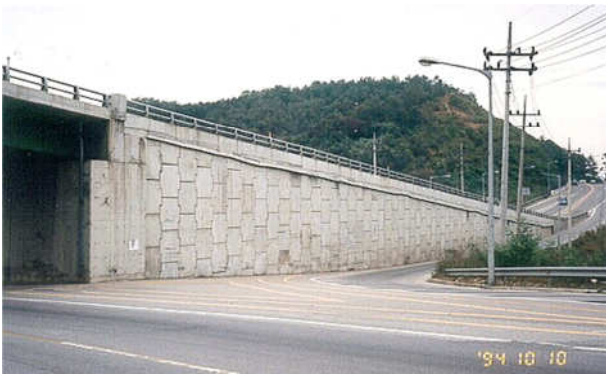
The maximum wall height constructed is 18.3m in Namyangju, Kyeonggi Province for the apartment complex on August, 1994. Figure 3.4 shows the construction of an approach embankment for overpass bridge on Kyeongchung Highway in Seongnam, Kyeonggi Province on November, 1992. These reinforced earth techniques are mostly used in the highway cut to secure the earth slope against sliding failure. The galvanized metal strip which manufactured in Korea is being used as a reinforcement(Figure 3.5). However, the quality is a little bit low as comparing with REW's in terms of mobilizing friction angle and coating along the strip.

Fig 3.4 Reinforced approach embankment for overpass bridge, Kyeongchung Highway.

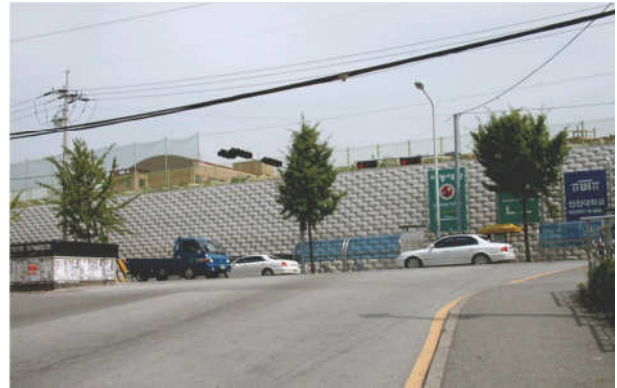
The modular block faced geosynthetic reinforced segmental retaining walls are extensively used in Korea. The trend of using this type of reinforced wall is very optimistic and very comparative in comparison with the conventional concrete retaining walls. It can be applied in the side wing of an approach embankment of bridge flyovers as shown in Figure 4.1

Fig 4.1 Modular block faced reinforced wall in an approach embankment of bridge flyover.

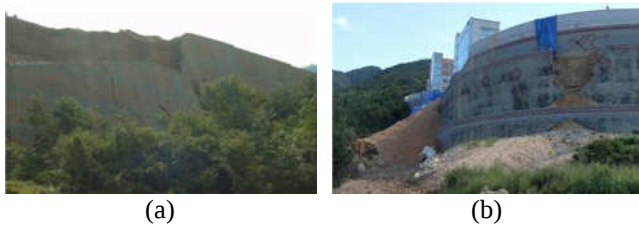
Total collapse of reinforced earth wall could be caused by the lack of stability of overall sliding in design, not sufficient drainage system and bearing capacity of foundation soil, and usage of a lot of fine grained soil as a backfill material and poor soil compaction as shown by Figure 5.3

Figure 5.3 Total failure of entire reinforced earth wall ((a) Highway construction site - Overall sliding failure; (b) High school construction site - Overall sliding failure and facing block sliding)(Lee and Cho, 2011)

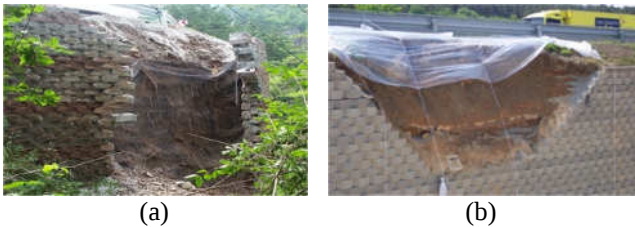
The facing block collapse can be occurred due to the poor design of drainage layer in the behind of reinforce earth wall and broken connector by freezing during winter season. Figure 5.4 shows the failure of facing wall in local road construction site.

Figure 5.4 Facing wall failure case history (Local road construction area : (a) Deformed of middle part of REW and collapse of facing wall, (b) Facing block sliding)(Lee and Cho, 2011)
