# Application of large scale ring shear tests to the analysis of tsunamigenic landslides at Stromboli

Keywords: landslide, laboratory tests, liquefaction, shear strength, volcanoclastic soil

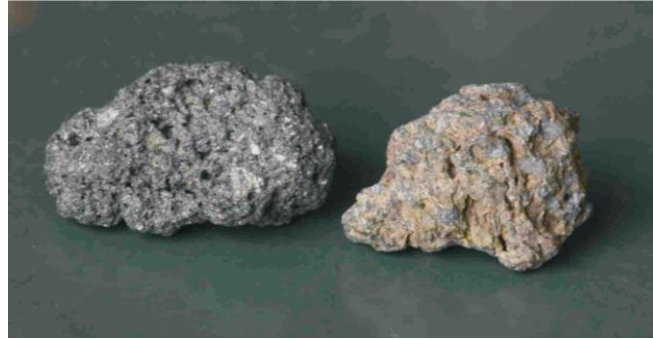
Figure 7

52  
53 Physical and mechanical properties of grains were determined by Tommasi et al. (2005b and  
54  
55 2007). Scanning electron microscope showed grains that appeared to be formed by small lumps,  
56  
57 ranging from a few tenths to a few millimetres in size, welded together so as to form a continuous  
58  
59  
60  
61  
62  
63  
64  
65

1  
2  
3 frame (Figs. 7 and 8). Pores are extremely diffuse and generally do not exceed a few tenths of a  
4  
5 millimetre in size, even though larger pores (up to 2-3 mm) are observed (Figs. 7 and 8). Most  
6  
7 grains result from the disruption of the lava flow fronts during the cooling and advancing on the  
8  
9 steep Sciara slope (autoclastic breccia); spatters from slides of the cinder cones are also present.  
10  
11 Fragments of low-porosity aphanitic lava, coming from the core of the lava flows, are less frequent.  
12  
13 The mean value of the density of the entire sample set, measured with a mercurium pycnometer, is  
14  
15 2.34 Mg/m<sup>3</sup>, with a standard deviation of 0.04 Mg/m<sup>3</sup> (43 determinations). Solid matrix density,  
16  
17 determined with a helium pycnometer on powders (<0.074 mm,) is on average 2.90 Mg/m<sup>3</sup>,  
18  
19 yielding a mean value of the total porosity of the grains of 19.2%, that is almost completely
