On the observation of strain before and after the occurrance of rock-falling.

Michio TAKADA

Abstract

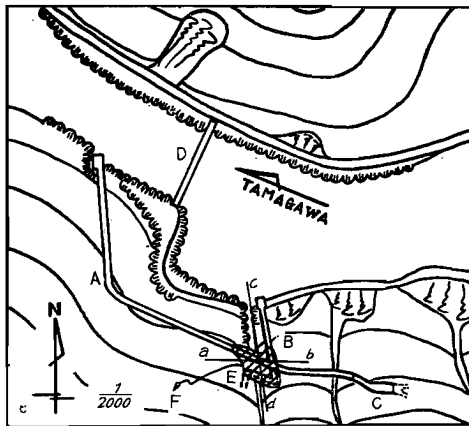
Fig. 2. Plane figure of the observatory and location of rock-falling.

A : new adit, B : old adit, C : observation room, D : dam, E : dead adit, F · location of rock-falling

The place where the rock-falling occurred, which was extending over 15 meters, was at the position adjacent to junction of old and new adit just beneath the valley. This part of adit was said to be very dangerous due to the nature of rocks is so brittle that the concrete lining shoud have been applied at the time of excavating.

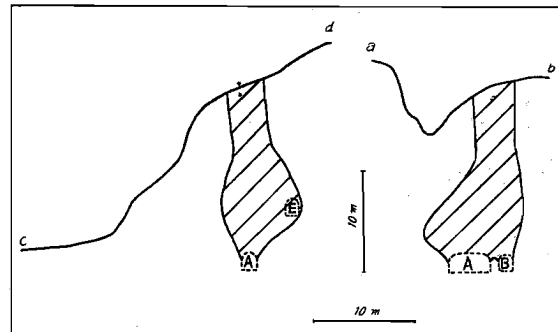
Fig. 3. State of rock breakage on the location of rock-falling. (vertical section a–b and c–d)

A : new adit, B : old adit, E : dead adit.

After two days suspension, the work resumed again and we could safely get into observation room on 31st January for the first time after rock-falling taken place. Of course, onece a while we had sneaked into adit under dangerous condition removing the rocks aside and investigated the status of the rock breakage, which seemed to have been broken extending to about 450 m³. as is shown in Fig. 3.

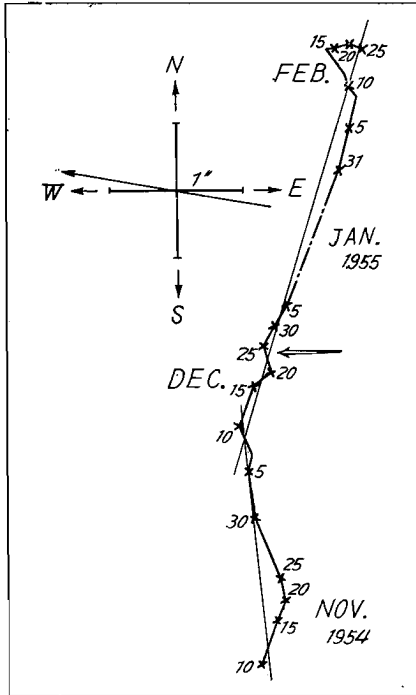
Fig. 8. Vector diagram of variation of ground tilt. (excluded annual variation) Single arrow shows the direction of place of rock-falling. Double arrow shows the time of occurrence of the 1st rock-falling.

The Fig. 8 is the result obtained from the change of tile compounded with components A, B, by vector diagram. A part, marked with —·—·— on this diagram shown the period while no record had been written and remaining part of before and behind of above mentioned mark is obtained by actual survey. As we take notice of these variation, the data shows remarkable difference between before December 10th and thereafter. Those phenomenon are investigated as folloes.

On the variation to begin with, this sort of variation had been indicated normal change to certain direction up to beginning of December and thereafter the abnormal change had been taken place. Since rock-falling occurred the

It can be clearly noticed the change effected by rock-falling, shown the variation of Tiltmeter on Fig. 8. The variation of before and after 10th of December is quite different. It has been inclined to the direction of N 6°W with velocity of 0.060″/day up to 10th of December according to the indication but after that toward the direction of N 17° E with 0.039″/day. This variation is shown in Fig. 12 marked with ✕. By this result the variation of tilt concern-

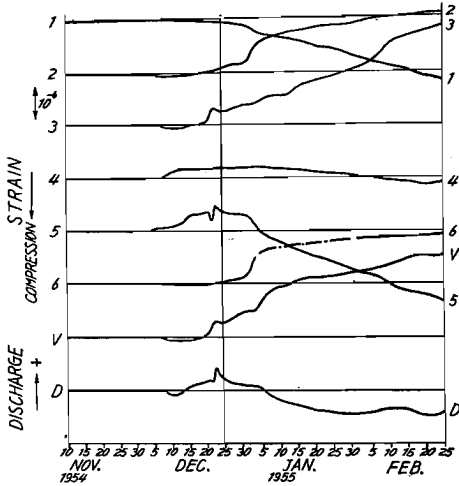
Fig. 9. Variations of strain and discharge concerning to the occurrence of rock-falling. Double arrow shows the time of occurrence of the 1st rock-falling.

It might well be deduced that in case of rock-breaking in the csource of nature, such as rock-falling stress distribution of nearby rock commence to change gradually for suitable period befor break down and once it occurs the rock transforms suddenly its shape different from as it was. According to the fact as mentioned above, it might be deduced that the variation indicated before December 10th seemed to be normal change which has nothing to with the rock-falling. On the contrary, it will be inferred that the variation thereafter might be caused by rock-falling. The change of both strain and discharge in connection with the rock-falling is shown in Fig. 9.

As for the variation of Discharge Meter, however, it's change had been so small up to 10th of December, but thereafter it has been gradually increased. On the contrary after the event it has begun to decrease. This means that there exists same cause on the • variation of crack gaped the interior rock, effected by the change of stress.

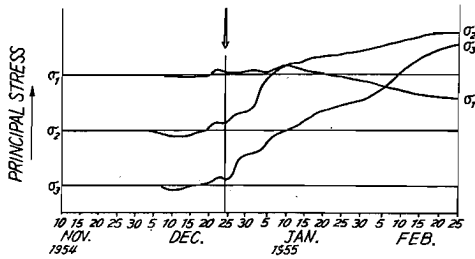
Fig. 10. Principal stresses obtained from strain.

From above relation, principal stresses σ_1, σ_2 and σ_3 obtained assuming as $\nu = 0.25$ and ε_1, ε_2, ε_3 are strain of component 1, 2, 3, respectively which shown in Fig. 10.

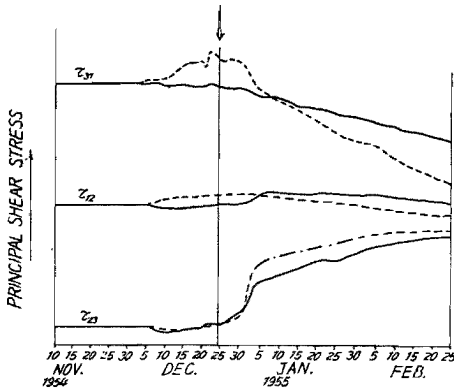
Fig. 11. Principal shear stresses obtained from strain.

ψ_{12}, ψ_{23} and ψ_{31} can be obtained from not only 4, 5 and 6 components but also from 1, 2, and 3 components. The value obtained from former components marked with - - - - - and that of obtained from latter components marked with ——— is shown in Fig. 11. As a matter of fact these two values should be concorded with each other notwithstanding it shows similar figure as a whole. The difference of these two values seems to be considered caused by previous hypothesis.

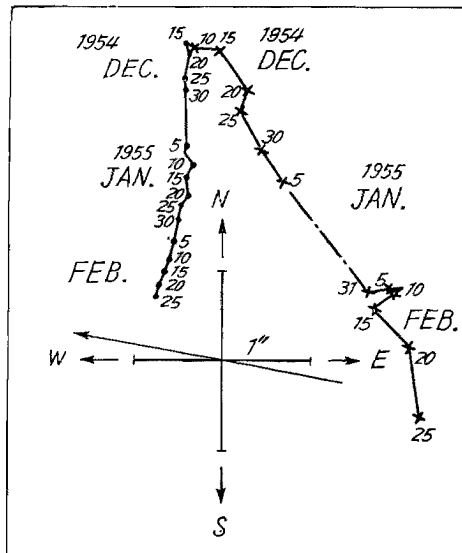
Fig. 12. Variation of ground tilt concerned with the occurrence of rock-falling.

ing to rock-falling shall be with the velocity of 0.031″/day to the direction of S 34°E. The place of rock-falling is located to the N80°W direction from the observing point. Ground-tilt shifted to the opposite direction. If the rock were to be homogeneous isotropic elastic body, the variation of ground tilt would be obtainable from strains of 3 components 1, 2, and 3. This variation is illustrated with the mark ⊙ in Fig. 12, and this variation inclined to the S 6°W direction with velocity of 0.018″/day.

Though this fact can not be said to concord sufficiently with the result of observation, it is natural when we think about so uncertain hypothesis was applied as aforesaid.
