**Geotechnical Study on  
Ground and Masonry Structures  
in Angkor for Safeguarding Monuments**

**September 2001**

**Yoshinori Iwasaki**

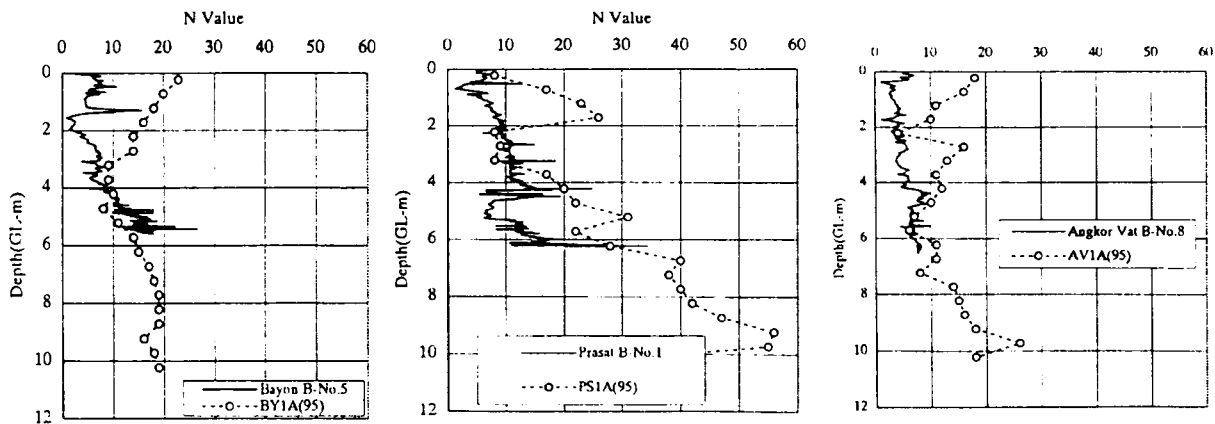
Fig.5-9 Comparison of SPT N-value (white circle/dry season) vs. Dynamic cone (solid line/rainy season)

The comparison between the SPT values against dynamic cone resistance number was shown in Fig.5-9. The dynamic cone resistances were converted  $N_{SPT} = N_{DC} / 20$ . It may be concluded the surface will become hard due to desiccation of the surface during dry season. These effects are found down to 5-6m in the area.

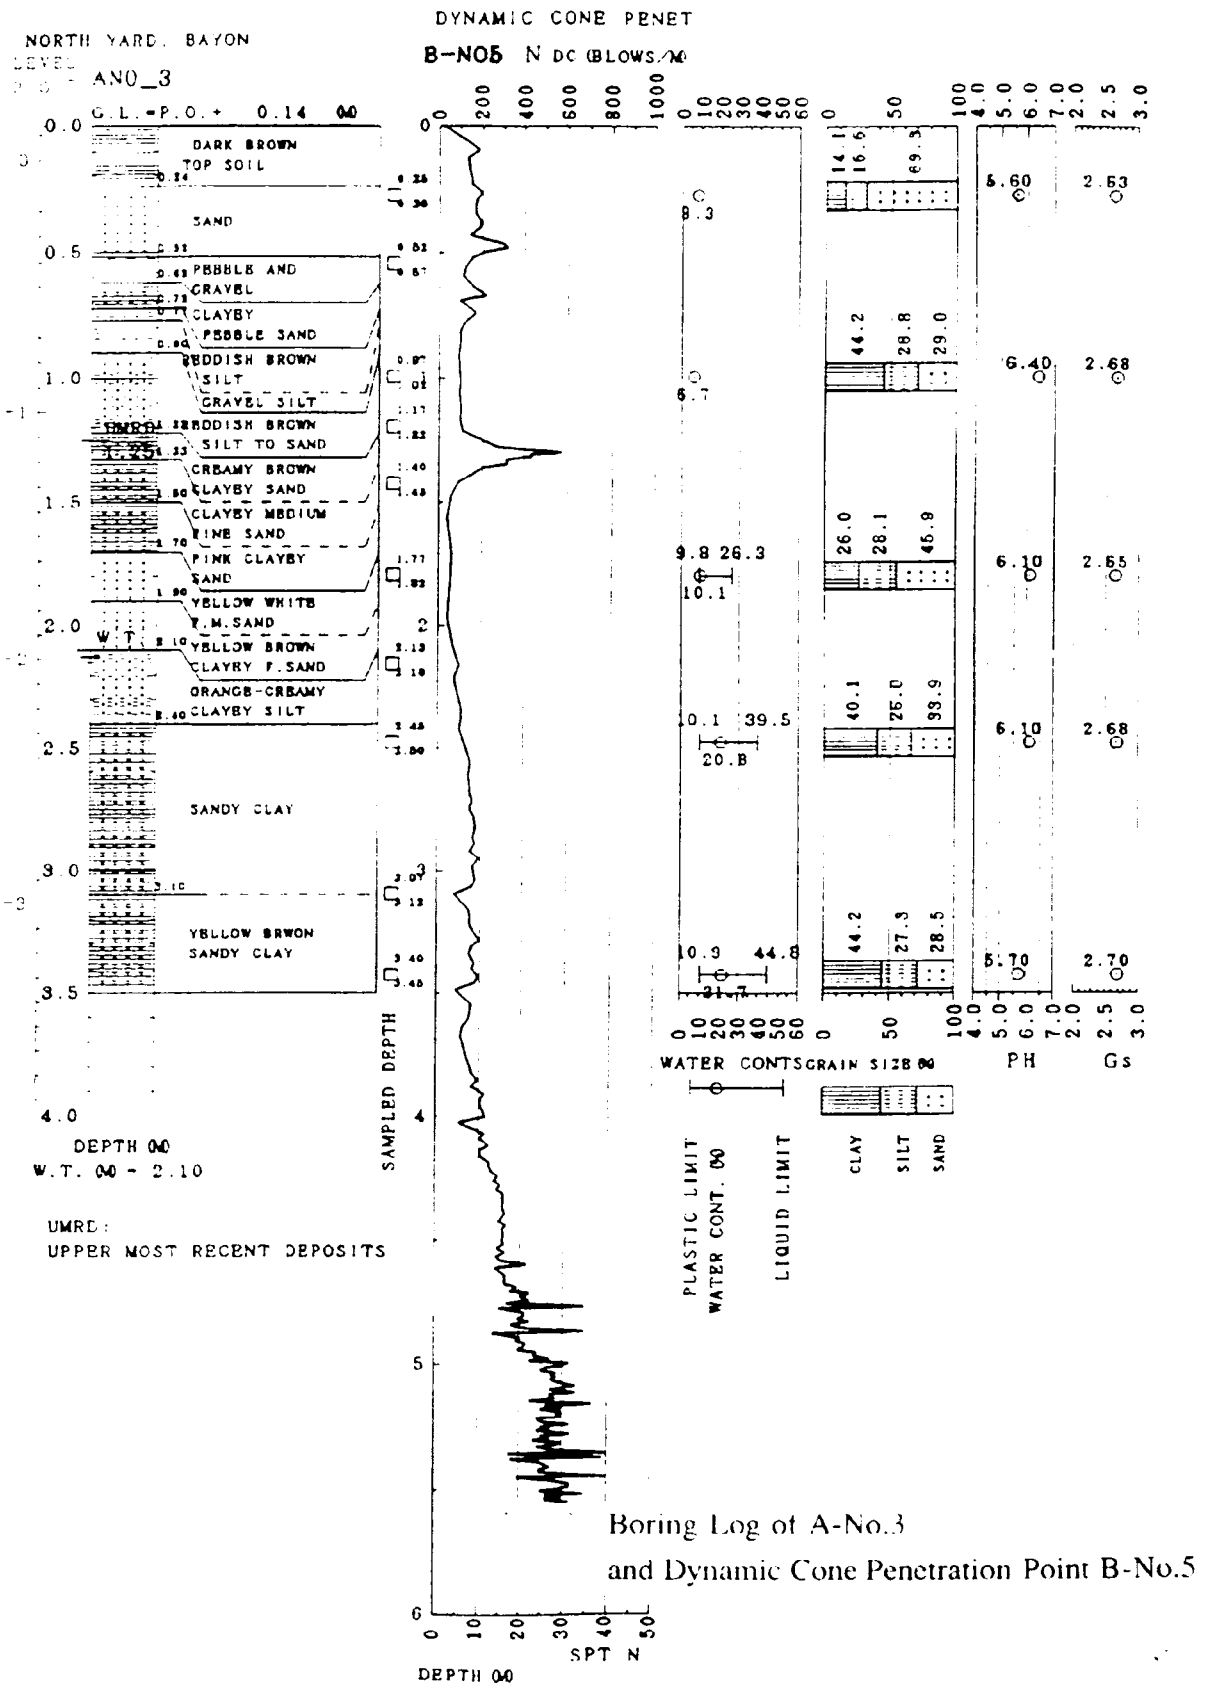
Fig.5-10 Results of Dynamic Cone Test (B.No-5) and Soil Characteristics for sampled at A.No-3

As shown in Fig.5-10, the upper surface soil is much more complicated than shown in the conventional drilling with SPT sampler. Alternations of sandy and clayey layers are predominant, which makes much easier horizontal flow of underground water. The rainwater infiltrates into ground may not only form vertical flow as well as horizontal one.

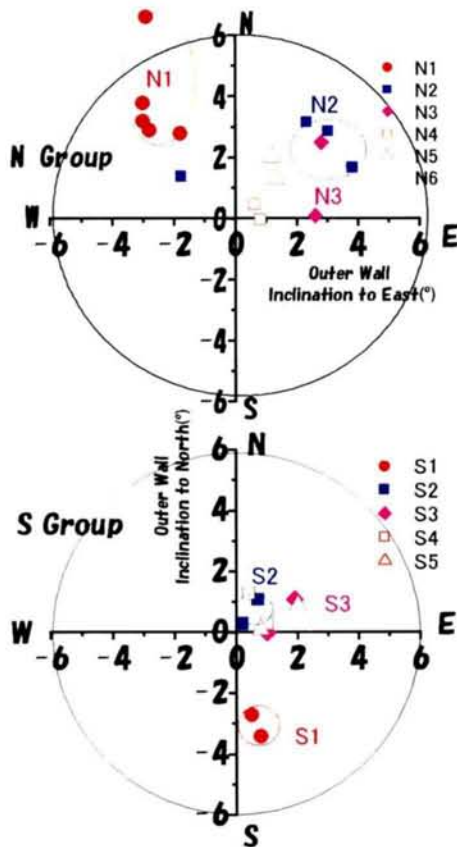
Fig.6-2 Distribution of Inclination of North and South Tower of Prasat Suor Prat

It should be noted that the towers near the ponds shows much larger inclination than others and the directions of inclinations are towards the ponds. The inclination varies in a range from a few degrees towards Ponds. The S1 tower has inclined 2-3 degrees towards south direction. On the other hand, the

N1 tower has inclined towards north direction. The maximum inclination of 6.6 degrees to north is found for N1 tower.

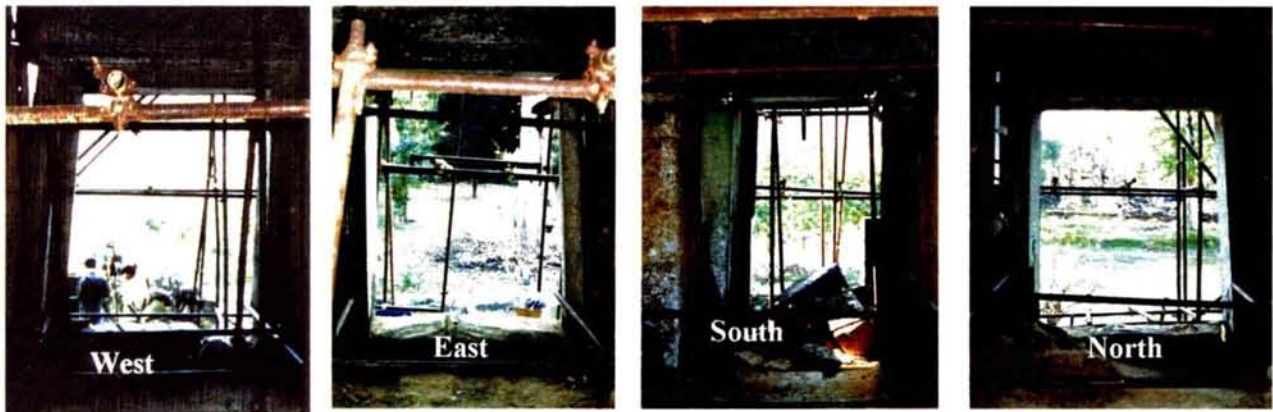
Photo 6-6 West, East, South, and North Wall from inside out direction.

For any wall, the bottom parts of the openings are found wider than the upper part. The largest difference in the width is at west wall. The next is at north wall.

It is found that the opening at north wall is the lowest level among others. The north column of the west wall opening is also found the lowest among 8 columns.

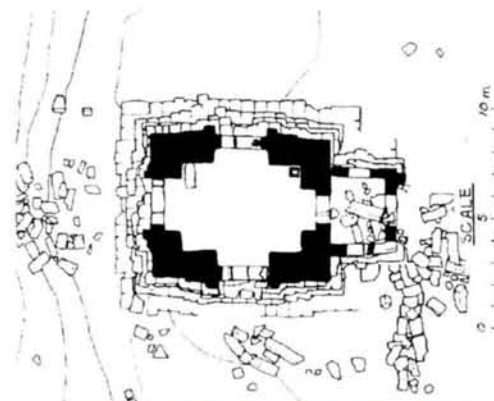
Fig.6-4 Plan view of N1 Tower at foundation level

Fig.9.4 shows plan view of N1 tower of Prasat Suor Prat at the foundation level. There are several steps made of laterite blocks surrounding foundation. The level of the surface of each step was measured and plotted in Fig.9-5 for west side of the N1 tower.

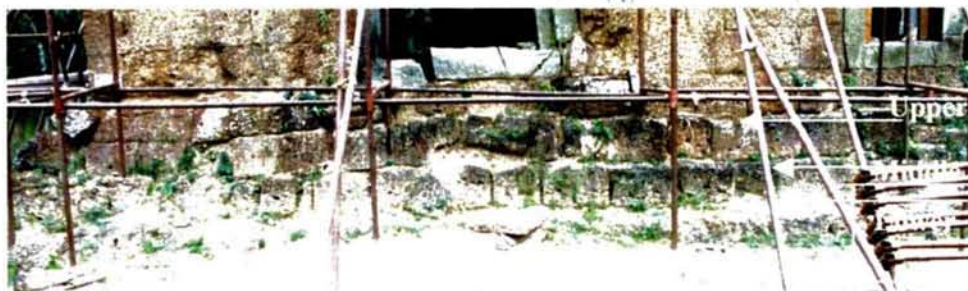
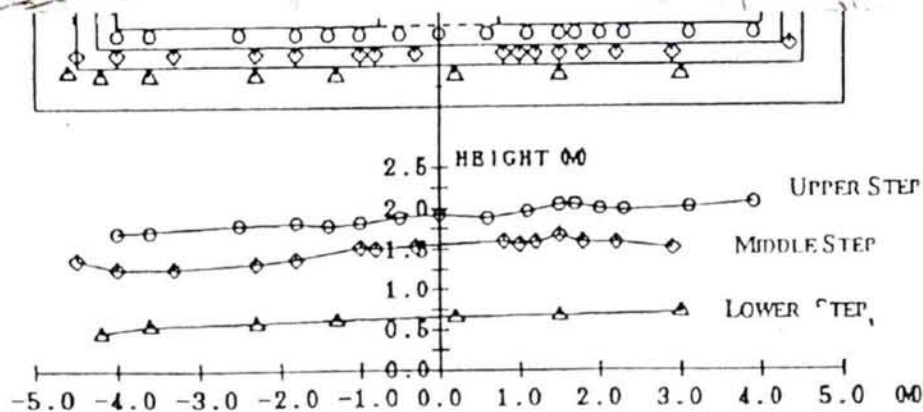
Fig.6-5 Height of each step along west wall

The maximum inclination of the foundation is north side foundation of about 40cm/10m, which is the same inclination direction as shown in Table 6-3. The inclination itself is one half of the inclination of the bottom beam of west opening.

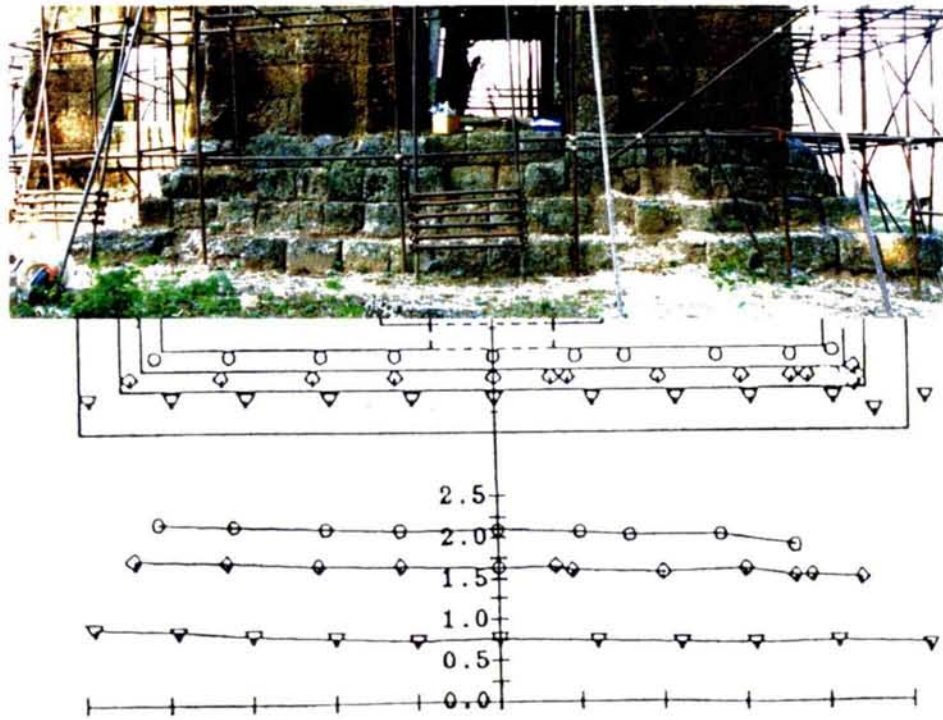
Fig.6-6 Height of each step of east wall

Fig.6-6 and 6-7 also show the height change of the steps for east and north wall. The northeast corner of the foundation was found the lowest level.

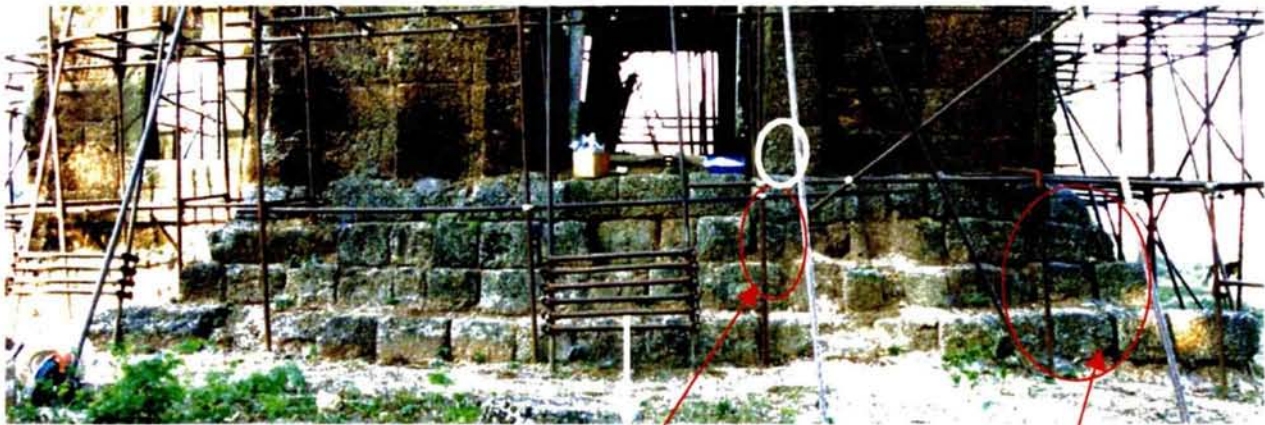
Photo 6-10 east foundation

Any opening gap greater than 2mm is in block letter. The gap in any level shows larger value at the edges. At the base level, the large gap is found at the beneath of the edges of opening. This pattern of distribution of gaps suggests that the foundation is spreading horizontally, which have been caused by the ground movement beneath the foundation. The spreading portion of the grounds may be in the area where the larger stress had been concentrated by the tower structure. The deformations may be creeping characteristics in long term.

Fig.6-11 Distribution of Opening of adjacent stone elements (East side;N1)

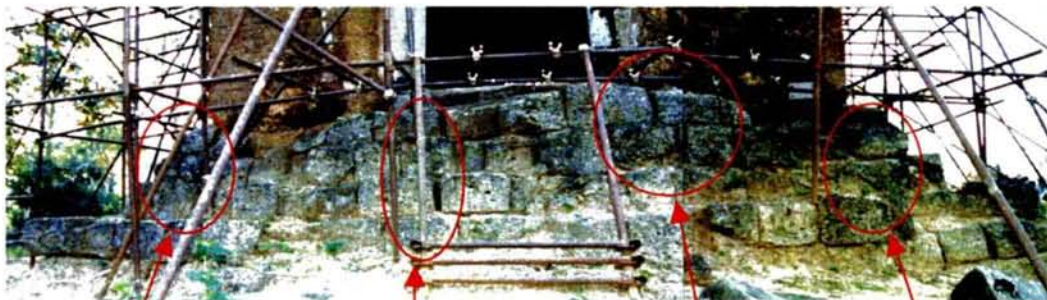
Photo 6-11 North foundation

In Table 6-4, the gaps beneath the openings are summed for east and north sides, the total opening is about 10-18cm, which accounts for the difference between the top and bottom width of opening of the north wall.

The main cause might be due to horizontal outwards movement of compression of ground beneath the corner column where the load concentrated in long term. Wind force might have contributed to cyclic horizontal loading to the Tower, which additional horizontal displacements. The plant root intruded between laterite blocks had also widened the openings. The ground itself might have had expanded by some reason.

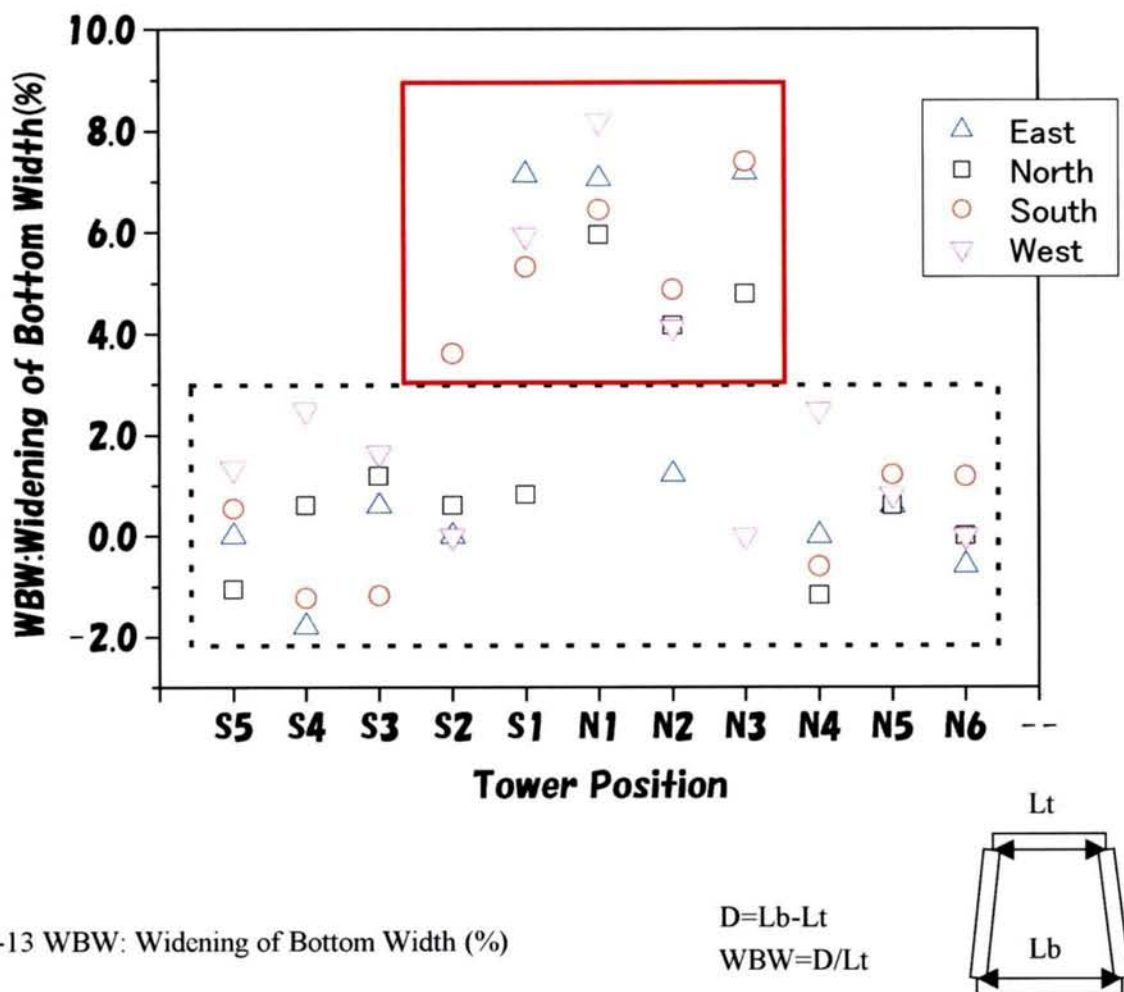
Fig.6-13 WBW: Widening of Bottom Width (%)

Table-6.5 shows the inner widths of the bottom and top of the open windows, their differences, and the widening percentages of the bottom widths for all of 11 Towers except S6. These are plotted and shown in Fig.6-13. Among 11 Towers, they are divided into two groups. One is blocked within red color and another one is blocked in black color. The first group is characterized by the larger widening of the bottom width than the top. The larger values of the widening percentage of the bottom to the top are for N1 and S1 that are very near the Ponds. It is also found the same trend for N2, N3, and S2,

After the construction of the Towers, there were some differences of widths between the top and the bottom. Since it is found that there are some cases where the bottom widths are shorter than bottom ones, the original width may be within a variation of  $\pm 2.5\%$  as shown in the black block in Fig.6-13.

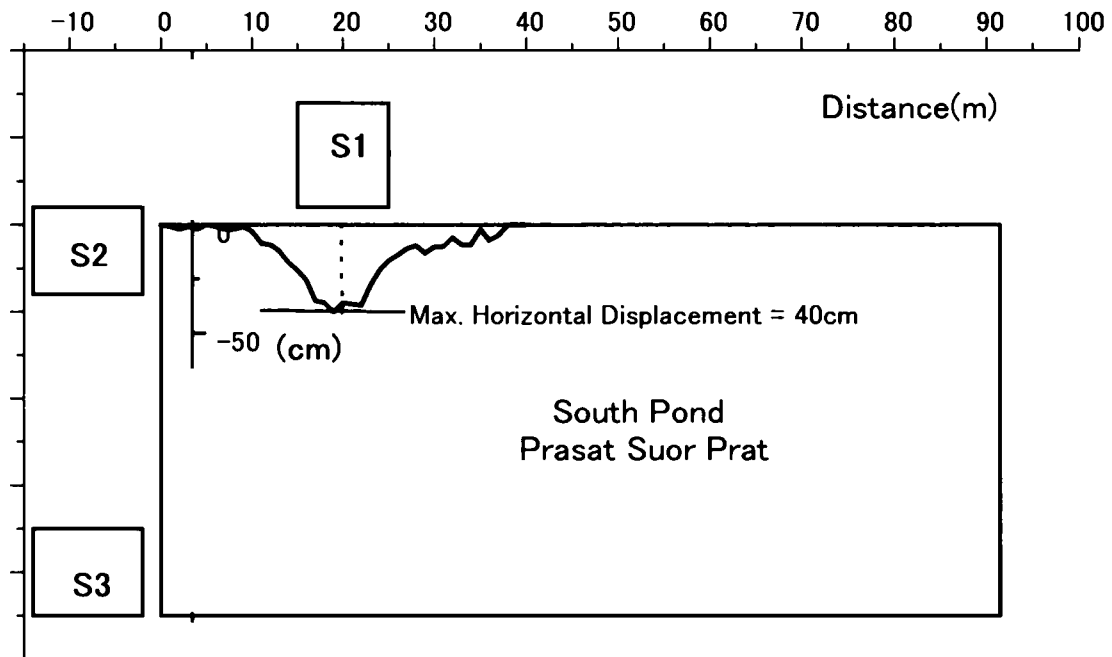
Fig.6-14 Displacement of the North side Embankment of the South Pond, Prasat Suor Prat

The displacement of the north embankment of the South Pond is found almost symmetry against the centerline of the S1 Tower as shown in Fig.6-15. The right hand western side shows a little bit larger displacement than the left eastern side. The offset along the west embankment near S2 and S3 were not visible by naked eyes. The constraining condition for displacement of the

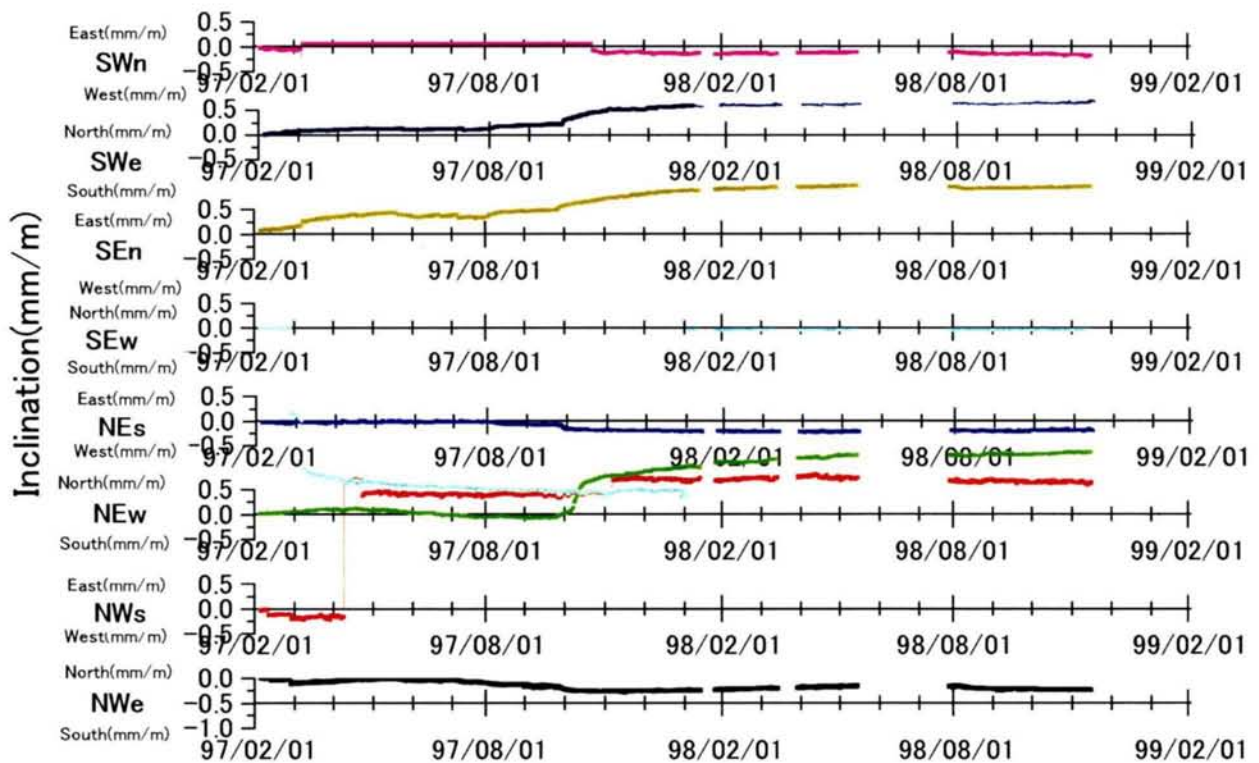
Fig.6-18 Inclination of stone column inside of N1 Tower, Prasat Suor Prat

In fall of 1997 there was a heavy rain when the embankment of moat near the west gate was failed at Angkor Wat. The inclinometer of N1 tower of Prasat Suor Prat had recorded movement of the tower caused by this rain. The inclinometer record of Fig.6-18 indicates the movements of the four walls as follows,

NW column; inclination towards SW

SE column: inclination towards N  
 SW column: inclination towards N

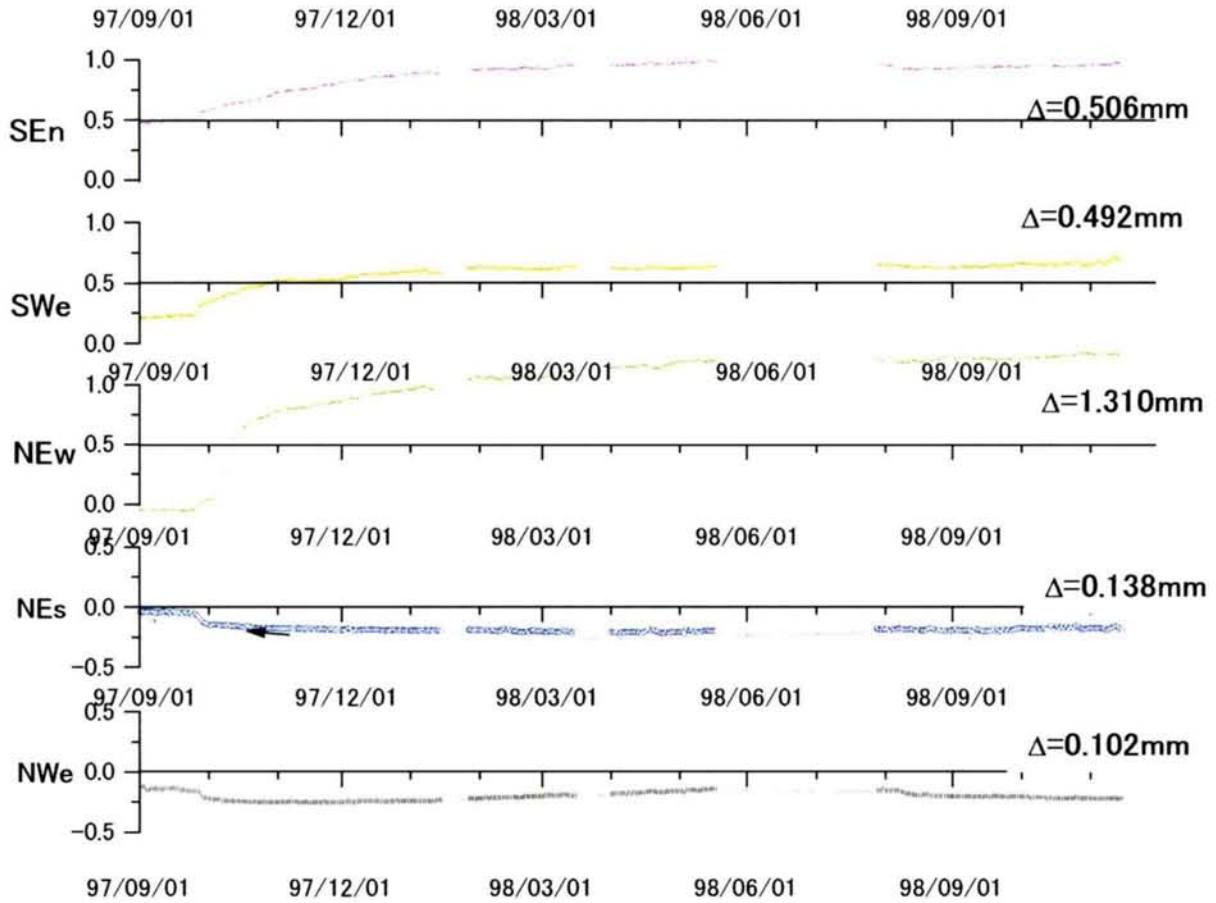
Fig.6-19 Creep of Inclination of Inside Column of N1 Tower, Prasat Suor Prat

The movements continued for more than several months. In Fig.6-19, five components among eight inclination records were selected and shown to see how the inclination increased after the event had been triggered from September 1, 1997 to November 16, 1998

The maximum creep inclination observed was 1.3mm/m of NE column in northward direction. In

The present absolute inclination of N1 tower is about 40mm/m, which means that 30times larger than the inclination changes comparable to the 1997 event. We have not confirmed yet the specific mechanism of this event. However, the inclination change was due to foundation/soil system and/or upper structure of the tower itself.

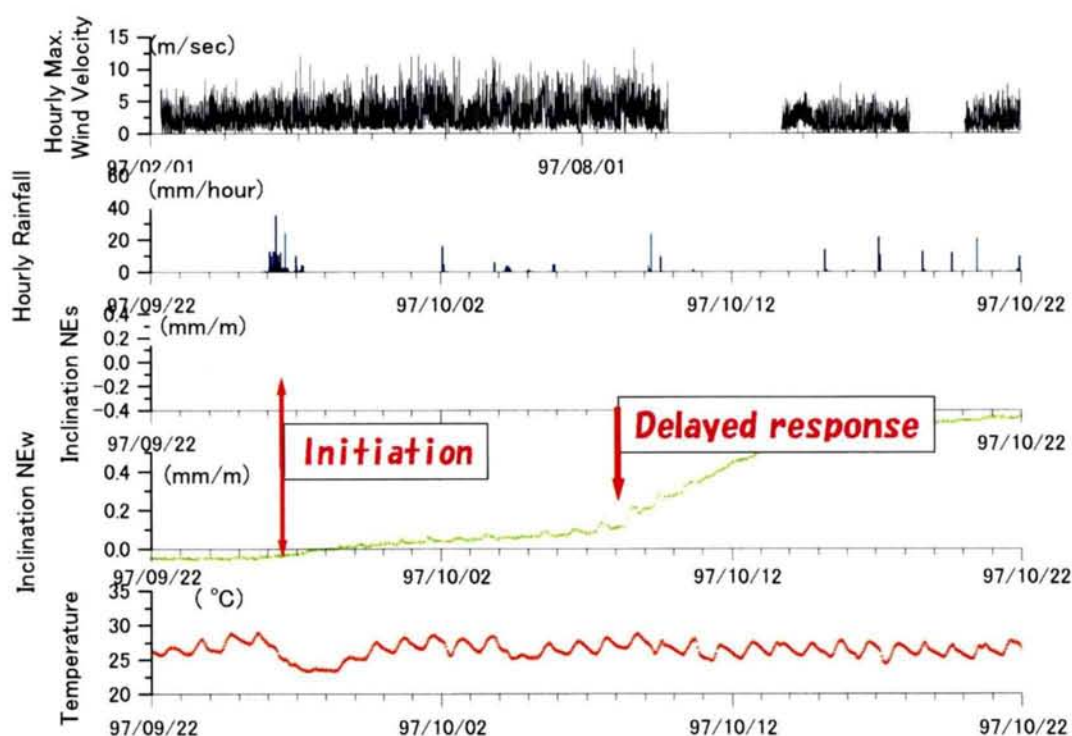
Fig.6-20 The Initiation of creep

Fig.6-20 shows the initial process of creep to start. It is of a great interest to see there is some delay of about 10days between the initiation of change and the delayed response time of creeping.

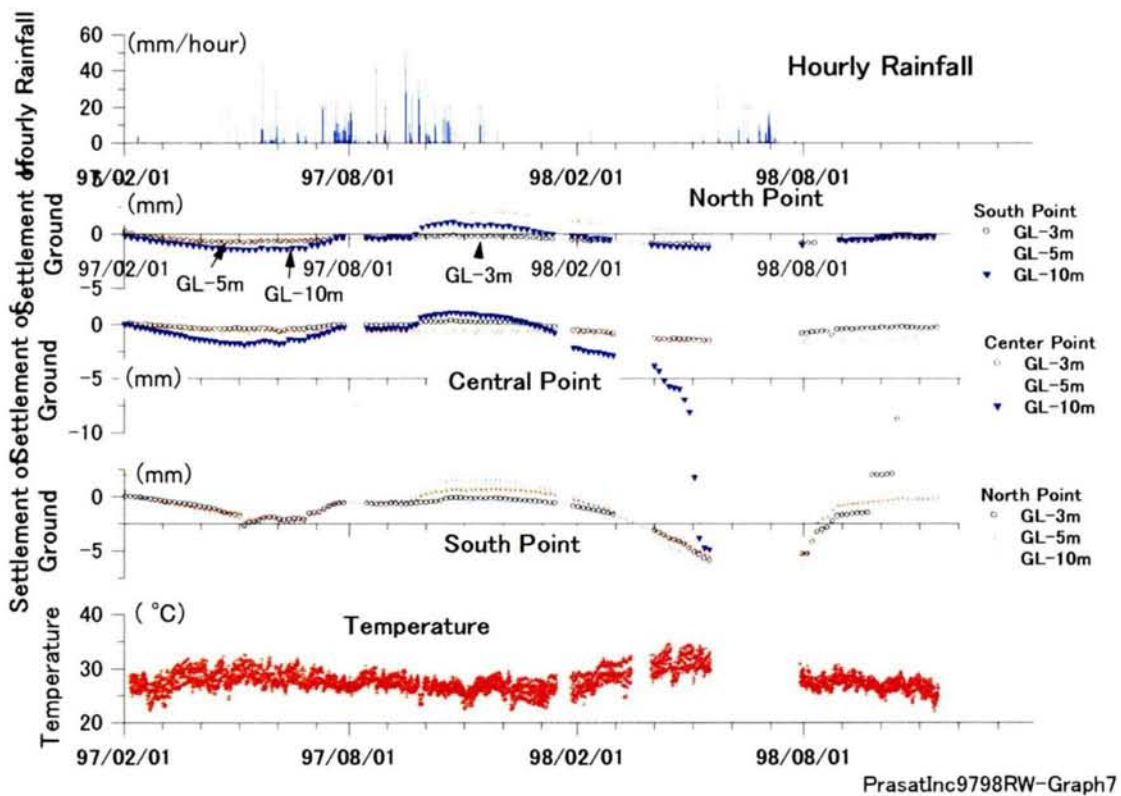
Fig.6-21 Settlement vs. Rainfall and Temperature at west of N1 Tower, Prasat Suor

Fig.6-21 shows the results of monitored ground settlement near N1 tower as well as rainfall and temperature change. The settlement was measured at three points of north, center, and south along a N-S line that is about 8m apart from center of N1 (see p.314, JSA Report 1997). North and south points are located at the extension lines of north and south edges of front room of the tower. Center point locates at the middle between the north and the south points. At each point, three different settlement pipes of three, five, and ten meter in length have been installed, which measures shrinkage or heaving between the ground surface and three different depths. Fig.6-21 shows the monitored results from February 1997 to November 1998 with a lack of data in summer 1998.

In dry season of 1997, the ground settlements of about 1-2mm were observed from February 1 to May 1, 1997.

After May when the rainy season starts, the settlement stops and heaving takes. The north point shows the largest settlement and swelling among three monitoring points. The settlements became rather stable during rainy season from August 1997 before the end of September when the heavy rain occurred. They have been activated due to the heavy rain that had caused the swelling of the ground. There are some common characteristics of these three points. In each point, the heaving from the ground surface to the shallowest 3m depth is almost negligible. However, the deeper points of 5m and 10m show much larger heaving after the heavy rain. This suggests that the water had infiltrated into the deeper layer, which became to expand to swell.

The maximum changes of ground settlement and swelling at three monitoring points are 3-4mm with an average of 2.13mm. After one year from 97/2 to 98/2, the maximum settlement residual is 2mm with an average of 0.39mm. It should be noted that the settlement during the later part of dry season showed about three times larger than the same period in the previous year of 1997, which may be due to rather high temperature in 1998 compared to those in 1997, which are also shown in Fig.6-23. Characteristics of settlements or swelling along the depth shall be treated in the next section.

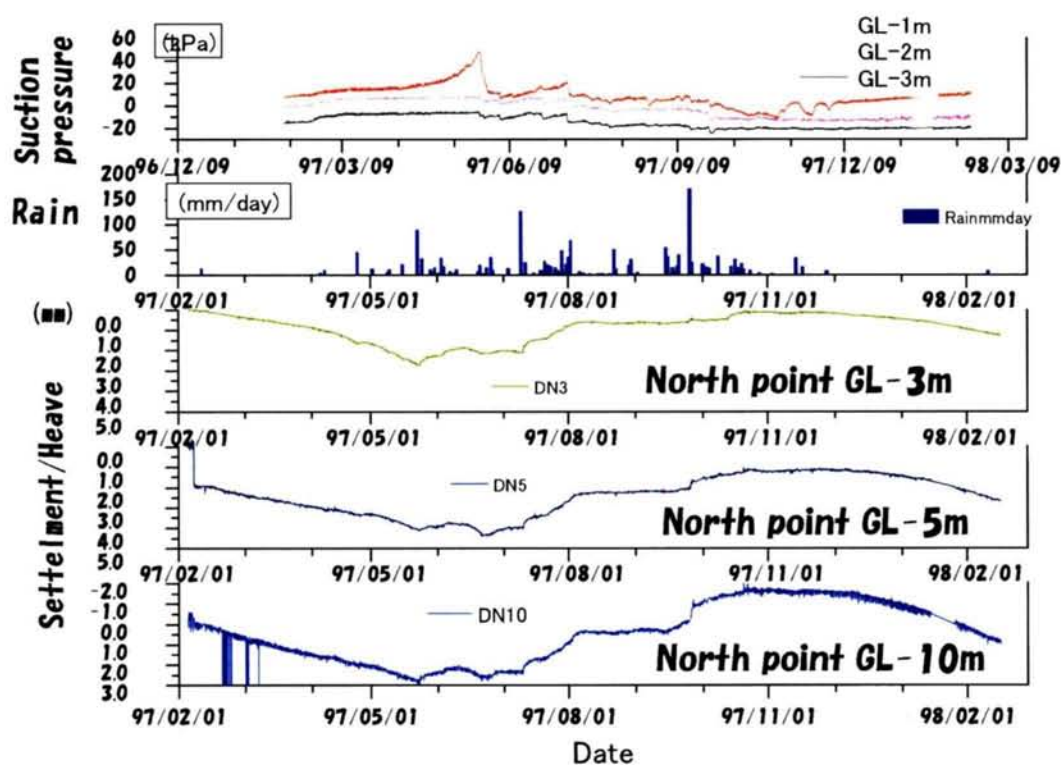
Fig.6-23 Suction, Rain, and Settlements

The monitored results of suctions at north point are plotted in Fig.6-23 with rainfall and settlements. Suction pressures increased with time in dry season from February to April 1997 and began to decrease in May when rainy season started. The suction pressure at GL-1m shows the largest value among three depths.

It should be noted that the settlements and swellings are closely related with each other. The shrinkage of the ground continued when the suction pressure increased until the suction began to decrease.

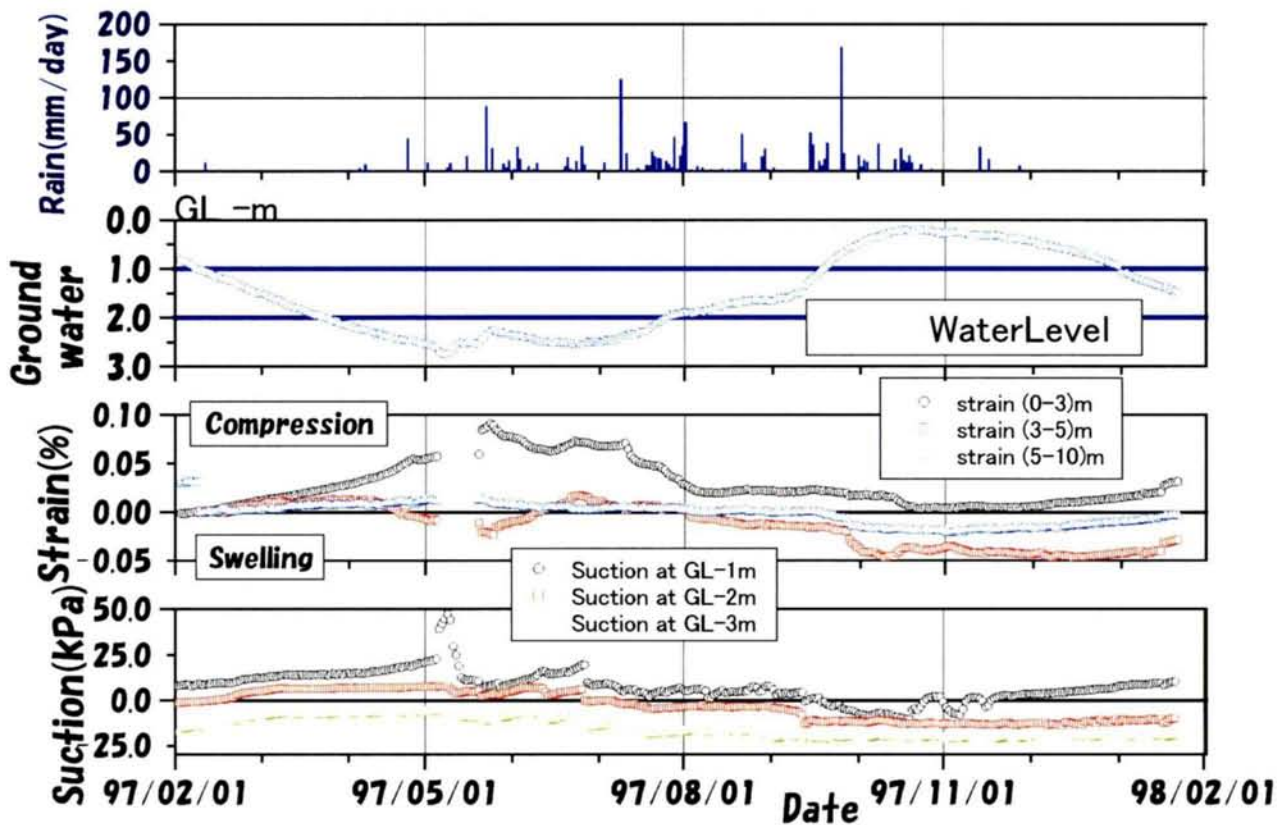
Fig.6-24 Rain, Ground Water, Strain of the Ground, and Suction

Fig.6-24 shows time histories of rain, ground water level, vertical strains, and suctions at north point. Vertical strains are computed by the differential settlement between GL-3, GL-5, and GL-10m divided by corresponding distances.

In dry season from February 97, suction pressure at GL-1m increased which corresponds the dewatering of underground water level. The compression of the ground from GL to GL-3m is found also increased.

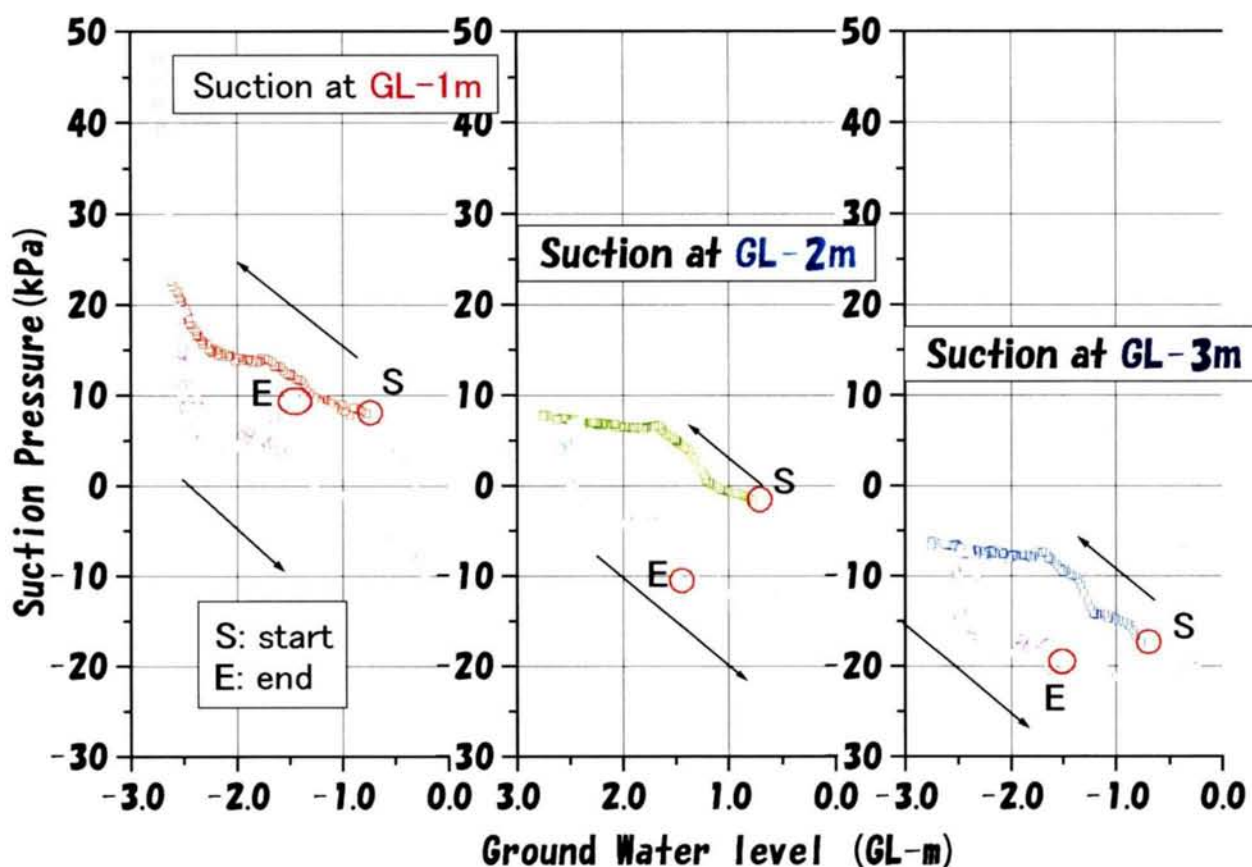
Fig. 6-25 Ground water level vs. Suction pressure

Fig.6-25 shows the relationship between ground water level and suction pressure for three depths of GL-1m, GL-2m, and GL-3m. All three suction pressures have strong relationship between ground water levels. When the ground water level decreases, the suction pressure increases.

The suction pressure installed at GL-1m showed sudden increase of the pressure when the ground water level decreased about GL-2.5m.

Since the ground water level has varied from GL-0.8m to GL-2.5m, suction sensor at GL-3m was considered as under the ground water level and the measured values are negative, which indicates the suction pressure has disappeared and pore pressure was build up. However, the pore-pressure responds with ground water with hysteresis. This may be due to unsaturated states of ground. Overall responses of suction pressure against change of water level are found about 10kPa per 1.0m.

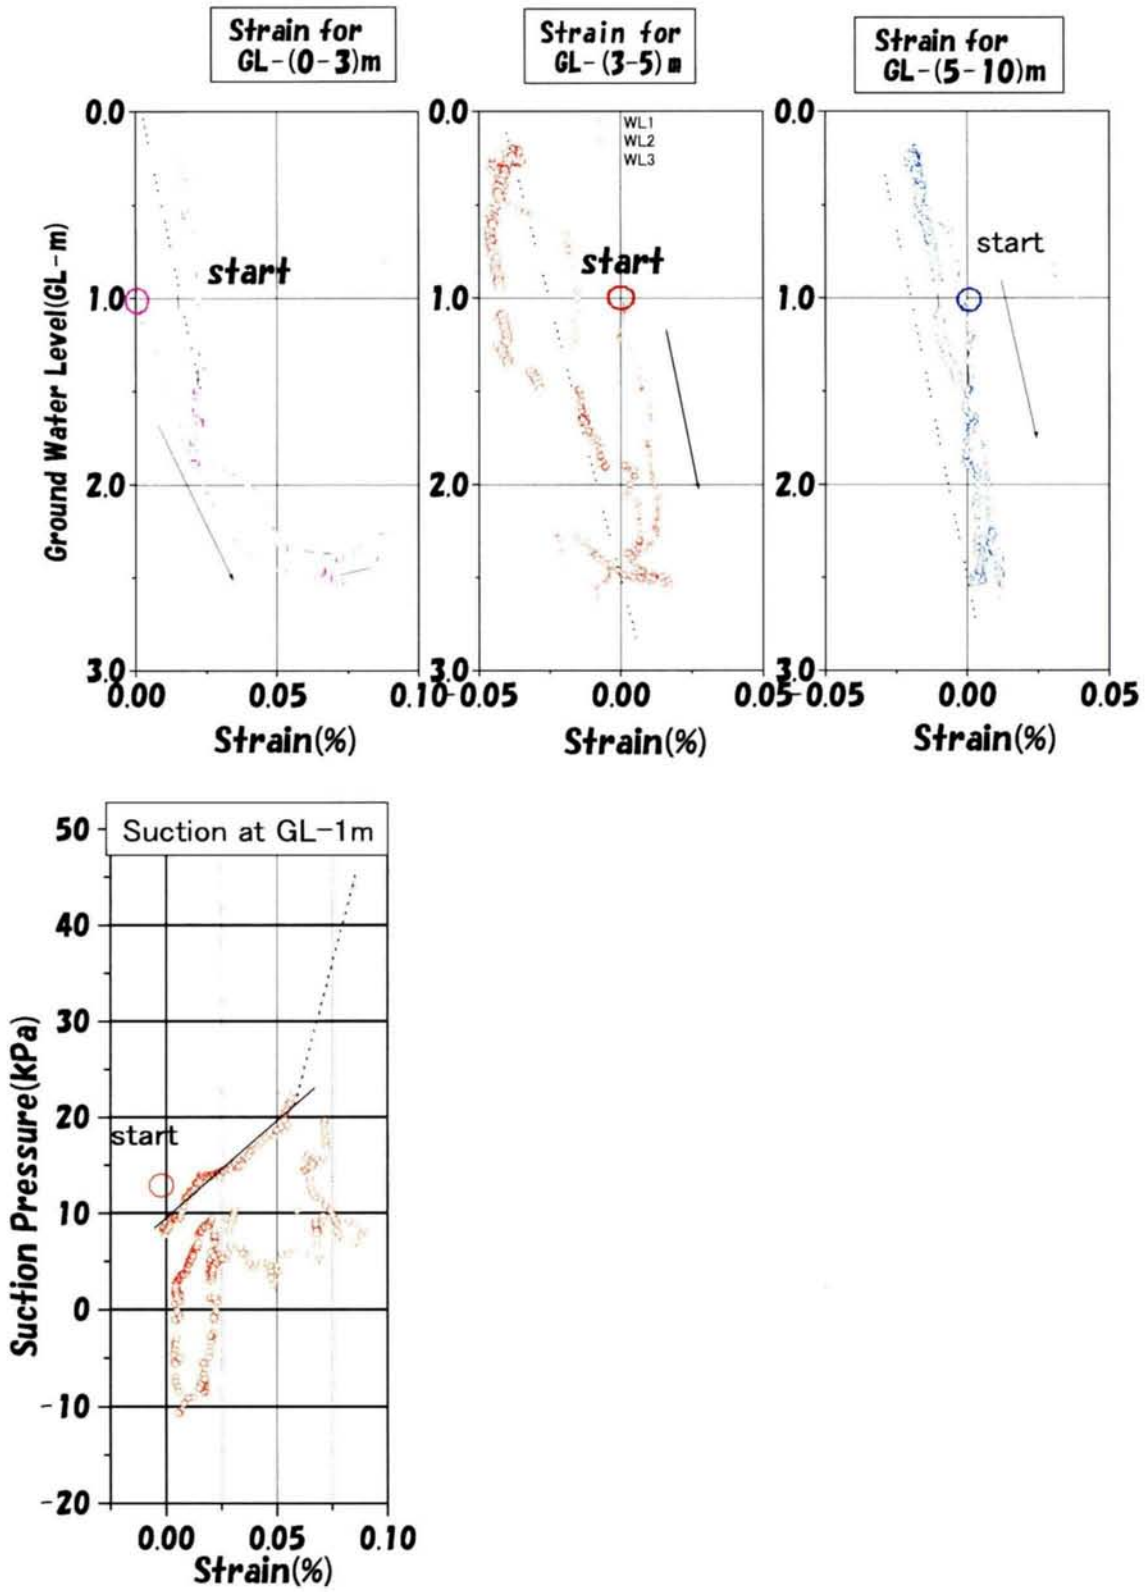
Fig.6-26 Vertical strain, Ground Water and Suction Pressure

Fig.6-26 compares vertical strains with ground water level and suction pressures. In general, the change of underground level induces the effective stress on the soils in the ground, which results in volume change of the ground.

The compressibility was found to increase with the depth. The apparent compressibility from effective stress change caused by water level and suction change were obtained as the same value of 40MPa.

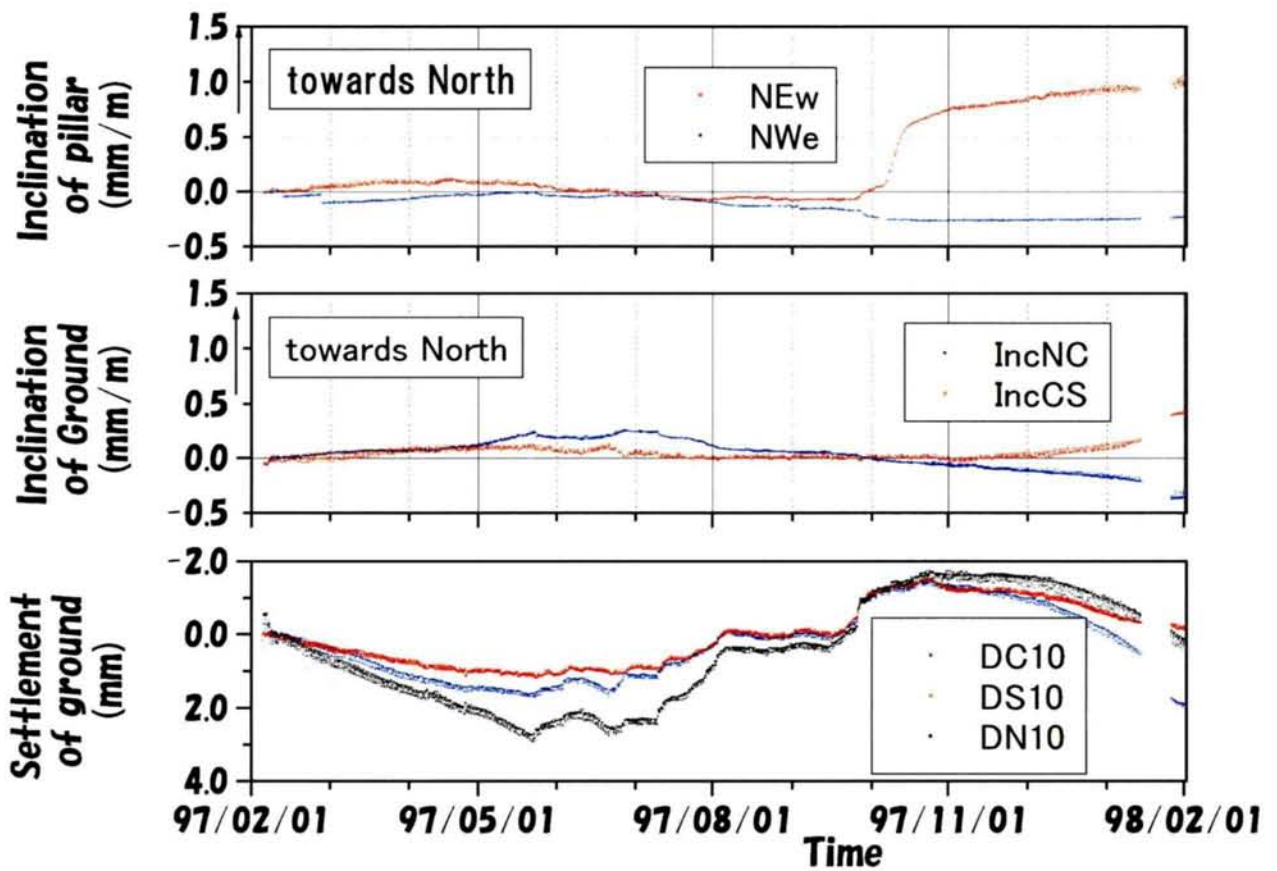
Fig.6.27 Settlements at north, center, and south points, inclination of masonry pillar at NE and NW corners, and inclination of ground

Fig.6.27 shows settlements at north, center, and south points, inclination of masonry pillar at NE and NW corners, and inclination of ground estimated by settlement measurements.

The increases of the inclinations of the pillars are found no relation with ground behavior.

If the tower inclination has been caused by the ground settlement/heaving, the inclination should be the same trends of the ground behavior.

The allowable settlement to keep the masonry structures from differential settlements is not known at this time. It is necessary to keep the present underground condition and to continue to monitor the ground water level as well as responses of the masonry structures to prepare any situations that may occur in the future.

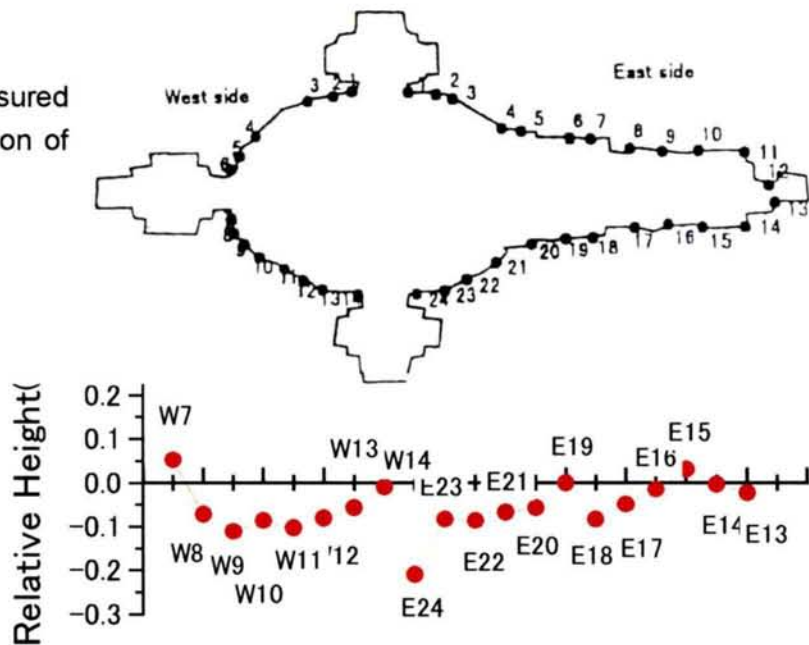
Fig.7-5 Relative Height of Basement around the main tower, Bayon on the Upper Terrace

The top and the bottom of Fig.7-5 show the height for northern and southern halves. It is understood that the western side of the tower is symmetrical in height. Both north and south subsided to the centerline. On the other hands, the eastern side of the tower is one sided.

The northern half (E1 to E4) is higher than southern counter part (E24 to E21) by about 0.25m. In the peripheral circle of the central tower, there are some portions of differential height or settlement. However, there is no definite trend to show one sided inclination.

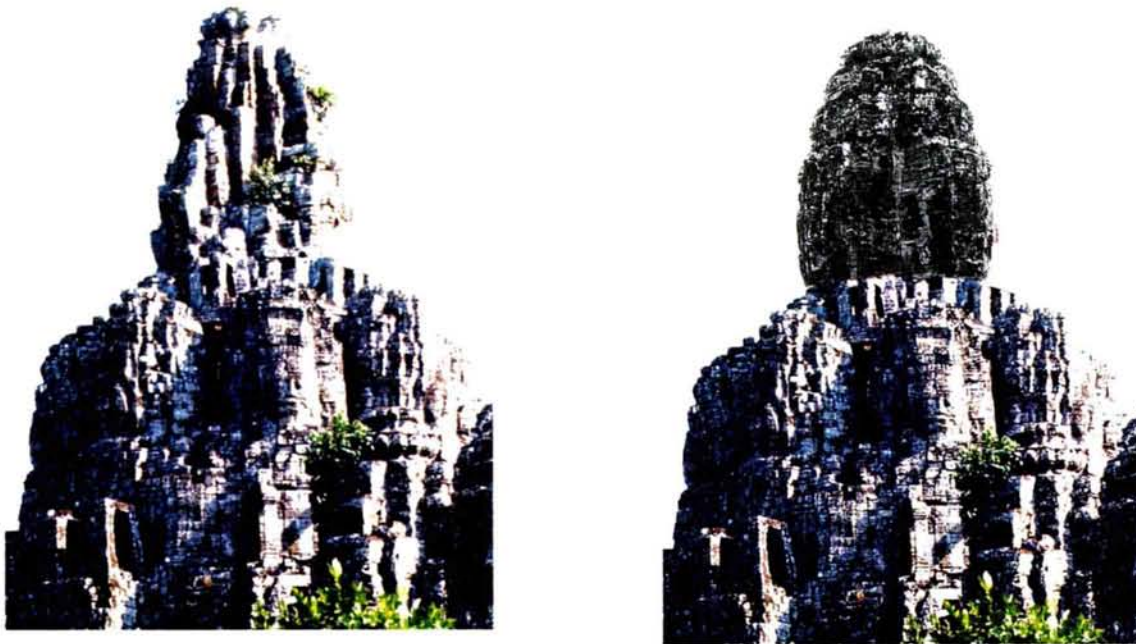
Photo 7-4 The comparison of present and estimated original shape of the Central Tower, Bayon

It is found the lack of the symmetry against the center of the tower. Photo 7-4 shows a comparison of the present and estimated original shape of the Tower. One of the reasons why the outer shape of the tower silhouette differs each other depending on the direction is not known. However, these characteristics of the shape of the tower strongly suggests stone elements might have been fallen out in the long period after being lost by the Khmer Empire.
