**Geotechnical Study on  
Ground and Masonry Structures  
in Angkor for Safeguarding Monuments**

**September 2001**

**Yoshinori Iwasaki**

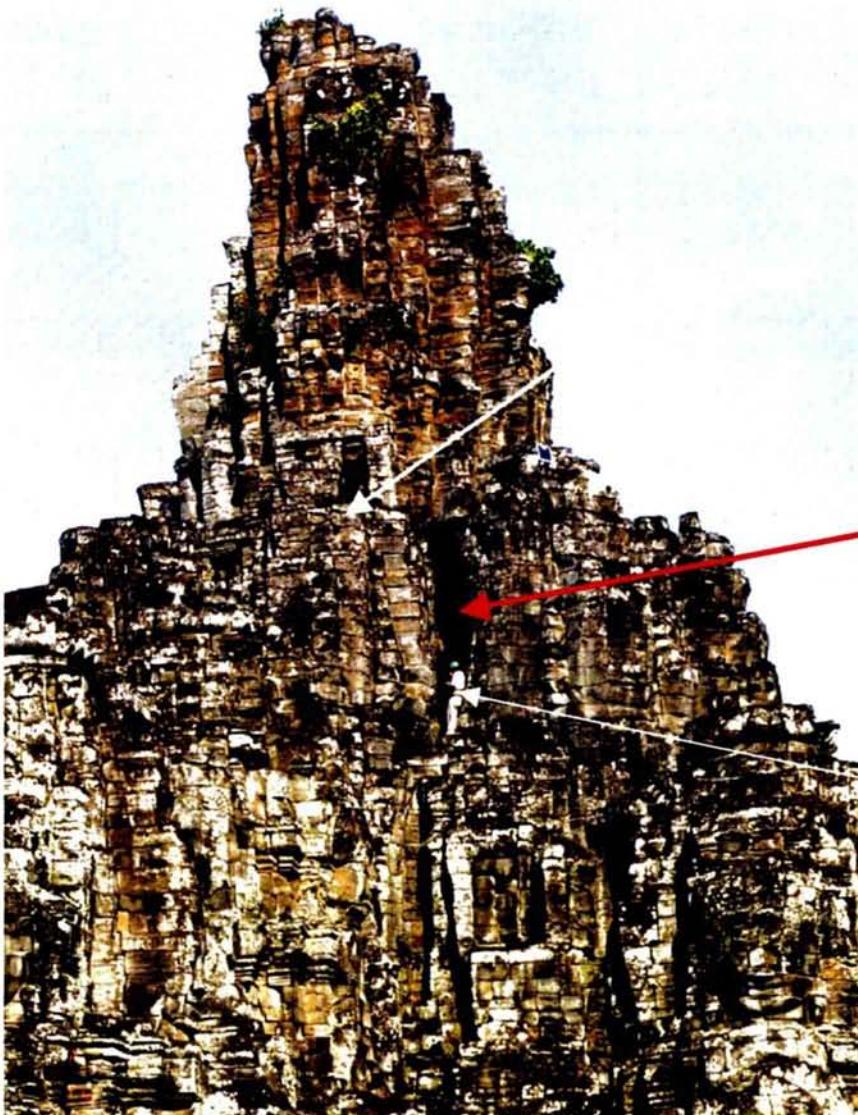
Photo7-6 Gallery of the Central Tower

There is a gallery within the central tower as shown in Fig.7-1, which surrounds the tower at a level of about +25m from the ground level. We can observe the present situation of the fall out process of the main tower. The Gallery is the space between the inner central tower and eight sub-towers. The Gallery is open at the spaces between the sub-towers as shown in Photo 7-6.

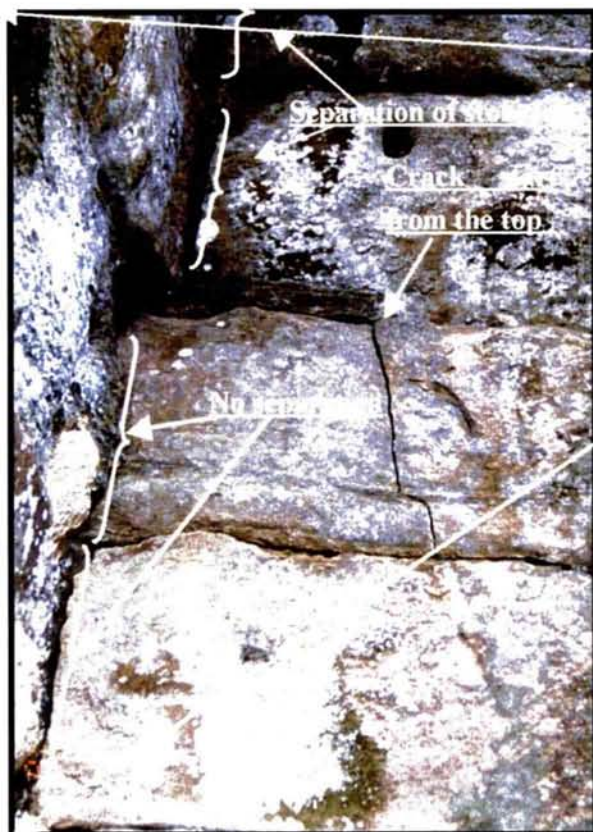
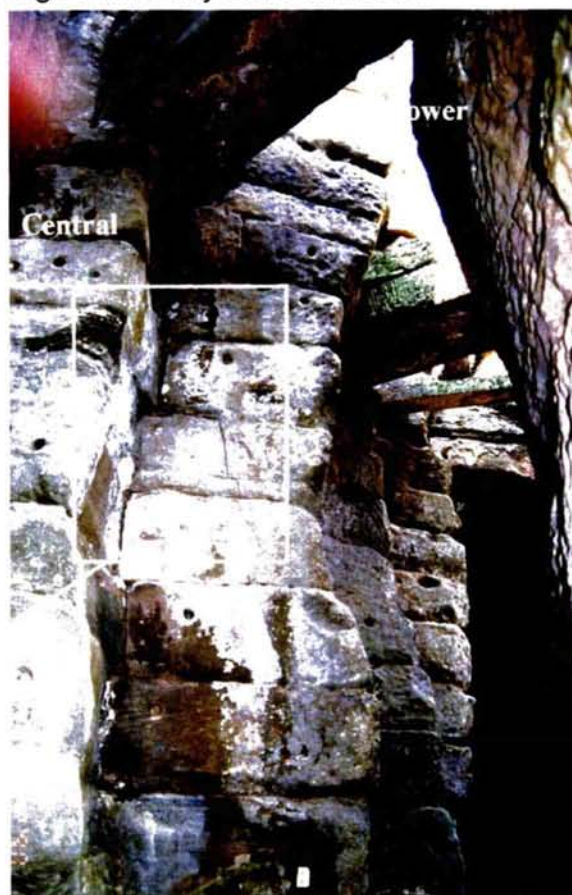
Photo 7-7 Inside of the Gallery of Central Tower (northwest corner)

Photo 7-6 shows the inside of stonewalls of the Central Tower around the corner of northwest. It should be noted that a vertical crack develops in the side surface of a sand stone at the middle height, which is enlarged and shown in the left of the Photo 7-7. The crack on the stone surface initiates at the upper surface and has developed downwards. It should be also noticed that the separation of sandstone above the cracked one from the left neighbor stone, while no separation of the spacing between the cracked stone and the adjacent one. The separation of the spacing above the cracked stone is found continued upwards. At the same time, no separation is found at the lower stones than the cracked one.

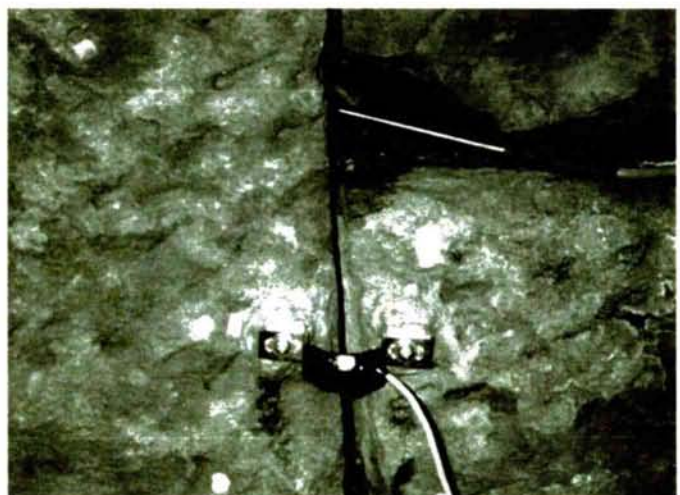
Photo7-12 Gap opening and temperature

Photo7-12 shows an example of installation of a gap sensor and thermometer at NW sub-tower. The measured data of changes of gap and temperature from October 1997 to November 1998 are shown in Figs.7-8 and 7-9. The sensors are named as NE, NW, W, S, SE, and E according to the directions of sub-towers that are being monitored. Figs. 7-10 and 7-11 also show the same data only for three-month period from May 1, 1998, where the more detailed movement can be observed. Among six sensors, it is noticed that the trend of gap changes has some common and different characteristics. The daily change in common is found to close the opening the gap in daytime and to widen in night. The magnitude of the gap closing and widening is different for each point. The temperature changes shown in Fig.7-10 also have different characteristics for each point. Temperature sensors at NE, NW, and W are located at the gap sensors except at S sub tower point where the sensor is exposed directly to the sunshine.

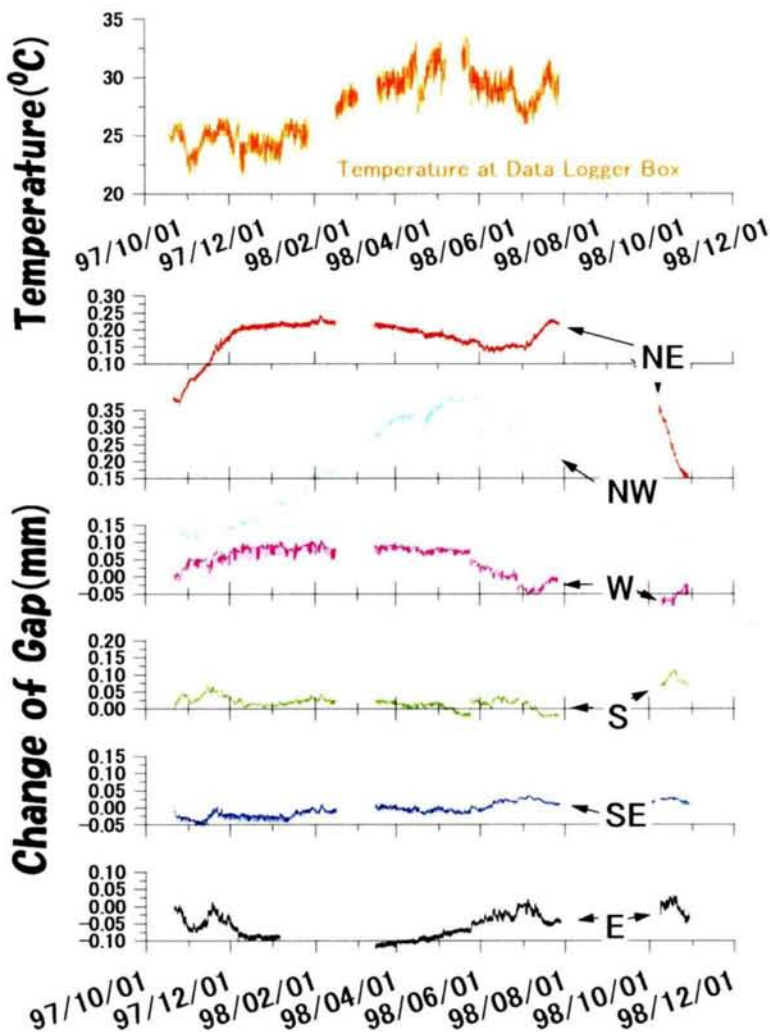
Fig.7-9 Change of Gap of Opening at Central Tower Bayon

The relationship between the magnitude of gap opening and temperature is expected. It is found in Fig.7-9 and 7-10 that the gap opening becomes wide when the temperature change is also large for each sensor.

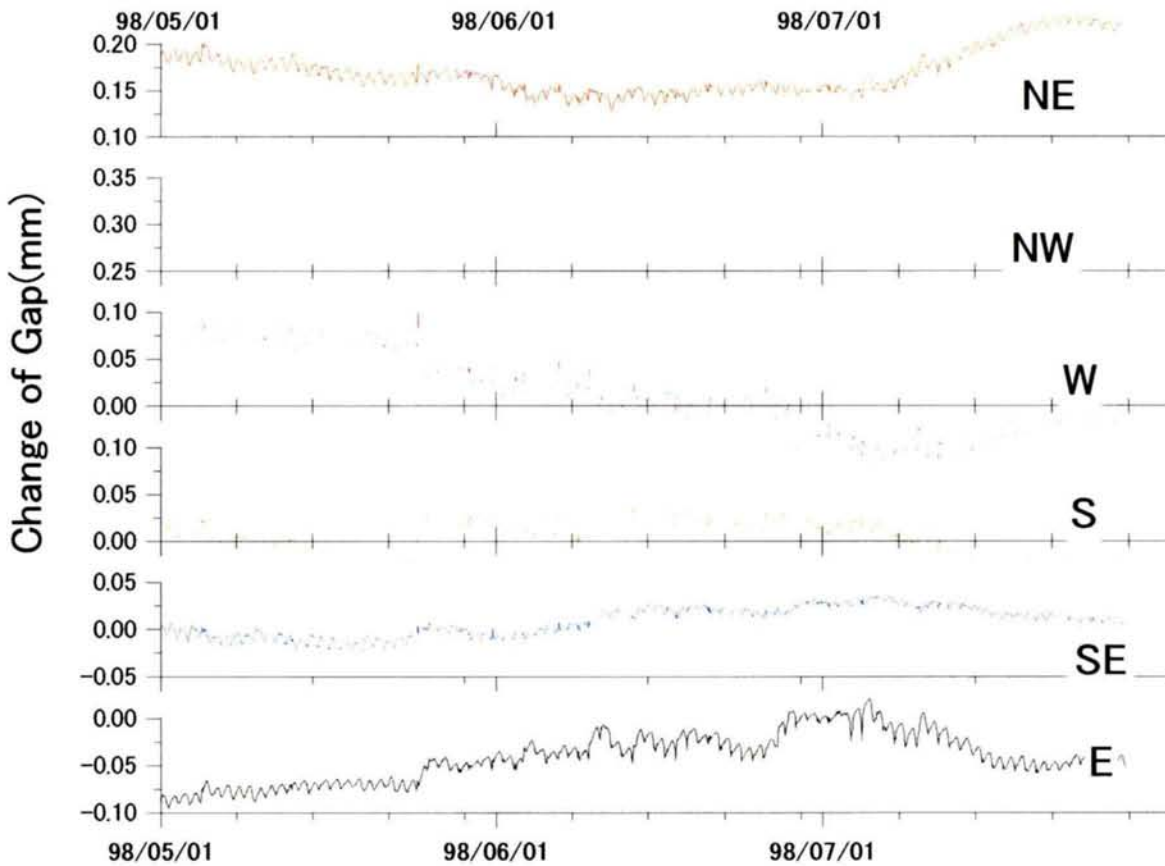
Fig.7-11 Change of Gap Opening at Central Tower

Among the continuous change of the gap opening, it is also found some sudden change as found on May 23, 1998 in Fig.7-11. On the day, the temperature decreased in sudden. The gap opening of NW, W, S, SE, and E had increased except NE point. Within a few days later those of NW and W points decreased, but those of S, SE, and E continued as sudden increased opening.

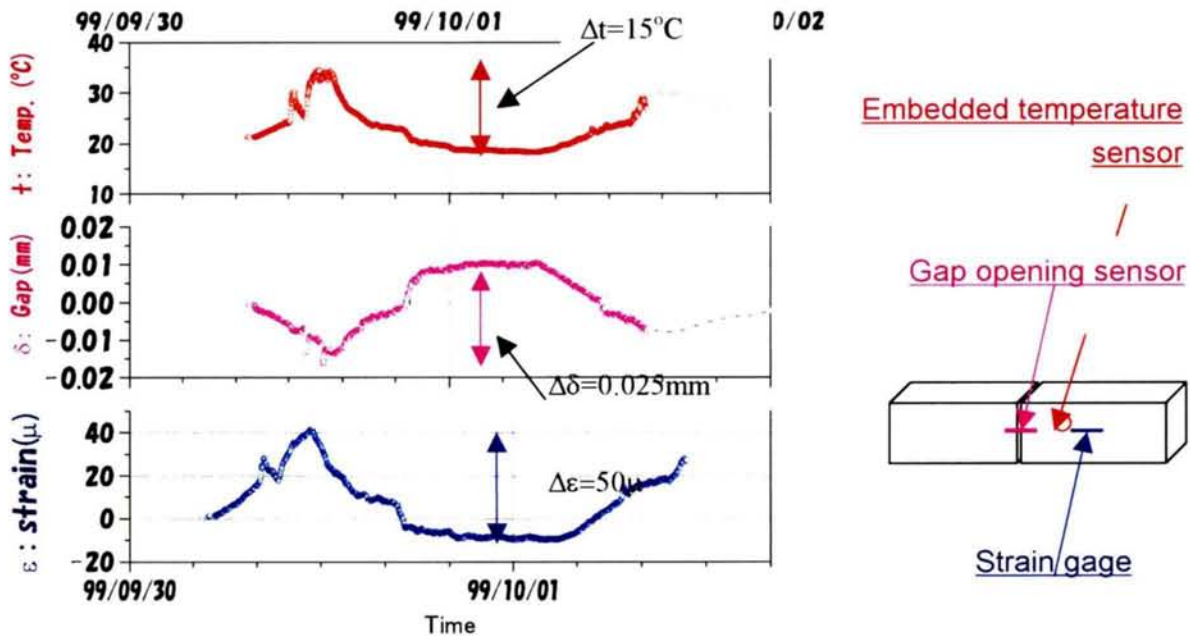
Fig.7-12 Temperature, strain of stone surface, and Gap opening

Fig.7-12 shows the relationship between strain of the stone surface, temperature inside the stone, and the gap opening of space between adjacent stone.

The measured gap change is 0.025mm, which well corresponds to the estimated value.

It was shown that the basic behavior of change of the gap between stones is the elongation or shrinkage of stones caused by temperature change.

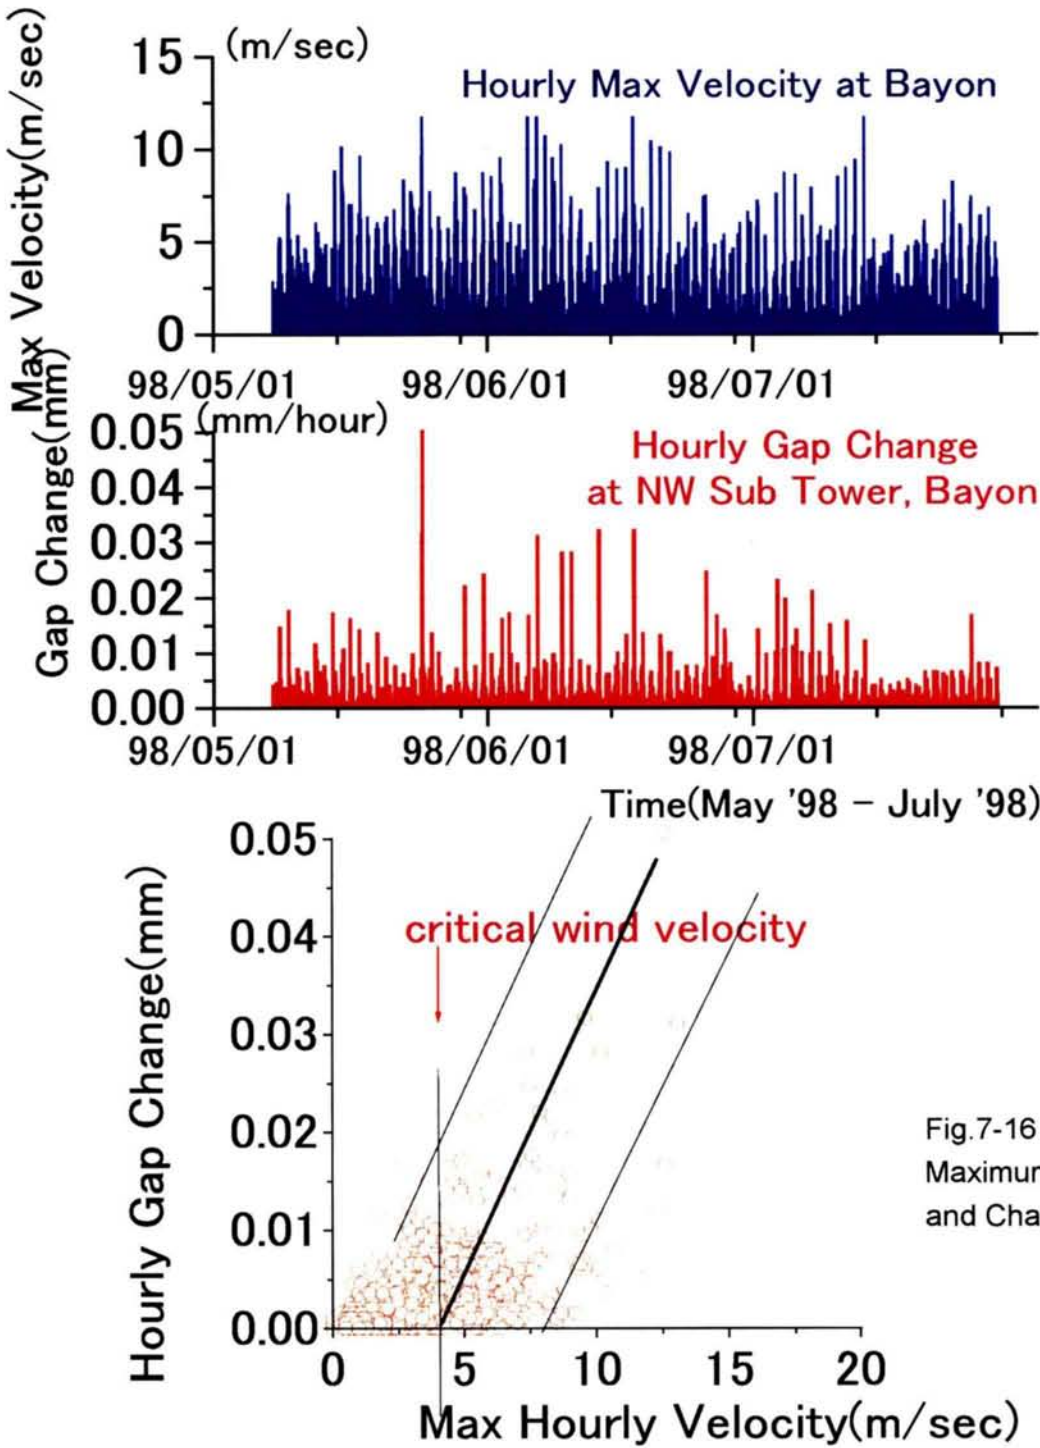
Fig.7-16  
Maximum wind Velocity and Change of NW Gap

Based upon the gap records, hourly gap changes are computed and shown in the upper part of Fig.7-16 with hourly maximum velocities. The relation between the hourly gap changes at NW point vs. the hourly wind velocities in the same time range shown in the lower part can be understood that the stronger wind velocity had triggered the larger sudden gap change in the same hour duration. We may define a critical wind velocity over whose value large sudden gap changes are observed. The critical wind velocity at NW point is about 4km/sec.

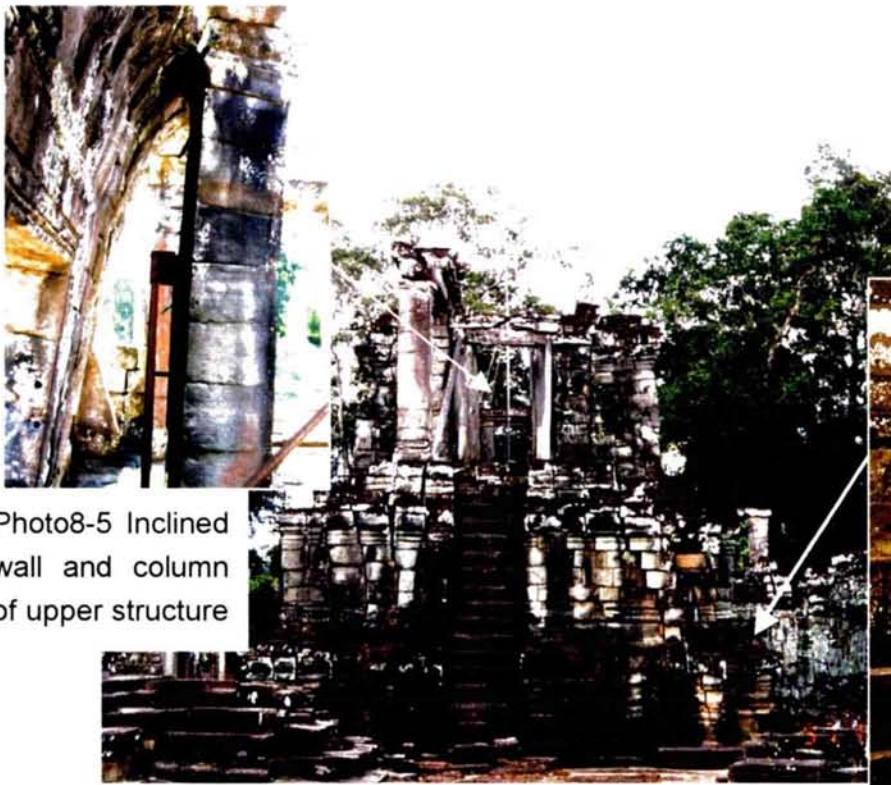
Photo8-5 Inclined wall and column of upper structure

The walls of upper structure are heavily inclined towards inside (Fig. 8-5). The boundaries of porches and the main structures at both ends are found settled and have become the lowest level. Lintels of porches have been struted against structural collapse.

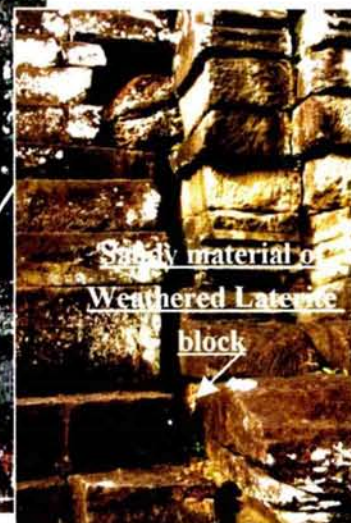
Photo.8-6 South-west corner of the foundation

At the west and south corner of the South Library, we could see the outcome of sandy materials from weathered lateritic blocks from a large opening between blocks.

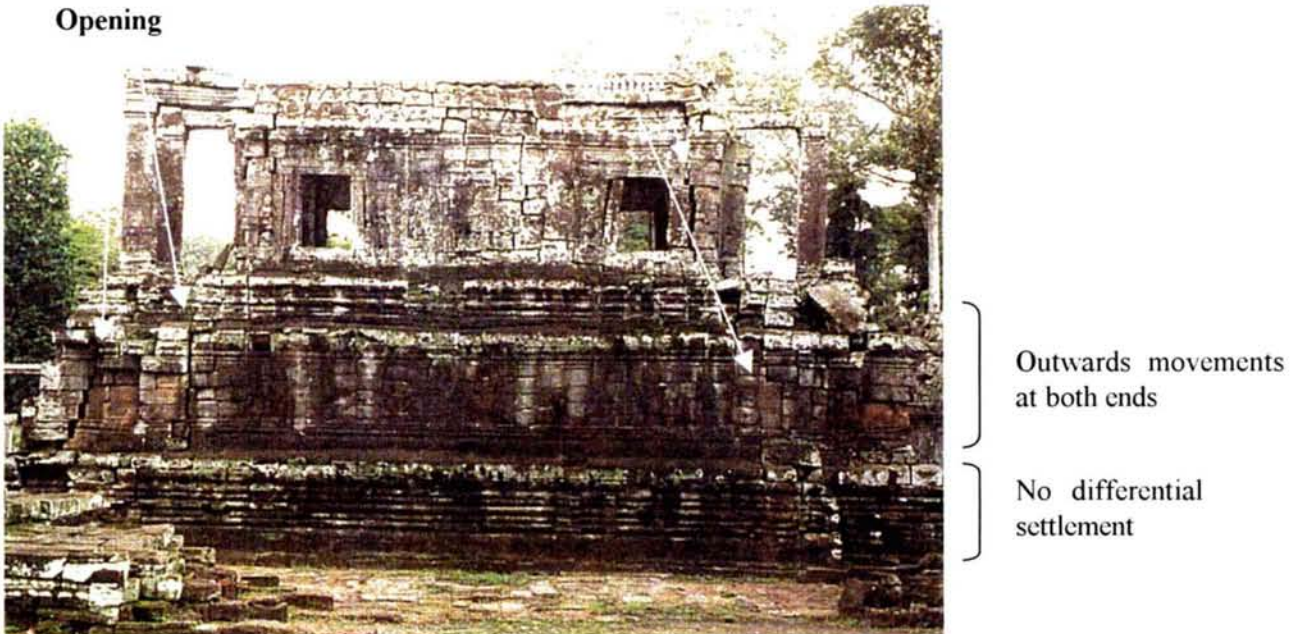
Photo 8-7 North Library, Bayon, side view from south

In Fig.8-7 and 8-8, several large vertical openings are found at the corner of North Library as well South Library.

Most stone elements covering the corner surface of the foundation are found slid outwards. These movements are caused not by the settlement of soil-foundation but by some deformations of the retaining foundation and/or movement of stones themselves.

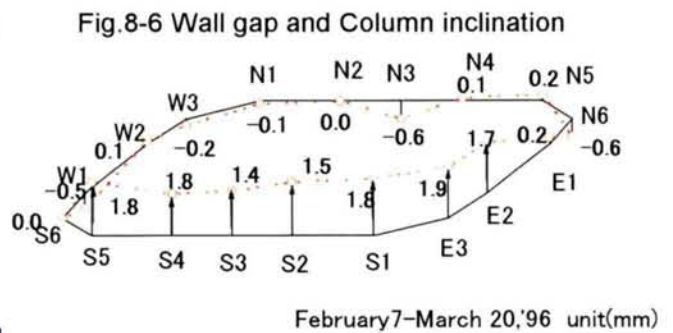
Fig.8-8 Relative heave to S6 during dismantling

The final heaving was calculated relative to a reference point of  $S_0$ . The maximum heave was observed at south-east corner as 1.8mm and the maximum relative settlement was estimated at N3 point as -0.6mm. These resulted in the maximum uneven heave as 2.4mm. Unfortunately, absolute settlements were not obtained because of damage of reference point for leveling. However, the heave is estimated with the differential heave as discussed below.

It was also recognized that the heave of about 2mm at south east corner compared to northwest one. The averaged inclination due to dismantling was about 2/12000=1/6000 to southeast direction. The settlement caused by reconstruction process is expected as the same amount. It is expected that the reloading effects on the foundation ground are negligible based upon this observation.

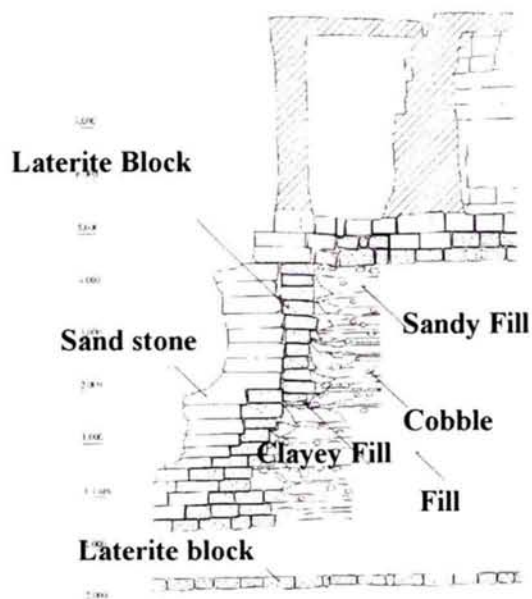
Fig.8-10 Inside structure based upon excavation of the west side of North Library, Bayon

Fig.8-10 shows the revealed retaining wall structure. The inside of the platform itself is made of compacted filled mound enclosed by laterite blocks with sandstone blocks at the outer surface. The laterite blocks are found badly weathered and there are some holes as evidences of erosion of soils by water or small animals.

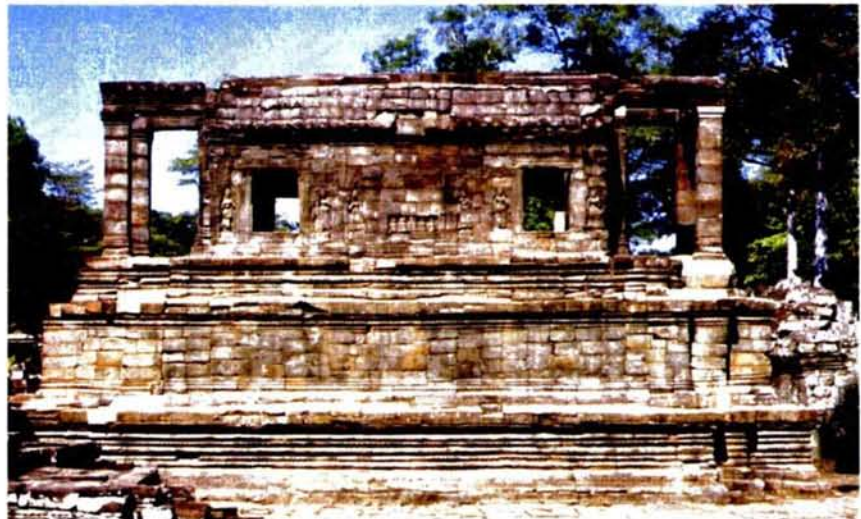
Photo 8-17 After Restorations

Started in November 1994 JSA had continued their efforts to restore North Library of Bayon and took about 1500 days to complete the restoration work in September 1999.

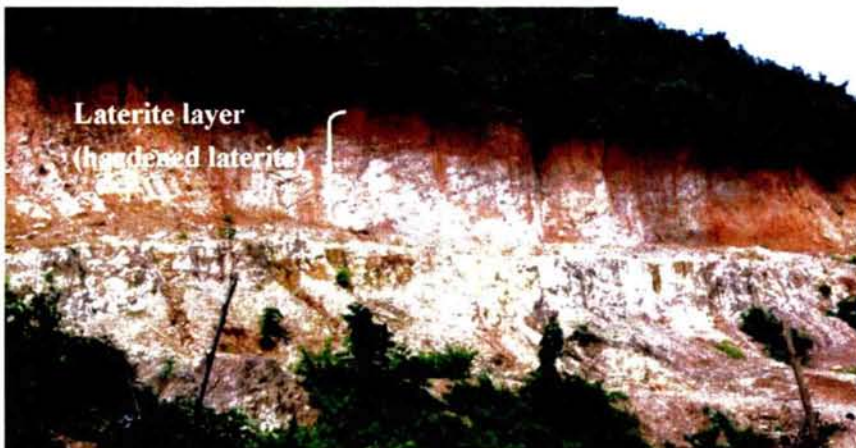
Photo 9-1 Laterite layer

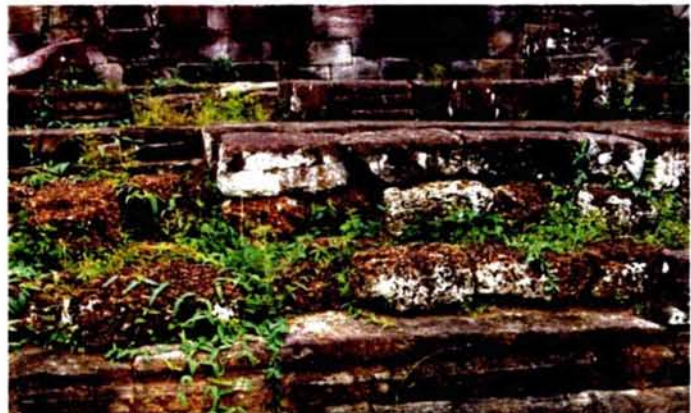
Photo 9-3  
Decayed laterite blocks  
(Foundation of Bayon temple)  
desharpened edges  
and surface weathering

Typical example in Photo 9-3 is de-sharpened edges of laterite blocks and volume of block is found decreased. It is shown in Photo 9-4 that decomposed laterite block inside the sandstones flows out through an opening between sandstones.

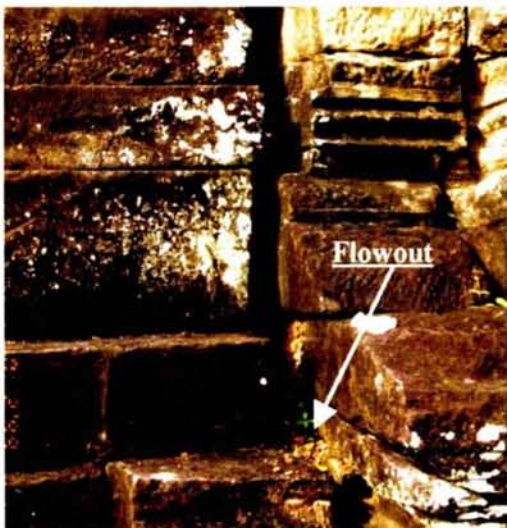
Photo 9-4  
Flow out of decomposed laterite  
(South Library, Bayon Temple)

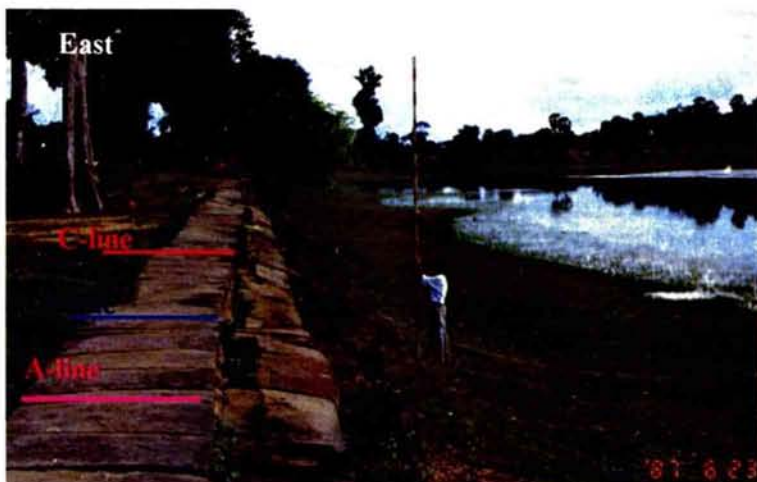
Photo 9-6 Leveling of steps of embankment at Srah Srang (see the location of Srah Srang in Fig.2-3)

As shown in Photo 9-6, A-line is the nearest one to the corner. Among three sections, the top of the embankments of three lines are almost the same, the lower levels of the three lines are different each other. It is expected that the mechanism to cause the inclination phenomenon does not include sliding of the slope failure. If the inclination is related with sliding shear failure, the top level of the embankment along A-line becomes lower than that of C-line.

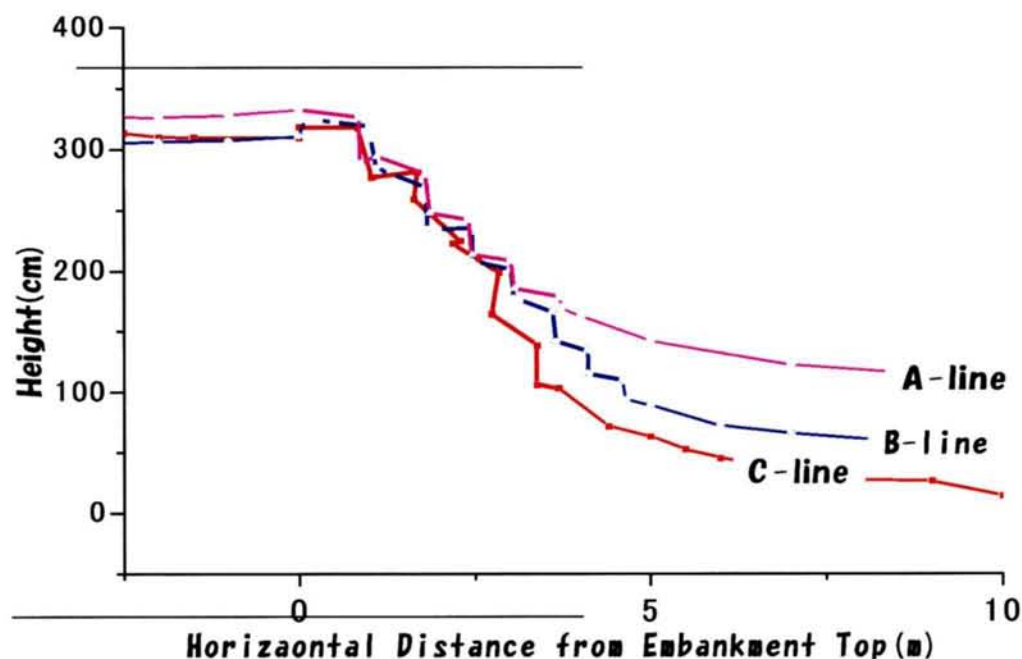
Fig.9-2 Leveling of surface of step stones at Srah Srang

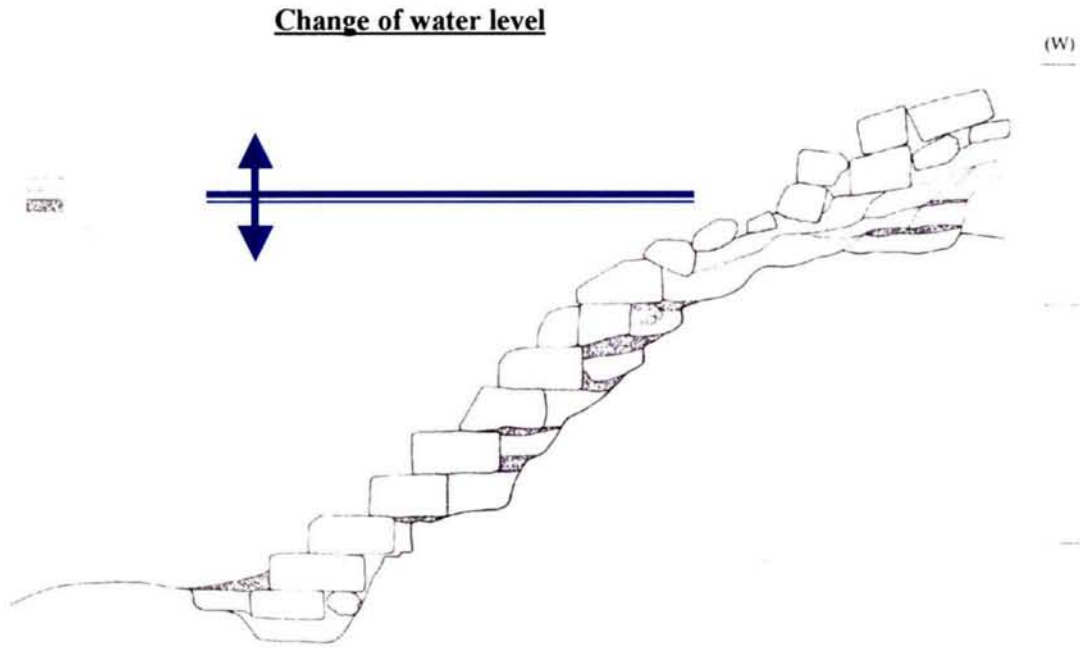
Archaeological Unit of JSA, had performed trench excavation at the west side of North Pond, Prasat Suor Prat, where the embankment section was disclosed as shown in Fig.9-3. Fig.9-4 shows imaginary reconstruction of the original embankment at the side by the archaeological unit, J.S.A.

The top block is found inclined towards waterside, however, the trend is not always the same.

From the bottom of the pond, the slope with an inclination of about 40 degrees was constructed by compacted soils with surface covered by laterite blocks. Apparently, laterite blocks around GL-1m have significant changes of shapes of blocks. Some are broken into a few pieces. The broken pieces were further weathered and the surface of the stone became dissolved and blocks became very small.

The present level of water in the pond is about GL-1m in rainy season and becomes lower in the dry season. It is easily anticipated that the fluctuation of water level makes severe change of temperatures of the block surface, which contributes to accelerate weathering at this level.

Fig.9-3 Section of the existing state of shore protection work at the embankment of North Pond, Prasat Suor Prat (JSA Report(1998))

The inclination of the step blocks towards pond side will take place if the lower block deteriorates earlier than the upper blocks

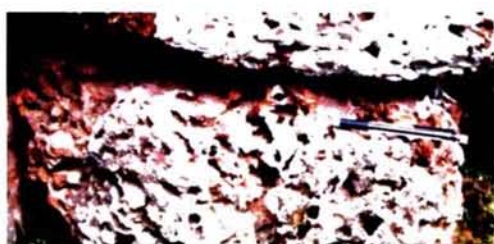
The quality of laterite blocks depends upon several factors. If the quality is poor, the laterite may have small strength and easy to decay. Photo 9-7 shows old used laterite block, which has many voids in the surface. The void was originally filled with such materials as kaolin and considered eroded out during weathering process. The new laterite should be checked and selected to obtain good quality material to be used.

Photo 9-7 Old laterite block

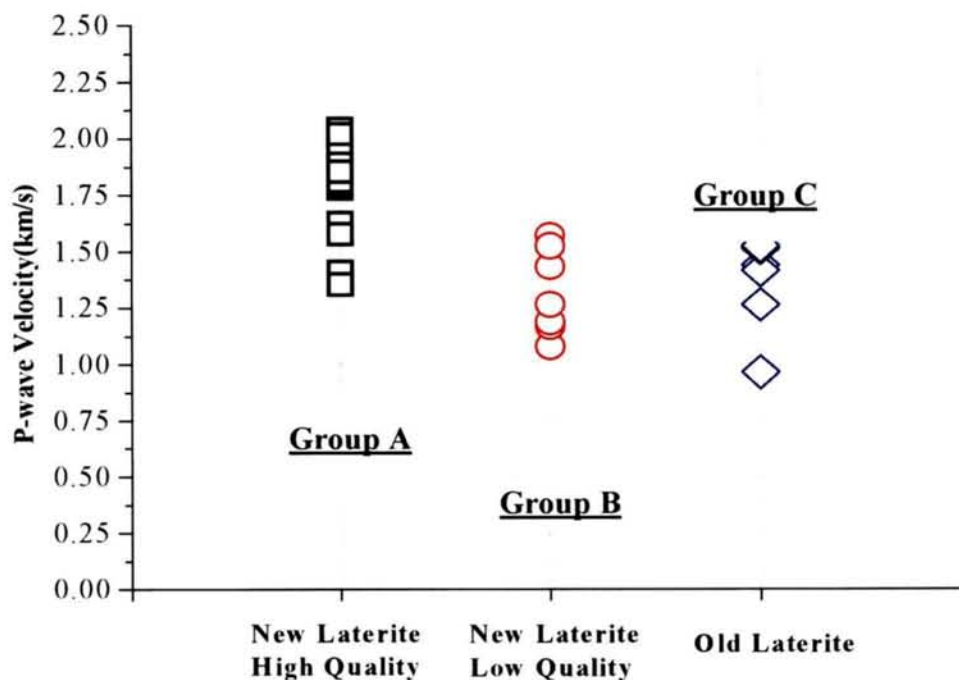
The old used laterite showed a little faster velocity than the insufficient quality.

If the P-wave measurement is used for classifying quality, a threshold value of 1.75km/sec may be used for safer side. Any laterite material with P-wave value less than 1.75km/sec or un-measurable may be classified into insufficient quality laterite.

Fig.9-5 Distributions of P-wave velocities for three groups of laterite material

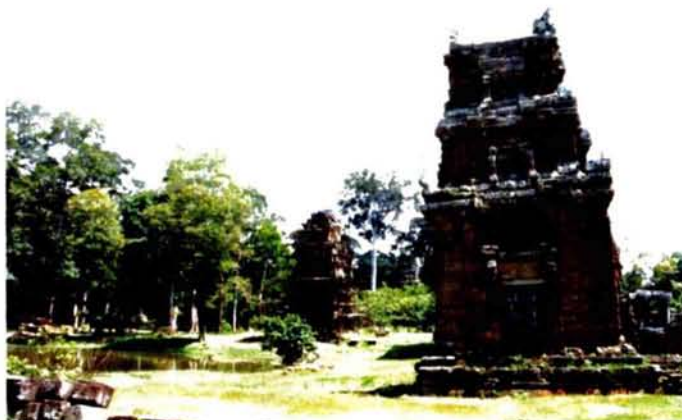
Leaning Tower of Prasat  
Suor Prat  
Awaiting for Help
