Global monitoring of large concrete structures using acoustic emission and ultrasonic techniques: case study.

Tomoki Shiotani¹, Dimitrios G. Aggelis² and Osamu Makishima³

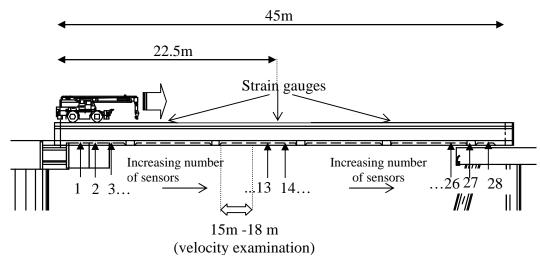
Fig. 1. Representation of the crane passing over the bridge and sensor location.

The load for the AE monitoring was supplied by a 20-ton crane, which passed over the bridge with a constant speed of approximately 0.5 m/s (see Fig. 1). As the crane moved over the bridge, the strain on the top surface of the bridge at the mid-span was monitored and can be seen in Fig. 2. The maximum strain was recorded at 88 s, when the truck was in the middle of the span, suggesting the highest tensile stress due to bending at the bottom layer of the structure, where the sensors were attached. In the same figure, the cumulative number of AE hits recorded by all the sensors is depicted for one passage. It can be seen that the rate of AE hits was more intensive before the crane reached the center of the bridge at 88 s. Up to that moment more than 70% of the total number of hits was recorded, implying that more active sources were located in the first half of the bridge. In the same figure, the cumulative number of hits recorded only by the two sensors located close to the center of the bridge is depicted. For clarity reasons they are multiplied by a factor of 5 in the figure. The hits of these sensors started at 14 s before the crane reaches the middle point, and the last hit was recorded 10 s after the crane had passed over that point, showing again higher activity at the first half of the structure.

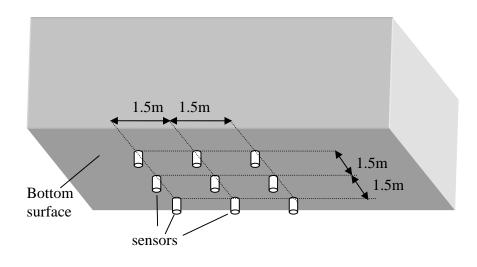
Fig. 5. Sensor arrangement for surface wave measurements.

For the velocity measurement, nine AE sensors were used in an arrangement of three parallel arrays of three. The separation distance was 1.5 m, resulting in an examined area of 3 m by 3 m (see Fig. 5). The excitation was conducted by pencil lead break near the location of each transducer. Therefore, each time, one sensor was used as trigger for the acquisition and eight as receivers. This way a number of intersected paths were examined, and the results can be considered more representative of the area and more reliable than one single measurement between two points. The velocity was measured by the time of the first detectable disturbance of each waveform. Although surface propagation includes different kinds of waves, with the Rayleigh occupying most of the energy of the excitation, it is straightforward that the first arrival belongs to longitudinal waves which are the fastest type. It is mentioned that the excitation at each point was repeated five times to check repeatability. The waveforms were identical since the excitation of pencil lead break is quite repeatable.

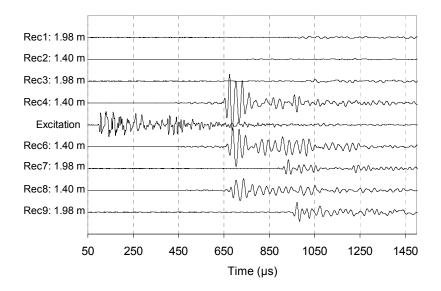
Fig. 7 Typical waveforms after excitation at the center position of Fig. 6.

for Rayleigh wave measurement (Qixian and Bungey, 1996). This is shown in Fig. 7. This is an example of waveforms acquired after excitation at the center sensor. The excitation waveform has been reduced by a factor of 10 to fit in the graph. For sensors 4-9 the Rayleigh burst is easily identified, and the measurement of its velocity can be conducted by a reference point (i.e. the first positive peak). However, for sensors 1-3 which correspond to the top of Fig. 6, no Rayleigh part is identified and the energy is much lower. This again shows that the propagating zone was disrupted by a discontinuity. Using the Rayleigh velocity of 2500 m/s and the major frequency component of 50 kHz (see Fig. 8), the wavelength is calculated to approximately 50 mm. Therefore, since the Rayleigh component was not visible through some paths, this should be due to a weak material zone or discontinuity that extends very close to the surface (even closer than 50 mm). From Fig. 8 it is concluded that the major frequency component of around 50 kHz survives the propagation while attenuation severely diminishes the higher frequency content introduced by the pencil lead break. The characterization depth using surface wave examination (including Rayleigh and longitudinal components) needs further study, which is currently undertaken.
