Creep and Failure of Palaeozoic-Rock Slope

By Yoshimasa KOBAYASHI and Akira NAKAGAWA

Abstract

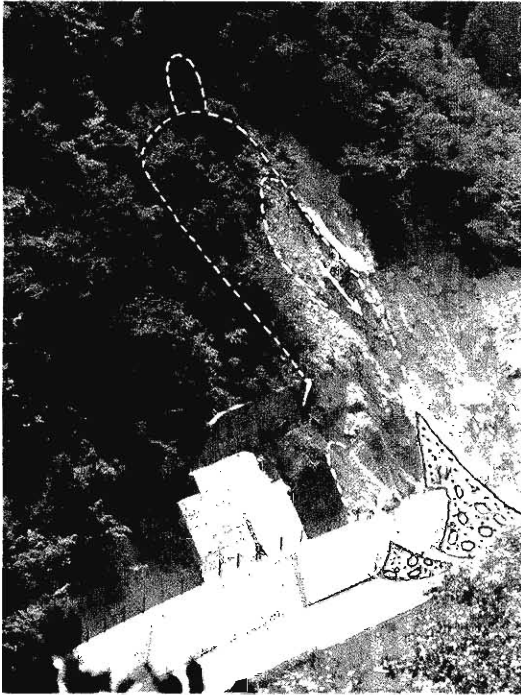
Fig. 5. View of the site.

As a result of site investigation it was found out that a larger area including the two present slides is moving downhill. Its upper end is bounded by an old slide scarp, the northern side by a boundary of sprayed concrete, and the southern side by a line which coincides with a fresh crack found in the existing old retaining wall (Fig. 4, 5). The scarp exhibits a height difference of 2 to 3 m across it and is accompanied in the northern half by another smaller slide of 5 m long, which also is bounded by a scarp of 5 m high. Also the southern periphery of the main slide is accompanied by a small slide of about 1 m width. After the accident a new

The longitudinal section of the slope through the point E is shown in Fig. 7, from which the average inclination of the slope is revealed to be about 40 degrees in the upper half and 60 degrees in the lower half. On the main sliding mass there is a channel-like depression, which begins at about 35 m height and comes down curving gradually to left as shown schematically in Fig. 4. The depression seems to be the space from which the main larger slide originated.
