Reconnaissance report of the 2004 Great Sumatra-Andaman, Indonesia, Earthquake – Damage to geotechnical works in Banda Aceh and Meulaboh –

Tetsuo TOBITA¹, Susumu IAI¹, Banta CHAIRULLAH² and Wimpie ASPER³

¹ Disaster Prevention Research Institute (DPRI), Kyoto University

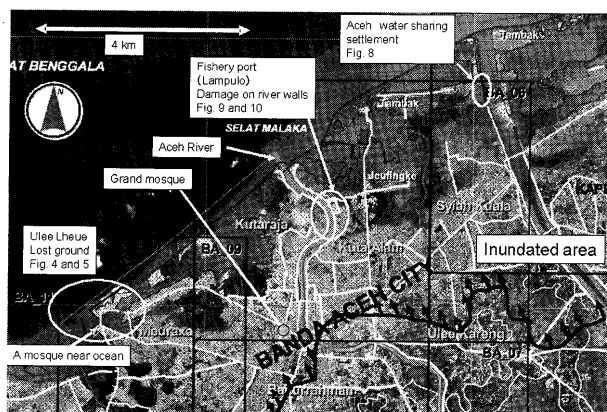
that form the coastline of Banda Aceh. Buildings or houses located from 3 to 5 km inland were affected by a tsunami as shown in Fig. 2. The height of the tsunami in Banda Aceh ranged from 5 to 30 m (Tsuji *et al.*, 2005). The inundated area is shown with a black line with small arrows in Fig. 2.

Fig. 2 Inundated area of Banda Aceh (DLR, 2005)

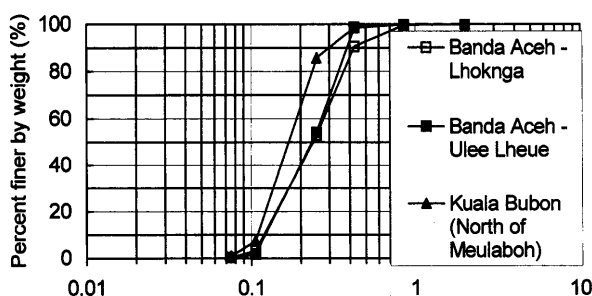
Fig. 6 Grain size distribution curve of sand samples collected at Banda Aceh and Meulaboh

Eyewitness reports of water coming out from the cracked floors of houses accounts for the occurrence of liquefaction in Kuala Bubon. The soil was sandy and the grain size distribution analysis of the sand collected in Kuala Bubon reveals the possibility of liquefaction (Fig. 6). The combined effects of liquefaction and tsunami might be responsible for the submersion of land near the deltas. Other eyewitness reports of liquefaction and sand boils

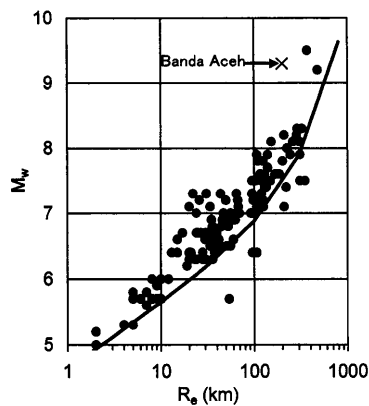
Results of the reconnaissance indicate that the loss of land along coastlines submerged into the sea was mainly due to erosion by the hydrodynamic force of tsunamis; however, liquefaction also likely contributed. According to the witness accounts of residents, liquefaction occurred before the tsunami struck. The sites consist of clean sand with an average particle size of 0.2 - 0.3 mm (Fig. 6). The epicentral distance of the liquefied site in Banda Aceh, although it might not be the farthest site for this event, can be plotted in the figure developed by Ambraseys (1988) from the worldwide database of shallow earthquakes (Fig. 7). As seen in Fig. 7, the distance between Banda Aceh and an epicenter of 250 km for an earthquake of M_w 9.3 is consistent with existing findings.

Fig. 7 Maximum epicentral distance to liquefied sites R_e and moment magnitude M_w (after Ambraseys 1988)

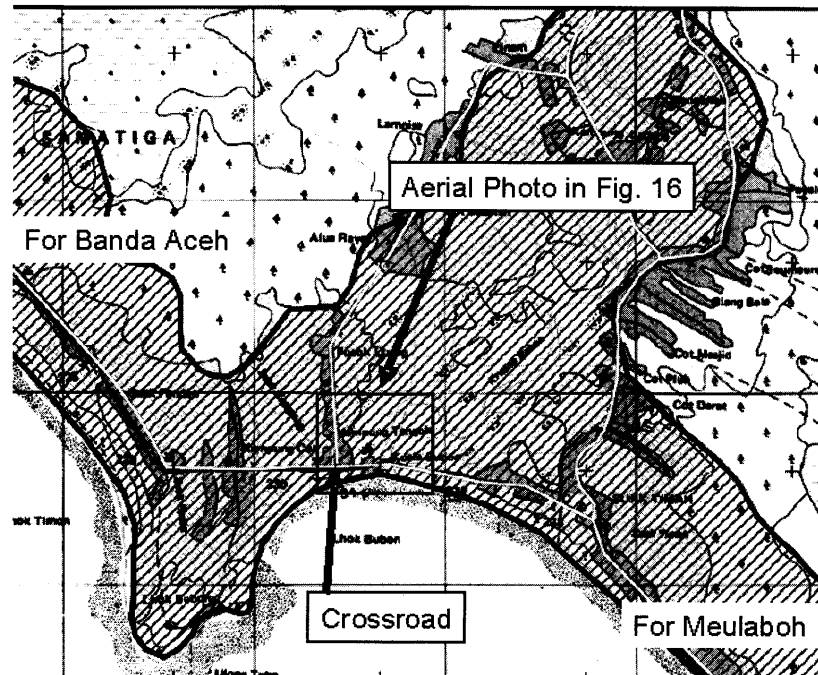
The suburbs of Meulaboh, the city closest to the epicenter, were investigated. Due to the limited time and road conditions, reconnaissance was restricted within 45 km along the west coast of Sumatra Island. The northernmost village was Kuala Bubon located about 15 km north of Meulaboh (Fig. 13 and 14) and the southernmost village was Kuala Tadu about 30 km south of Meulaboh.

Fig. 13 Inundated area in Kuala Bubon and the direction of the aerial photograph shown in Fig. 16 (DLR, 2005).

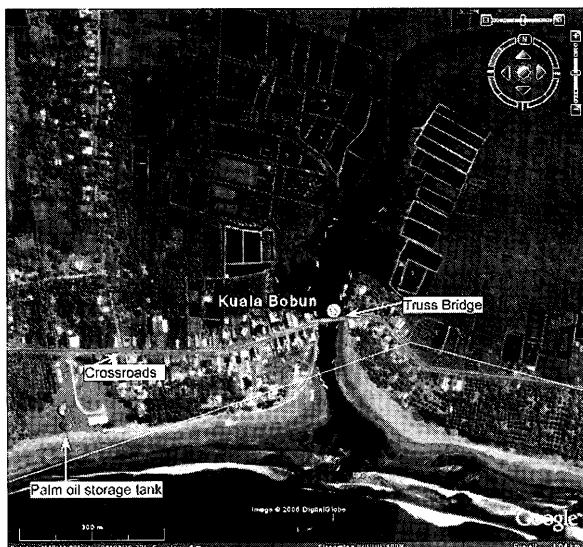
Fig. 14 Satellite image of Kuala Bubon before the earthquake and tsunami (Google Earth)

There was a 60 m steel truss bridge at the river estuary of Bubon River (Fig. 14). Its girders fell and only two bridge abutments are left (Fig. 18). Wave force is responsible for the bridge
