A Case Study of Observational Method for a Failed Geotechnical Excavation in Singapore

Y. Iwasaki

ABSTRACT: Observational Method (OM) was studied based upon a case history of failed geotechnical excavation in Singapore. Several items including inclinometer provide vital information on the safety of the geotechnical construction sites. Engineer who is specialized in OM, adequate knowledge of geotechnical engineering as well as instrumentation, should be engaged during the design and construction phase. An ISO standardization is necessary to provide a basic process to implement OM.

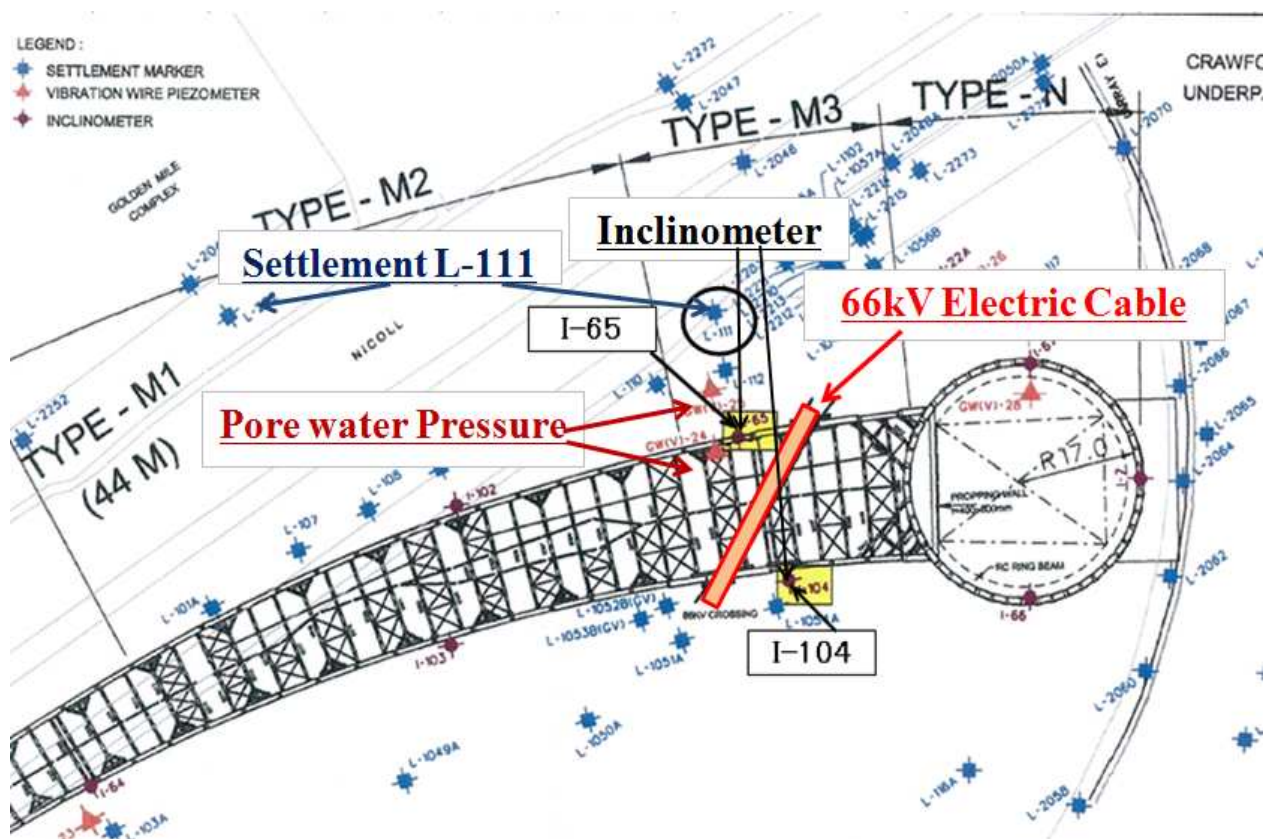
Fig.4 Instrumentation at the failed site

The site was rather well instrumented to monitor settlement, pore water pressure, strut strain, as well as inclination along diaphragm wall as shown in Fig.4. Settlement was to monitor the ground where Nicoll Highway passes north of the excavation site nearby. Decrease of pore water pressure that would cause consolidation settlement of the foundation of the Nicoll Highway was also monitored. Inclinometer monitoring points at I-65 and I-104 were installed along the diaphragm wall where the electric cable of 66kVolt had been installed and the diaphragm walls were missing at the sections where the cable cross over the wall lines.

The inclinometer guide pipes were installed at I-65 and I-104 at the failed section.
