Failure of a Cut Slope and Deterioration of Shear Strength due to Weathering

Akitoshi Mochizuki, Professor Emeritus*¹, Dr. of Eng., Graduate School, Tokushima Univ., Japan
Xianfeng Ma, Associate Professor *², Dr. of Eng., Dep. of Geotechnical Eng., Tongji University, China
Sreng Sokkheang, Researcher*³, Dr. of Eng., R&D Center, Nippon Koei Co., Ltd., Japan

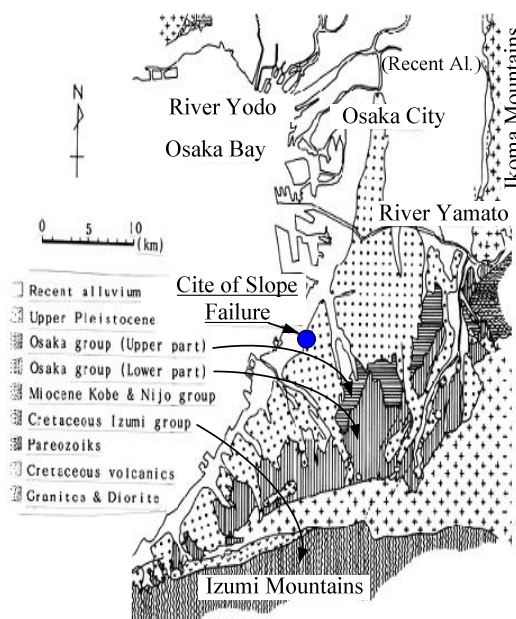
Fig. 2 Surface geological map of Osaka plane

Fig.2 shows a surface geological map of Osaka plain and the surrounding area. The site of the cut-slope failure, which is marked on the map, is located 5km east from Osaka bay and 23km west of the Ikoma-Kongo mountain range. From a view point of geological history, Osaka plain was formed over the last two million years as sedimented cyclic layers of clay, silt, sand or gravel due to cyclic geological movements and climatic changes. Depth of the sedimented plain ranges from 600 to 1000m.

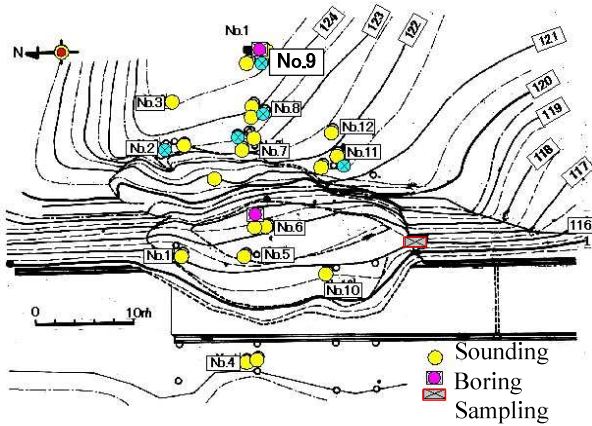
Fig. 3 Topographic map of failure site

Fig.3 shows a plan of the area around the landslide and the location of *in-situ* sounding tests.

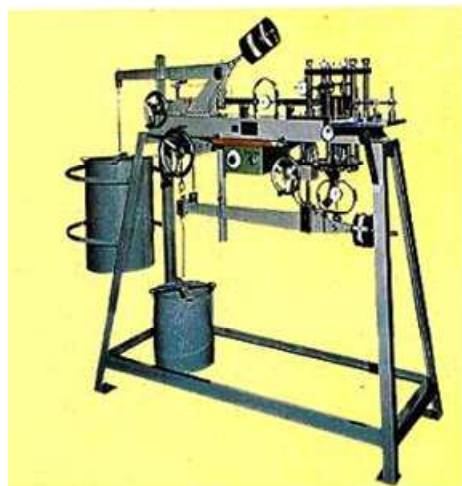
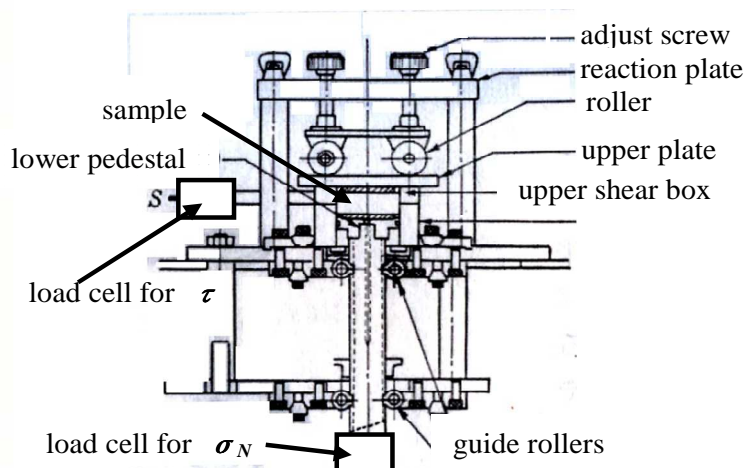
Fig.7 Outline of Mikasa's direct shear apparatus

The direct shear apparatus used in this study is an improved version of the system developed by Mikasa (1960, see Fig.7(1)). The diameter of specimen is 6 cm and the thickness is 2 cm. The main feature parts of apparatus are shown in Fig.7(2). The new version has overcome several inadequacies inherent in standard apparatus such as tilting of the shear-box during a test, and the development of friction between the upper and lower half of the shear boxes. The other important feature is that a test under consolidated and undrained conditions, *CU*, can be performed by keeping the volume of a sample constant by increasing/decreasing vertical stress, σ_N , on the sample during the test. From the results of *CU-test*, the effective strength parameters, c' and ϕ' , and the total strength parameters, c_{cu} and ϕ_{cu} , are obtained. Here, parameters c' and ϕ' are regarded as equivalent values as those of *CD-test*, c_d and ϕ_d .

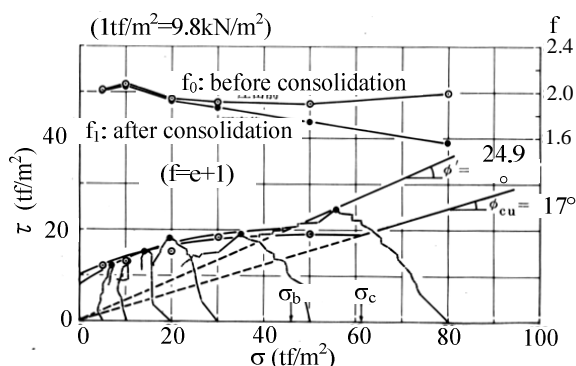
Fig.9 Relationships of shear stress to vertical stress and strength curves: Test-A (CU-test)

Table 2 shows the testing program, and procedures followed for the JGS guide line on the CU-test using the direct shear apparatus (Takada, 1993). Fig.9 shows the effective stress path of tests obtained in terms of shear stress, τ , and vertical effective stress, σ' . The strength parameters, c' and ϕ' , are obtained from a strength envelope connecting τ_{max} and σ' on stress paths. The envelope line is divided into two parts at a stress of σ'_b , where the stress σ'_b is the stress representing influence of consolidation yield stress (Mochizuki, 1996). It is known that the envelope generally shows an upward curve for a stress range less than σ'_b , whereas a higher strength stress range than σ'_b gives a straight line which passes through the origin of the graph.

Hence, the strength parameters, c_{cu} and ϕ_{cu} , are obtained from an envelope passing through stresses characterized by the maximum shear stress, τ_{max} , and the consolidation stresses of soil, σ'_0 . The envelope for CU-condition is also divided into two parts at a stress of σ'_c , showing an upward curve for $\sigma > \sigma'_c$, and a straight line for $\sigma'_c > \sigma$. Here, stress, σ'_c , is named as 'yield stress from a CU-shear test', and is regarded as being equivalent to the consolidation yield stress, σ'_y . This test denoted as Test-A, and the strength obtained is termed as Strength-A, which will be dealt with as an index strength for Strength-B to E, which will be shown in the following section. 2.4

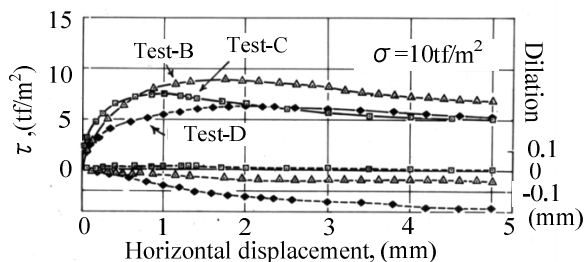
Fig.10 Relationships of shear stress to displacement: *Test-B, C, D*

Fig.10 shows stress-strain curves for Test-B to Test-D. Fig. 11 shows shear strength, τ_f , plotted against consolidation stress, σ_0 , and the strength envelopes from all of the tests. Results of unconfined compression tests, c_u ($=qu/2$) are also plotted. These envelopes show a decrease in strength from Test-A to Test-E. At stresses higher than σ'_b , the ϕ_d defined by Test-B, -C and -D ($\phi_d=27.6^\circ$) almost coincide with ϕ' of Test-A ($\phi'=24.9^\circ$), whereas ϕ' is slightly smaller. It is found that curves in a stress level less than σ'_b are almost parallel corresponding in Strength-B to D. Strength-B shows almost half shear strength of Strength-A, and Strength-D is almost a quarter of Strength-A.

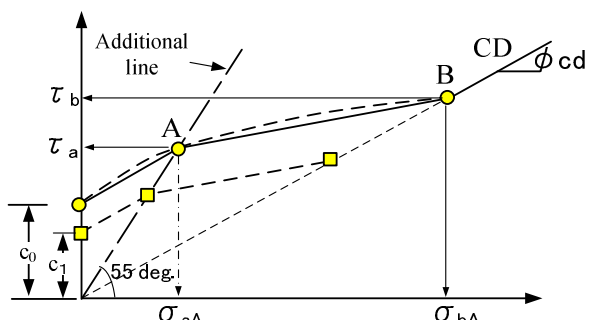
Fig.12 Substitute method of strength by two straight lines for a convex curve

Fig.12 shows a method schematically to obtain strength parameters in a stress range of $\sigma < \sigma_b$, which is developed; First, an additional line with an appropriate degree against the horizontal axis, 55 degree in this case, is put into a diagram of $\tau \sim \sigma_N$ relationships.
