Case Study on Causes and Countermeasures of a Largely Deformed Reinforced Earth Wall with Geotextile in Hyogo, Japan

ABSTRACT: This study examines causes and countermeasures of large deformation that took place on the reinforced earth wall, a part of the Tottori expressway planned to pass Hyogo, Japan. Since this reinforced earth wall had experienced unexpected deformation of the wall during construction, the wall was re-constructed twice. However, the wall deformation showed no sign to cease even at the final stage of the construction. In this paper, case study was carried out on the interpretation of the mechanical behavior of the severely damaged reinforced earth wall comprising geotextile with the concrete panel facing. At First, the outline of the damaged reinforced earth wall is in detail described. The background and cause of the damage are discussed based on the results of site investigation. The engineering properties of the fill were examined by performing various in-situ and laboratory tests, including the surface wave survey (SWS), PS-logging, RI-logging, soaking test, the direct shear box (DSB) test, bender element (BE) test, etc. Consequently, the background as well

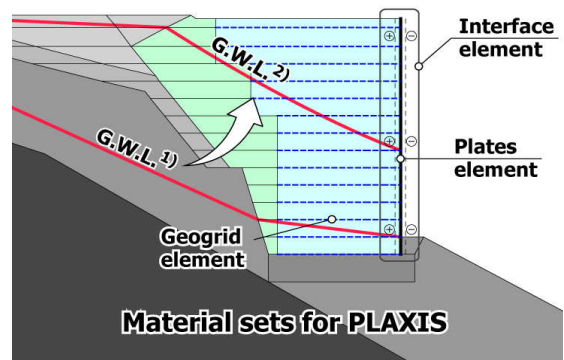
Fig. 17 Seepage analysis by PLAXIS

As shown in Fig.17, the geogrids were modeled using “GEOGRID ELEMENT” of the PLAXIS.
