Piping Failure of a Metro Tunnel Construction

Wei F. Lee

Kenji Ishihara

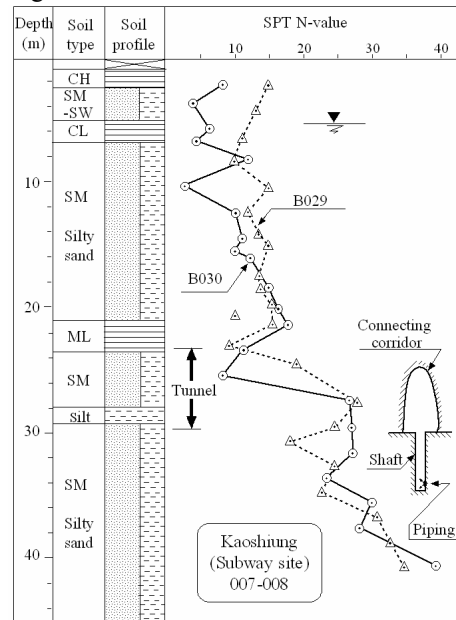
Figure 5. Soil profile at the site of collapse

The soil profiles at the locations BO29 and BO30 shown in Figure 2 are indicated in Figure 5, where it can be seen that the deposits are comprised predominantly of silty sand with occasional layers of low-plasticity clay (CL) to a depth of 40m. The blow count, N-value, in the standard penetration test is shown to increase with depth and to have a value of 20 to 30 at the depth where the sump for water collection was excavated.

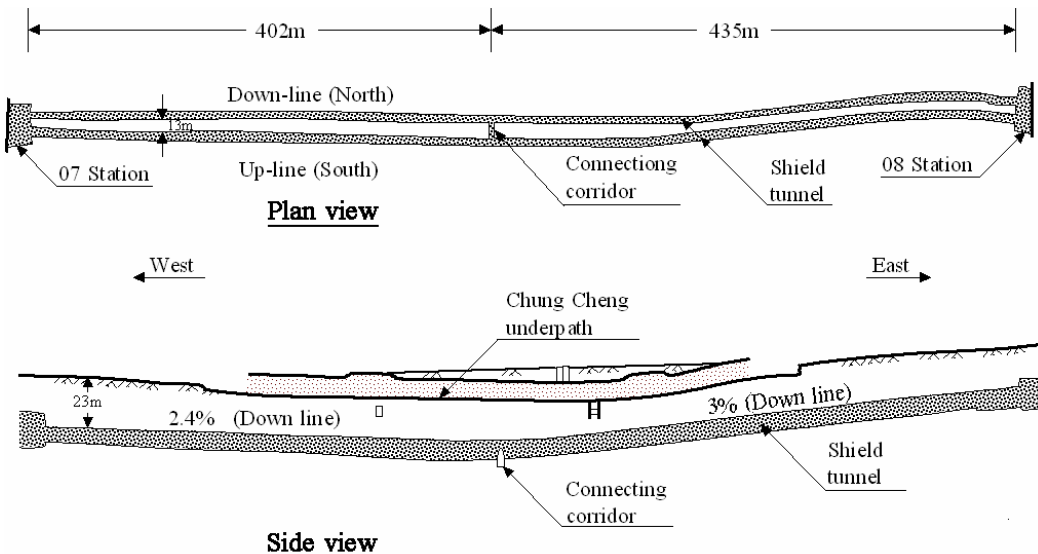
Figure 4. Plan and side view of the tunnel

The location of the collapse is shown in Figure 1 and the feature of the cave-in on the ground surface is displayed in Figure 2. A bird-eye view over the cave-in is displayed in Figure 3. The plan and side view of the tunnel are shown in Figure 4. It is to be noted that there was an underground roadway called Chung Cheng underpath just above the subway tunnel. The dual tunnels were constructed by the tunnel boring machine (TBM) which can advance by rotating a large steel disk equipped with cutting blade, while the cutting face is balanced by the mud pressure.

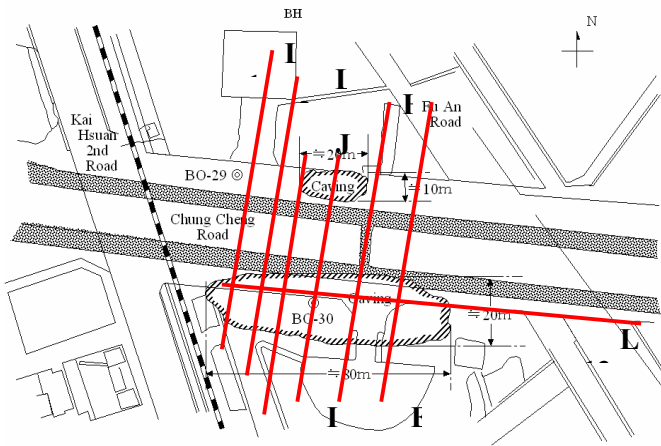
Figure 11. Layout of the RIP test.

In this study, surface 2D RIP testing was conducted to probe ground condition, and to check the effectiveness of remediation grouting right after the accident. Figure 11 shows the layout of the 2D RIP testing. As depicted in the figure, six survey lines in north-south direction and one in east-west direction were installed in an attempt to cover the damaged area; and hopefully to identify different soil conditions and underground structures. As described in previous paragraphs, the corridor was surrounded by grout material which was installed to stabilize the ground prior to excavation. Large numbers of sand bags and backfill material were dumped into the surface sinkholes to stabilize the disturbed ground after the event. Ground conditions were fairly complicated when the 2D RIP survey was conducted.

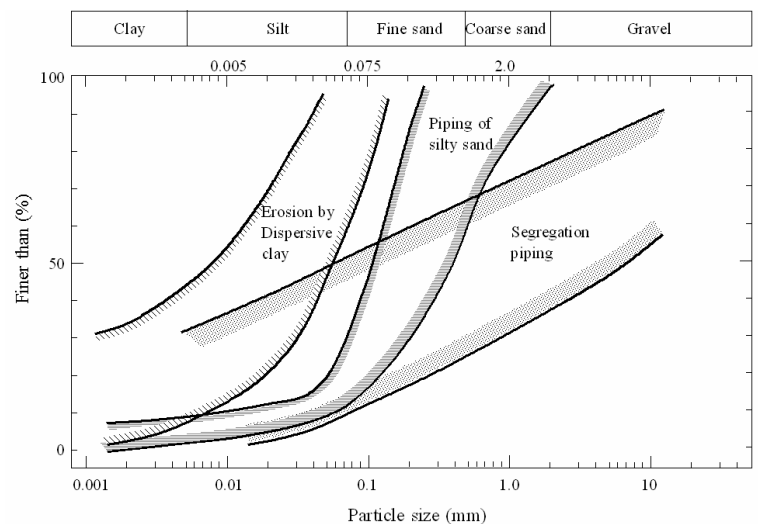
Figure 13. Three groups of soils in terms of grain size range associated with erosion and seepage instability

The outcome of the grain-size analyses for the silty sand at Kaohsiung has shown that the soil there belongs neither to the broadly graded gravelly sands for the segregation piping nor to the dispersive clay related to the erosion or gully formation. In fact, the grain size in Kaohsiung soil lies midway in the range of silt and sand, as shown in Figure 13, which is coarser than the dispersive clay and finer than the soils related with segregation piping.

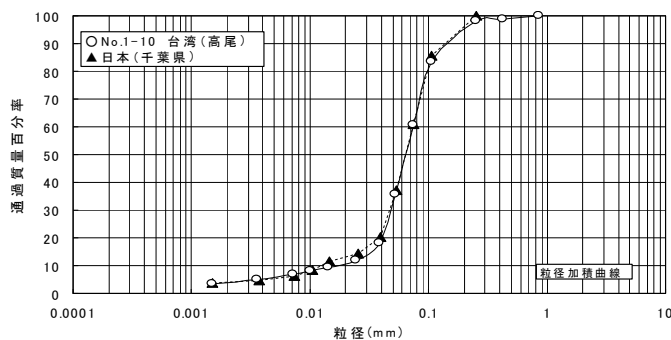
Figure 15. Grain size distribution curves of silty sands used for the pinhole tests

The silty sand from Kaohsiung tested had a grain size distribution as shown in Figure 15. For comparison sake, another material from a site in Chiba, Japan was secured and used for the same testing. The grading of this Japanese soil was almost the same as indicated in Figure 15. It is to be noticed that both silty sands had an average grain size of about $D_{50}=0.075\text{mm}$ and fines content was about 50%. The physical characteristics of these two materials are shown in Table 1. The two samples were compacted so as to have the same wet density of 1.902 g/cm^3 . A sample from Kaohsiung as prepared for the pinhole test is displayed in the middle of Figure 16 and gravel layers to be placed on top and at the bottom are shown on both sides of Figure 16. The procedures for testing were as follows.

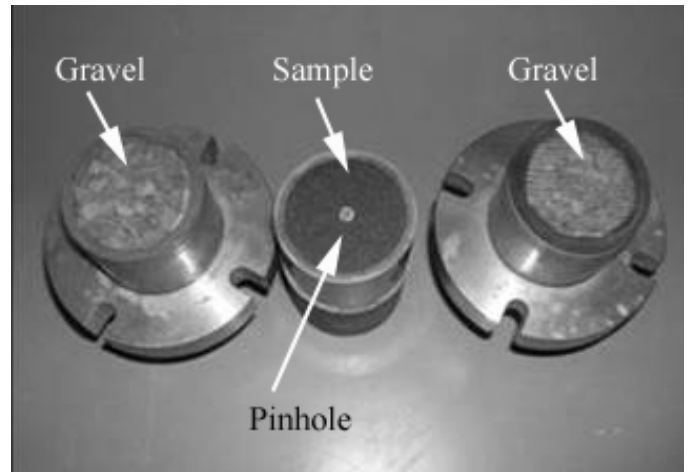
Figure 16. A samples from Kaohsiung for the pinhole test (the middle)

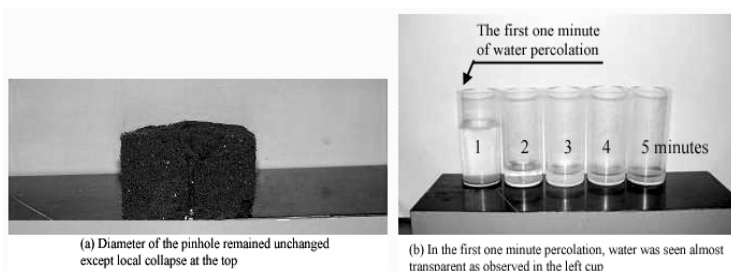
Figure 18. The results of the pinhole test on the Japanese silty sand
