# Damage by the 2011 Great East Japan Earthquake

Masakatsu Miyajima  
Kanazawa University, Japan

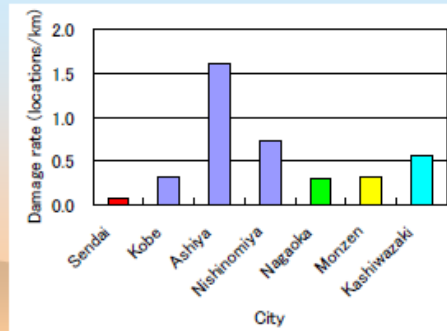
## Comparison of damage rate

Damage to transmission main, distribution main and branch pipelines

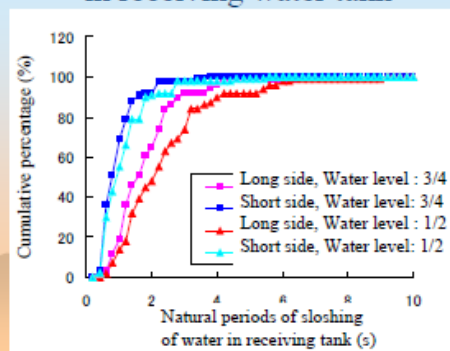
## Predominant period of water in receiving water tank

- If sloshing of water in receiving water tank is occurred by an earthquake, draw of water to receiving water tank from pipeline starts by error of sensor of water level in the receiving water tank. Sloshing of water in receiving water tank, therefore, seems to be one of the causes of unusual phenomena.
