## Study on Landslides in Weathered Granite Areas of Hai Van Mountain, Vietnam

Pham Van TIEN, Kaoru TAKARA and Kyoji SASSA<sup>(1)</sup>

### Synopsis

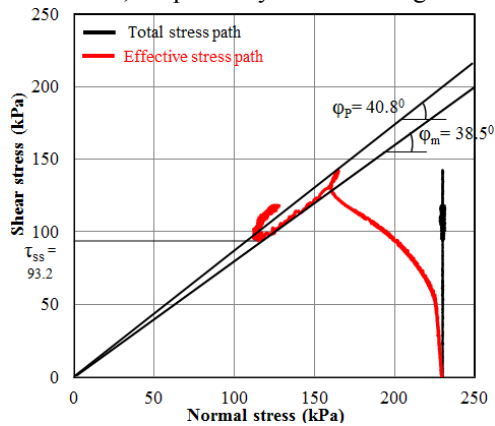
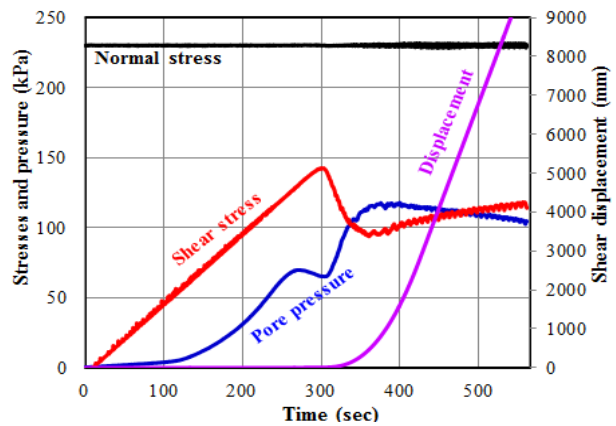
Fig. 11 Effective stress path (left) and time series (right) of shear stress control test for HV1 sample

Undrained monotonic shearing was carried out to explore landslide mechanism and to observe the pore water pressure generation as well as initiation of failure motion. Test results showed that excess pore water pressure generated during shear displacement after failure of HV2 sample, but there was not much pore water pressure increasing during shearing (Fig. 11 & 12). Seen from results, the steady state shear resistance of HV1 sample was 93.2 kPa while HV2 sample obtained 5.9 degrees of apparent friction angle. The peak friction angle of HV1 sample and HV2 sample are around 41.0 degrees and 36.0 degrees with 143.5 kPa and 133.1 kPa maximum shear resistance, respectively. Friction angle during

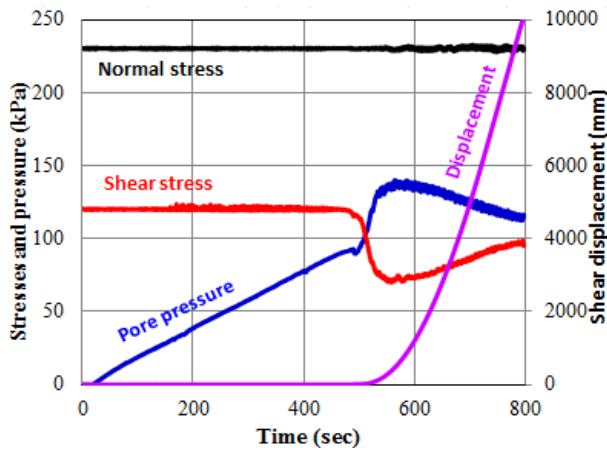
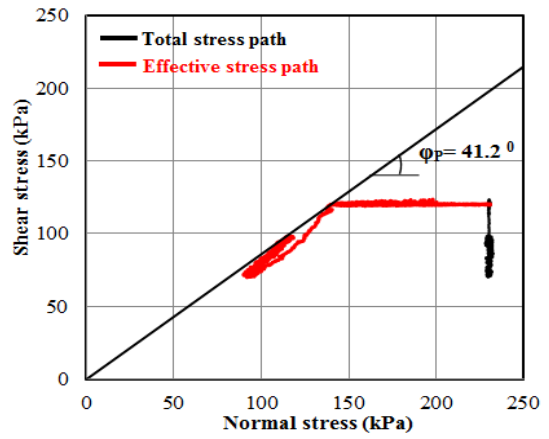
Fig. 13 Time series data and effective stress path of pore-water pressure control tests on HV1 sample

The test results of two landslide samples are shown in the Fig. 13 and Fig. 14, with a red color line showing effective stress path and a black color line showing total stress path. The results indicate that HV1 sample failed around 95 kPa of pore water pressure increment while failure occurrence of HV2 sample was earlier to occur with about 80 kPa of additional pore water pressure value. The critical pore

pressure ratios of HV1 sample and HV2 sample ( $r_{u1}$  and  $r_{u2}$ ) are 0.41 and 0.34, respectively, in which the parameter of  $r_u$  is defined as a ratio of pore water pressure increment triggering failures and its normal stress).

For the HV1 sample, the friction angle at peak ( $\phi_p$ ) stayed at about 41.3 degrees and for the HV2 sample, this angle value was only 36.4 degrees.

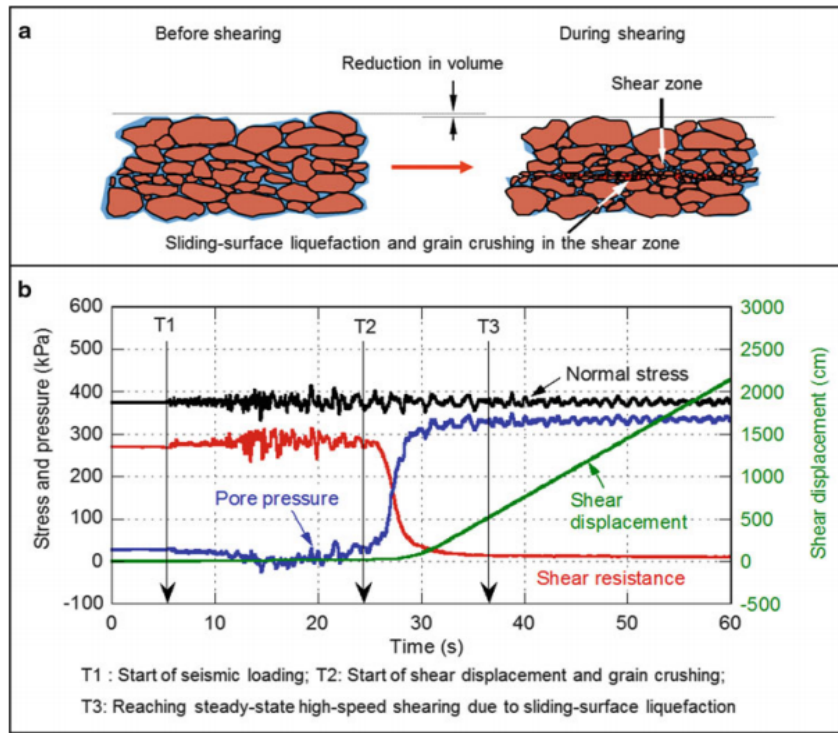
Fig. 15 Explanation of the mechanism of sliding surface liquefaction

liquefaction behavior at sliding surface because its material is not susceptible to be crushed during shearing tests. In contrast, HV2 sand sample is more susceptible to grain crushing and sliding liquefaction. Consequently, the mechanism of rapid motion of the landslides only occurs in the tests of HV2 sample while HV1 sample would not show a mobility behavior. The term of sliding surface liquefaction (Sassa, 1996 and 2000) mentions to the behavior of shearing zone due to grain crushing of samples. Grains in the shear zone are crushed during shearing and the soil structure was subjected to volume reduction. A grain crushing leads to excess pore water pressure generation and a rapidly consequent reduction in effective stress resistance strength. The mechanism of sliding surface liquefaction is explained comprehensively in Fig. 15.

As seen in Fig. 15 above, T1 in Figure 2B is the onset of seismic loading. Under the loading condition pore-water pressure started to decrease immediately. It is explained that dilatancy occurred which is a characteristic of dense materials. T2 in Figure 2B shows a starting point of post-failure shear displacement. Value of pore pressure accelerates progressively to close to normal stress and remain unchanged. The normal stress at steady state ( $\sigma_{ss}$ ) is mainly the difference between normal stress and pore water pressure correspondingly. T3 in Figure 2B is the start of steady state high speed motion like rapid landslide motion. The mobilized shear resistance at this stage is mainly steady state shear resistance. The ring shear simulation will reproduce a rapid motion of landslides.

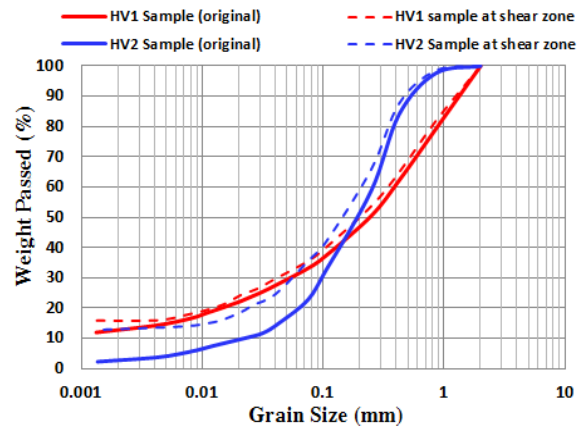
Fig. 16 Grain-size distribution of two samples at the sliding surface after shearing until 10m in compared with two original samples

To examine how grain crushing of samples occurred at sliding surfaces, after the shear test was finished, both disturbed and undisturbed samples were collected from the shear zone and other than sliding zone of the shear box; then grain-size analysis was performed on these samples (Fig. 16). Grain-crushing, sliding plane and liquefied materials of two difference landslide tests are compared and denoted in Fig. 17 below.
