Experimental Evaluation of Seismic Residual Performance for Deteriorated Rubber Bearings in Highway Bridges

Kunihiro HAYASHI¹, Yukio ADACHI², Naota SAKAMOTO³, Akira IGARASHI⁴
and Ji DANG⁵

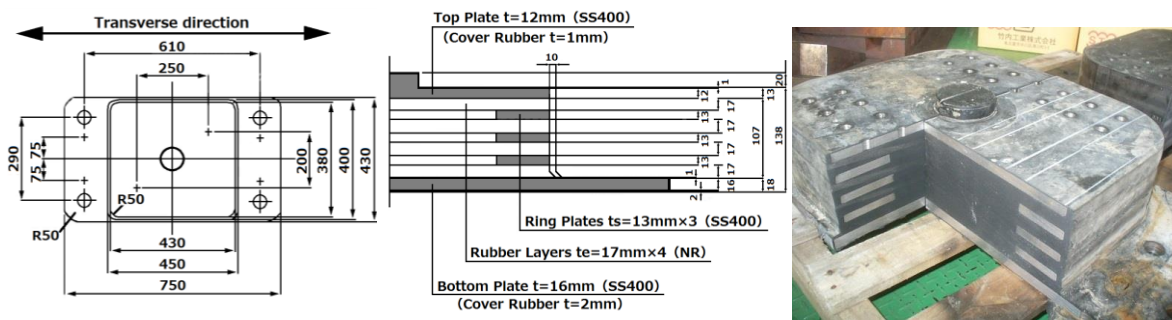
Figure 2.1 Dimensions of ring bearing samples

The elastomeric bearings for the experimental performance evaluation in this study were installed in 1985 and designed as seismic isolators to distribute the horizontal seismic force. Energy dissipation during seismic response is not expected in the design. The elastomeric bearings consist of 4 NR layers and steel ring plates, as shown in Figure 2.1. The plan dimensions are 400mm×450mm, the total thickness is 107mm with 4 rubber layers of 17mm thickness and 3 ring plates of 13mm thickness. The shape factors are $S_1=5.93$ and $S_2=3.55$. The elastic share modulus of the natural rubber material is 1.05N/mm^2 (G10.5).

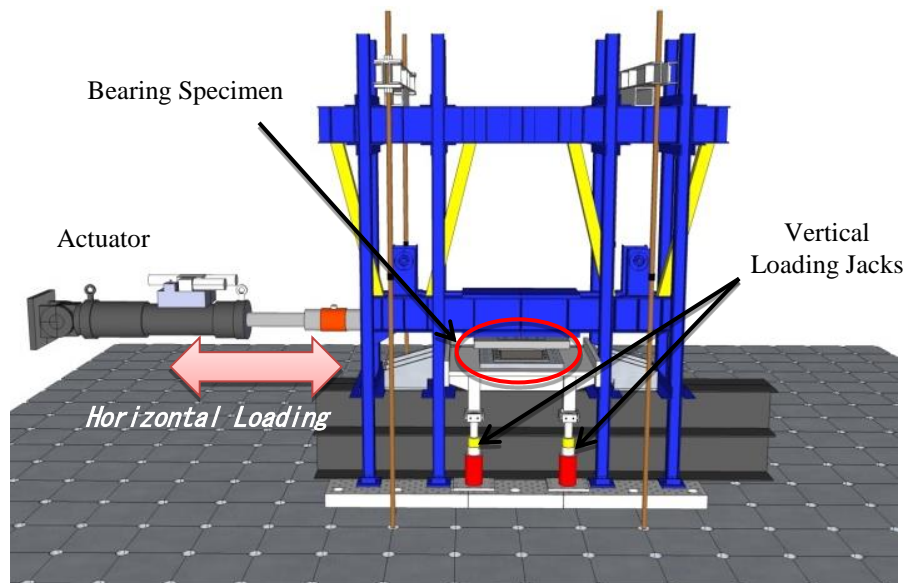
Figure 3.1 Loading test equipment

The test equipment used in the loading tests is shown in Figure 3.1. All tests are horizontal shearing loading tests under a constant vertical load corresponding to the dead load of the superstructure. The specimen is connected to a 200tf horizontal hydraulic actuator through a load beam constrained by the link mechanism attached to a rigid steel frame so as movement only in the horizontal direction is allowed during shear loading. At the same time, a constant vertical load of 563kN equivalent to the dead load reaction force was applied to the specimen using four 500kN vertical loading jacks and a bottom loading table constrained in the horizontal direction with stoppers.

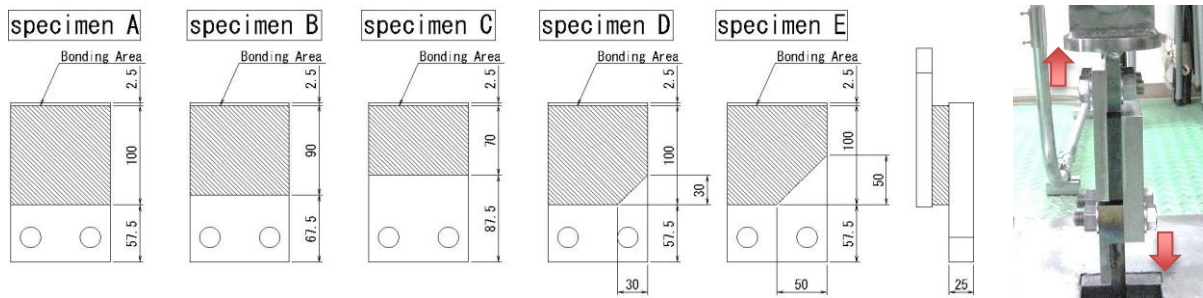
Figure 3.8 Specimens of lap shear tests

The lap shear tests were carried out to evaluate the influence of rubber surface cracks and debonding between the steel plate and rubber on the seismic performance of the bearing. As shown in Figure 3.8, five types of specimen (A~E) taken from differed distances from the bonding area and shape were prepared, and the failure strength in shearing direction were measured. The test results are shown in Figure 3.9.

The difference of the failure stresses between the specimens is not significant. It is also noteworthy that the results of the specimen E are in the same range in spite of possible high stress concentration in the specimen E due to partly cutout. When a good bonding condition is ensured, the bonding between the steel plate and rubber is not regarded as a critical factor for the cause of rupture and failure of the bearing.
