## Experimental Evaluation of Seismic Residual Performance for Deteriorated Rubber Bearings in Highway Bridges

**KEYWORDS:** Rubber bearing, Aging deterioration, Seismic residual performance

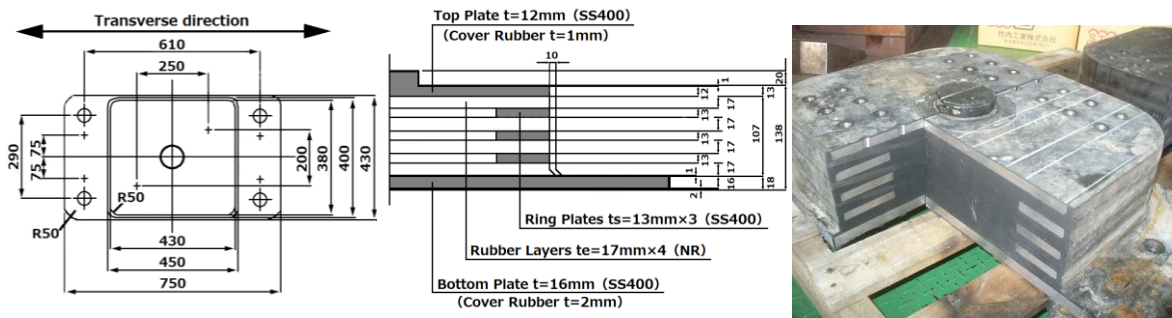
Figure 2.1 Dimensions of ring bearing samples

The elastomeric bearings for the experimental performance evaluation in this study were installed in 1985 and designed as seismic isolators to distribute the horizontal seismic force. Energy dissipation during seismic response is not expected in the design. The elastomeric bearings consist of 4 NR layers and steel ring plates, as shown in Figure 2.1. The plan dimensions are 400mm×450mm, the total thickness is 107mm with 4 rubber layers of 17mm thickness and 3 ring plates of 13mm thickness. The shape factors are  $S_1=5.93$  and  $S_2=3.55$ . The elastic share modulus of the natural rubber material is 1.05N/mm<sup>2</sup> (G10.5).
