- Outline of the earthquake and damage
- Damage to water supply facilities
- Unusual phenomena; an abrupt increase in flow rate and a decrease in water pressure of water distribution system in spite of no damage to pipelines
- Conclusions

## Characteristics of damage to water supply facilities

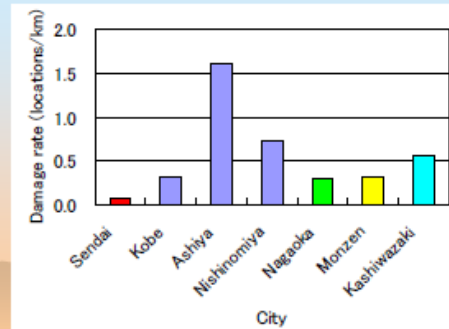
## Comparison of damage rate

Damage to transmission main, distribution main and branch pipelines

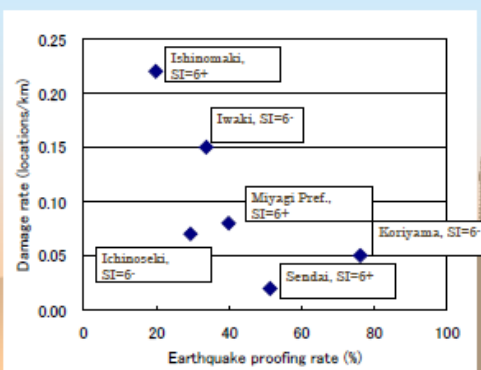
## Earthquake proofing rate and damage rate

- Damage to aged pipelines with small diameter
- Damage to air valves
- No damage to earthquake-proofing pipeline
- Malfunction of purification plants in flooded area

- The entire damage to water supply pipelines is not revealed in flooded areas by tsunami. We must collect all damage data and analyze it to learn the lessons from this disaster.
- Effect of earthquake-proofing for pipeline was verified. We must accelerate the earthquake proofing, especially for aged facilities.
- Force of tsunami acted on a buried pipe is not clear. The effect of tsunami must be studied soon.

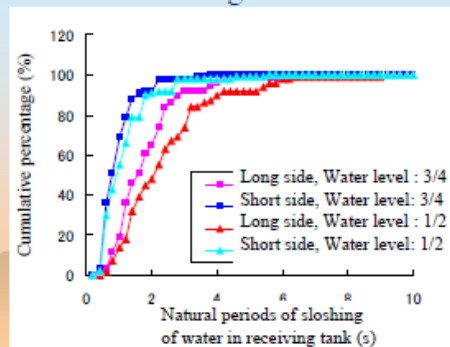
## Predominant period of water in receiving water tank

- If sloshing of water in receiving water tank is occurred by an earthquake, draw of water to receiving water tank from pipeline starts by error of sensor of water level in the receiving water tank. Sloshing of water in receiving water tank, therefore, seems to be one of the causes of unusual phenomena.
