# Failure of a Cut Slope and Deterioration of Shear Strength due to Weathering

*Akitoshi Mochizuki, Professor Emeritus\*<sup>1</sup>, Dr. of Eng., Graduate School, Tokushima Univ., Japan*  
*Xianfeng Ma, Associate Professor \*<sup>2</sup>, Dr. of Eng., Dep. of Geotechnical Eng., Tongji University, China*  
*Sreng Sokkheang, Researcher\*<sup>3</sup>, Dr. of Eng., R&D Center, Nippon Koei Co., Ltd., Japan*

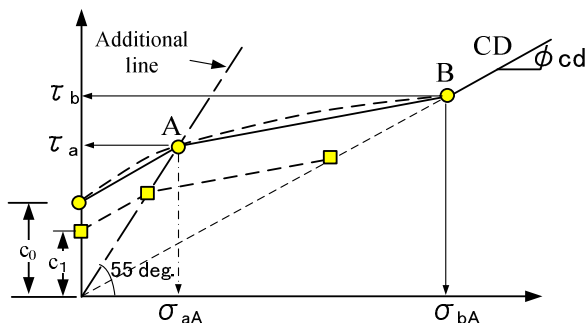
Fig.12 Substitute method of strength by two straight lines for a convex curve

Fig.12 shows a method schematically to obtain strength parameters in a stress range of  $\sigma < \sigma_b$ , which is developed; First, an additional line with an appropriate degree against the horizontal axis, 55 degree in this case, is put into a diagram of  $\tau \sim \sigma_N$  relationships.
