## Collapse of Braced Excavation in Singapore

K. Ishihara

**ABSTRACT:** After the collapse of the subway excavation in the Nicoll Highway, extensive in-situ investigations were carried out to identify causes of the accident. The results of detailed studies disclosed that lack of toe-in depth of the diaphragm wall into the stiff competent strata could be one of the causes of the incident. This aspect of the studies is highlighted in this paper.

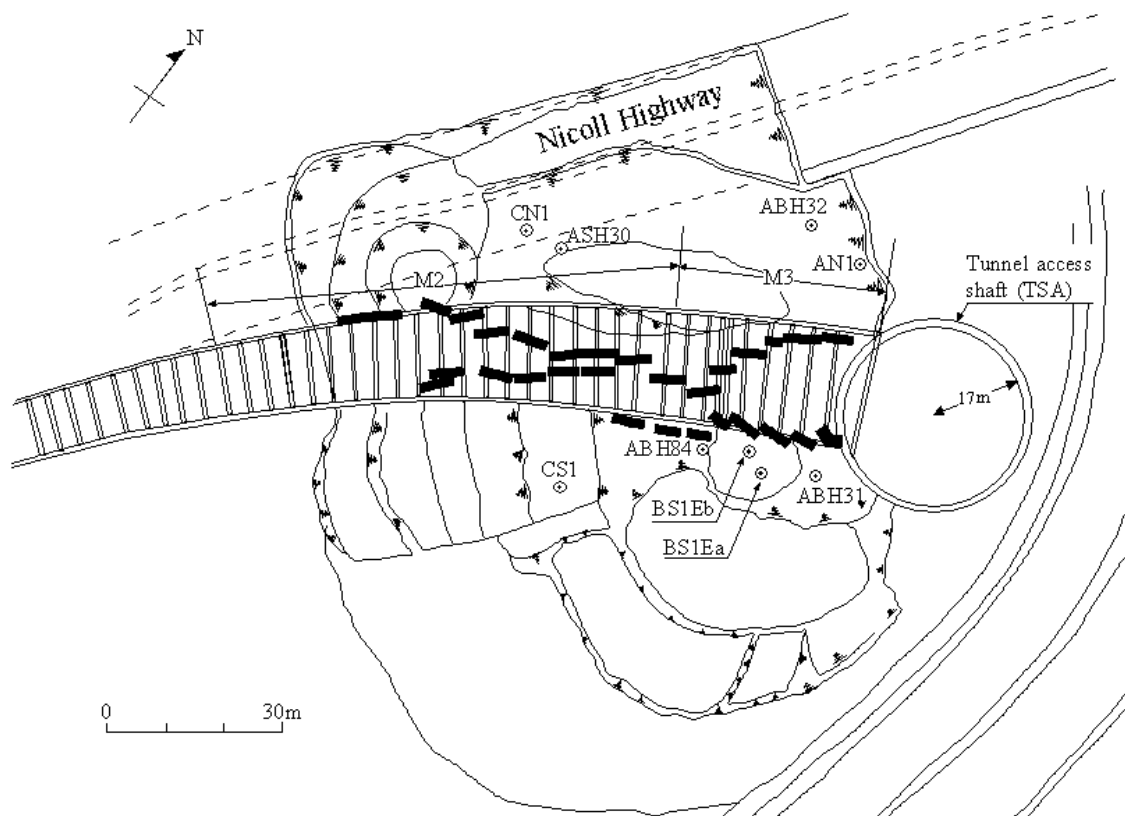
Fig.4 Plan view of the area of the failure and braced wall system.

huge amount of soil mass moved into the excavated space. In fact, a subsidence of the ground surface as much as 10m was observed on the south side in proximity to the wall and the settlement extended about 50m southward, as seen in Figs. 4 and 12. The area of the ground settlement extended also north towards the Nicoll Highway but to a lesser extent as can be seen in Fig. 4. Thus, it was considered certain that the failure was initially triggered by the breakage of the diaphragm walls on the southern side, thereby involving a landslide towards the excavated space. As a result of losing the horizontal support, the northern walls moved also towards the excavation, inducing sliding of soil mass towards the south but to a lesser extent.

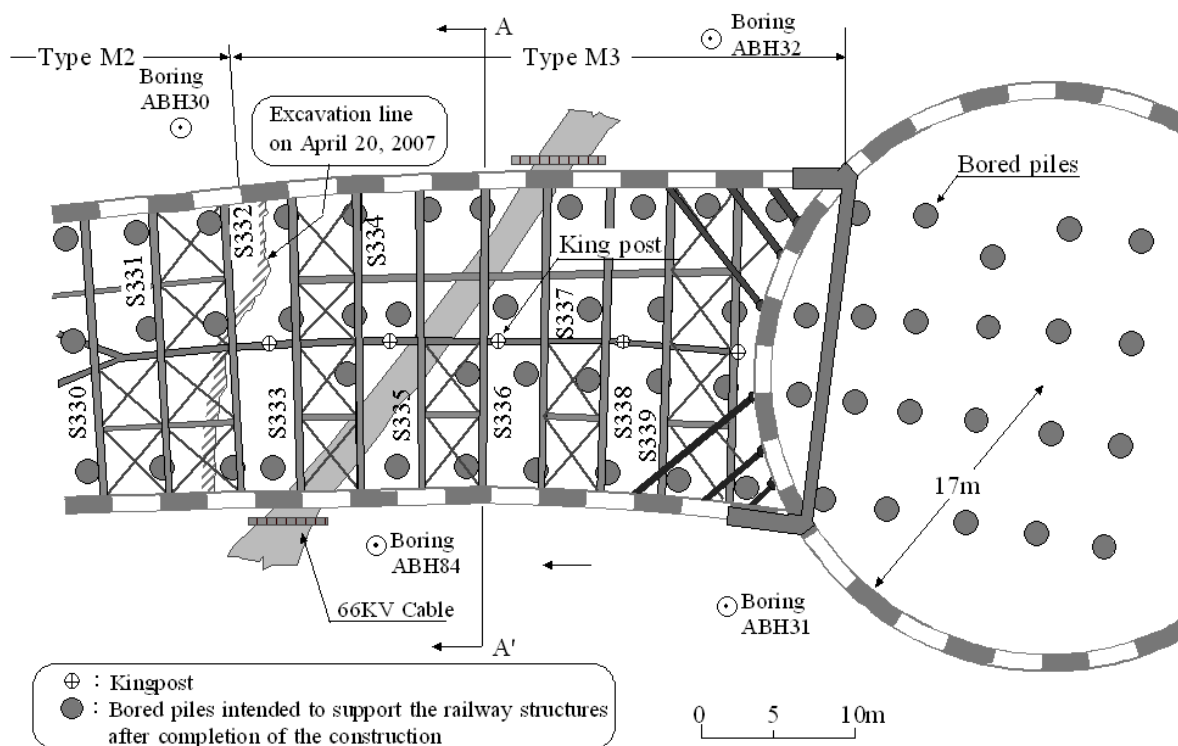
Fig. 5 Plan view of the Type M3 section due west of the access shaft.

forcement cages, concrete was poured in by Tremie pipes. Joints of neighboring elements of the wall was sealed against water penetration, but not rigidly connected as structures. The diaphragm walls, over the section Type M3, were for the curved stretch closest to the access shaft and constructed in May 2003. The walls were designed to be extended 3m into the stiff base layer called Old Alluvium (OA-layer). A detailed plan view of the M3 section is shown in Fig. 5 and a typical side views of the strutting system for the cross section A-A' is displayed in Fig. 6.

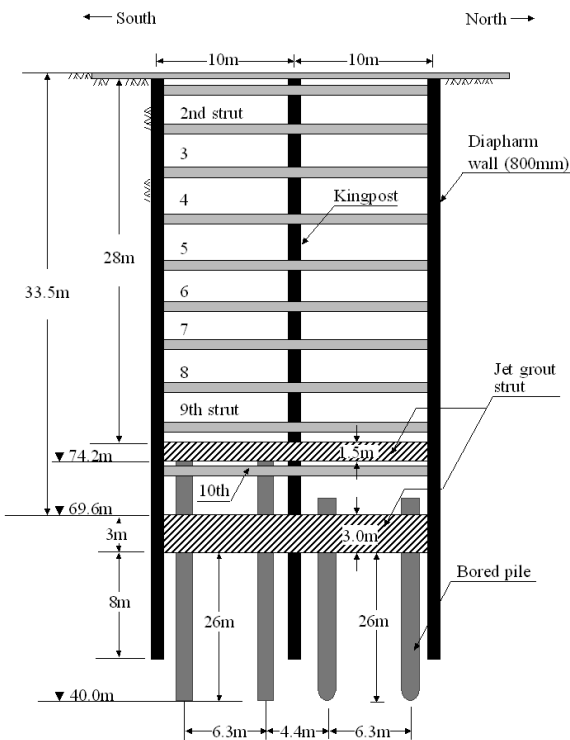
Fig. 6 A typical side view of the strutted system for the A-A' cross section.

The diaphragm walls were supported by the 10 levels of steel struts with discontinuous walers except at the top strut. To reinforce the strutting action, two soil layers at the depths of 28 to 29.5m (sacrificial strut) and of 33.5m to 36.5m were stabilized as shown in Fig. 6 by means of the jet grouting which had been installed from the ground surface before the excavation began. At the same time, with an aim of providing support for the railway tunnel structures to be placed later, four lines of bored piles each 1.4 to 1.8m in diameter were installed from the ground surface at a spacing of 4m or 6m as shown in Fig. 6. The depth of the pile embedment was 34.2m on the north side counted downwards from the elevation of 74.2m RL and, it was 29.6m RL on the south side from the elevation of 69.6m RL as shown in Fig. 6, where RL (Reduced Level) means a local measure of elevation with a zero point taken at a depth 100m from the mean sea level.

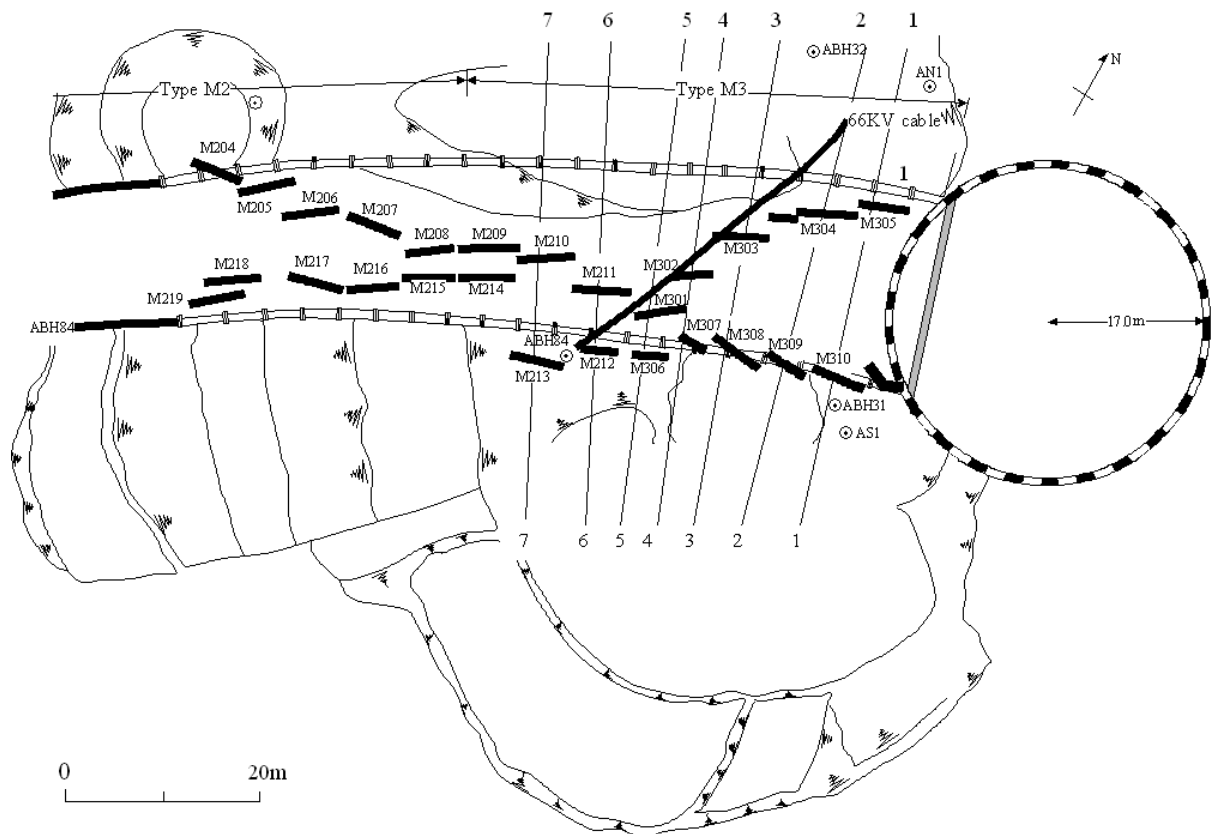
Fig.14 Cross sections for which the damage features were depicted.

As a result of the post-incident in-situ investigations as above, it became possible to figure out approximately the states of collapse for each of the cross sections indicated in Fig. 14. Shown in Fig. 15 are probable features of the collapsed water-strut system buried within the ground which were speculated for the cross section 1, 5 and 7. It is to be noticed that in the cross section 1 and 5, the intermediate layer  $F_2$  is inclined towards the excavation as verified by the boring data at ABH31 and 32 and also at AS1 and AN1 conducted after the failure. This is indicative of the settlement of the even deep-seated soil layer involved in the slide.
