## A Case Study of Observational Method for a Failed Geotechnical Excavation in Singapore

Y. Iwasaki

**ABSTRACT:** Observational Method (OM) was studied based upon a case history of failed geotechnical excavation in Singapore. Several items including inclinometer provide vital information on the safety of the geotechnical construction sites. Engineer who is specialized in OM, adequate knowledge of geotechnical engineering as well as instrumentation, should be engaged during the design and construction phase. An ISO standardization is necessary to provide a basic process to implement OM.

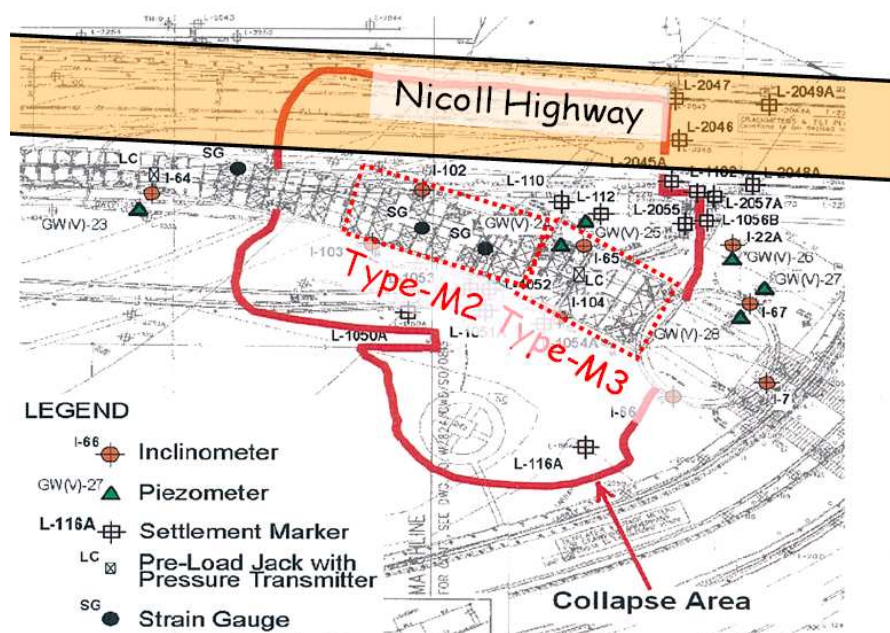
Fig.1 General Plan view

As shown in Fig.1, the section is parallel to the existing Nicoll Highway on the ground surface and consists of different types of retaining wall including M2 and M3 that failed as shown in Fig.1.
