## Damages to Metro Tunnels due to Adjacent Excavations

**ABSTRACT:** Metro tunnels are vulnerable to ground movements, therefore precautionary measures must be taken to prevent potential damages to existing tunnels if excavations are to be carried out in close proximity to tunnels. Presented herein are the regulations adopted to protect the Taipei Metro and three case histories on damages occurring to metro tunnels to illustrate how tunnels respond to activities associated with excavations. It has been found that localized ground treatment would not serve the purpose of reducing wall movements and neither would a single buried cross panel in excavations with considerable lengths.

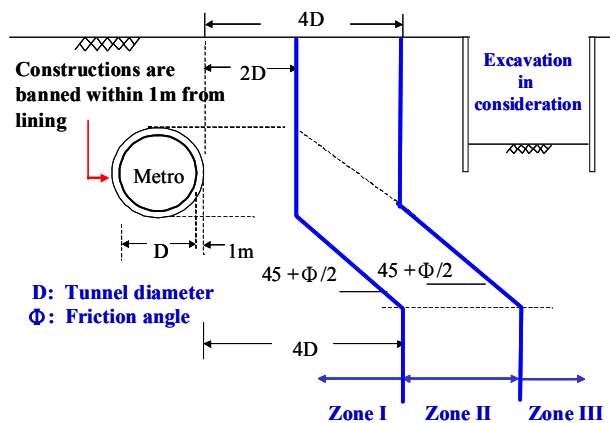
Fig. 1 Zoning for restricting excavations in the vicinity of metro tunnels

For shield tunnels, as shown in Fig. 1, construction activities are totally banned within 1m from

For soft ground, the width of the restricted zone is 100m or the thickness of soft deposits, whichever smaller, from the outer edges of metro facilities. For hard ground, this width is reduced to 30m, and for river crossings it is increased to 500m. In other situations, the width of restricted zone is 50m.

For shield tunnels, the changes in tunnel diameter are limited to 20mm in any direction. The lining should in no case ingress into the dynamic envelope of trains which is the outer limit of the space required for operation and safety.

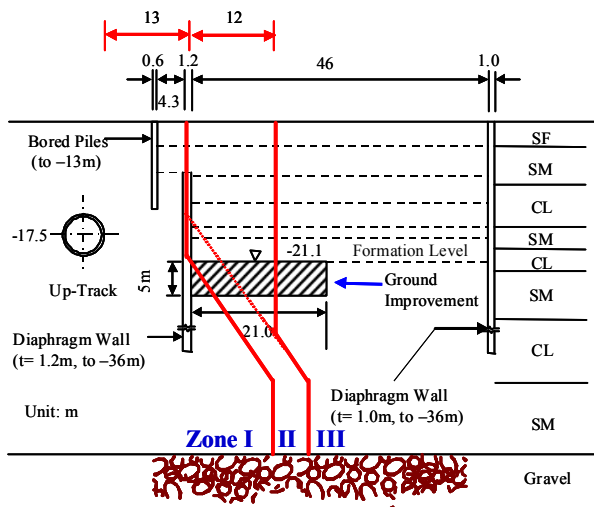
Fig. 3 Case 1 – Soil profile and excavation scheme

The soft deposits at surface are underlain by a thick gravelly layer at a depth of 50m. The retaining diaphragm walls were 1.2m in thickness and 36m in length. Despite the fact that, as shown in Figs. 2 and 3, jet grouting had been conducted to treat a block of soil in an attempt to reduce wall movements, lateral movements of the ground were

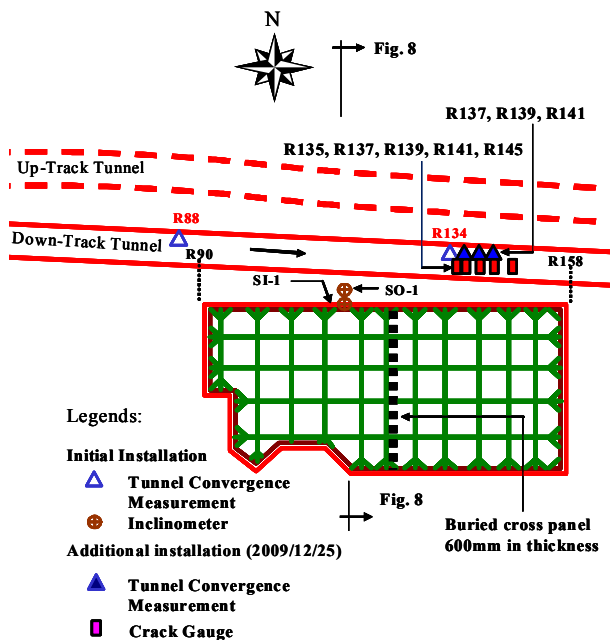
Fig. 7 Case 2 – Site plan and locations of instruments

Shown in Fig. 7 is a case in which excavation was carried out to a depth of 15.9m with a minimum distance of 7.3m to the nearest tunnel, i.e., the down-track (Hwang, et al., 2010). The soft

deposits at surface are underlain by a thick gravelly layer at a depth of 50m. The retaining diaphragm walls were 0.8m in thickness and 32.5m in length. As shown in Fig. 8, excavation was partly carried out in Zone 1 and measures were required for reducing ground movements. Accordingly, a cross panel, 0.6m in thickness and 10m in depth, was installed by using the diaphragm walling technique and was structurally connected to the diaphragm walls to form T-joints at its two ends.

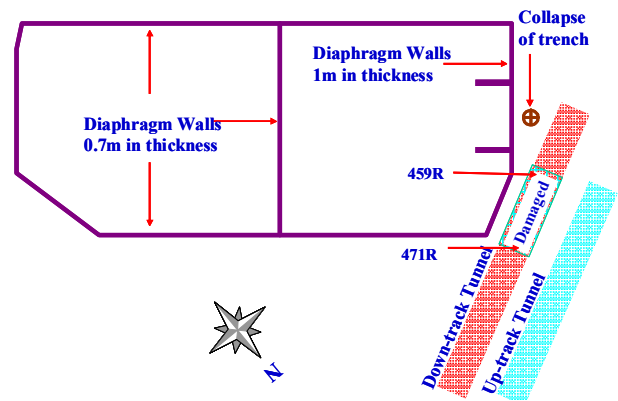
Fig. 12 Case 3- Site Plan

Shown in Figs. 12 and 13 is a case in which tunnel linings were damaged even before the commencement of excavation (Ju, et al., 2007). The diaphragm wall at a corner was only 3m to the nearest tunnel, i.e., the up-track, which was completed on 28 December 2004. The subsoil at the depth of tunnels mainly consists of silty clays (Soil Type CL). The bearing stratum was not encountered at the maximum drilling depth of 40m.
