**Geotechnical Study on  
Ground and Masonry Structures  
in Angkor for Safeguarding Monuments**

**September 2001**

**Yoshinori Iwasaki**

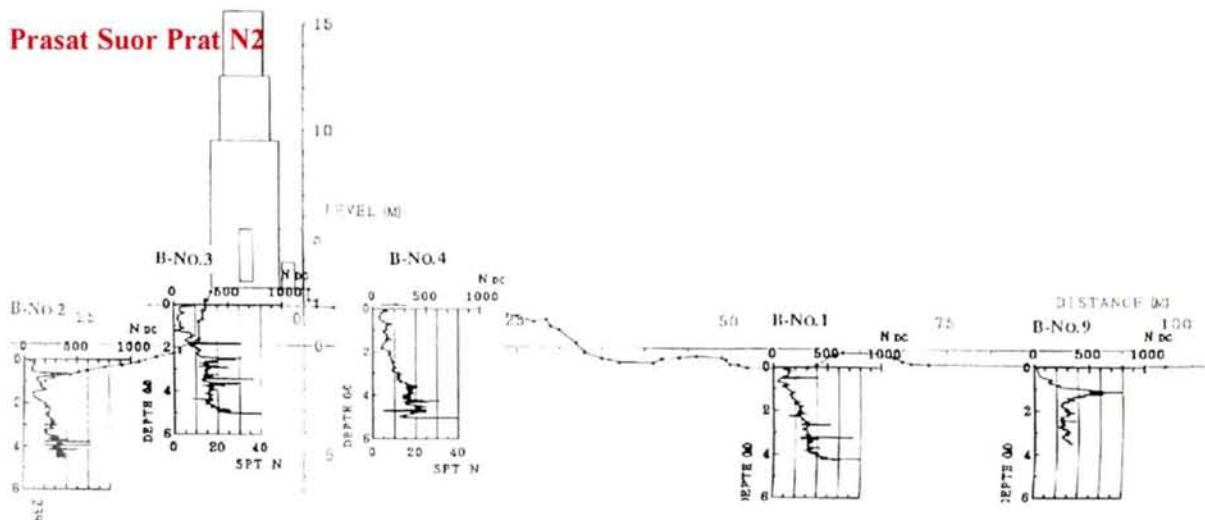
Fig.5-4 Results of Dynamic cone resistance near Prasat Suor Prat N2 and Royal Plaza

Top subsurface of 2 to 3 m is soft to medium clay. At the point (B.No.6) west of north library at Bayon, the penetration was rejected by laterite block, which may be a part of foundation system of the library. Some places (B.No.5 at Bayon and A.No.8 at North Library inside of the outer wall, Angkor Wat) showed softer characteristics than the average tendency. At Prasat Sour Prat, Towers are built upon filled material. The thickness of the fill is about two meters and is found soft ( $N_{dc} < 50$ ) in the layer less than 1.5m from the surface.

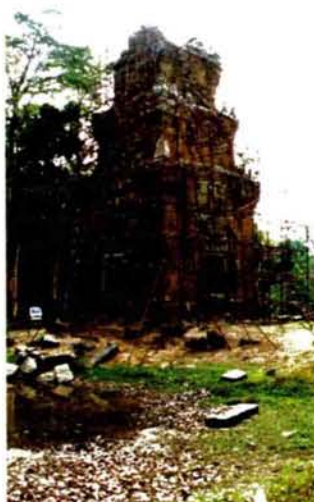
Photo 6-2 N1 Tower, Prasat Suor Prat and North Pond under dry season, February 1996

It should be noted that the towers near the ponds shows much larger inclination than others and the directions of inclinations are towards the ponds. The inclination varies in a range from a few degrees towards Ponds. The S1 tower has inclined 2-3 degrees towards south direction. On the other hand, the

N1 tower has inclined towards north direction. The maximum inclination of 6.6 degrees to north is found for N1 tower.

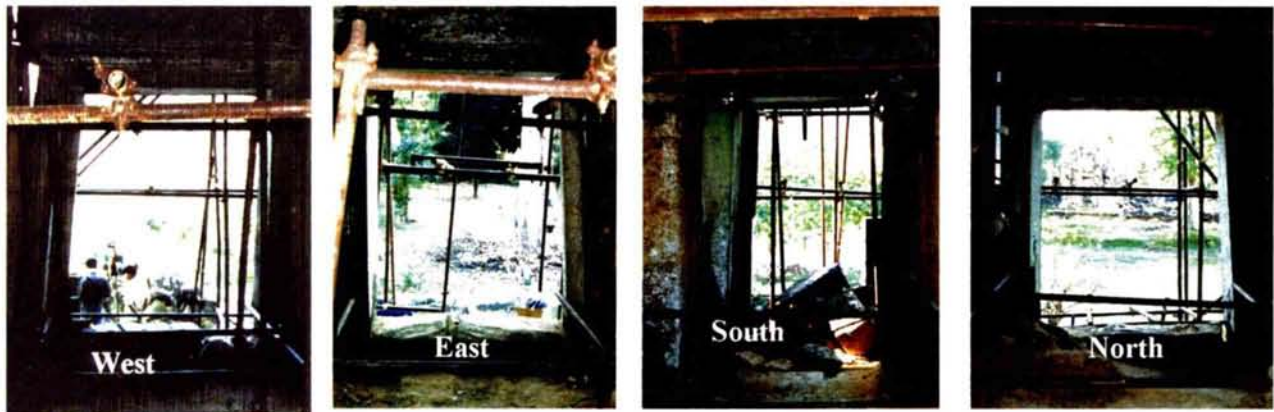
Photo 6-6 West, East, South, and North Wall from inside out direction.

For any wall, the bottom parts of the openings are found wider than the upper part. The largest difference in the width is at west wall. The next is at north wall.

It is found that the opening at north wall is the lowest level among others. The north column of the west wall opening is also found the lowest among 8 columns.

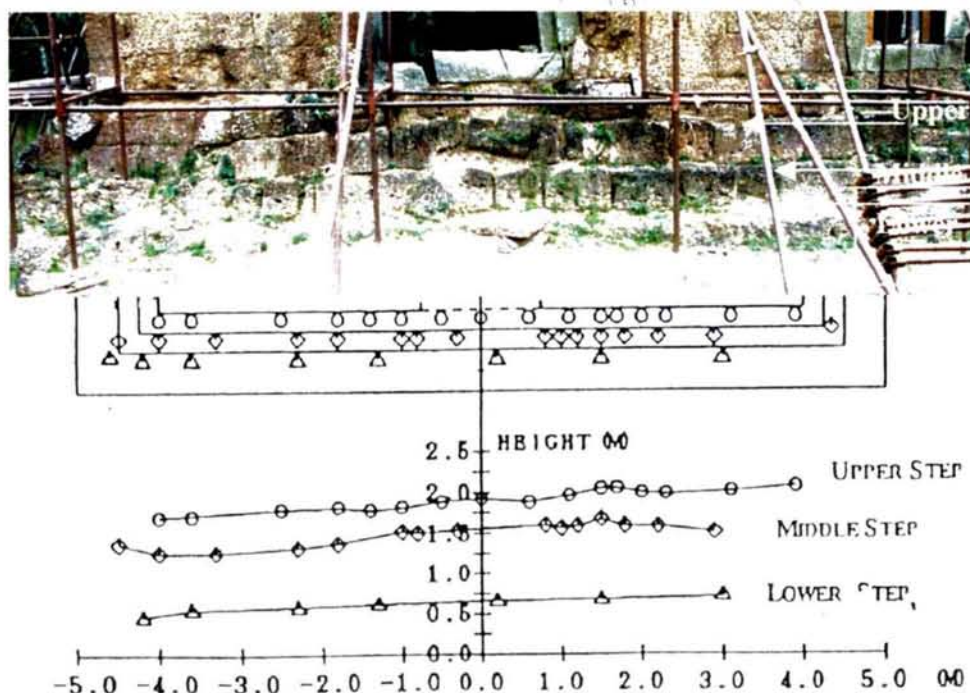
Fig.6-5 Height of each step along west wall

The maximum inclination of the foundation is north side foundation of about 40cm/10m, which is the same inclination direction as shown in Table 6-3. The inclination itself is one half of the inclination of the bottom beam of west opening.

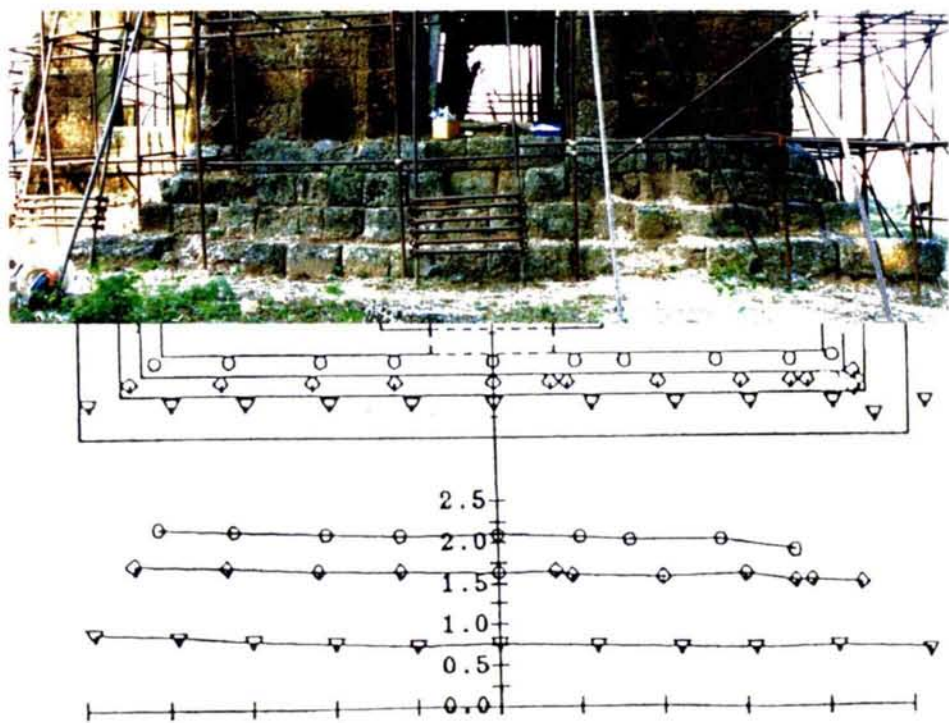
Fig.6-6 Height of each step of east wall

Fig.6-6 and 6-7 also show the height change of the steps for east and north wall. The northeast corner of the foundation was found the lowest level.

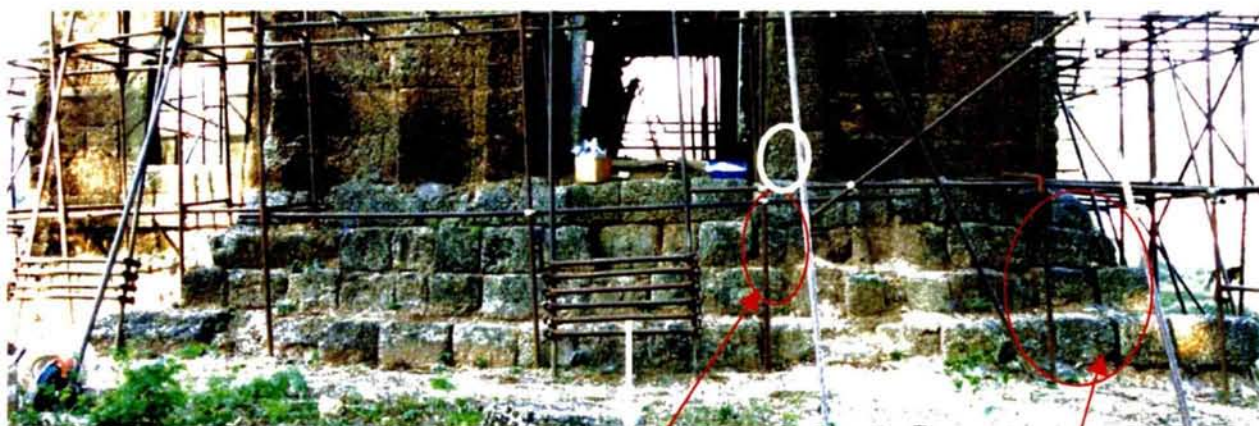
Photo 6-10 east foundation

Any opening gap greater than 2mm is in block letter. The gap in any level shows larger value at the edges. At the base level, the large gap is found at the beneath of the edges of opening. This pattern of distribution of gaps suggests that the foundation is spreading horizontally, which have been caused by the ground movement beneath the foundation. The spreading portion of the grounds may be in the area where the larger stress had been concentrated by the tower structure. The deformations may be creeping characteristics in long term.

In Table 6-4, the gaps beneath the openings are summed for east and north sides, the total opening is about 10-18cm, which accounts for the difference between the top and bottom width of opening of the north wall.

This phenomenon of horizontal spreading of the foundation is confirmed at every faces of the tower except the south face, where the measurement is not possible. The horizontal spreading was caused by several reasons.

The main cause might be due to horizontal outwards movement of compression of ground beneath the corner column where the load concentrated in long term. Wind force might have contributed to cyclic horizontal loading to the Tower, which additional horizontal displacements. The plant root intruded between laterite blocks had also widened the openings. The ground itself might have had expanded by some reason.

In the eastern face, there is a crack on east wall above an opening of stones in the upper level foundation. Since this crack is found rather fresh, the joint movement of the laterite blocks beneath the block might have caused the opening to begin and to continue to develop.

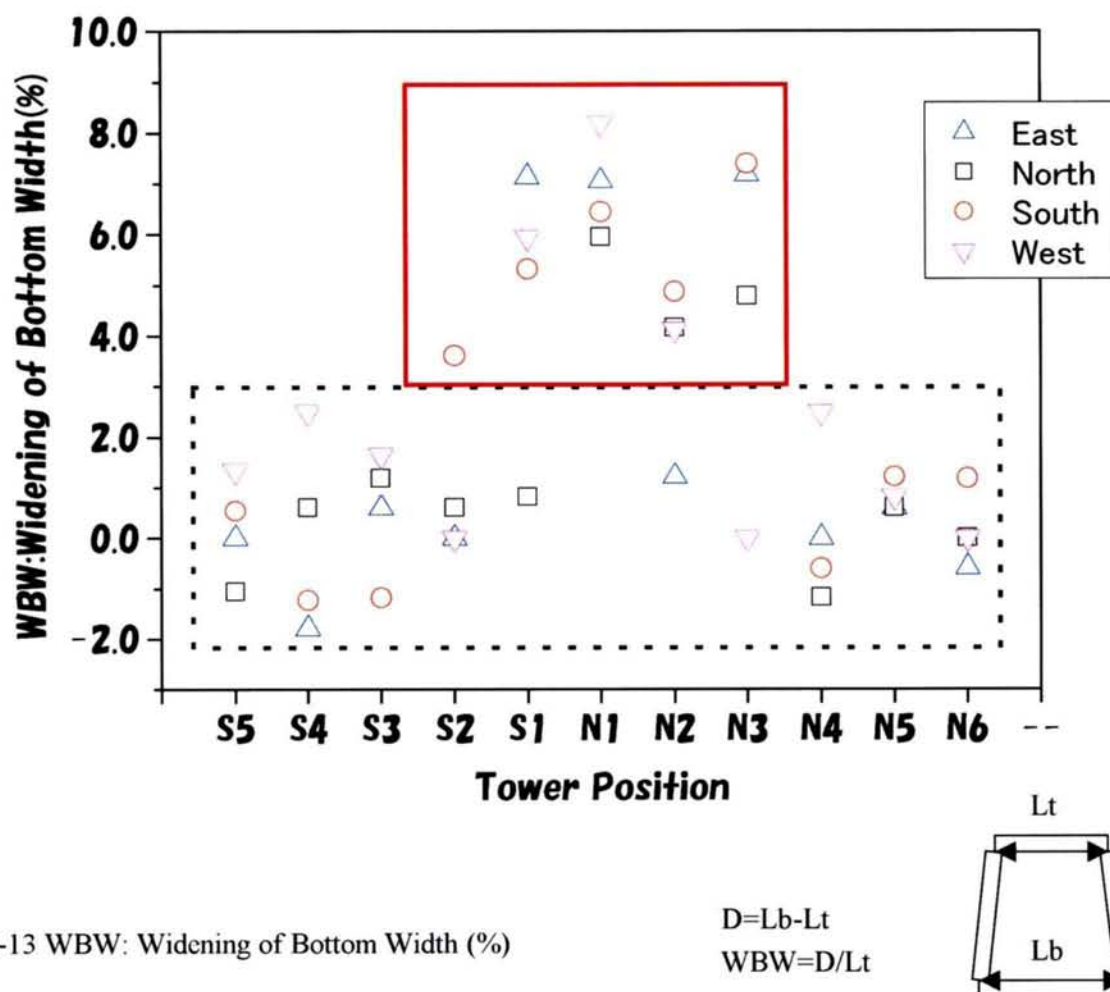
Fig.6-13 WBW: Widening of Bottom Width (%)

Table-6.5 shows the inner widths of the bottom and top of the open windows, their differences, and the widening percentages of the bottom widths for all of 11 Towers except S6. These are plotted and shown in Fig.6-13. Among 11 Towers, they are divided into two groups. One is blocked within red color and another one is blocked in black color. The first group is characterized by the larger widening of the bottom width than the top. The larger values of the widening percentage of the bottom to the top are for N1 and S1 that are very near the Ponds. It is also found the same trend for N2, N3, and S2,

After the construction of the Towers, there were some differences of widths between the top and the bottom. Since it is found that there are some cases where the bottom widths are shorter than bottom ones, the original width may be within a variation of  $\pm 2.5\%$  as shown in the black block in Fig.6-13.

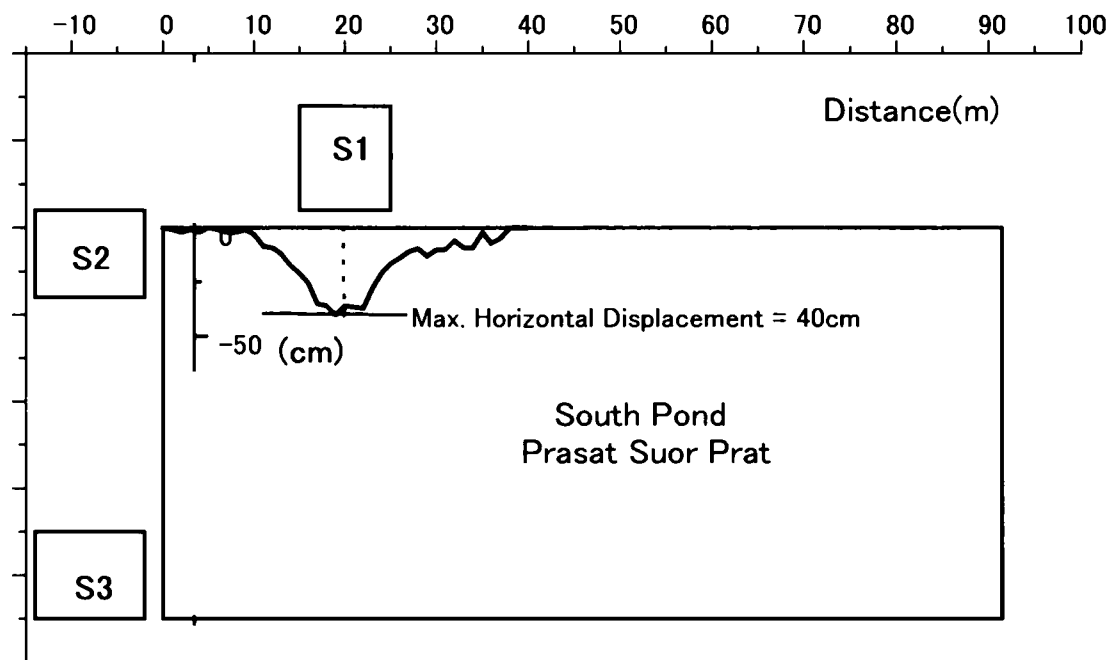
Fig.6-14 Displacement of the North side Embankment of the South Pond, Prasat Suor Prat

The displacement of the north embankment of the South Pond is found almost symmetry against the centerline of the S1 Tower as shown in Fig.6-15. The right hand western side shows a little bit larger displacement than the left eastern side. The offset along the west embankment near S2 and S3 were not visible by naked eyes. The constraining condition for displacement of the

embankment in three-dimensional effect may have contributed the little offset found in the west embankment of the South Pond. It might have also contributed the smaller deformation of the western side than the eastern side. This effect may be due the difference of plain-strain condition of the right of eastern side and the constrained condition of the western side by the west embankment. The N1 Tower might have had the same effect of the deformation of the south embankment of the North Pond, however, no further discussion is made due to no possible measurement on the North Pond.

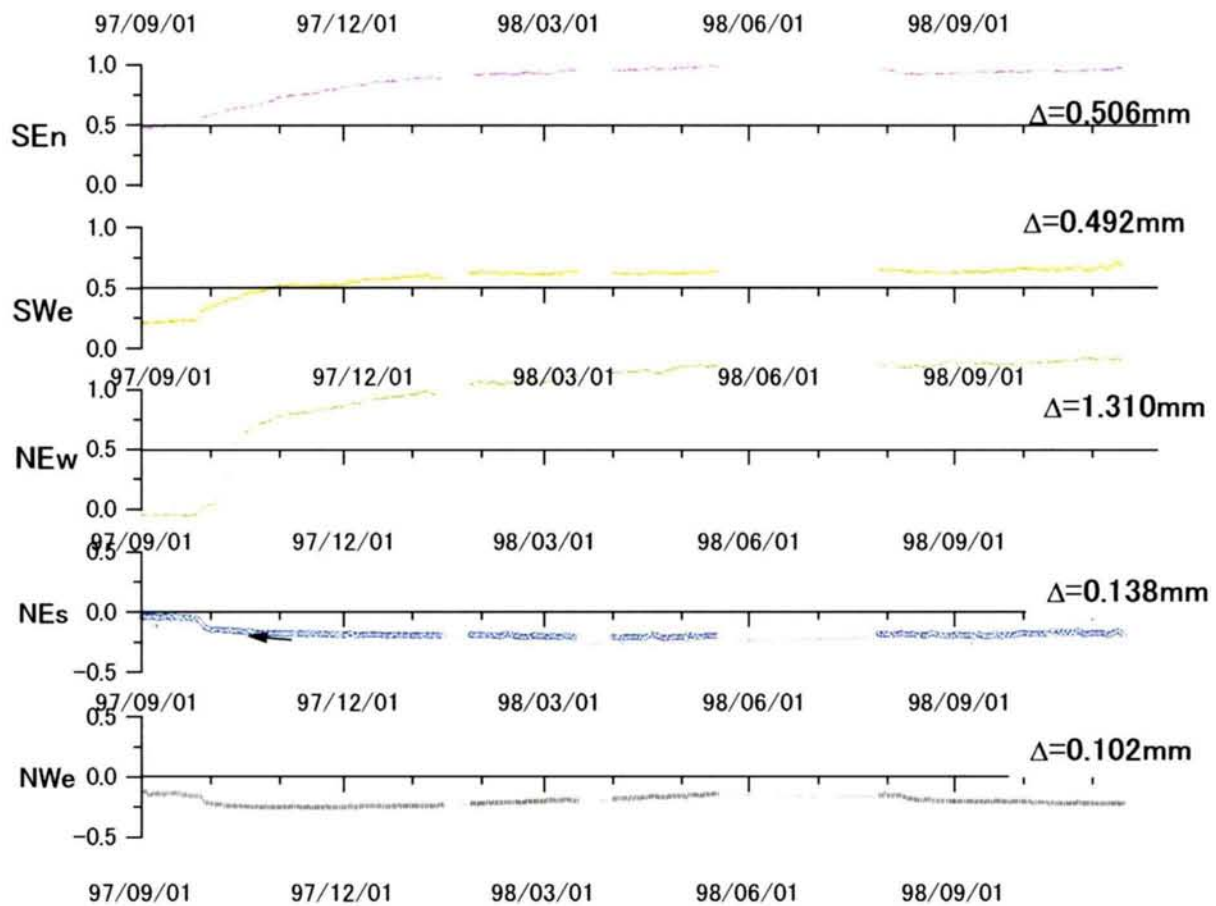
Fig.6-19 Creep of Inclination of Inside Column of N1 Tower, Prasat Suor Prat

The movements continued for more than several months. In Fig.6-19, five components among eight inclination records were selected and shown to see how the inclination increased after the event had been triggered from September 1, 1997 to November 16, 1998

The maximum creep inclination observed was 1.3mm/m of NE column in northward direction. In

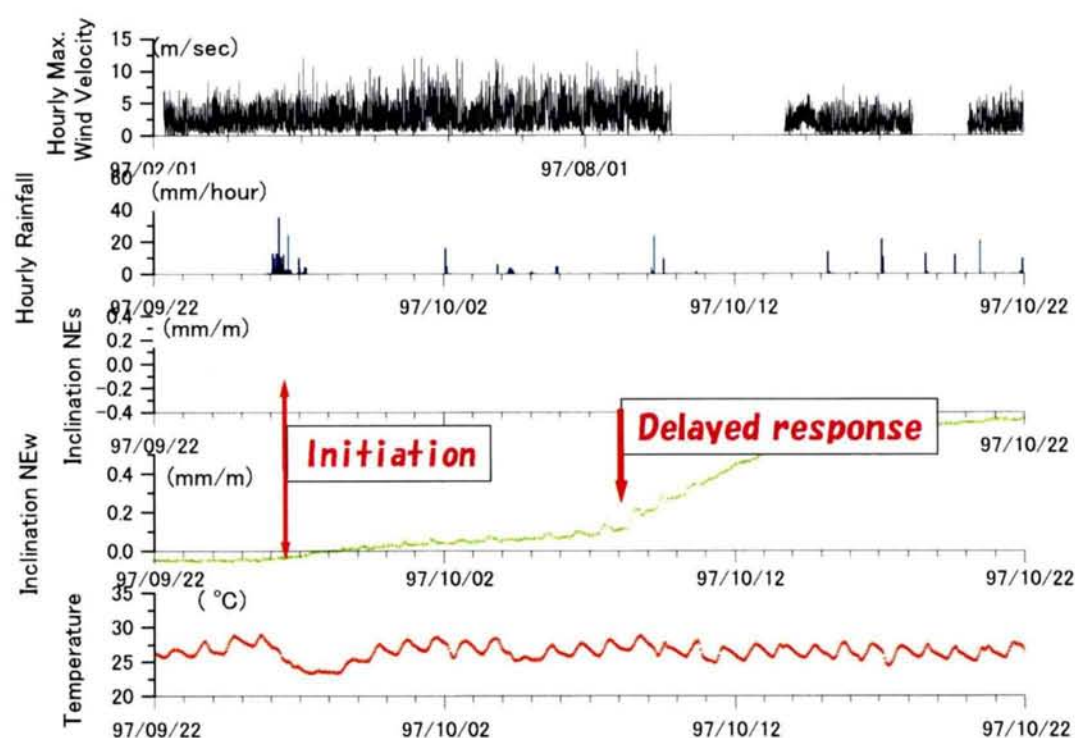
Fig.6-20 The Initiation of creep

Fig.6-20 shows the initial process of creep to start. It is of a great interest to see there is some delay of about 10days between the initiation of change and the delayed response time of creeping.

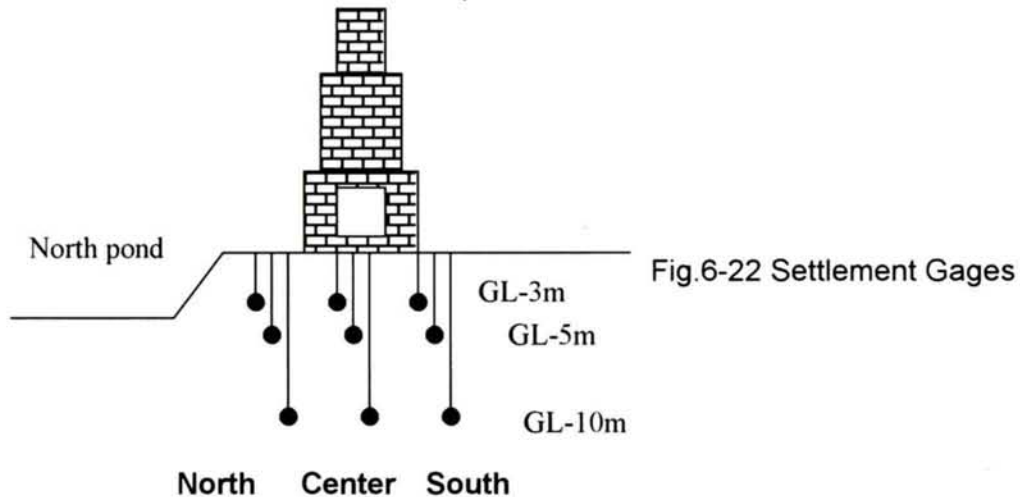
Fig.6-21 Settlement vs. Rainfall and Temperature at west of N1 Tower, Prasat Suor

Settlement/heaving characteristics based upon the monitored data in the last two years are summarized as follows.

In dry season of 1997, the ground settlements of about 1-2mm were observed from February 1 to May 1, 1997.

After May when the rainy season starts, the settlement stops and heaving takes. The north point shows the largest settlement and swelling among three monitoring points. The settlements became rather stable during rainy season from August 1997 before the end of September when the heavy rain occurred. They have been activated due to the heavy rain that had caused the swelling of the ground. There are some common characteristics of these three points. In each point, the heaving from the ground surface to the shallowest 3m depth is almost negligible. However, the deeper points of 5m and 10m show much larger heaving after the heavy rain. This suggests that the water had infiltrated into the deeper layer, which became to expand to swell.

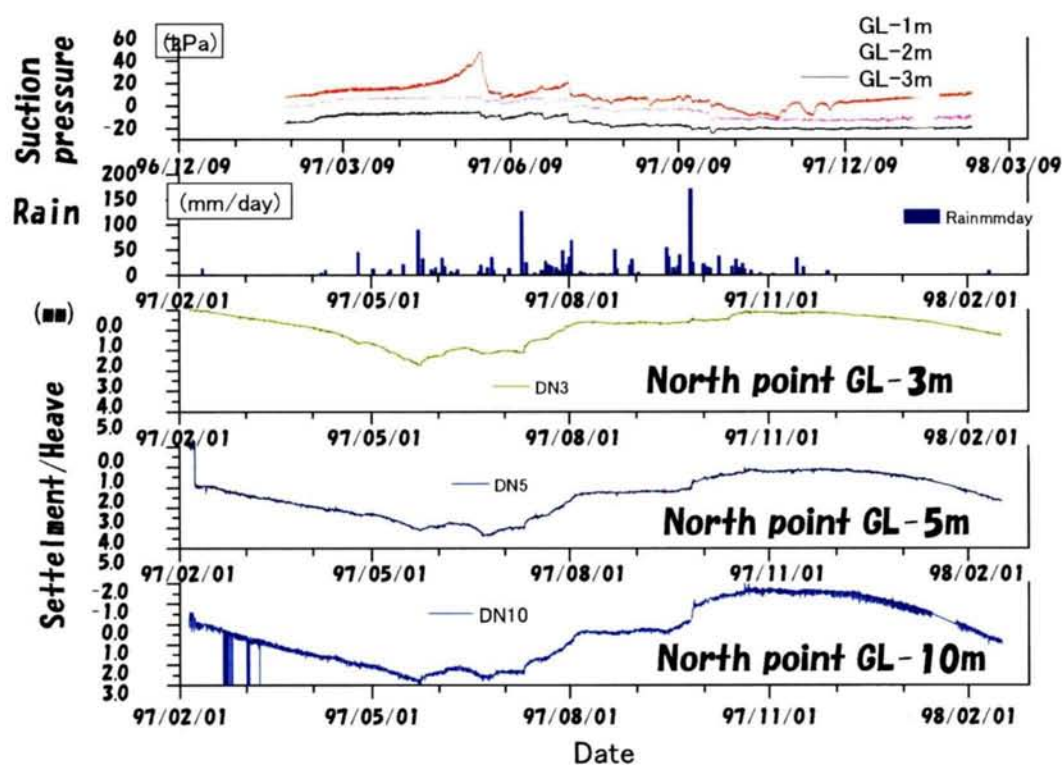
Fig.6-23 Suction, Rain, and Settlements

It should be noted that the settlements and swellings are closely related with each other. The shrinkage of the ground continued when the suction pressure increased until the suction began to decrease.

In dry season from February 97, suction pressure at GL-1m increased which corresponds the dewatering of underground water level. The compression of the ground from GL to GL-3m is found also increased.

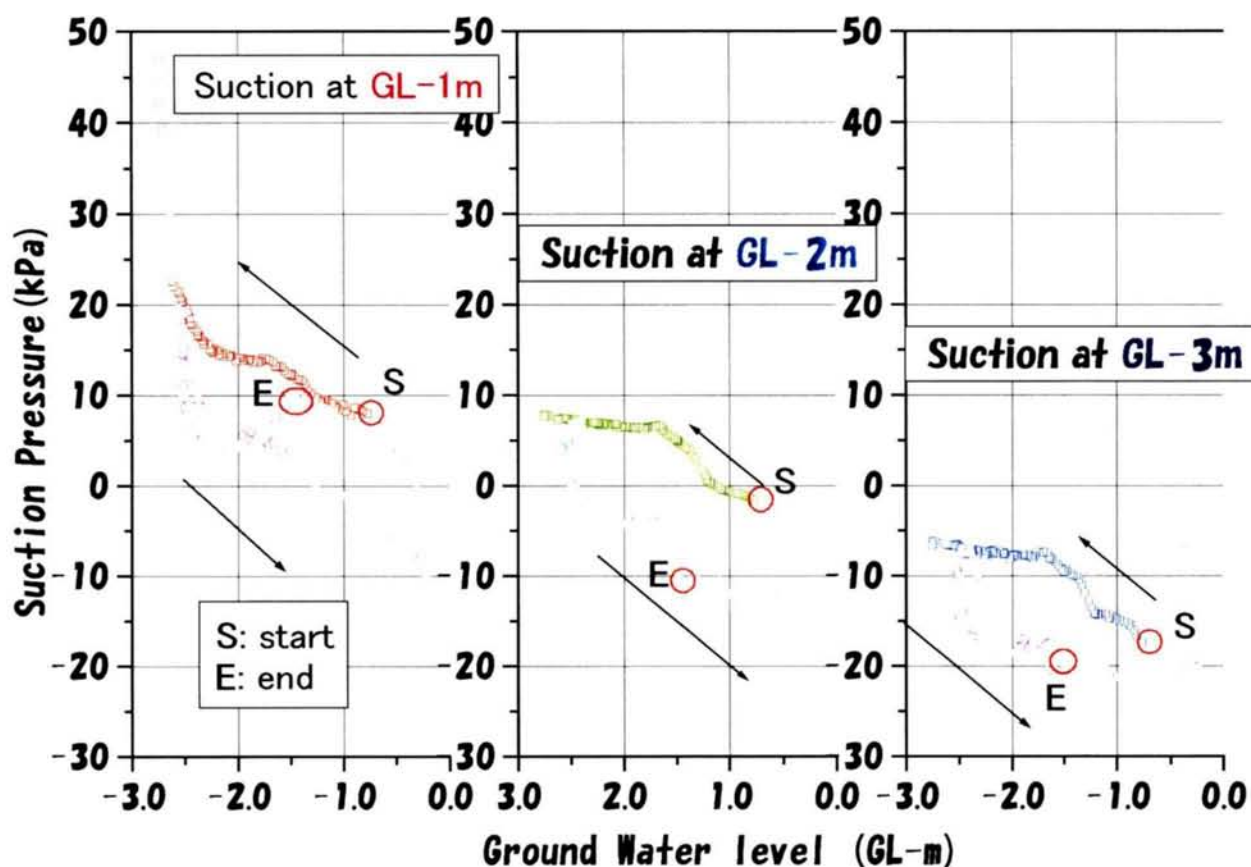
Fig.6-25 shows the relationship between ground water level and suction pressure for three depths of GL-1m, GL-2m, and GL-3m. All three suction pressures have strong relationship between ground water levels. When the ground water level decreases, the suction pressure increases.

The suction pressure installed at GL-1m showed sudden increase of the pressure when the ground water level decreased about GL-2.5m.

Fig. 6-25 Ground water level vs. Suction pressure

Since the ground water level has varied from GL-0.8m to GL-2.5m, suction sensor at GL-3m was considered as under the ground water level and the measured values are negative, which indicates the suction pressure has disappeared and pore pressure was build up. However, the pore-pressure responds with ground water with hysteresis. This may be due to unsaturated states of ground. Overall responses of suction pressure against change of water level are found about 10kPa per 1.0m.

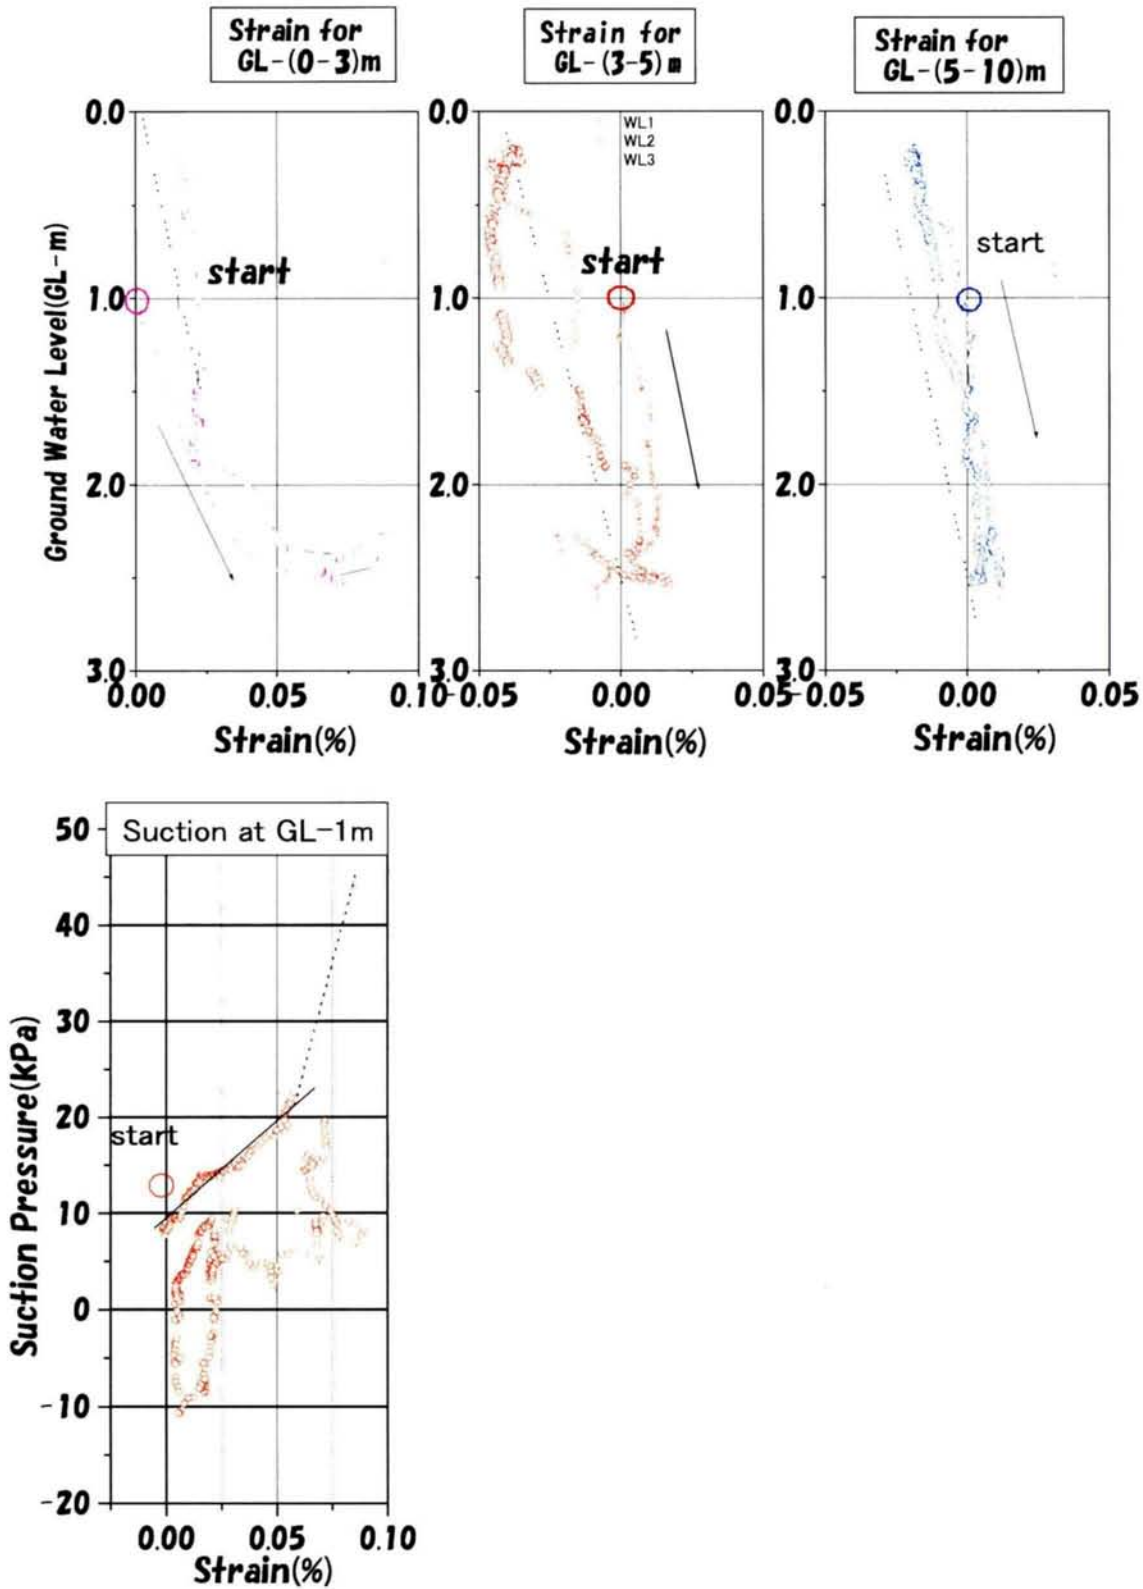
Fig.6-26 compares vertical strains with ground water level and suction pressures. In general, the change of underground level induces the effective stress on the soils in the ground, which results in volume change of the ground.

Based upon Fig.6-26, the compressibility of the ground may be computed for each layer as follows,

Fig.6-26 Vertical strain, Ground Water and Suction Pressure

The compressibility was found to increase with the depth. The apparent compressibility from effective stress change caused by water level and suction change were obtained as the same value of 40MPa.

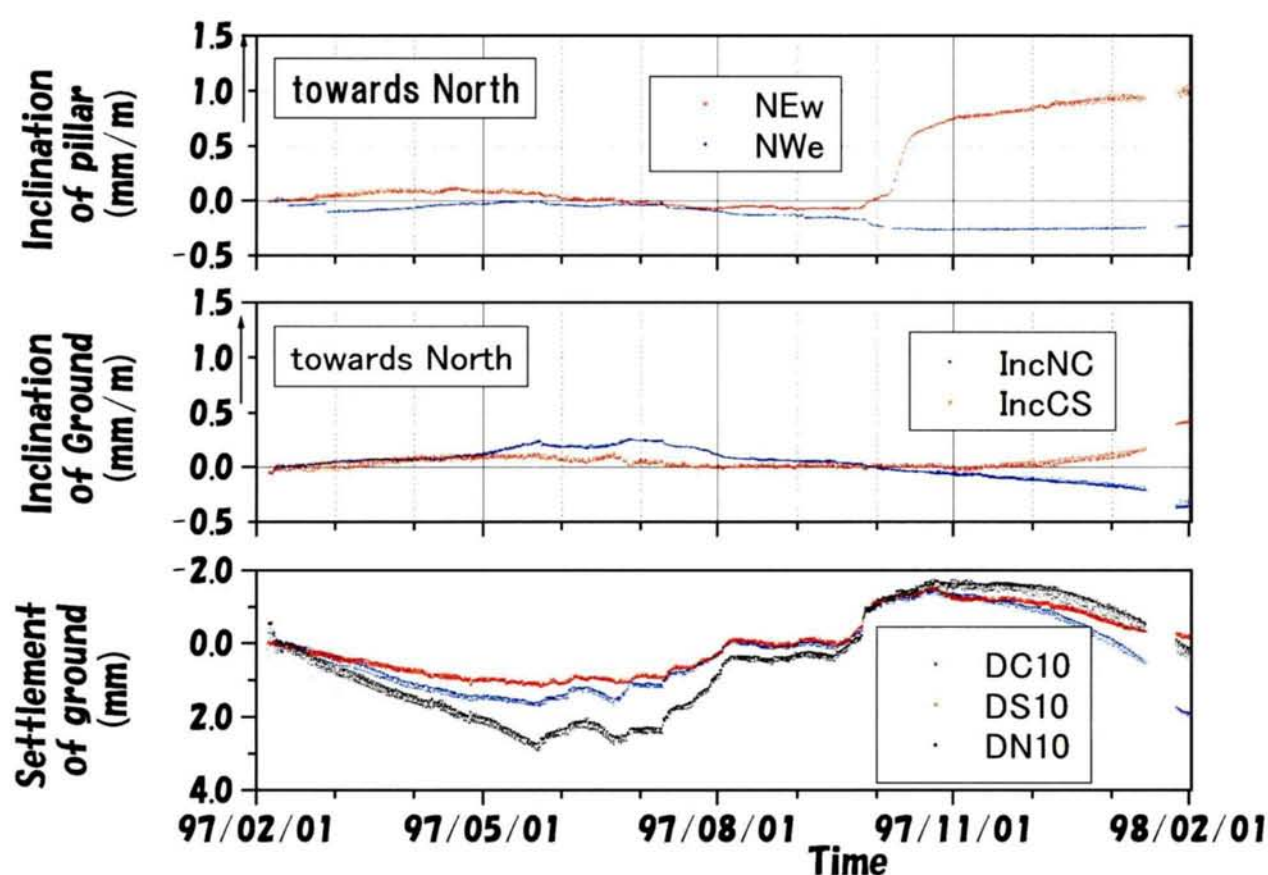
Fig.6.27 Settlements at north, center, and south points, inclination of masonry pillar at NE and NW corners, and inclination of ground

Fig.6.27 shows settlements at north, center, and south points, inclination of masonry pillar at NE and NW corners, and inclination of ground estimated by settlement measurements.

The inclination of masonry pillar takes the same tendency until the heavy rain in September. The increases of the inclinations of the pillars are found no relation with ground behavior.

If the tower inclination has been caused by the ground settlement/heaving, the inclination should be the same trends of the ground behavior.

The allowable settlement to keep the masonry structures from differential settlements is not known at this time. It is necessary to keep the present underground condition and to continue to monitor the ground water level as well as responses of the masonry structures to prepare any situations that may occur in the future.

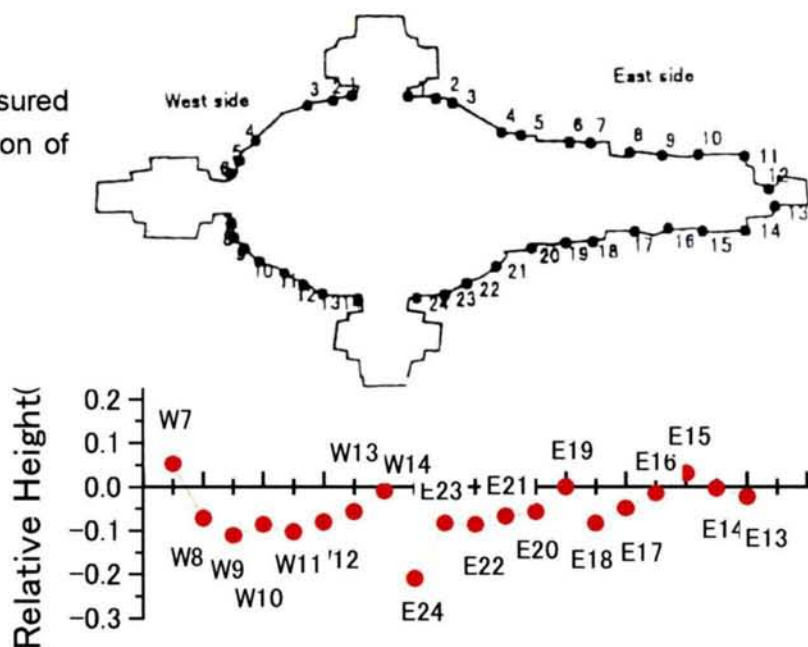
The top and the bottom of Fig.7-5 show the height for northern and southern halves. It is understood that the western side of the tower is symmetrical in height. Both north and south subsided to the centerline. On the other hands, the eastern side of the tower is one sided.

Fig.7-5 Relative Height of Basement around the main tower, Bayon on the Upper Terrace

The northern half (E1 to E4) is higher than southern counter part (E24 to E21) by about 0.25m. In the peripheral circle of the central tower, there are some portions of differential height or settlement. However, there is no definite trend to show one sided inclination.

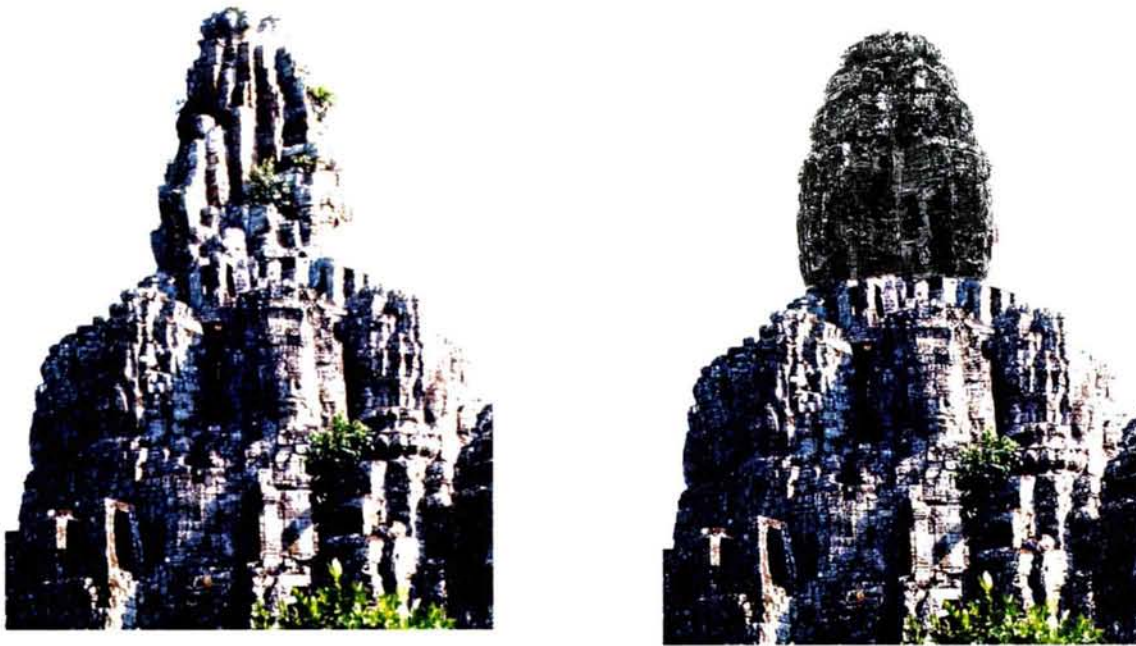
Photo 7-4 The comparison of present and estimated original shape of the Central Tower, Bayon

It is found the lack of the symmetry against the center of the tower. Photo 7-4 shows a comparison of the present and estimated original shape of the Tower. One of the reasons why the outer shape of the tower silhouette differs each other depending on the direction is not known. However, these characteristics of the shape of the tower strongly suggests stone elements might have been fallen out in the long period after being lost by the Khmer Empire.

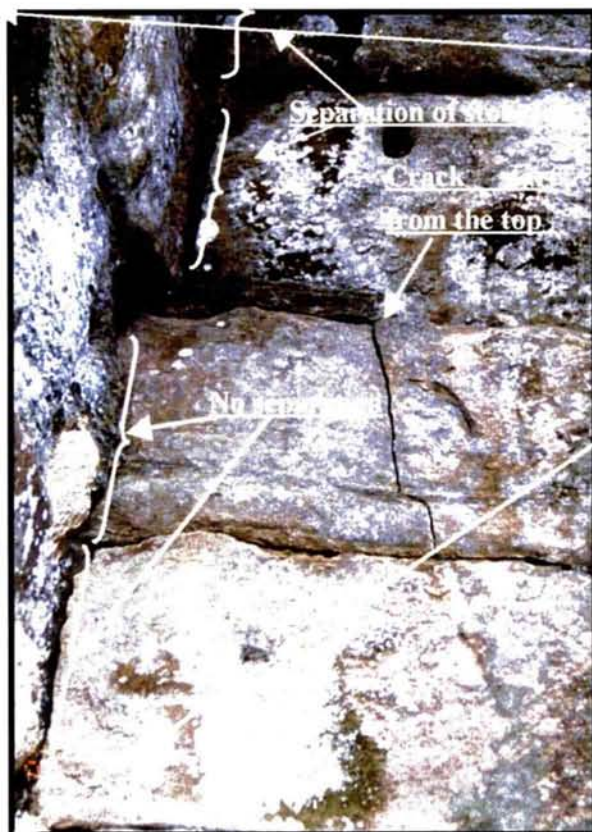
Photo 7-7 Inside of the Gallery of Central Tower (northwest corner)

Photo 7-6 shows the inside of stonewalls of the Central Tower around the corner of northwest. It should be noted that a vertical crack develops in the side surface of a sand stone at the middle height, which is enlarged and shown in the left of the Photo 7-7. The crack on the stone surface initiates at the upper surface and has developed downwards. It should be also noticed that the separation of sandstone above the cracked one from the left neighbor stone, while no separation of the spacing between the cracked stone and the adjacent one. The separation of the spacing above the cracked stone is found continued upwards. At the same time, no separation is found at the lower stones than the cracked one.

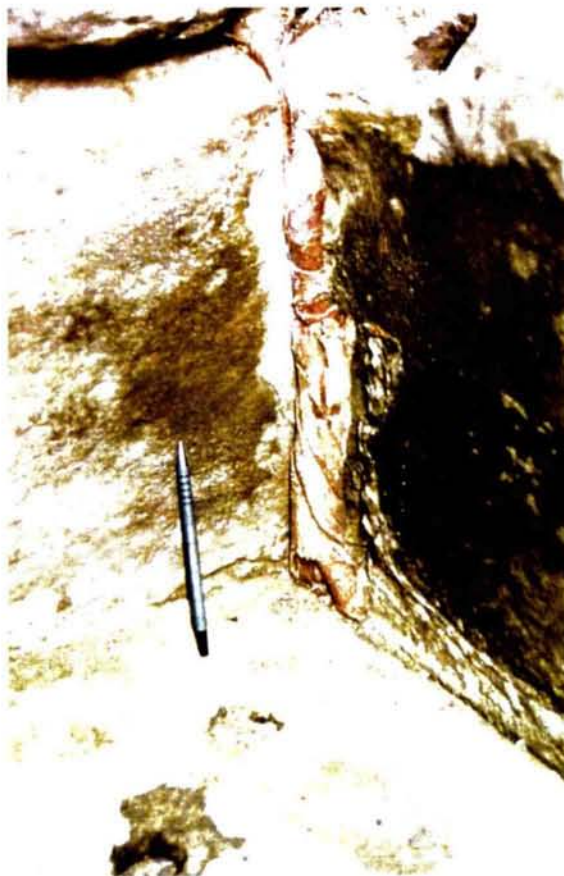
Photo 7-10 Plant root between vertical gap (SE corner)

The forced displacement might be caused by horizontal widening of the spaces between columns at upper level by some reasons under the condition of being fixed at the bottom level stone to the floor stone. It is expected that an increasing friction force had been mobilized between the stone surfaces at the bottom due to the horizontal movement of the column. Photo 7-10 shows plant root grown in the gap of stones. It is obvious the plant root develops with enlarging the size of the root that makes widening the space between stones.

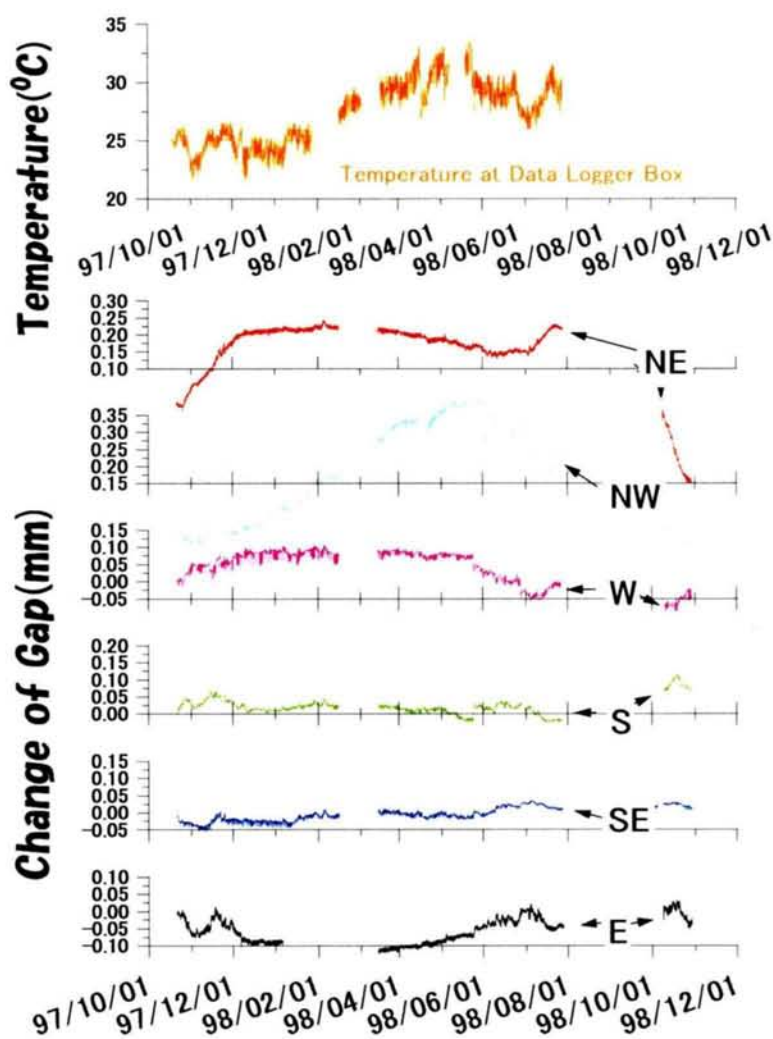
Fig.7-9 Change of Gap of Opening at Central Tower Bayon

The relationship between the magnitude of gap opening and temperature is expected. It is found in Fig.7-9 and 7-10 that the gap opening becomes wide when the temperature change is also large for each sensor.

However, the comparison of gap opening and temperature changes among different points in Fig.7-9 and Fig.7-10 does not show quantitative relationship between gap opening and temperature change. It is expected that how much the gap closes or opens depends not only the temperature change but also some other characteristics related with the specific site condition. The seasonal change of gap shows their extremes at different times according each point. Though it is difficult to reduce any conclusions on the seasonal changes, it may be found that some relationship between the gap and temperature in a period from June 1, 1998 to August 1, 1998 when the both record show some trends. During these two months, the temperature decreased, reached its minimum, and then increased. The most of the gaps except NW point show the same characteristics with different trends. For these points of S, SE, and E, gap opening increased, reached their maximum, and decreased. For other points of NE and W, the opening decreased, reached their minimum, and then increased. NW point is difficult to be grouped into which group it belongs. The gap movement of NE point is unique and different from any other points. It increases from October and reaches its maximum at the end of May, decreases, and reaches its minimum. The mechanism of these different characteristics to temperature change is not understood.

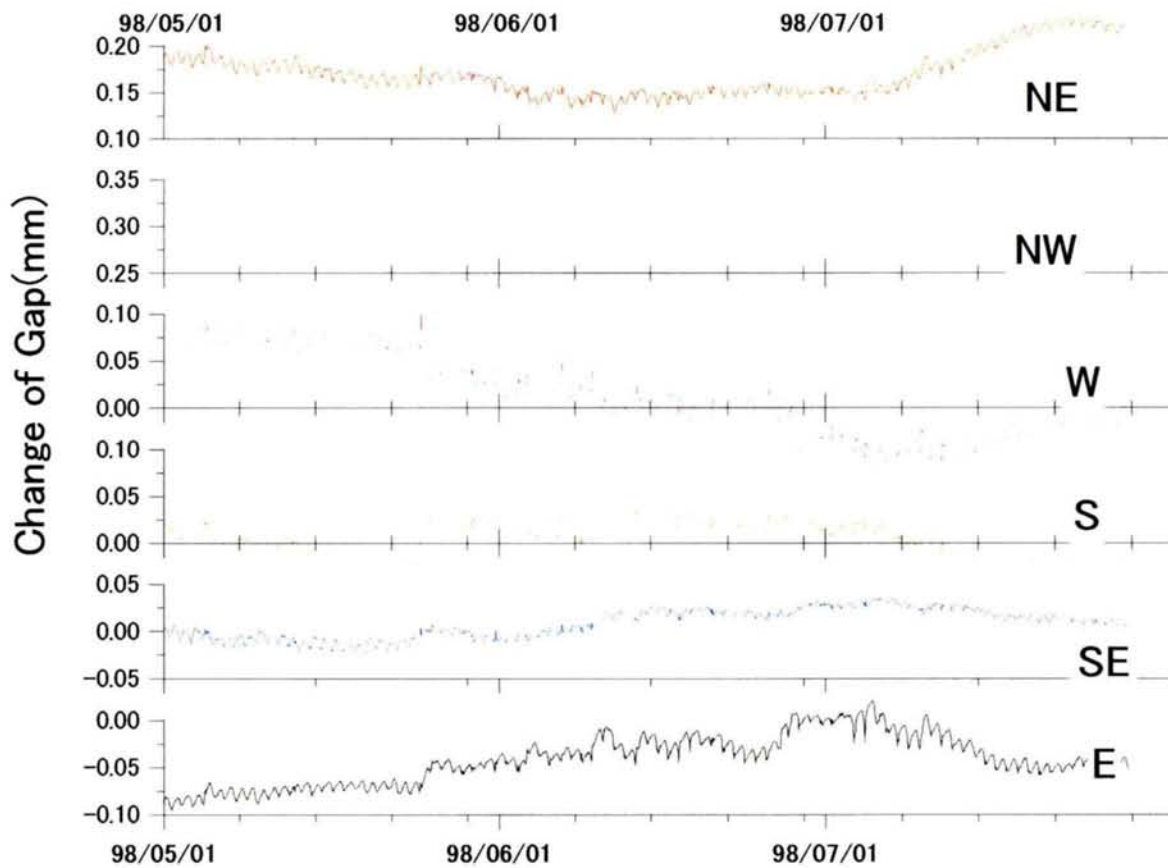
Fig.7-11 Change of Gap Opening at Central Tower

Among the continuous change of the gap opening, it is also found some sudden change as found on May 23, 1998 in Fig.7-11. On the day, the temperature decreased in sudden. The gap opening of NW, W, S, SE, and E had increased except NE point. Within a few days later those of NW and W points decreased, but those of S, SE, and E continued as sudden increased opening.

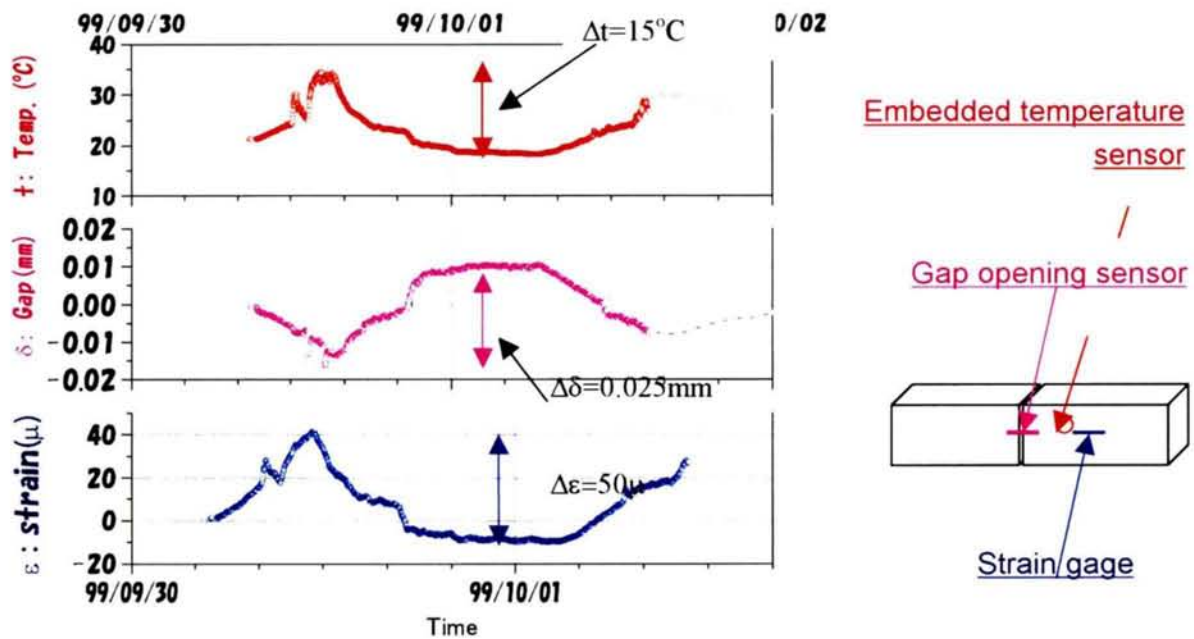
Fig.7-12 shows the relationship between strain of the stone surface, temperature inside the stone, and the gap opening of space between adjacent stone.

The measured gap change is 0.025mm, which well corresponds to the estimated value.

Fig.7-12 Temperature, strain of stone surface, and Gap opening

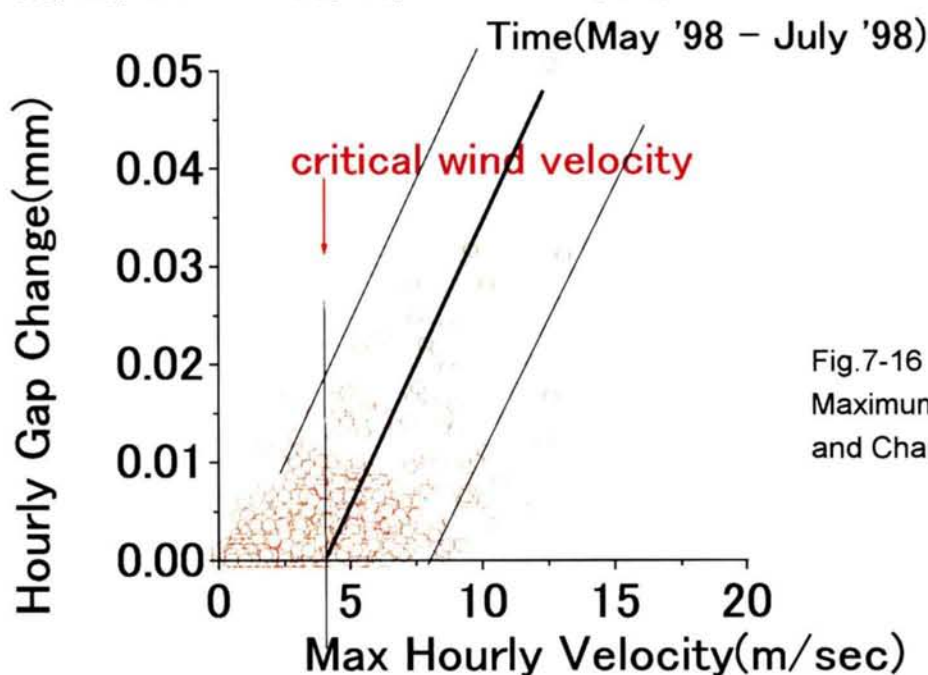
Based upon the gap records, hourly gap changes are computed and shown in the upper part of Fig.7-16 with hourly maximum velocities. The relation between the hourly gap changes at NW point vs. the hourly wind velocities in the same time range shown in the lower part can be understood that the stronger wind velocity had triggered the larger sudden gap change in the same hour duration. We may define a critical wind velocity over whose value large sudden gap changes are observed. The critical wind velocity at NW point is about 4km/sec.

The relation of sudden gap( $\delta$ : $\mu$ m) is expressed as a function of the wind velocity( $v$ :m/sec) as follows,

$$\delta=2(v-4)$$

Fig.7-16  
Maximum wind Velocity  
and Change of NW Gap

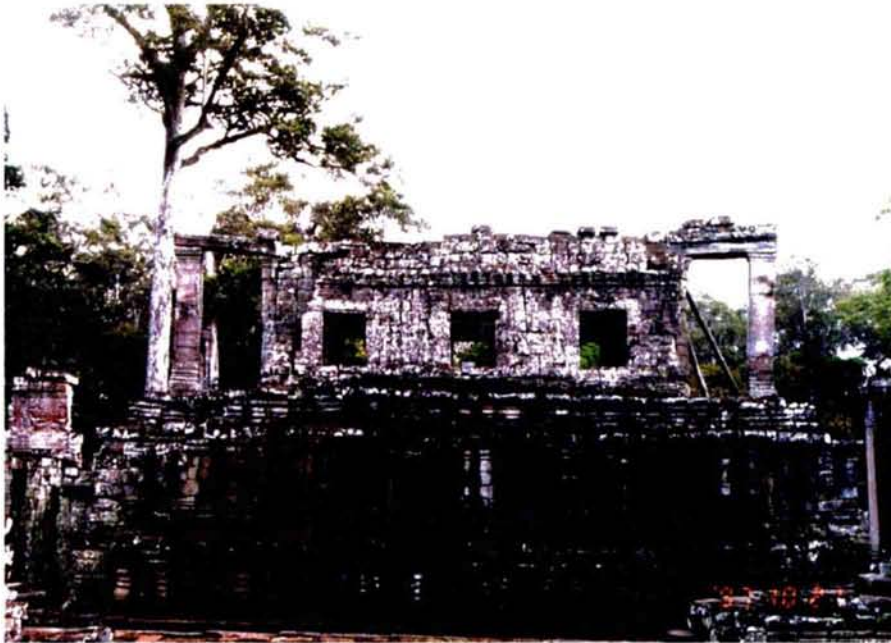
Photo 8-3 South Library, Bayon, Side look from north

The walls of upper structure are heavily inclined towards inside (Fig.8-5). The boundaries of porches and the main structures at both ends are found settled and have become the lowest level. Lintels of porches have been struted against structural collapse.
