**Geotechnical Study on  
Ground and Masonry Structures  
in Angkor for Safeguarding Monuments**

**September 2001**

**Yoshinori Iwasaki**

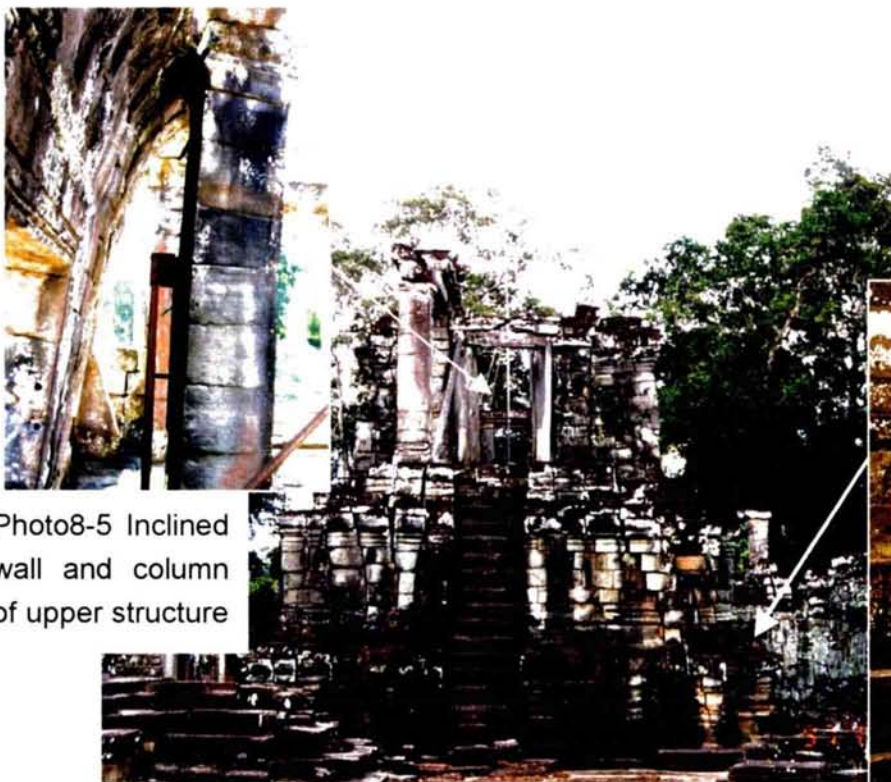
Photo8-5 Inclined wall and column of upper structure

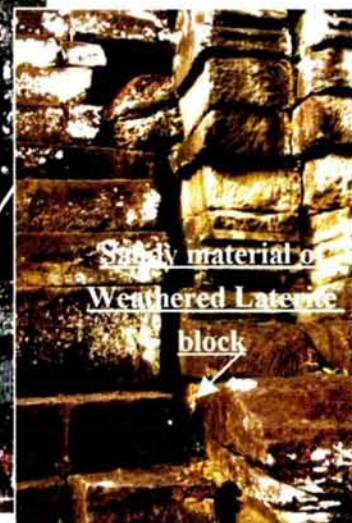
Photo.8-6 South-west corner of the foundation

Ends of both sides are found to have deformed extensively outwards. Careful inspections of the basement of the platform have revealed that there is little uneven settlement at the bottom line of the foundation.

At the west and south corner of the South Library, we could see the outcome of sandy materials from weathered lateritic blocks from a large opening between blocks.

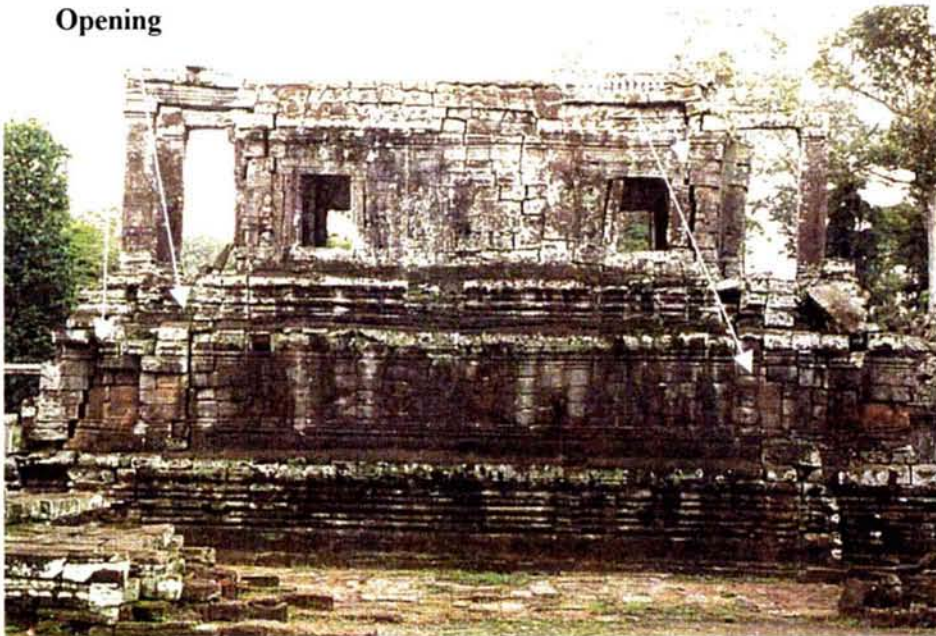
Photo 8-7 North Library, Bayon, side view from south

### Opening

Outwards movements  
at both ends

No differential  
settlement

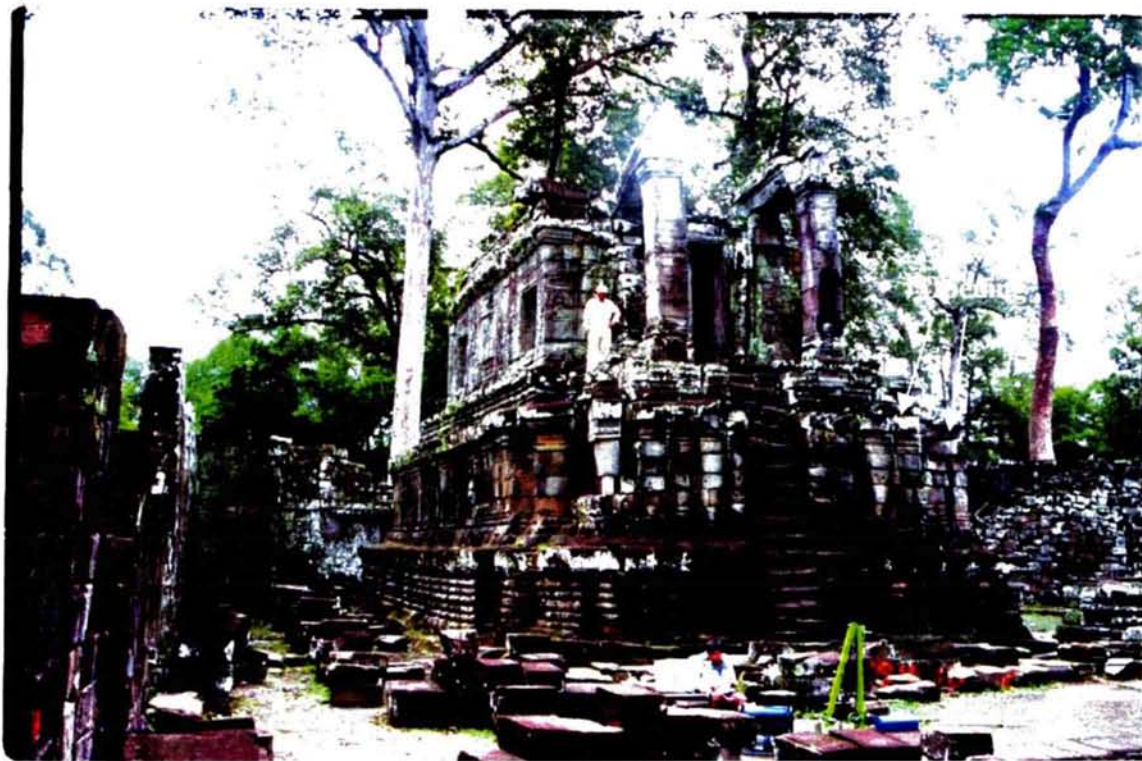
Photo 8-8 North Library, Bayon, front view from west

In Fig.8-7 and 8-8, several large vertical openings are found at the corner of North Library as well South Library.

Most stone elements covering the corner surface of the foundation are found slid outwards. These movements are caused not by the settlement of soil-foundation but by some deformations of the retaining foundation and/or movement of stones themselves.

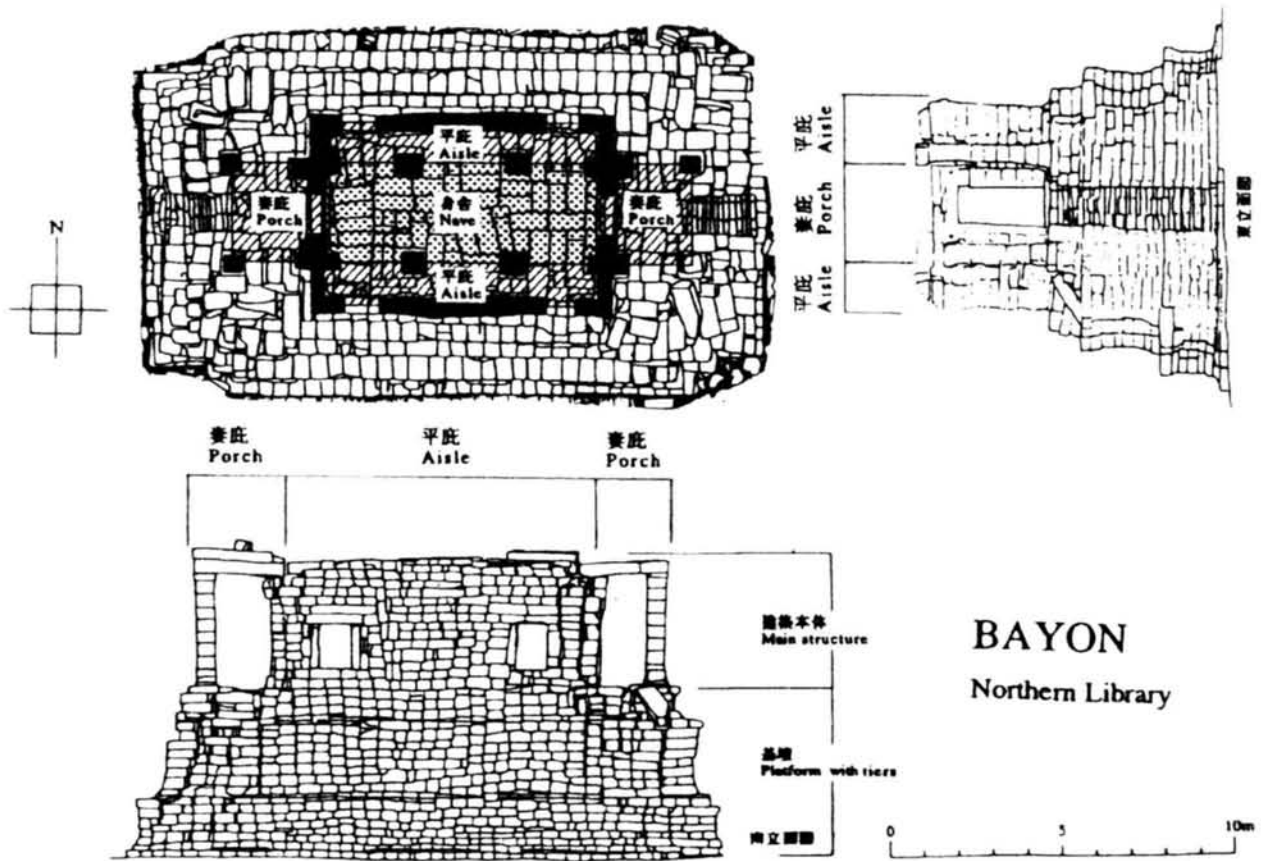
Fig.8-2 Masonry structure of North Library, Bayon

Fig.8-2 shows plan and side views of North Library, Bayon with names of each parts of the structures. The original shape is expected to have an additional roof structure, which has been fallen and missing at present as referred before.

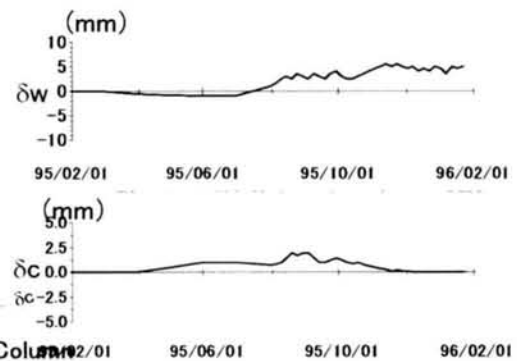
Fig. 8-6 Wall gap and Column inclination

Fig.8-6 shows two typical results of the monitored behavior. One is the change of vertical opening gap between two stone elements at SW wall corner ( $\delta w$  in Fig.8-5). Another is to measure gap between column stones to estimate inclination of vertical pillar ( $\delta c$  in Fig.8-5). Monitoring started from March 1995 and continued to January 1996. During the rainy season from May to October, these gap openings were found increasing. However, the behavior is different each other. The wall gap had increased about 3mm during the rainy season and the column stone gap increased about 2.5mm. The difference is seen in dry season. The column gap had returned to the original position, while the wall gap had developed its tendency. Wall movement might be considered as reaching final failure. We had to terminate the monitoring by dismantling upper structures in February 1996.

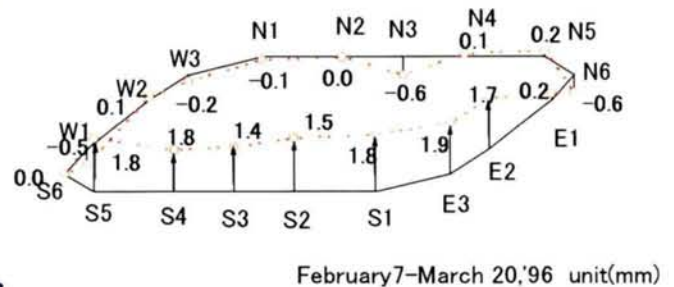
Fig. 8-8 Relative heave to S6 during dismantling

The final heaving was calculated relative to a reference point of  $S_0$ . The maximum heave was observed at south-east corner as 1.8mm and the maximum relative settlement was estimated at N3 point as -0.6mm. These resulted in the maximum uneven heave as 2.4mm.

It was also recognized that the heave of about 2mm at south east corner compared to northwest one. The averaged inclination due to dismantling was about  $2/12000=1/6000$  to southeast direction. The settlement caused by reconstruction process is expected as the same amount. It is expected that the reloading effects on the foundation ground are negligible based upon this observation.

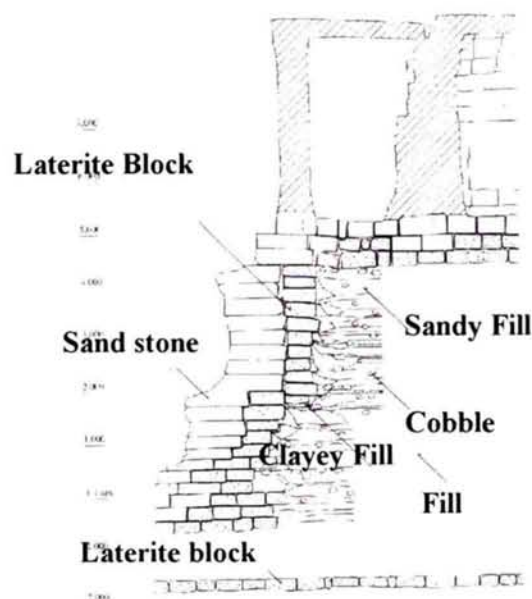
Fig.8-10 Inside structure based upon excavation of the west side of North Library, Bayon

Fig.8-10 shows the revealed retaining wall structure. The inside of the platform itself is made of compacted filled mound enclosed by laterite blocks with sandstone blocks at the outer surface. The laterite blocks are found badly weathered and there are some holes as evidences of erosion of soils by water or small animals.

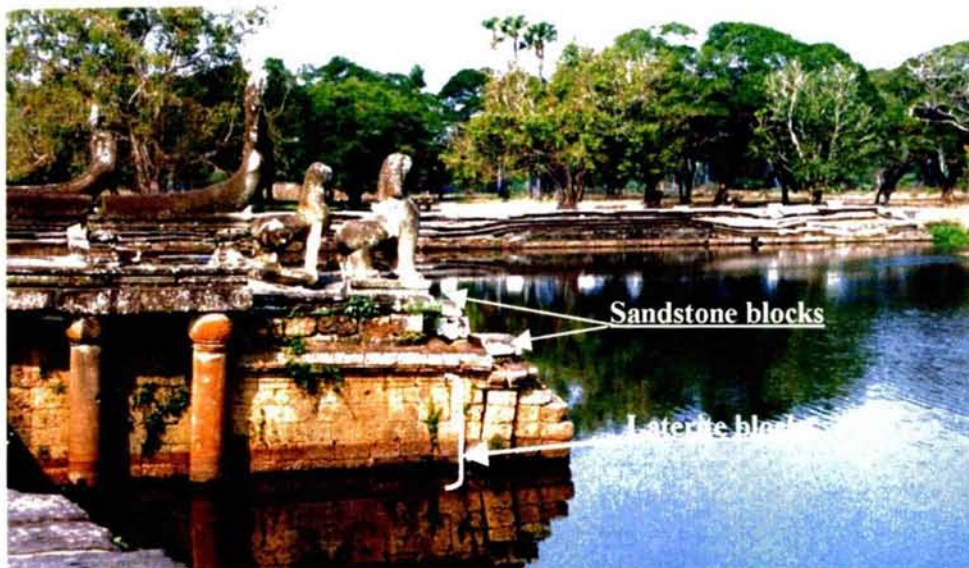
Photo 9-2  
West  
causeway  
Angkor Wat

In Angkor monuments, laterite blocks were used fundamental construction material as structural element covered with sandstones with relief on the surface as shown in Photo 9-2.

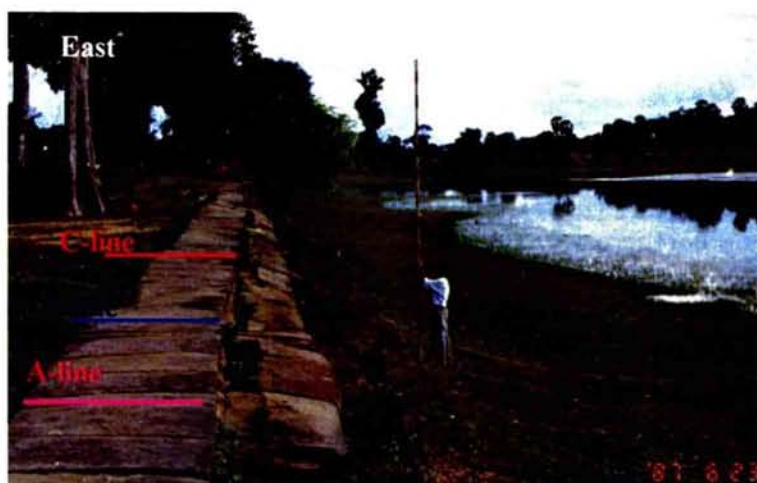
Photo 9-6 Leveling of steps of embankment at Srah Srang (see the location of Srah Srang in Fig.2-3)

There is a pond named “Srah Srang,” whose embankment steps were measured with leveling. Three

As shown in Photo 9-6, A-line is the nearest one to the corner. Among three sections, the top of the embankments of three lines are almost the same, the lower levels of the three lines are different each other. It is expected that the mechanism to cause the inclination phenomenon does not include sliding of the slope failure. If the inclination is related with sliding shear failure, the top level of the embankment along A-line becomes lower than that of C-line.

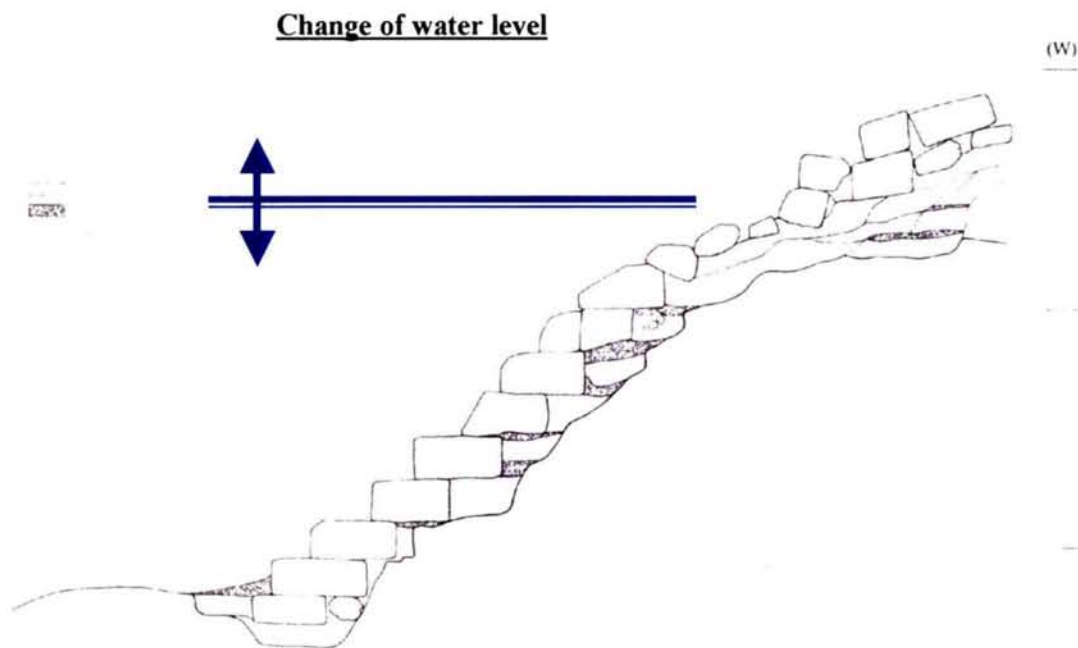
Fig.9-3 Section of the existing state of shore protection work at the embankment of North Pond, Prasat Suor Prat (JSA Report(1998))

The steps of the embankment were made of one bottom stone and 13 step blocks of laterite stones. The bottom stone was embedded in the foundation trench at 4.5m from the ground surface.

The top block is found inclined towards waterside, however, the trend is not always the same.

From the bottom of the pond, the slope with an inclination of about 40 degrees was constructed by compacted soils with surface covered by laterite blocks. Apparently, laterite blocks around GL-1m have significant changes of shapes of blocks. Some are broken into a few pieces. The broken pieces were further weathered and the surface of the stone became dissolved and blocks became very small.

The present level of water in the pond is about GL-1m in rainy season and becomes lower in the dry season. It is easily anticipated that the fluctuation of water level makes severe change of temperatures of the block surface, which contributes to accelerate weathering at this level.

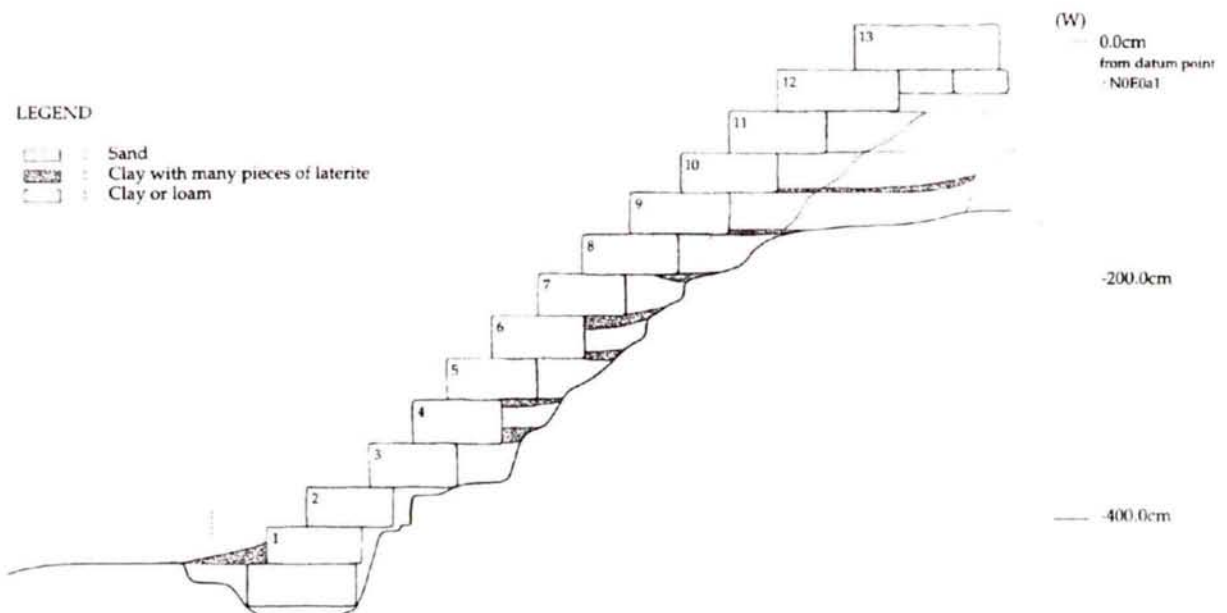
Fig.9-4 Imaginary Section of the original state of shore protection work at the embankment of North Pond, Prasat Suor Prat (JSA Report(1998))

The inclination of the step blocks towards pond side will take place if the lower block deteriorates earlier than the upper blocks

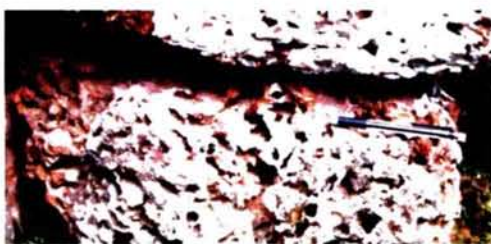
Photo 9-7 Old laterite block

The quality of laterite blocks depends upon several factors. If the quality is poor, the laterite may have small strength and easy to decay. Photo 9-7 shows old used laterite block, which has many voids in the surface. The void was originally filled with such materials as kaolin and considered eroded out during weathering process. The new laterite should be checked and selected to obtain good quality material to be used.

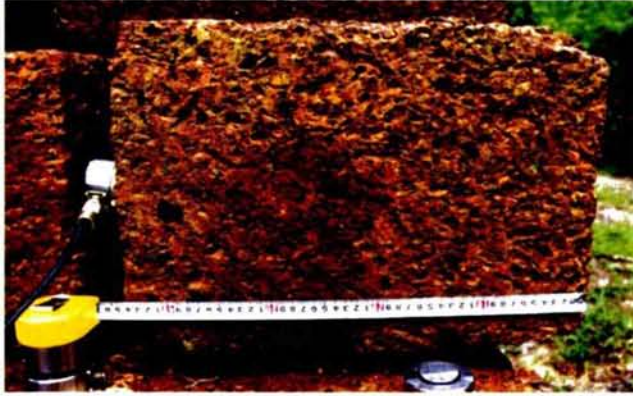
Photo 9-9 P-wave measurement for group B

We measured P-wave velocity by ultra-sonic measurement device. The results are shown in Table 9-1 and plotted in Fig.9-5. Photo 9-9 shows sensors of P-wave measurement and laterite of new material grouped into B.

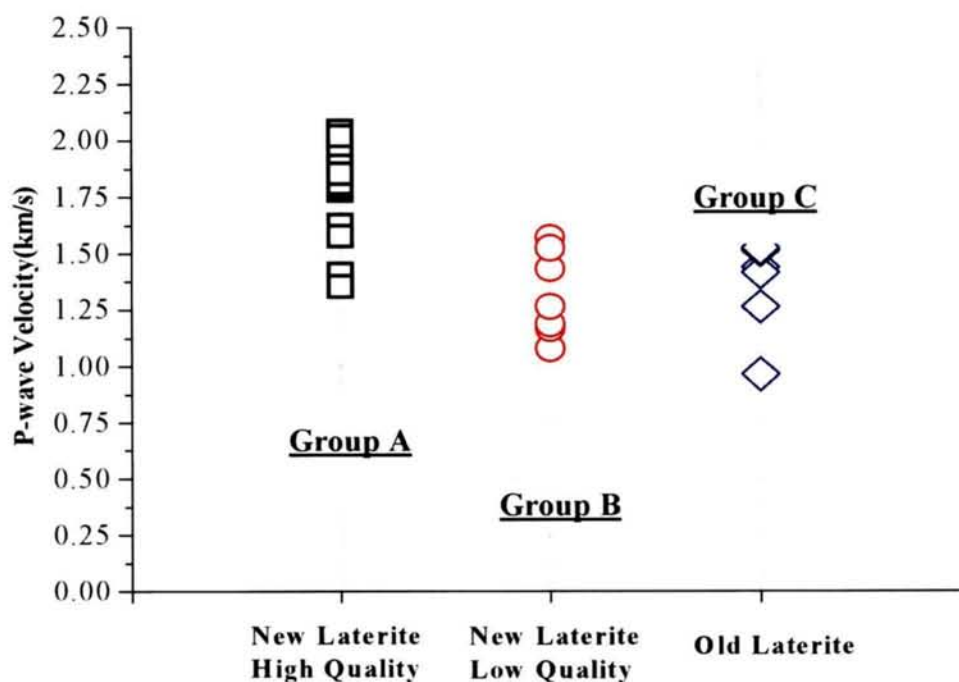
Fig.9-5 Distributions of P-wave velocities for three groups of laterite material

The old used laterite showed a little faster velocity than the insufficient quality.

If the P-wave measurement is used for classifying quality, a threshold value of 1.75km/sec may be used for safer side. Any laterite material with P-wave value less than 1.75km/sec or un-measurable may be classified into insufficient quality laterite.
