## Creep and Failure of Palaeozoic-Rock Slope

By Yoshimasa KOBAYASHI and Akira NAKAGAWA

### Abstract

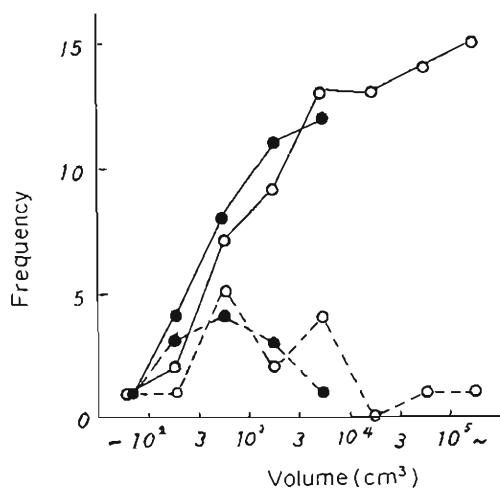
Fig. 3. Size distributions of debris; ○ sandstone, ● slate; ..... size frequency curve, — size accumulation curve.

- in case of sandstone, 50 to 200,000 cm<sup>3</sup> and
- in case of slate, 90 to 4,000 cm<sup>3</sup> (see Fig. 3).
