## THE DAMAGE TO STRUCTURES CAUSED BY THE SECOND MIYAKOJIMA TYPHOON

by Hatsuo ISHIZAKI, Junji KATSURA and Tatsuo MUROTA

### Abstract

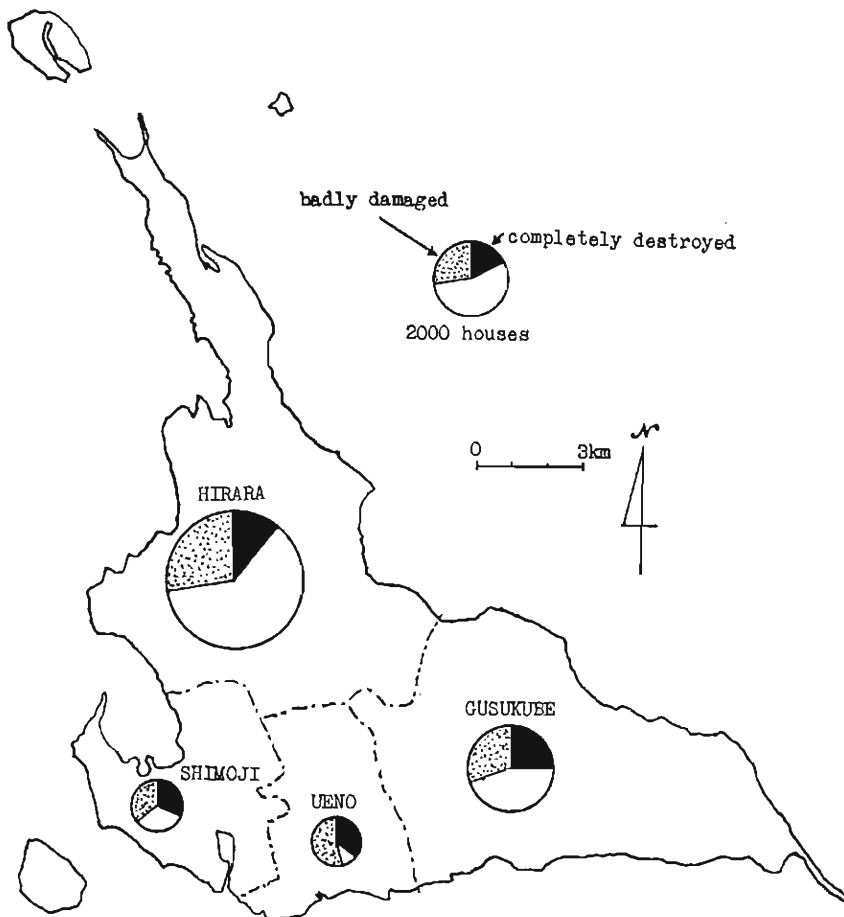
Table 1 shows the number of damaged houses in Miyakojima and Ishigakijima by administrative districts, which is illustrated in Fig. 2 in the case of Miyakojima.

Fig. 2 Damage to houses by administrative districts in Miyakojima.

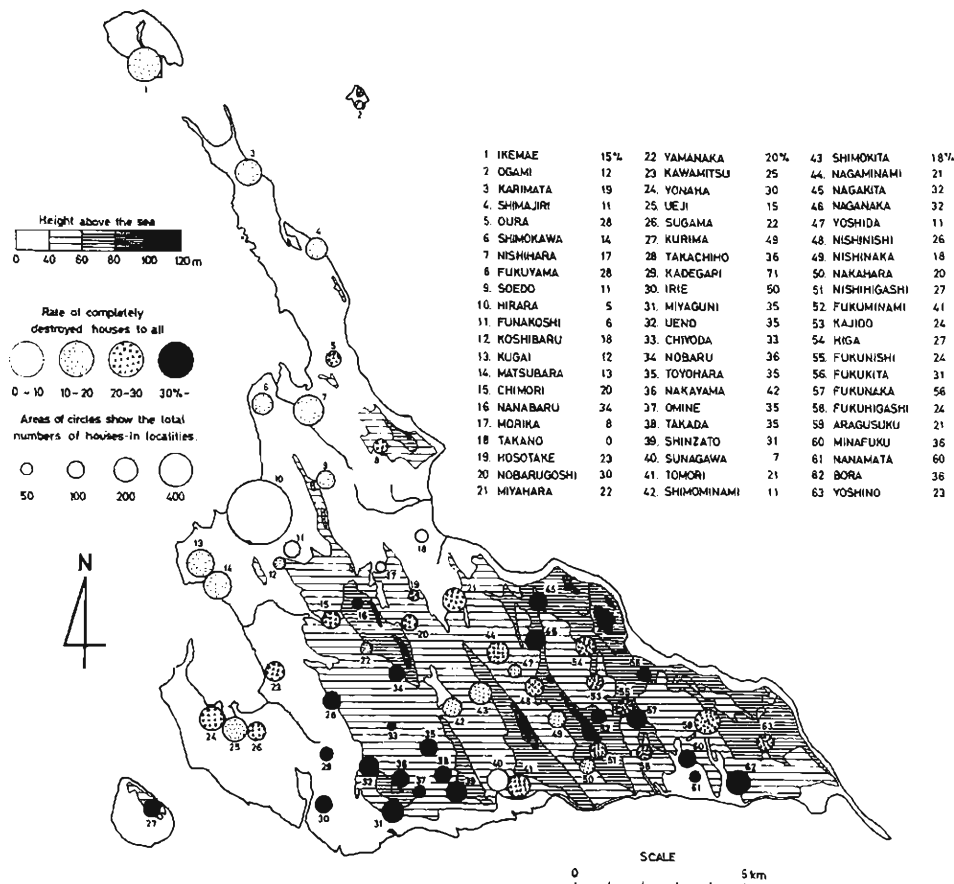
Table 2 and Fig. 3 show the rate of damaged houses in communities on Miyakojima. In some communities 60% of the houses were completely destroyed and 90% were damaged. As averages the

Fig. 3 Rate of completely destroyed houses in communities on Miyakojima.

rates of completely destroyed and damaged houses were 17.6% and 48.7% respectively. Such a high rate of damage seems to be because of the open nature of the island and the lack of trees to break the force of the wind.

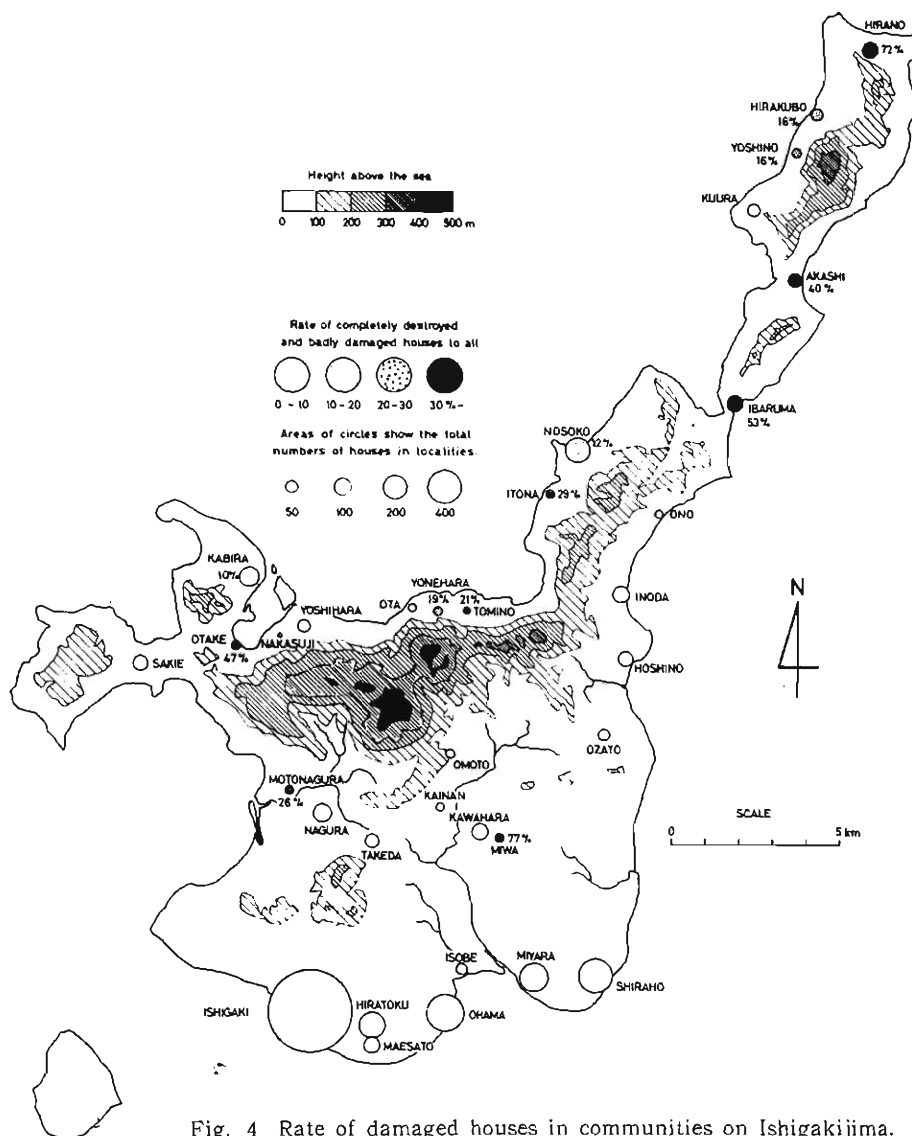
Table 3 and Fig. 4 show the damage to houses in communities on Ishigakijima. The damage is confined to the communities on the northeast peninsula and is minor in other regions. So the average rates of completely destroyed and damaged houses are very small compared with Miyakojima, being 0.9% and 2.6% respectively. This is considered to be mainly due to the relatively long distance from the center of the typhoon and also to the wind-shelter effect of the topography. In fact the maximum wind speed of 27.3 m/s and the maximum peak gust of 44.9 m/s observed at the south coast of Ishigakijima are about half those in Miyakojima.

Fig. 4 Rate of damaged houses in communities on Ishigakijima.

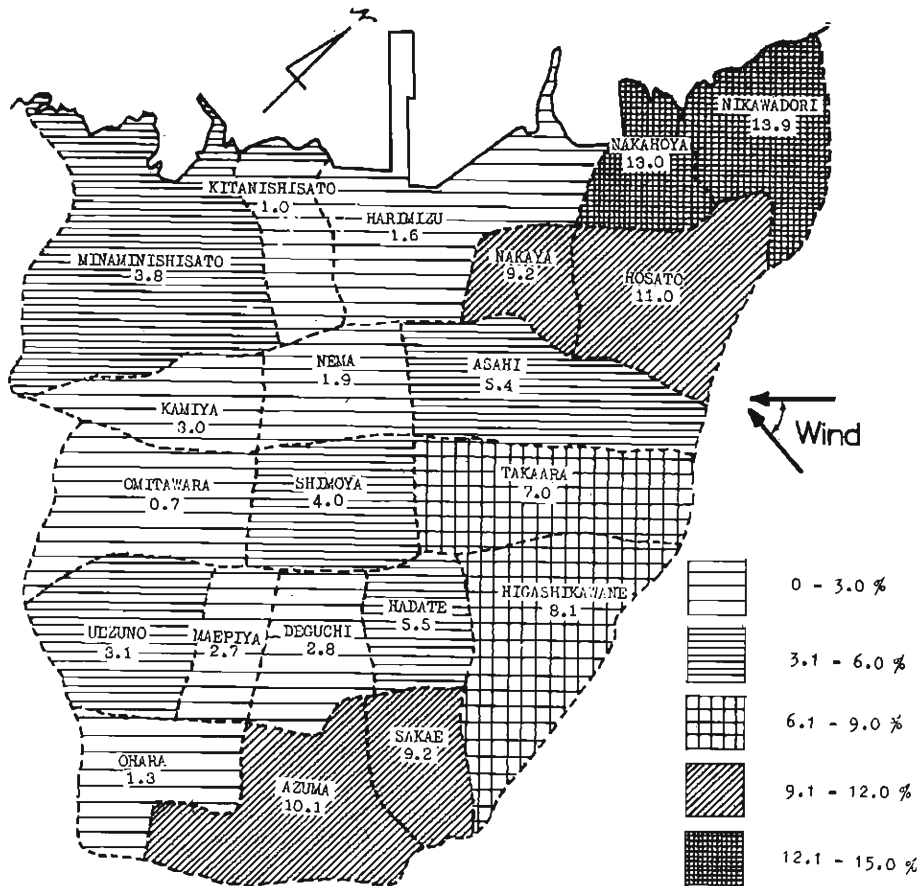
Table 4 shows the damage to houses in 21 communities in the city zone of Hirara City, Miyakojima, excluding the rural districts. In the city zone the rate of completely destroyed houses of 5.1% is 1/3 of the average value of 16.7% in Miyakojima.

Table 4 is illustrated in Fig. 5, indicating that the damage in the windward communities was severer than in the downwind ones.

Fig. 5 Zoning map of completely destroyed houses in Hirara City.

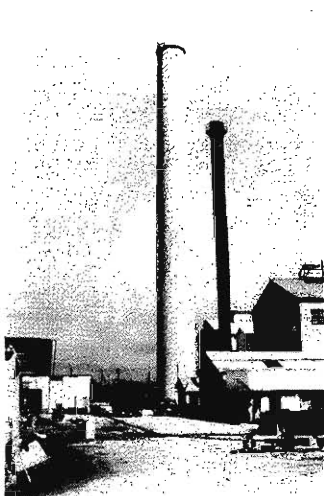
| | TYPE | SITE | DAMAGE |
|---|---|---|---|
| chimney | reinforced<br>concrete<br>and steel,<br>G. L. +20m | in a sugar factory,<br>Shimoji | no damage (Photo. 10) |

Photo. 10 Stacks in a sugar factory : no damage.
