# DAMAGE SEQUENCE AND SAFETY MARGIN ASSESSMENT OF EXPANSION JOINTS BY SHAKE TABLE TESTING

Yu Otsuki<sup>1</sup>, Masahiro Kurata<sup>2</sup>, Konstantinos A. Skalomenos<sup>2</sup>, and Yoshiki Ikeda<sup>2</sup>

## SUMMARY

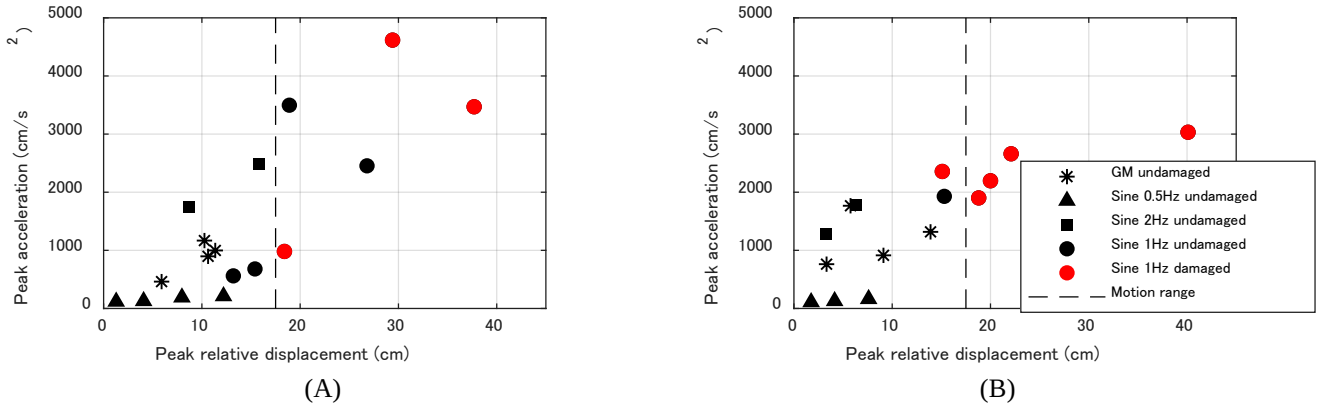
**FIGURE 9 Peak relative displacement vs peak acceleration response at the short-period frame for each input: (A) HP expansion joints and (B) SD expansion joints**

Figure 9 presents the relationship between the peak acceleration response at the short-period frame and the peak relative displacement between the two frames. Each plot corresponds to each input and red plot corresponds to the damage cases described later. It is observed that there is almost no damage within the motion range of the expansion joints regardless of type of inputs such as the ground motions and sine waves with 0.5 Hz, 1.0 Hz, and 2.0 Hz. These results indicate that the expansion joints exhibited stable and identical behavior within the motion range regardless of input waves. With respect to the behavior or damage of the expansion joints beyond the motion range, some differences can be expected depending on the type of inputs or building characteristics. For example, a collision between the components of the expansion joints at a low frequency or

The dependency of the damage to the expansion joints on the peak relative displacement or acceleration response is discussed. Figure 9 demonstrates that the sine waves of 2.0 Hz frequency and the ground motions caused a large acceleration response within the motion range of expansion joints, but there was no damage to them. In contrast, when the peak relative displacement exceeded the motion range, several damage patterns were observed. These results indicate that damage to the expansion joints was affected more by the peak relative displacement than the peak acceleration. Note that significantly large accelerations were observed at the damage cases especially for the HP expansion joints. These peak accelerations occurred when collisions between the components of the expansion joints occurred. Thus, the large acceleration was not the cause, but the result of the damage to the expansion joints. This point will be described in detail at a later section.

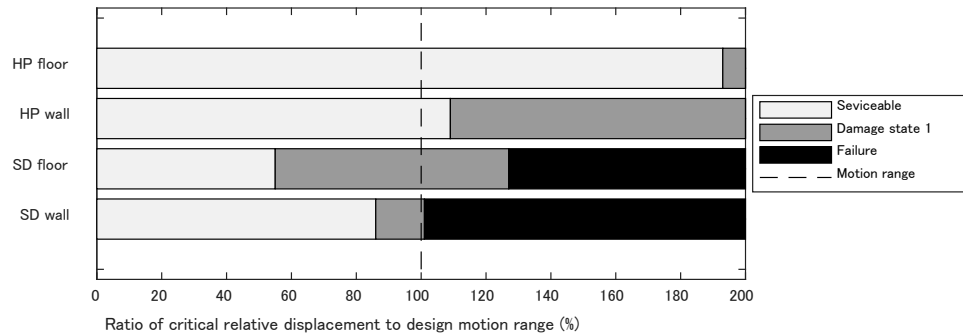
**FIGURE 19 Relationship between the damage states and the ratio of the critical relative displacement to the design motion range**

The relationship between the damage states and the ratio to the design motion range is summarized in Figure 19. The differences in the safety margin beyond the design motion range of the HP and SD expansion joints specimen are significant. The HP expansion joint specimens exhibited only damage state 1 within 200% of the motion range, whereas the SD expansion

Manufacturers should include at least some extent of safety margin in the nominal motion range, especially for expansion joints that are difficult to repair and whose damage may hurt people on the ground, such as wall expansion joints. For example, as seen in the tested SD floor expansion joint, a safety margin of at least 30% beyond the motion range is recommended to guarantee the performance expected from the drawing.

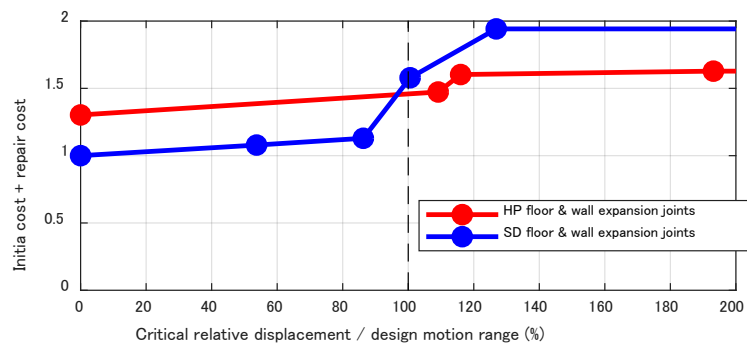
**FIGURE 20 Comparison of the sum of the initial cost and repair cost for HP and SD expansion joints**

As an example to evaluate the tendency of the cost for expansion joints, the sum of the initial cost and repair cost for the sets of wall and floor expansion joints against the peak relative displacement were calculated based on Table 4 and presented in Figure 20. Each cost was normalized by the initial cost of the SD wall and floor expansion joints, which was JPY 595,000 (USD 5,950). A tendency was observed that even though the initial cost of the HP expansion joints is 1.3 times higher than that for the SD expansion joints, the sum of the initial cost and repair cost of the SD expansion joints exceeds that of the HP expansion joints after the relative displacement exceeds the motion range of the expansion joints. The presented cost evaluation can be used as one reference, but uncertainty must be taken into account in a probabilistic way to achieve a more reliable evaluation.

The repair information shown in Table 4 includes 1) repair procedures, 2) replacement materials for expansion joints, 3) replacement materials for indirect materials such as finishing, 4) working hours with the number of workers, 5) material costs for the replacement of damaged expansion joint parts, and 6) construction costs for the replacement of damaged expansion joint parts. The cost is expressed as the ratio of the initial material or installation cost for expansion joints. For the estimation of construction cost for repair, it is assumed that the expansion joints are set on a passage between two buildings at a height of 20 m above the ground. Note that the original material cost for each of expansion joints was JPY 255,000 (USD 2,550) for the HP floor, JPY 220,000 (USD 2,200) for the HP wall, JPY 185,000 (USD 1,850) for the SD floor, and JPY 110,000 (USD 1,100) for the SD wall. The installation cost of each expansion joint was JPY 150,000 (USD 1,500) for reference.
