Micro-Process of the Tilting Motion of Ground and Structures

Yoshiro Itō

Abstract

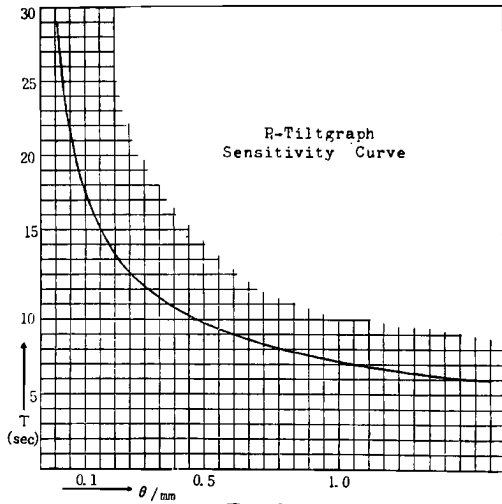
Fig. 3.

The general aspect of the relation between the sensitivity of P₁-Tiltgraph and the period of pendulum are shown in Fig. 3, where the

sensitivity is represented in $\theta''/1\text{ mm}$ meaning the displacement of the optical image on the recording paper is equivalent to the amount of ground-tilting in the seconds of angle, and we can easily observe the small amount of tilting of $0.1''$ by this instrument. Moreover, in case of need, the sensitivity of instrument can be raised up to the order of magnitude of $0.01''/\text{mm}$ by lengthening both the optical distance in recording and the period of pendulum.

It is to be remarked that the value of sensitivity in this Figure is applicable to the tilting motion of a long period, namely larger than that of one minute in the present case.

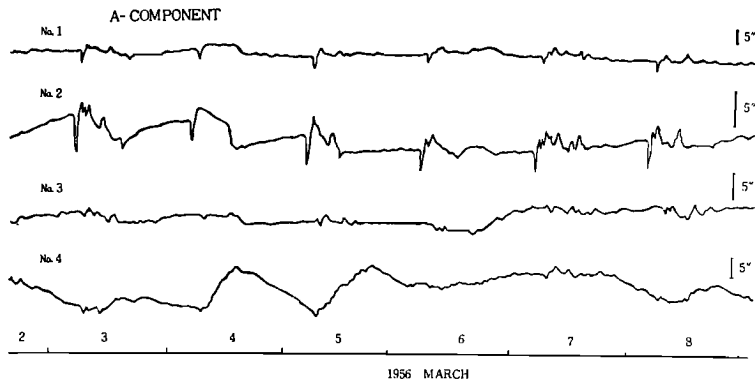
Fig. 8. Ground-tilting observed at Takeda.

Recorded curves of the tiltgraph in the direction of the well in long intervals of several days are shown in Fig. 8. In this case, the recharge of water is continuously operated in rate nearly 9.6 tons per hour daily from 4 to 13 o'clock. As seen in the Figure, the ground at the stations No. 2 and No. 3, especially at No. 2, shows a rapid sinking immediately after commencement of the recharge, and then reverses its tilting motion in raising up itself to the highest position over the neutral one in the time of about 2 hours after commencement of the recharge.

After stoppage of the recharge the ground begins again a gradual sinking and settles itself to a neutral position in about 2 hours. Concerning the ground at No. 4, it is strongly affected by the buckling and sinking motion of a close building, showing the so-called diurnal ground-tilting usually observed at any place. It is to be mentioned that the behavior of ground effected by water-recharge, is nearly the same for all points and days concerned, but their amounts and modes of tilting, as clearly seen in the Figure, are largely affected by soil conditions which properties are depending on meteorological changes and hysteresis such as the rainfall, sunshine and the like. It is also strongly modified by

by the recharge of water as is described in the following paragraph. Further, another consideration is here proposed that it depends upon the shortness of time interval of recharge, and really, in case of recharge of long durations, the ground is once sunk and then raised by the continuous recharge in long time intervals as shown in Fig. 8.

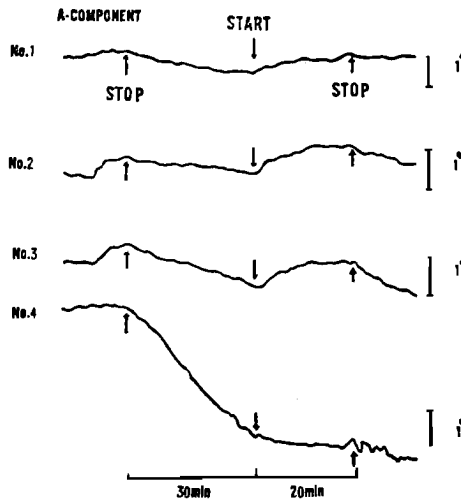
tinued during 30-40 minutes intervals, and then the stoppage of recharge operated in an interval of 1 hour. One example of tiltgram obtained in this experiment is shown in Fig. 11. The A-component means a tiltgram curve in the direction pointing to the well from the respective point of the tiltgraphs and the upward change shows a rise of the ground at the well. In this case, it is clearly ascertained that the ground at the well is raised by the effect of recharge of water into the well, and its effect extends to the ground of a considerably long distance from the well.

Fig. 11. Tiltgrams obtained at Osaka Gas Company.

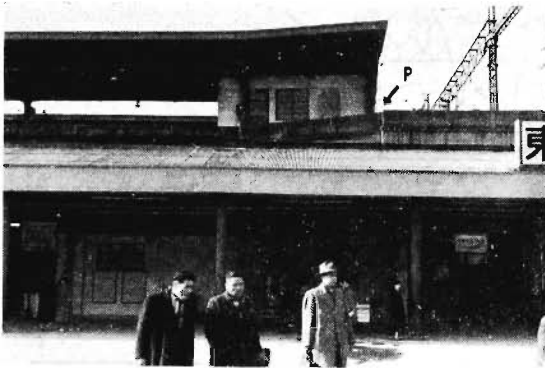
Fig. 20. Photograph of a part of Osaka Station.
P corresponds to P in Fig. 19.

ferent piles. The amount of sinking during 10 years after the establishment in 1934 was measured as shown in the lower figure in Fig. 19, reaching a surprisingly large amount of 100 cm in 10 years, and its effect is clearly seen in the photograph in Fig. 20.

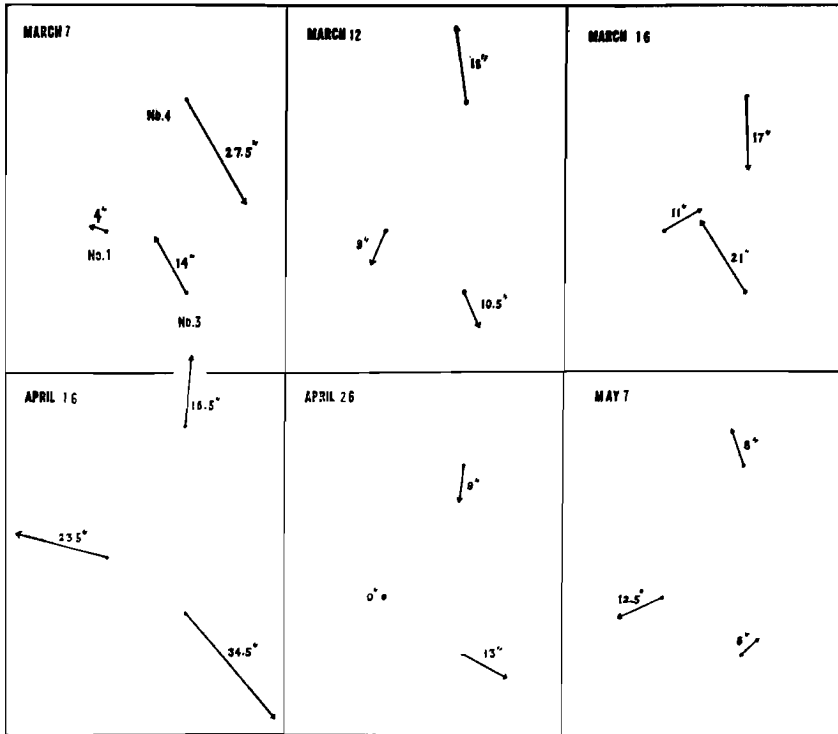
Fig. 27. Some examples of disturbed tilting-motion commonly observed at three points of No. 1, 3 and 4.

temperature, heavy rainfall, sudden level change of underground water, and some examples of disturbed tilting motion are shown in Fig. 27. In the Figure, two cases of March 12 and April 16 are clearly explained by the sudden rise-up of room temperature observed in the amount of 6°C and 12°C respectively. But, in other four cases of March 7, March 16, April 26 and May 7 in the Figure, no influential changes of meteorological origin or level of underground water recorded at two wells near the station, are not observed, and consequently these observed disturbances concerned remain unexplained.

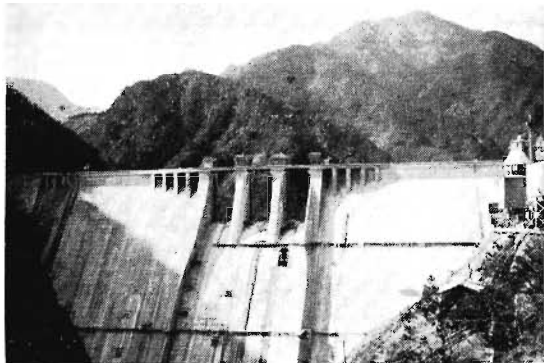
Fig. 31a. Photograph of Miyagawa Dam.

The Miyagawa Gravity Dam is situated at the upper stream of River Miya in Mie Prefecture. Its height, length and volume are 88.5 m, 225 m and 380,000 m³ respectively of which construction was initiated in 1953 and completed in December, 1956. The foundation rock is tight diabase, and no remarkable fault is found around the dam foundation. The capacity of impounding reservoir (pool) is about 64,000,000 m³, and the traverse and longitudinal sections are respectively represented in Figs. 31a and 31b.

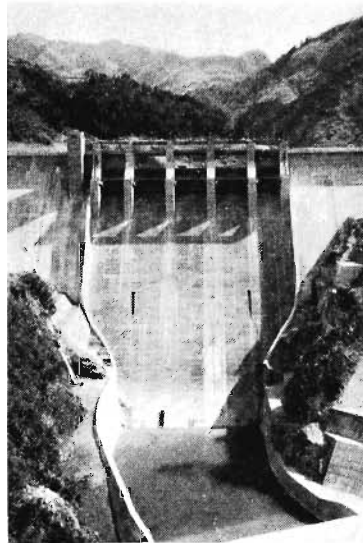
Fig. 40a. Photograph of Nagase Dam.

Nagase Dam is a gravity dam in the upper stream of River Monobe in Kōchi Prefecture. Its height and top length are 85 m and 180 m respectively as seen in Figs. 40a and 40b. It was already completed in construction and filled with water in the pool in the epoch of the present observation initi-
