## Study on Piping Failure of Natural Dam

Ripendra AWAL, Hajime NAKAGAWA, Masaharu FUJITA, Kenji KAWAIKE,  
Yasuyuki BABA and Hao ZHANG

### Synopsis

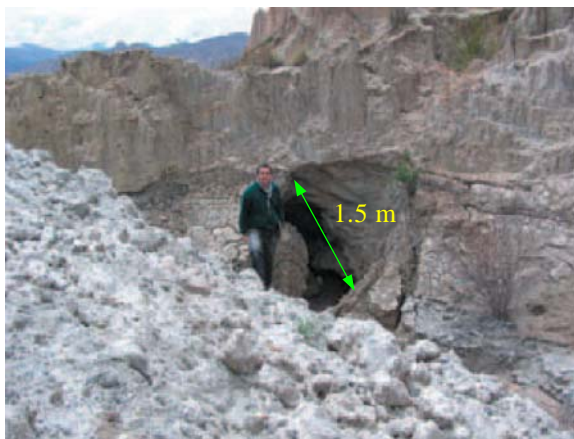
Fig. 1 Natural tunnel through a landslide dam in Allpacoma valley, La Paz, Bolivia, formed due to piping failure (Hermanns, 2005).

Seeps occurred on the downstream face of many landslide dams. Several seepage points developed before overtopping of a recent landslide dam formed on 4<sup>th</sup> January, 2010 in Hunza River at Attabad, Pakistan. Piping hole also developed in the downstream face of the Tangjiashan Barrier Dam, China in 2008 (Liu et al., 2009). Piping and undermining caused the collapse of the landslide dam that impounded Lake Yashinkul in 1966 (Schuster and Costa, 1986). Some other landslide-dam failures in which seepage erosion probably was the major cause were the 1906 Cache Creek dam in northern California, the 1945 Cerro Condor-Sencca dam on the Mantaro River in Peru, and the 1973 Costantino dam on the Buonamico River of southern Italy (Meyer et al., 1994). The failure of Rio Toro landslide dam in Costa Rica in 1992 was due to retrogressive sliding caused by seepage and internal erosion (Mora et al., 1993). Allpacoma Landslide Dam (see Fig. 1) in Bolivia failed due to piping and overtopping (Hermanns, 2005). A tunnel about 1.5 m in diameter formed

through the dam about 2 m below the dam crest due to erosion.

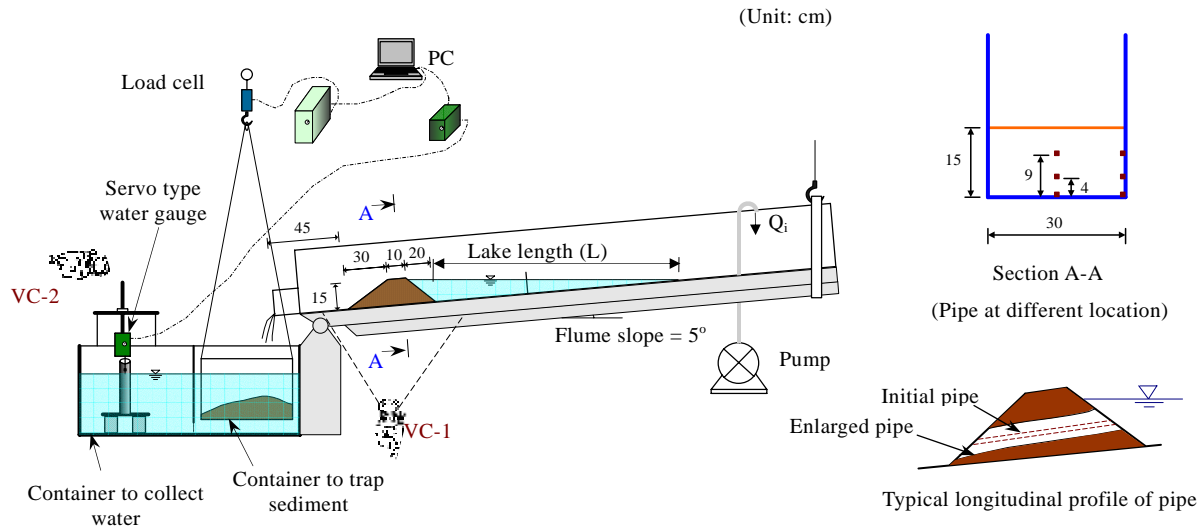
Fig. 2 Schematic diagram of the experimental setup.

The schematic diagram of the flume and other accessories used in the experiments are shown in

Fig. 2. The rectangular flume of length 500cm, width 30cm and depth 50cm is used. The shape and size of the dam used in experiments for the flume slope of  $5^\circ$  is shown in Fig. 2. In the case of the flume slope of  $2.5^\circ$ , the upstream and downstream slope lengths of the dam are 27.5cm and 22.5cm

respectively. The height of all dams is 15cm.

Load cell and servo type water gauge were used to measure sediment and total flow in the downstream end of the flume. Two video cameras were used to capture enlargement of the pipe from side and front of the dam. The summary of experiments is shown in Table 1.

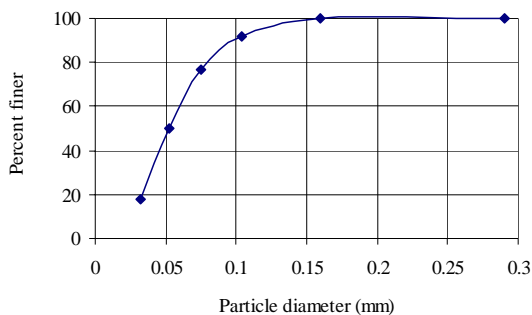
Fig. 3 Grain size distribution of sand used to prepare dam.

In order to form an eroded pipe the dam material must be strong enough to form a roof to keep the shape of the pipe. Dam material with sufficient fines content (% finer than 0.075mm > 15%) and partially saturated dams are favorable conditions for progression of erosion ability to support a roof (Fell and Foster, 2000). Silica sand of number 8 ( $D_{50} = 0.05\text{mm}$ ) was used to prepare the dam with different sized pipes in the flume. The particle size distribution curve of sand number 8 is shown in Fig. 3. Water was mixed with silica sand to make initial saturation of about 16% in all prepared dam. An artificial pipe was created in the dam body at the bottom, 4 cm up and 9 cm up from the flume bed at the center or side of the flume by using different square-shaped metal rods (see Fig. 2, Section A-A). After filling the upstream lake to the desired level, the inflow was stopped ( $Q_{in} = 0$ ). Then the steel rod was removed from the dam to initiate internal erosion of the pipe. The initiation stage of piping was not studied but attention was focused on growth of an initial pipe. In the beginning the pipe was enlarged due to erosion of the dam material in the pipe (see Fig. 2, Typical longitudinal profile of the pipe). The top part of the dam above the pipe may collapse or stable based on size of enlarged pipe, properties of the dam material and lake water volume. In the case of stable top, erosion of the pipe was occurred from bottom and sides when flow was changed to free surface flow.

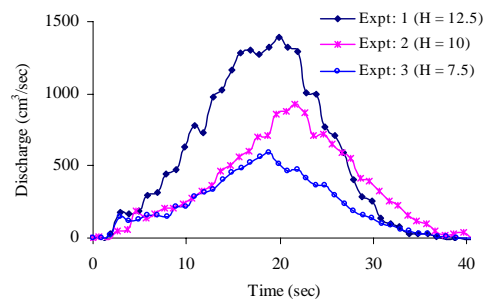
Fig. 4 Outflow hydrographs (Different lake water level).

Fig. 4 shows the outflow hydrographs due to piping under different lake water level. Flow through the pipe is directly proportional to hydrostatic head on the pipe, so the resulting peak discharge is higher for higher lake water level. The final shape of the enlarged pipe is bigger for higher lake water level in the lake as shown in Fig. 5 and Fig. 6. The enlargement of the pipe is not uniform along its length.

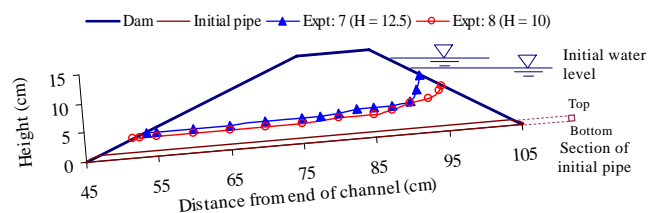
Fig. 5 Side view of final shape (top and bottom) of enlarged pipe.

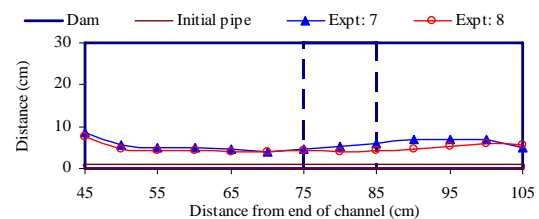
Fig. 6 Plan view of final shape of enlarged pipe and dam.

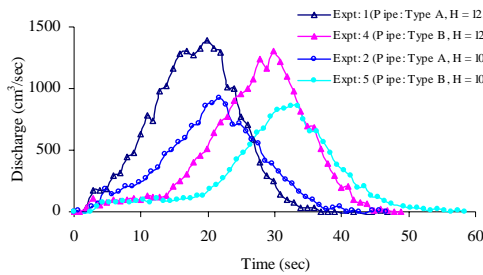
Fig. 7 Outflow hydrographs (Different initial sized pipe).

Fig. 7 shows the outflow hydrographs due to piping under pipes with different initial sizes. The size of the pipe developed after flowing full water of the lake is slightly smaller than that in the case of initial pipe of Type B (7.5 x 7.5 mm). Thus peak discharges produced by initial pipe size of Type B (Expt: 4 and 5) are also slightly lower than that produced by initial pipe size of Type A (Expt: 1 and 2). However, it takes more time to enlarge the pipe in the cases of initial pipe size of Type B, so time-to-peak is higher in these cases.

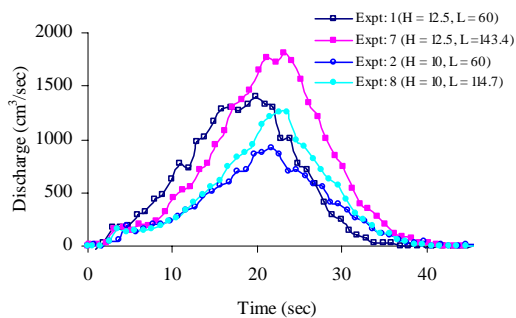
Fig. 8 Outflow hydrographs (Different lake water volume).

Fig. 8 shows the outflow hydrographs due to piping under different lake water volume. For the same initial pipe size and lake water level, the peak discharges produced by lakes with large lake water volume are higher than small lake water volume. The rate of drawdown in lakes with relatively large lake water volume for a given water level is slow compared with small lake water volume, which affects the enlargement of the pipe and peak discharge. The enlargement of the pipe in the upper part is bigger for large lake water volume as shown in Fig. 9 and Fig. 10.

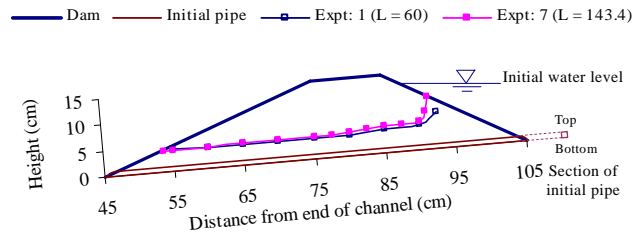
Fig. 9 Side view of final shape (top and bottom) of enlarged pipe (H = 12.5cm).

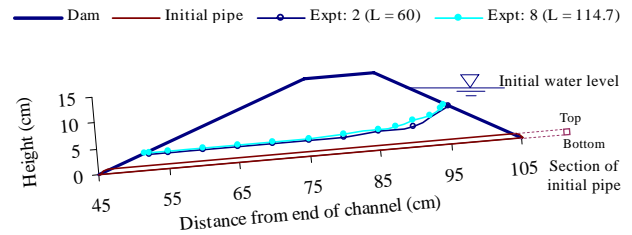
Fig. 10 Side view of final shape (top and bottom) of enlarged pipe (H = 10cm).

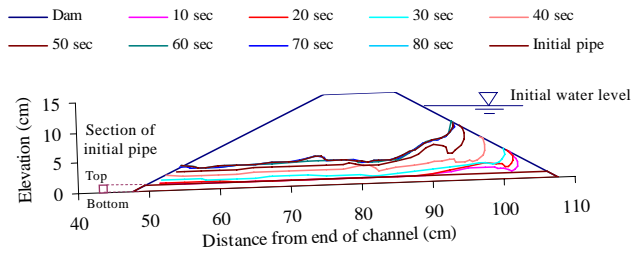
Fig. 11 Side view of temporal change (top and bottom) of the pipe at different time step (pipe at bottom) – Expt: 15.

Expt: 15, 16 and 17 were carried out with initial pipes at different level. The enlargement of the pipe and erosion of the dam at different time steps in three cases are shown in Fig. 11, Fig. 12 and Fig. 13. The failure processes in three cases were different. When the location of the pipe was at the bottom of the dam the failure was due to enlargement of the pipe. When the location of the pipe was at 4 cm up from the flume bed the failure was partly due to enlargement of the pipe and partly due to headcut erosion. Headcut erosion initiates at the outlet of the pipe and progress upstream internally during erosion process due to development and migration of headcut. Physical model test of large scale earthen embankment dam showed similar process before collapse of the top part of the dam above pipe (Hanson et al., 2010). When the location of initial pipe was at 9 cm up from the flume bed the hydrostatic head on the pipe was not sufficient to enlarge the pipe. In this case the dam was failed due to headcut erosion of the dam due to free surface flow. The erosion of downstream face proceeded upstream and big flood occurred when it reached near the lake water. Thus the shape of hydrograph, magnitude of peak discharge and time to peak are different according to location of pipes at different level as shown in Fig. 14.

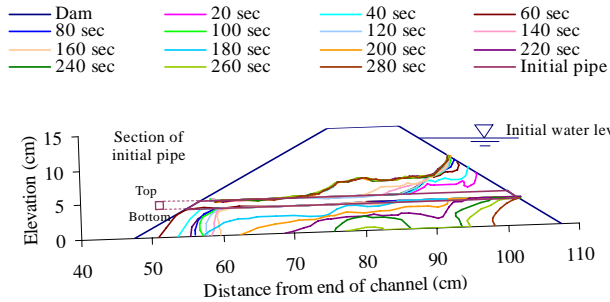
Fig. 12 Side view of temporal change (top and bottom) of the pipe at different time step (pipe at 4cm up) – Expt: 16.

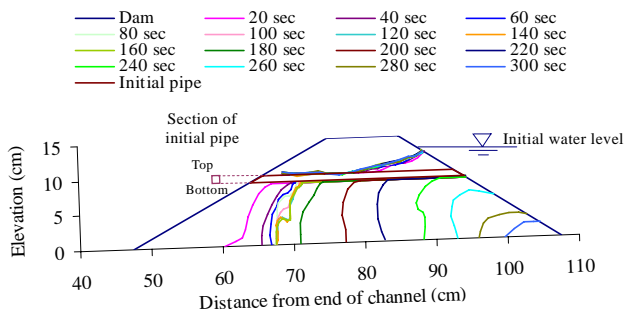
Fig. 13 Side view of temporal change (top and bottom) of the pipe at different time step (pipe at 9cm up) – Expt: 17.

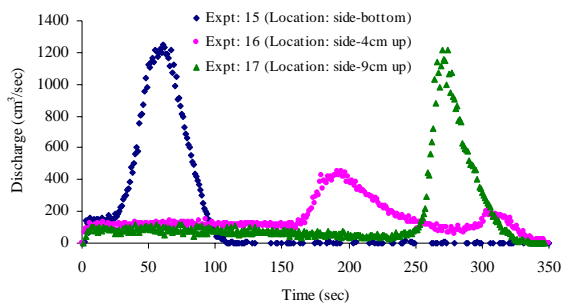
Fig. 14 Outflow hydrographs (Pipes at different vertical location).

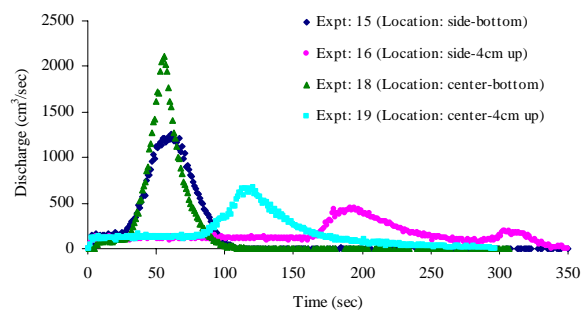
Fig. 15 Outflow hydrographs (Pipes at different lateral location).

For the same lake water level, volume, initial pipe size and slope of the pipe the outflow hydrograph depends on different lateral location of the pipe as shown in Fig. 15. Peak discharge is higher when the pipe is located at the center of the dam where enlargement is possible in all sides for the pipe at the “center-4 cm up” and three sides for the pipe at the “center-bottom”. Location of the pipe significantly affect rate of the pipe enlargement and hence flood hydrograph. However, most of the existing models are based on assumption that enlargement will occur from all sides of the pipe.

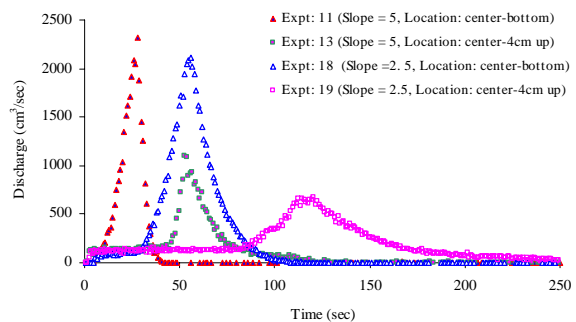
Fig. 16 Outflow hydrographs (Different pipe slope).

In all experiments the initial slope of the pipe is parallel to the flume bed. Fig. 16 shows the comparison of outflow hydrographs for the pipe slope of  $5^\circ$  and  $2.5^\circ$ . Enlargement of the pipe in the case of steeper flume/pipe slope is faster, so peak discharge occurred earlier and magnitude of peak discharge is also higher even if the volume of upstream lake water is smaller (see Fig. 16 and Fig. 17). The existing models assume zero sloped pipe, so these models will underestimate flood discharge

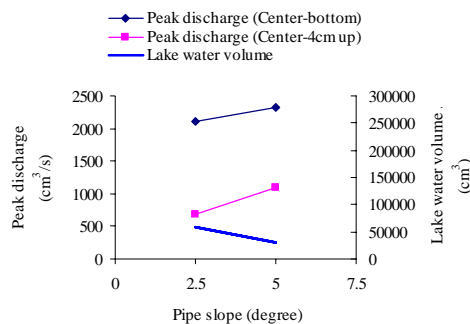
Fig. 17 Comparison of peak discharge for different pipe slope.

if the slope of the pipe developed in the dam is steeper.

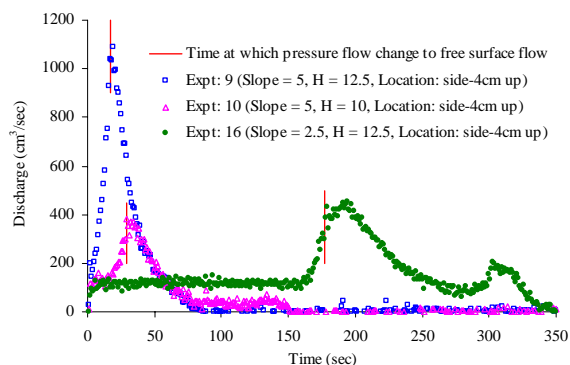
Fig. 18 Outflow hydrographs (Change in flow condition).

When flow changes from pressure flow in the pipe to free surface flow the flow discharge may increase based on progress of seepage flow in the dam, headcut erosion and size of the enlarged pipe. As already explained, the enlargement of the pipe depends on hydrostatic head on the pipe and slope of the pipe. In Fig. 18 red line indicates the time at which flow changes from pressure flow to free surface flow in the pipe. Outflow hydrograph of Expt: 9 shows sudden decrease in flow discharge where as Expt: 10 and Expt: 16 show increasing trend of flow discharge for short time period. The simplified assumption of NWS BREACH model, collapse of remaining material of the dam body when flow changes from orifice control to weir-control, always produce decrease in flood discharge for short time period is not valid for the dam in which the remaining material of the dam body is stable.
