## Seismic estimation of a stone lantern using 3-D DEM analysis and shaking table test

Akira Murata, Masakatsu Miyajima and Ryo Shimizu  
(Kanazawa University)  
Naohito Itoh  
(Nagoya City Office)

In this study, we estimate the seismic performance of a stone lantern using **3-D DEM analysis** and **real scale shaking table test**, and evaluate the seismic resistance of the reinforced lantern.

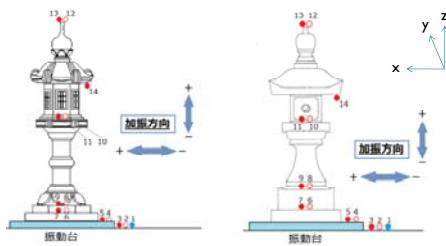
## Measurement of Specimen

○	x方向
●	y方向
●	z方向

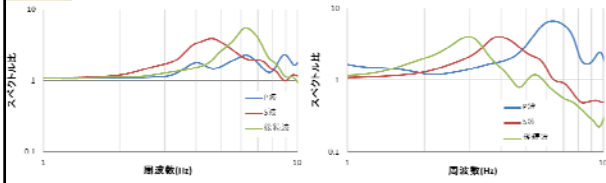
## Test Result (Kasuga: Reinforcement)

Transfer Function  
(JMA-Kobe: NS Component)

Transfer Function  
(K-NET Ichinoseki: NS Component)

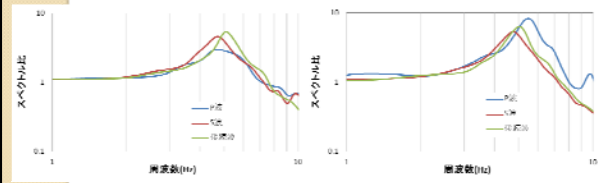
## Test Result (Shinzen: Reinforcement)

神戸波の伝達関数 NS方向

一関波の伝達関数 NS方向

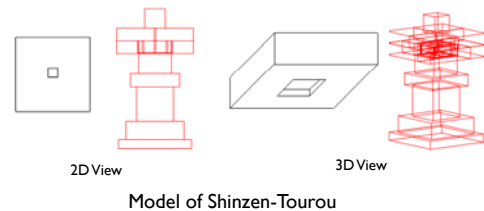
## Analytical Model

In order to create a simple model, a component is expressed in a rectangular parallelepiped. The part which is carrying out form with the complicated hole which inserts an axis is expressed by combination of two or more rectangular parallelepipeds.

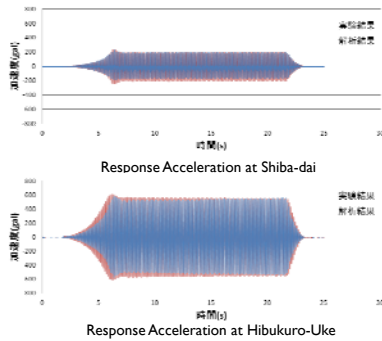
## Analytical Results

Sine Wave 7.5Hz NS Component

Response Acceleration(gal)	
	Experiment	Analysis
Shiba-Dai	1,014	975
Naka-Dai	1,064	970
Hibukuro-Uke	1,300	1,195
Giboshi	2,102	2,205
