## Experimental seismic response of a full-scale Japanese conventional wooden post and beam building

(Laboratory of Structural Function, RISH, Kyoto University)

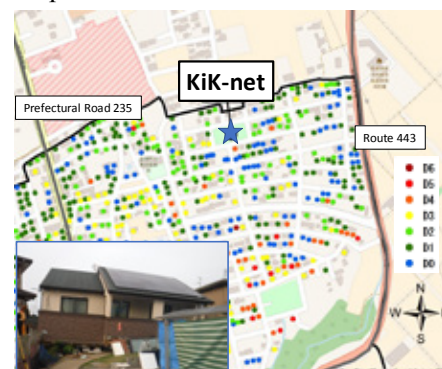
Figure 2. Observed damage to the test building with minimum requirement.

Shake table tests were conducted for the building in accordance with the minimum requirement of the Building Standard Law of Japan. As a result of the tests, the extent of damage almost agreed with the result of the survey in the disaster area, and this test building which complied with the standard law did not collapse even two mainshocks were input (Figure 2).
