南太平洋島嶼国におけるサイクロン災害後の住宅再建に関する研究
—フィジー農村集落ナバラ村とナコロンボヤ村の再建過程を事例として—

京都大学大学院
地球環境学舎・地球環境学専攻
博士課程

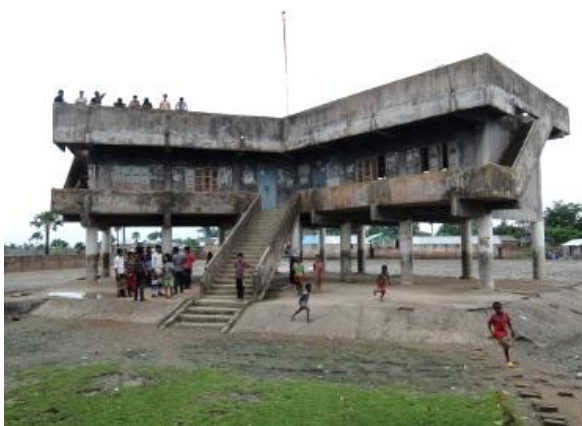
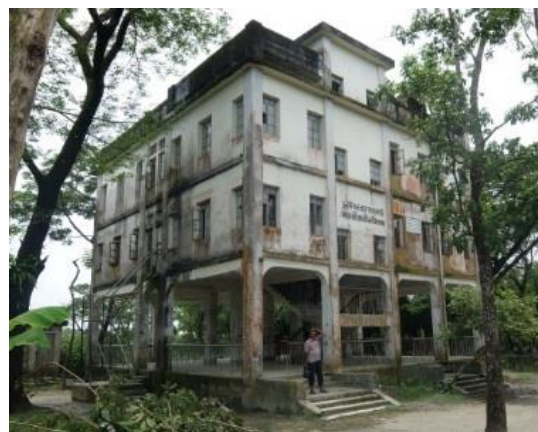
写真 2-3（左） JICA の支援によって建設されたサイクロンシェルター（筆者撮影）
写真 2-4（右） サウジアラビア政府の支援によって建設されたサイクロンシェルター（筆者撮影）

こうしたサイクロン災害に対し、独立前の 1960 年代後半からサイクロンシェルター（写真 2-3, 写真 2-4）建設が取り組まれてきた。1991 年のサイクロン被災時に多くの人命を救ったことから、サイクロンシェルター建設はバングラデシュ政府の防災対策の要となり、1993 年に UNDP と世界銀行の協力の下、マスタープランを作成し、さらに建設が促進されたが、その多くは海外援助に依存して進められた（国際協力事業団日本技術開発株式会社, 2003）。日本の国際協力機構（Japan International Cooperation Agency、JICA）も支援を要請された援助組織のひとつであり、1993 年に始まった第一次多目的サイクロンシェルター建設計画から 2004 年の第五次までおよそ 20 年にわたり建設援助を実施した（写真 2-3）。2007 年時点で確認された建設数は 3,976 棟であり（Paul, 2009）、2010 年に発表された防災計画では、人口増加に伴いさらに 2,000 棟のサイクロンシェルターが必要であると発表された（Government of People's Republic Bangladesh, 2010）。また、サイクロンシェルター建設と同時に電気が引かれていない遠隔地域の住民にサイクロン警報の伝達・避難誘導を行うことを目的に、住民ボランティアによって構成される早期警報システム（Cyclone Preparedness Programme）の導入が 1972 年から進められた。これは、国際赤十字・赤新月社とバングラデシュ赤新月社の支援によるものである。2011 年におけるボランティアは全国で 5 万人を超えると報告されている。

サイクロンシェルターの維持管理に関しては、2007年までに建設された3,976棟のサイクロンシェルターのうち、1,576棟が不適切なメンテナンスや河岸侵食を要因とする地盤沈下によって物理的に使用できなくなっていることが明らかにされている（Paul, 2009）。筆者が2014年及び2015年に実施した現地調査においても、壁や柱梁のコンクリートが剥離して内部の鉄筋がむき出しになっているサイクロンシェルターを多く確認され（宮地, 2017）、今後使用できなくなる可能性がある。また、サイクロンシェルターの多くは平常時に小学校として利用されているが、鍵を保有する校長や教員が災害時に不在であり、避難するために鍵を壊して入ったという事例も報告されている（齊藤, 2012）。こうした課題の主な要因は、サイクロンシェルター建設・計画が海外援助に依存した政府主導すなわち「ドナー主導」であり、避難所としての建物を建てることを優先したために利用者である住民が参画していないため、建設後の適切な運営ガイドラインが存在しない、または住民に共有されていないことが挙げられる。

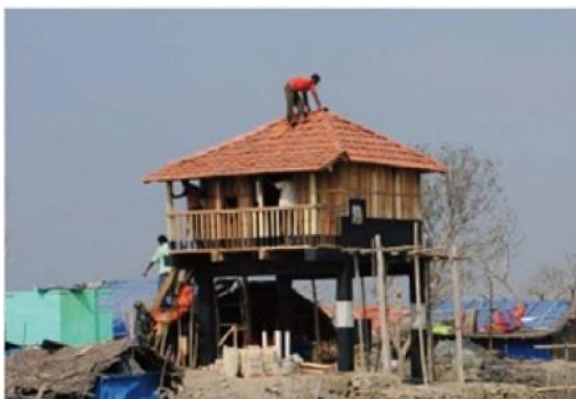
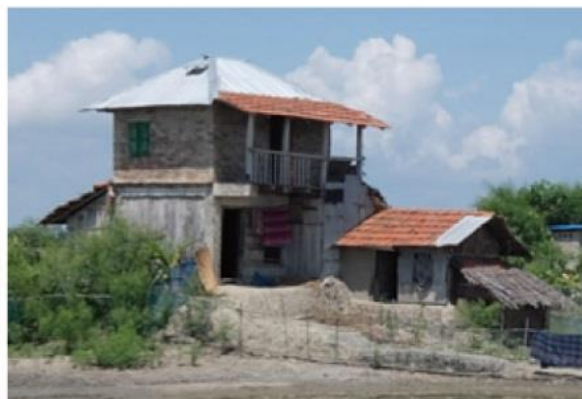
写真 2-5（左） BRAC 大学によって建設された住宅型シェルターの建設当初（出典：BRAC University）
写真 2-6（右） 住民による増改築後の住宅型シェルター（筆者撮影）

(Bangladesh Rural Advancement Committee) が運営する BRAC 大学は、2009 年のサイクロン・アイラ被災後、「サイクロンシェルターへ避難しなくても良い丈夫な住宅」を建設することを目的に住宅型シェルターを提案し（写真 2-5）、UNDP の資金援助を受けて実際に 43 戸の住宅型シェルターを建設した (Mallick, 2014)。多くのプロジェクトが従来の避難所としてのサイクロンシェルターの建設を提案する中で、「避難しない」選択肢を提案した画期的なプロジェクトであり、被災者の自立を促すためにデザイン決定から建設まで被災住民自身が行うように計画・実施された (Mallick, 2013)。2015 年に実施した現地調査では BRAC 大学が計画した住宅型シェルターの居住者から「BRAC 大学が改修すべき」という声も聞かれ、支援慣れの課題は依然として垣間見られたが、BRAC 大学による適切な改修・増築のためのワークショップが開催され 43 戸すべての住宅型シェルターにおいて住民による増改築が進んでいることも確認された（写真 2-6）(宮地, 2017)。

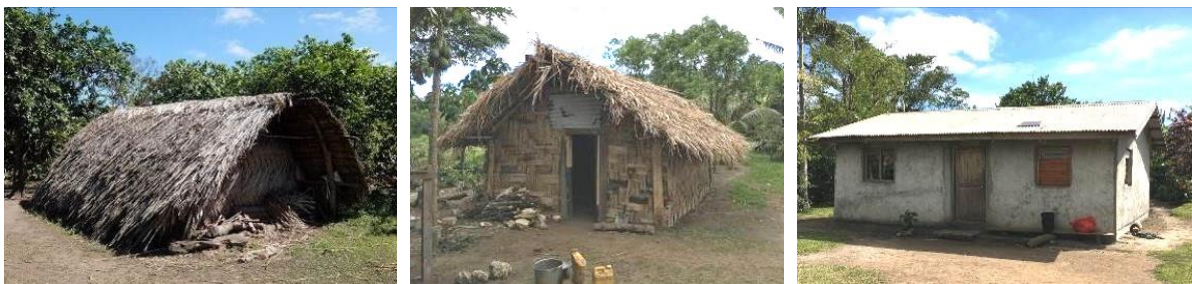
写真 2-7 (左) タンナ島の伝統住宅ニマラタン (著者撮影)
写真 2-8 (中) タンナ島において一般的に見られる住宅ニマイトウンガ (著者撮影)
写真 2-9 (右) タンナ島のコンクリート造トタン屋根のモダンハウス (著者撮影)

調査対象地のタンナ島では、木造草葺屋根の伝統住宅ニマラタン（*Nimulaten*, 写真2-7）が避難所（サイクロン・シェルター）として集落住民に認識され（Coiffier, 1988）、実際にサイクロン・パム襲来時に避難所として利用されたことが現地調査の聞き取りから明らかとなった。このニマラタンは伏屋式平地住宅で、軒下への風流入による被害を防ぎ、耐風工学的に合理的であるが（西嶋, 2016）、屋根と壁が一体となっており開口部が妻面しかないために、日中でも室内が暗く煮炊きによる煙が充満すること、また建設用の現地木材資源が枯渇してきたことなどから、採光が充分に取れ居住性が高く、製材により比較的簡易に建設できるニマイトウンガ（*Nimaitunga*, 西洋人の家という意味の柱梁構造の木造住宅、屋根は草葺かトタン葺き, 写真2-8）に代わっていった。さらに近年ではコンクリート造トタン屋根のモダンハウス（写真2-9）も増えつつあり、ニマラタンは徐々に減ってきている（藤枝ら, 2017）。

2017年8月時点のラウナウラ村の住宅はニマラタンが8戸、ニマイトウンガが71戸、モダンハウスが8戸であり、サイクロン被災前2015年2月においてもこの割合はほぼ同じであることがアンケート調査より確認され、サイクロン・パムによる被害で、このうち約80戸の住宅が全壊もしくは半壊した。被害を受けなかった住宅はニマラタンが3戸、ニマイトウンガが1戸、モダンハウスが6戸のみであった（宮地ら, 2017）。

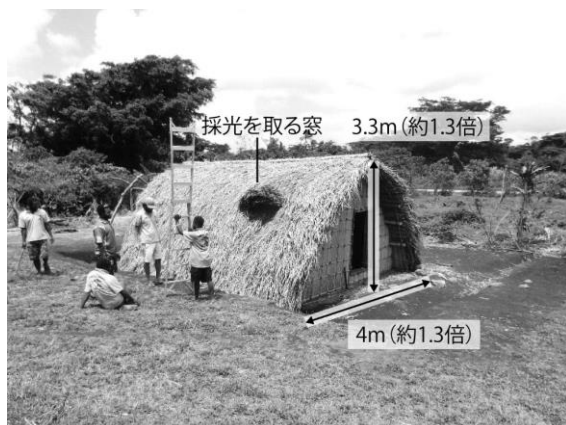
写真 2-10 (左) 建設された高度化ニマラタン
 写真 2-11 (右) 住民参加型ワークショップ

く、政府機関等からも再評価された。バヌアツの Shelter Cluster が発表したフレームワークの中では、ニマラタンがサイクロンシェルターとして機能したことを受け、伝統的な知恵や技術をより深く理解し、農村の防災レジリエンスの向上に生かすべきことが指摘されている。実際にタンナ島では French Red Cross (FRC) がバヌアツ政府と連携し、島北部を対象に各集落に 1 戸ずつニマラタンを再建するプロジェクトが取り組まれた。さらに、2016 年 9 月に筆者らが関わる JICA 草の根技術協力事業（代表：西嶋一欽）によるニマラタンの耐風性、耐久性、居住性を高度化したニマラタンを提案・建設するプロジェクトを実施した。このプロジェクトでは、従来のニマラタンの不便さや避難時に明らかになった問題点などを住民とのワークショップによって明らかにし、耐風性能および設計に関する基本的な知識を共有した上で、住民らとともにそれらを克服する高度化ニマラタンの建設を目指したものである。耐風性能を向上させ、課題となっていた採光を取る窓を加えたプロトタイプを設計し、2017 年 10 月にプロトタイプを建設（写真 2-8）、その後使用性・耐風性等に関するモニタリングを行われた。2018 年 5 月にプロトタイプの新設マニュアルを作成、対象集落に配布した。同時に、ニマラタンが現在住宅としては使用されていないこと、高度化ニマラタンがサイクロンシェルターの役割を担うため従来のニマラタンよりも大きく設計されたことを踏まえ、高度化ニマラタンをどのように普及していくか住民参加のワークショップが開催された。住民は高度化ニマラタンの普及には前向きであり、集落の農産物や工芸品の売店、女性用のための集会所やゲストハウスとしての利用可能性が住民によって挙げられた。同年 7 月には対象集落においてマニュアルを参照した高度化ニマラタンの建設が確認され、2018 年 9 月に本プロジェクトは終了したが、同年 10 月に住民によって新たな高度化ニマラタンが建設されたことが確認されている。また、高度化ニマラタン建設にあたって、建材である地域資材の枯渇も住民へのヒアリングから明らかになり、高度化ニマラタン普及と同時に地域資材の資源管理に関しても住民に対してワークショップが行われた（写真 2-9）。

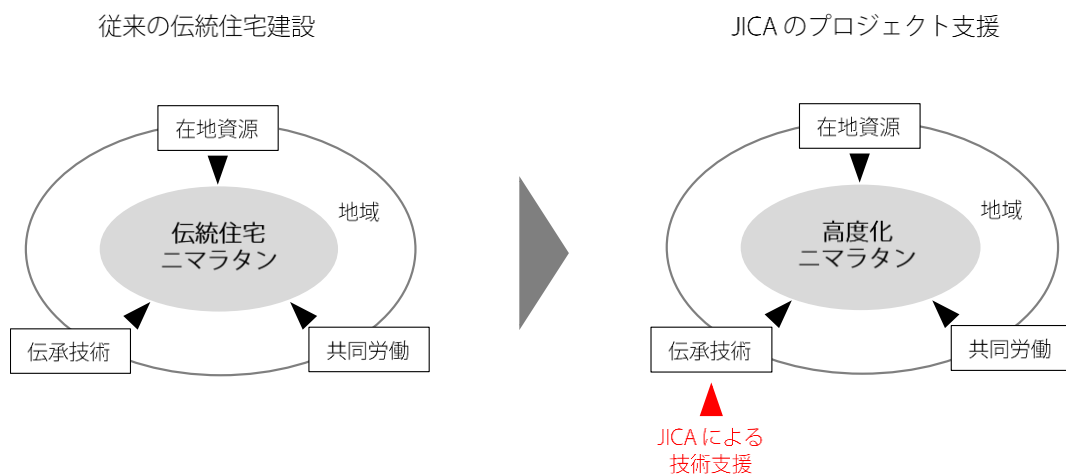
図 2-2 バヌアツの伝統住宅ニマラタンの建設フレームワーク

バヌアツの事例では、島嶼地域という立地条件から支援を受けづらいため、災害後も在地資源と伝承技術、コミュニティの共同労働によって住宅再建が行われていることが確認された。これは伝統住宅ニマラタンだけでなく、簡易住宅のニマイトゥンガに対しても同じフレームワークが成り立っている。しかしながら、自力で建設された住宅の耐災害性には課題が残ることから、JICAは知的資源である「伝承技術」に対して技術支援を行に、ニマラタンの高度化を図る「コミュニ

ティ主導」のプロジェクトを実施した。バヌアツはもともと共同労働が残る地域であり、「コミュニティ主導」の基盤が成り立っていたために、プロジェクトは受け入れられやすかったと思われる。外部支援の大きな課題とされる支援後のプロジェクトの存続や維持管理についても、バヌアツでは JICA が引き上げた後も続いていることが確認されている。これは、バングラデシュと同様にプロジェクトの計画段階からコミュニティの住民に話し合いに参加してもらうことで、計画に地域文化や生活が反映されたことが功を奏したと考察される。

以上、バングラデシュとバヌアツの事例について、Jhaら（2010）がまとめた分類に即してまとめたが、これらを小林（2014）の物的資源、知的資源、人的資源を用いたフレームワークに即してまとめると図 2-1 及び図 2-2 にまとめられる。

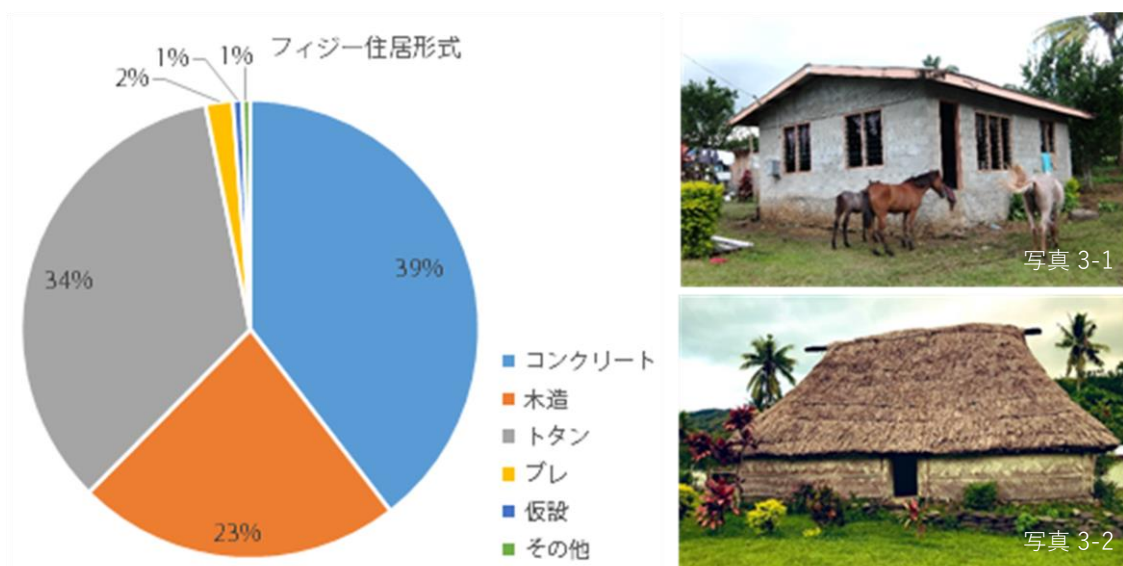
図 3-4 フィジーの住宅タイプ (壁材) (フィジー政府 2007 年統計データより著者作成)

フィジー政府の統計によると、2011 年においてフィジーの住宅は 146,292 戸であり、そのうち 57% が木造に木壁もしくはトタン壁の住宅であり、40% がコンクリート造 (写真 3-1) である (図

3-4)。後述する伝統住宅ブレ (*Bure*, 写真 3-2) は、コンクリート造や木造の住宅に代わり、全住宅に占める割合はおよそ 2%にまで減少した。一般的にフィジーの住宅は広く、コンクリート造の住宅で平均建築面積が 80 m²、木造住宅で 60 m²、ブレが 35 m²、仮設住宅で 75 m²であり (Government of Fiji, 2016)、ブレに比べて近代住宅の方が面積は広い。これは、後述するようにブレが一部屋の仕切りのない住宅であるのに対し、近代住宅は用途に応じて室を必要とするためと考えられる。建設費用はそれぞれ、コンクリート造で平均 650~750FJD/m²、木造住宅で 650FJD/m²、ブレが 300FJD/m²、仮設住宅が 200FJD/m²と算出されている (Government of Fiji, 2016)。これらから計算すると、コンクリート造の住宅建設費は 6 万 FJD、木造の住宅は 4 万 FJD であると計算できる。

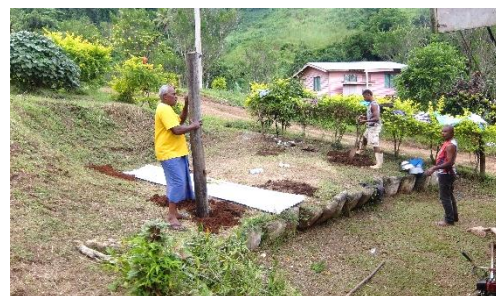
写真 4-5 (上) 学校から帰ってきた子供
写真 4-6 (下) 台所を建設する男性住民

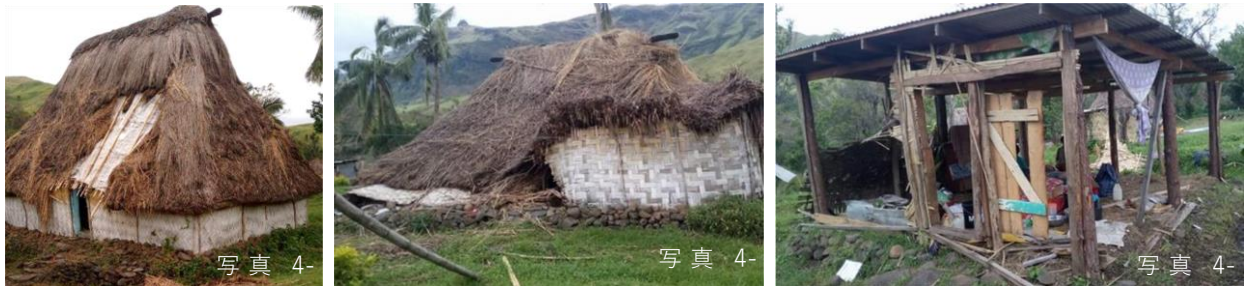
写真 4-11 及び写真 4-12（左，中） ウィンストンにより損壊したブレ
写真 4-13（右） ウィンストンにより被害を受けた新建材住宅（出典：Ba Office）

写真 4-11 はウィンストンにより屋根被害があったブレ、写真 4-12 は全壊したブレの写真である。ブレの屋根組は柱に載せてあり、強風で倒れる際、屋根組はそのままに柱が傾いてゆっくりと倒れていくため、外に避難しなくても中に生存空間が生まれるということ、ナバラ村住民の共通認識として持っていた。数世帯があえてブレに避難した行動とも関連する。実際に全壊した

ブレは、屋根の構造はそのまま残り、柱から外れて崩れている状態だった。一方で新建材住宅の住宅被害は屋根や壁に使われていたトタンが強風により吹き飛ばされたり、構造材と共に崩れ落ちたりして、中にいた住民が怪我を負ったり亡くなったりした事例がバ州内で確認された。ナバラ村においても、新建材住宅のトタンが飛散した（写真 4-13）。これらを踏まえ、「トタン屋根は強風により飛散しやすく人を傷つける恐れがあるが、草葺屋根は安全である」という多くの住民意見が聞かれた。

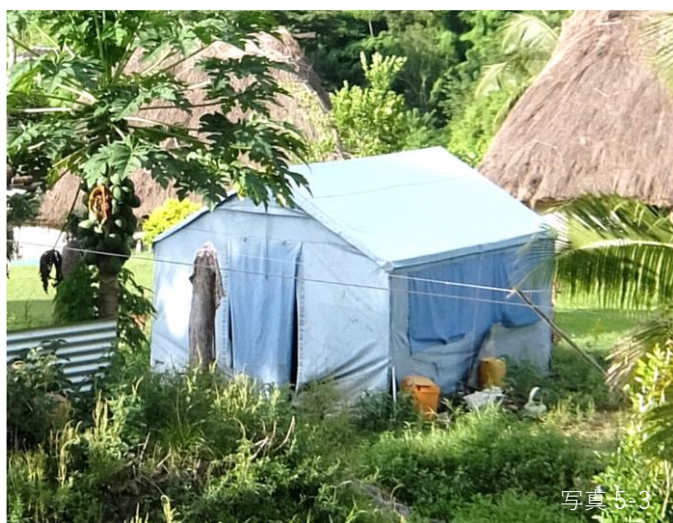
サイクロンによって住宅が被害を受け、住宅再建まで別の場所で仮住まいをしなければならなかった80世帯に対するアンケート結果では、仮住まい先の内訳は「避難所指定されていた小学校または教会」が39世帯(49%)、「近隣の家」が15世帯(19%)、「親戚の家」が3世帯(4%)、「テント」が4世帯(5%)、被災者が自ら簡易に建設した「仮設住宅」が14世帯(17%)、母屋とは別に建てられ被災を免れた「台所棟」が4世帯(5%)であった(図5-5)。村落内は氏族同士での結婚も多く、「近隣の家」は遠縁の親族である場合が多いため、実質「親戚の家」を選択していると思われる。また、最初の仮住まい先としては、避難所や親戚の家を頼り、1~2週間かけて仮設住宅を建設し移住する事例や、避難所から親戚の家へ移る事例など、生活が落ち着くまで転々と移住を繰り返している世帯も多かった。

2017年9月の調査時には寝泊まりに使われているテントを確認した(写真5-3)。このテントはフィジー政府を通じて中国政府から支援されたものである。テントを寝室として利用していた住民からは、「朝晩は気温が下がるので中で寝ることができるが、日中はテント内が暑くなるため中で過ごすことはできない」との声が聞かれた。強風等でテントが壊れてしまったために、2018年3月の調査時にはテントで生活をしている者はいなかった。安全性が懸念されたために残って

図 5-5 ナバラ村における被災後の仮住まい
写真 5-3 中国政府が支給したテント

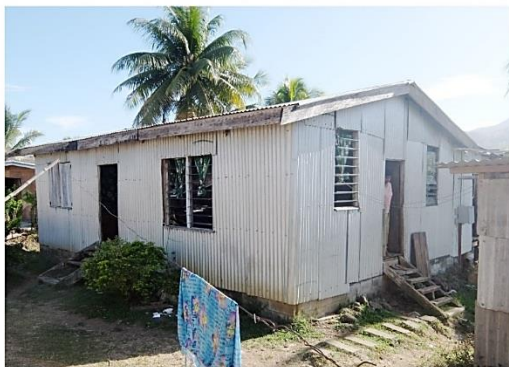
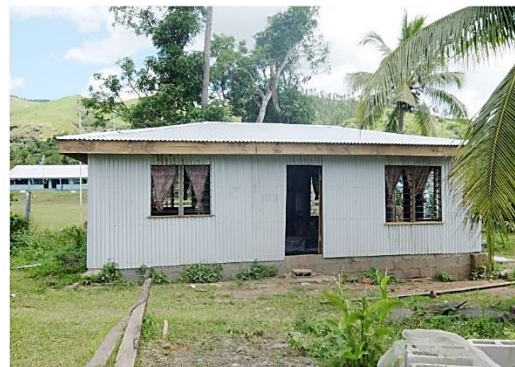
図 5-7 ナバラ村における新建材住宅

新建材住宅の再建は、5世帯が集落内の大工、2世帯が集落外の大工、1世帯が自力で再建したと回答した。資材の費用は4世帯が自費で賄い、3世帯は外部からの援助を受け、1世帯は被害を受けた住宅の資材を再利用したと回答した。外部からの援助の内訳は、カトリック・フォーラム(Catholic Forum)から5,000FJDを受け取った世帯が1世帯、社会福祉課からの600FJDの援助を受けた世帯が2世帯だった。自費で再建費用を賄った世帯は、被災後に市場価格が高騰したヤングナを売って得た収入で建材を購入していた。図5-7の(d)はナバラ村でウィンストン被災前に建設され、被災後に修繕された新建材住宅であり、住宅に併設して台所が建っている。

(d) 新建材住居

(e) HFH 再建事業による再建住居

図 5-7 の (d) はナバラ村で建設された再建事業の支援を受けた住宅である。再建事業で建設される新建材住宅は元の住宅の基礎の上に建てられるため、元の住宅と大きさは変わらない。基礎工事に必要なセメントやコンクリートブロック、杭は建材店より購入するが、砂は川岸から運んできていた。構造は主に松材で組まれ、壁はトタンのみもしくはトタンとコンクリートブロックの組み合わせ、屋根はトタンである。写真 5-4 及び写真 5-5 は住民が共同労働で新建材住宅を建設しているようすである。壁の組み合わせは家主が自由を選べる。新建材住宅の建設に関して、明確な基準はないため、コンクリートの水セメント比や、屋根組み、ブレースの位置等は大工の経験に基づく。

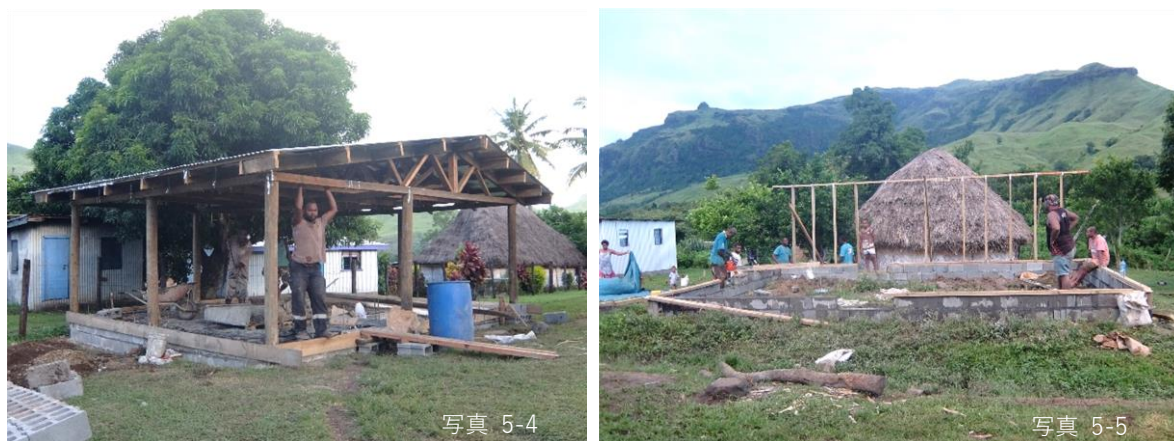
写真 5-4 及び写真 5-5 ナバラ村における新建材住宅の建設

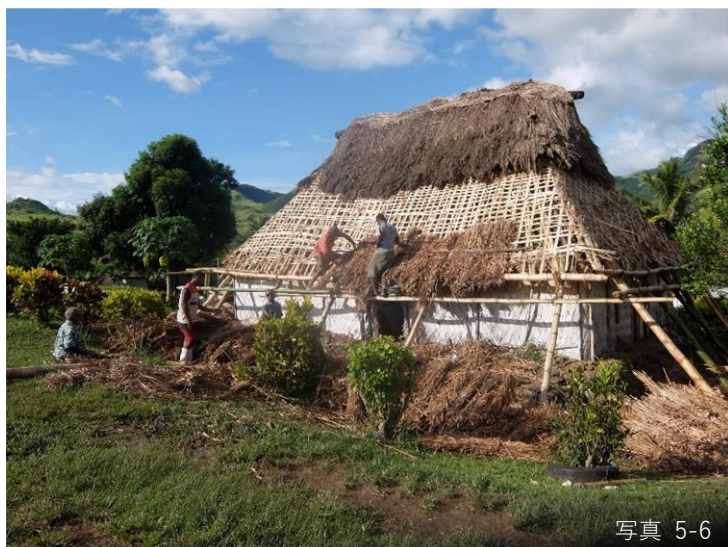
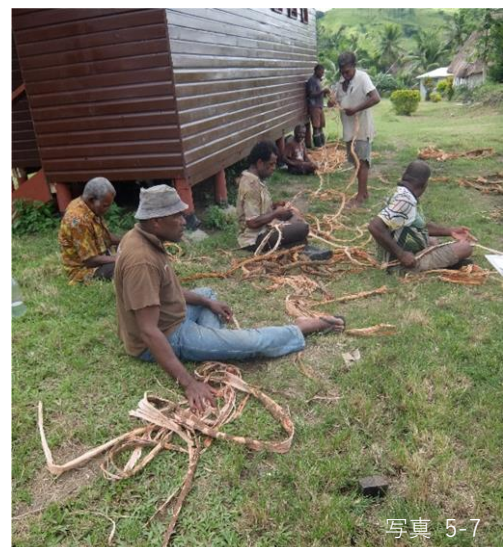
一方、新建材住宅の再建と平行して、ブレの屋根の修繕も倒壊したブレの屋根葺き材を再利用してコミュニティの共同労働により葺き替えられていることを 2018 年 3 月の調査時に確認した (写真 5-6, 写真 5-7)。このブレは村のチーフの住宅であり、屋根が雨漏りし始めたため、村落会議で急遽修繕することが決まった。住民へのインタビューでは共同労働作業に関わった人数は 10 人であり、4 日間かけて葺き替えは完了した。その後、2018 年 9 月の現地調査では、さらに 2 戸の屋根が葺きかえられており、年内にさらにもう 1 戸の屋根の葺き替えが予定されていた。いずれも雨漏りしてきたために緊急を要するとして、村落会議により葺き替えが決定されたが、先に葺き替えられたブレは、所有者の子供が結婚式を挙げるために葺き替えが優先して行われた。葺き替えは 20 人の親族と 10 人の住民によって、週 3 日の労働日を設け、計 4 週間かけて行われていた。工程は、屋根材の葦 (*Gasau*) と竹を刈り取り運搬するのに 2 週間、乾燥に 1 週間、葺き替え作業に 1 週間かかっていた。チーフのブレの屋根の葺き替えは古いブレの屋根葺き材を再利用していたが、残り 3 戸の屋根葺き材の葦は村の所有する森から刈ってきたものだった。

写真 5-6 及び写真 5-7 共同労働によるブレの屋根の葺き替え

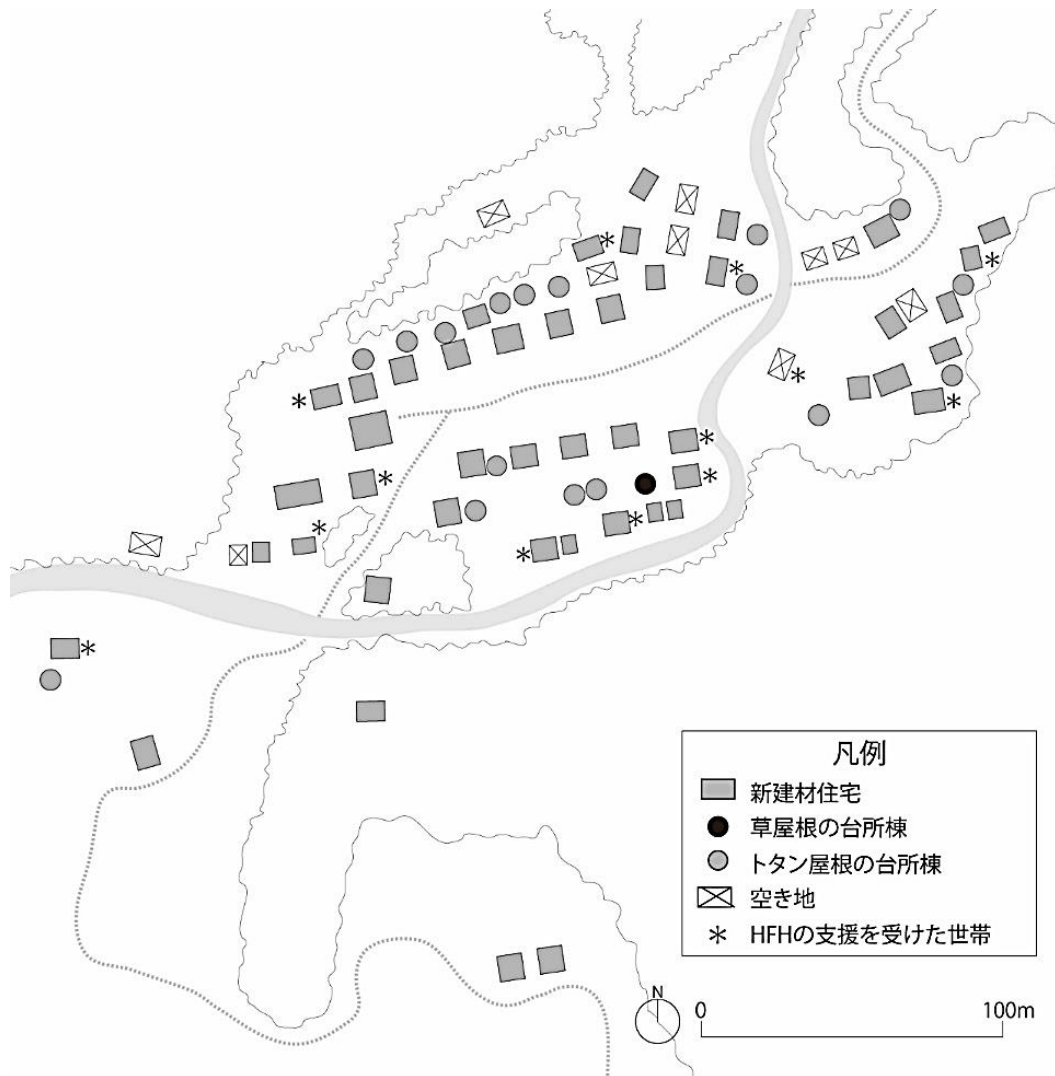
ナコロンボヤ村の住宅再建は、被災後1~2ヶ月以内の応急対応として簡易の仮設住宅兼台所棟の建設及び被災住宅の修繕と、恒久住宅の再建の2つのフェーズに分けられるが、ナバラ村と異なり、大工がいなかったために、HFHによる建材が配送された後も住宅再建は始まらなかった。恒久住宅の再建が始まったのはハビタットによる住宅建設技術のワークショップが行われた2017年9月以降である。図5-11に2019年3月の現地調査において確認した住宅の配置を示す。

図5-11 2019年3月のナコロンボヤ村の住宅配置

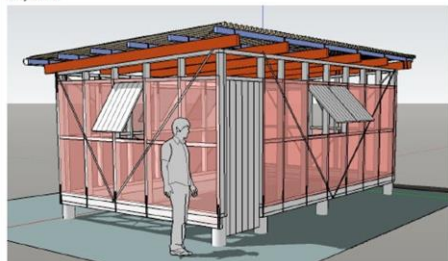
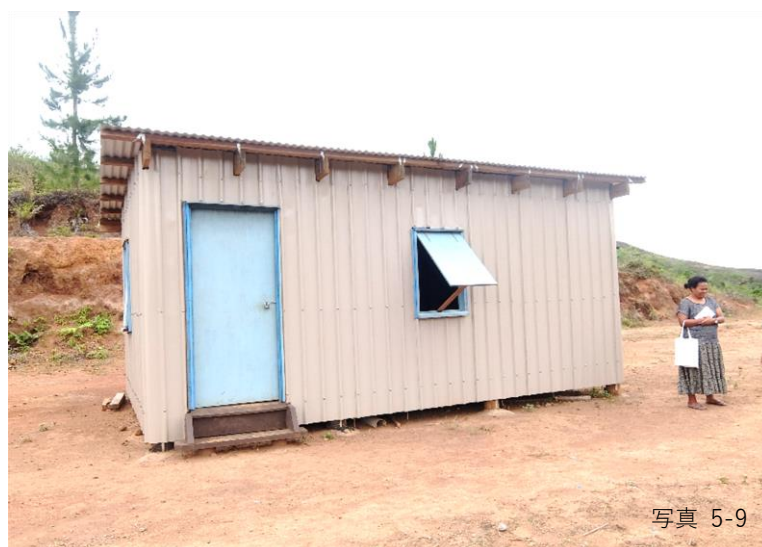
This structure is designed around a construction time of 3 days.

1. All window and door panels to be fabricated offsite prior to commencement of house construction.
2. Site is to be profiled and all holes to be dug by the home-partner prior to commencement.
3. Sand and gravel to be delivered to site before Day 1.
4. Locate water for mixing concrete before Day 1.

図 5-14 ハビタットの建設マニュアル（出典：Habitat for Humanity Fiji）
写真 5-9 ナコロンボヤ村でハビタットにより建設された住宅

を建設する際に、村長から「デモンストレーションとして住民にも建設方法を教えてほしい」と頼み、技術トレーニングに至ったとのことだったが、ハビタットは HFH の技術トレーニング計画に参画しており、2012 年のサイクロン・エバンの被災後に復興住宅のクオリティ・コントロールを目指したマニュアルも作成していたことから、マニュアルに沿った建設が進められた（図 5-14, 写真 5-9）。技術トレーニングでは、水平計の使い方や構造材の接合方法等についてレクチャーがあり、参加した住民は修了証を授与していた。また、トレーニング終了後、電子カード申請時に配布された Tips for Build Back Safer のポスターが印刷された看板を村の広場に立てていったとのことだった。

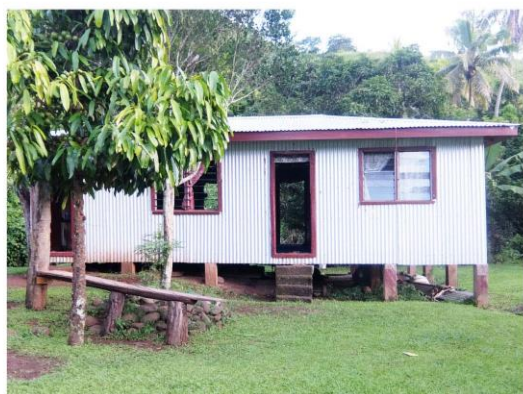
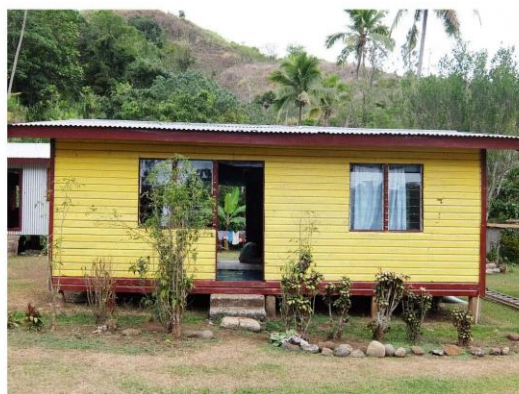
図 5-15 ナコロボヤ村にて HFH 事業で再建された住宅（左）と 1984 年に建設された住宅（右）

図 5-15 に住民が中心となって再建した新建材住宅と 1984 年に外部の大工によって建設された新建材住宅の実測図面と写真を示す。1984 年に建設された新建材住宅は、一室空間であり、壁材に木材が使用され、ペンキによって黄色や緑色など、カラフルに塗られている。壁面にも屋根面にもブレースが入れられ、さらに屋根の上から基礎にかけてワイヤーがかけられ、サイクロンにたいして強固に造られていた。一方、ウィンストン被災後に住民主体で建設された新建材住宅は、壁材はトタンが用いられており、屋根と基礎を繋ぐワイヤーはかけられていたが、壁面や屋根面のブレースの数は住宅によってまちまちであり、サイクロンに対して強固に造られているとは言い難い状況だった。

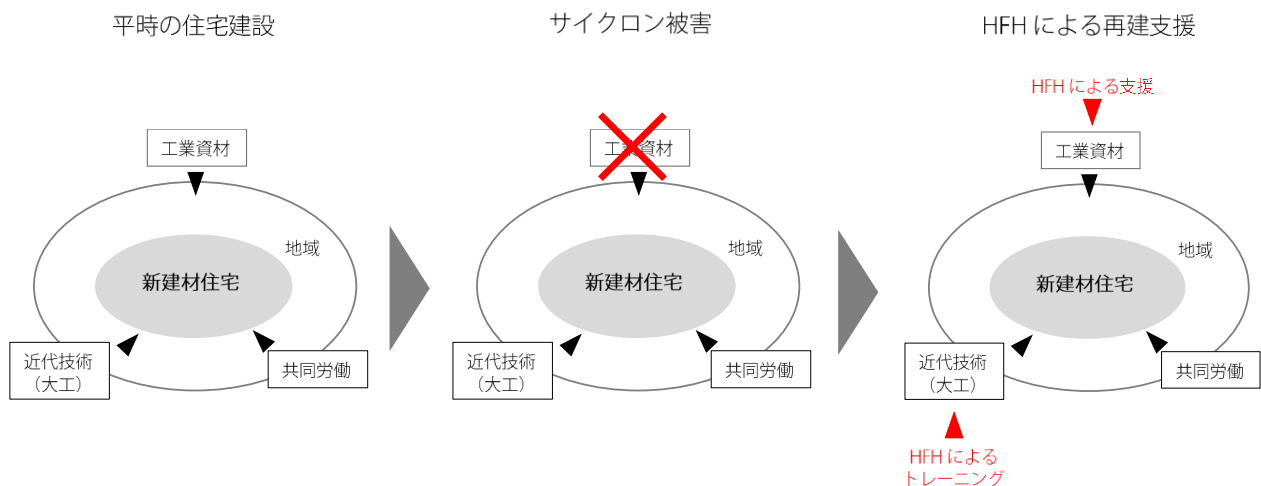
HFH が当初想定していた住宅再建支援のシナリオは、新建材住宅が多数を占める農村集落において、建設技術を持った大工と共同労働が成り立つことを前提として、サイクロン災害によって被害を受けた住宅の建材を支給し、大工への技術トレーニングを行うことで、耐災害性の高い住宅を再建するという **Build Back Safer** を目指すものであり、図6-1のようにまとめられる。

図6-1 HFHが想定していた住宅再建シナリオ

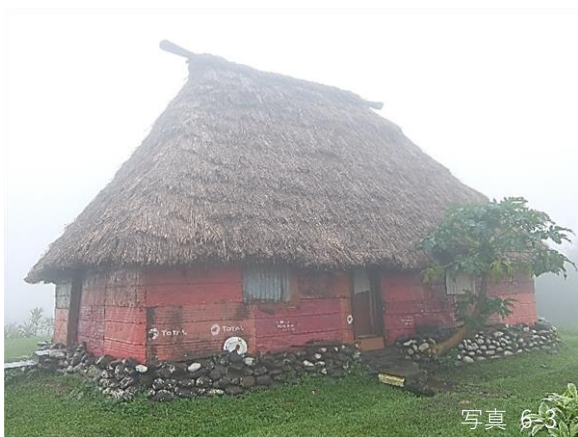
写真 6-3 ナコロンボヤ村でウィンストン被災後に再建されたチーフのブレ
写真 6-4 集会所として利用されている市街地近郊の集落のブレ

氏族制が色濃く残るフィジー農村集落において、ブレは未だにチーフの住宅として象徴的な意味を持っている。ナバラ村では、サイクロン被害後、他のブレが応急的な屋根の修繕で済ませている中、チーフのブレは屋根全面の葺き替えを行っていた。ナコロンボヤ村では、集落外に移住したチーフのブレを共同労働によって、いち早く再建している(写真 6-3)。壁は伝統的なブレと異なり、応急的にトタンが用いられたが、チーフ・ブレが被災住民にとって文化的・精神的に心の拠り所だったことが推測される。

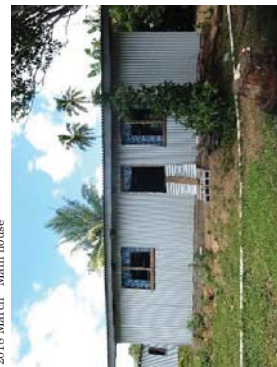
2018 March. Main house.

Ugolavia is now replaced by a corrugated iron house. Kitchen is the same as Basania.

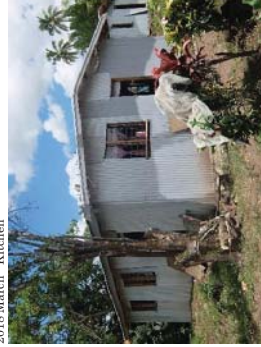
2018 March. Kitchen

They stayed at kitchen before repair. The const of repair was 560FJD by themselves.
