## Study on Piping Failure of Natural Dam

Ripendra AWAL, Hajime NAKAGAWA, Masaharu FUJITA, Kenji KAWAIKE,  
Yasuyuki BABA and Hao ZHANG

### Synopsis

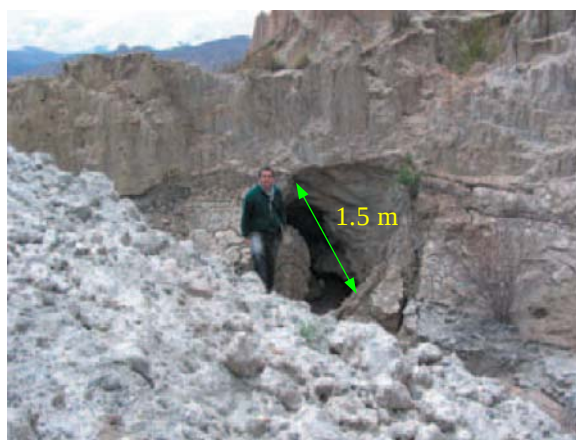
Fig. 1 Natural tunnel through a landslide dam in Allpacoma valley, La Paz, Bolivia, formed due to piping failure (Hermanns, 2005).

Seeps occurred on the downstream face of many landslide dams. Several seepage points developed before overtopping of a recent landslide dam formed on 4<sup>th</sup> January, 2010 in Hunza River at Attabad, Pakistan. Piping hole also developed in the downstream face of the Tangjiashan Barrier Dam, China in 2008 (Liu et al., 2009). Piping and undermining caused the collapse of the landslide dam that impounded Lake Yashinkul in 1966 (Schuster and Costa, 1986). Some other landslide-dam failures in which seepage erosion probably was the major cause were the 1906 Cache Creek dam in northern California, the 1945 Cerro Condor-Sencca dam on the Mantaro River in Peru, and the 1973 Costantino dam on the Buonamico River of southern Italy (Meyer et al., 1994). The failure of Rio Toro landslide dam in Costa Rica in 1992 was due to retrogressive sliding caused by seepage and internal erosion (Mora et al., 1993). Allpacoma Landslide Dam (see Fig. 1) in Bolivia failed due to piping and overtopping (Hermanns, 2005). A tunnel about 1.5 m in diameter formed

through the dam about 2 m below the dam crest due to erosion.
