# **Challenges and Potentials of Retrofitting Masonry Non-Engineered Construction in Indonesia**

**A Dissertation Submitted for the Fulfillment of  
Doctoral Program  
in Global Environmental Studies**

**Graduate School of Global Environmental Studies  
Kyoto University  
Japan**

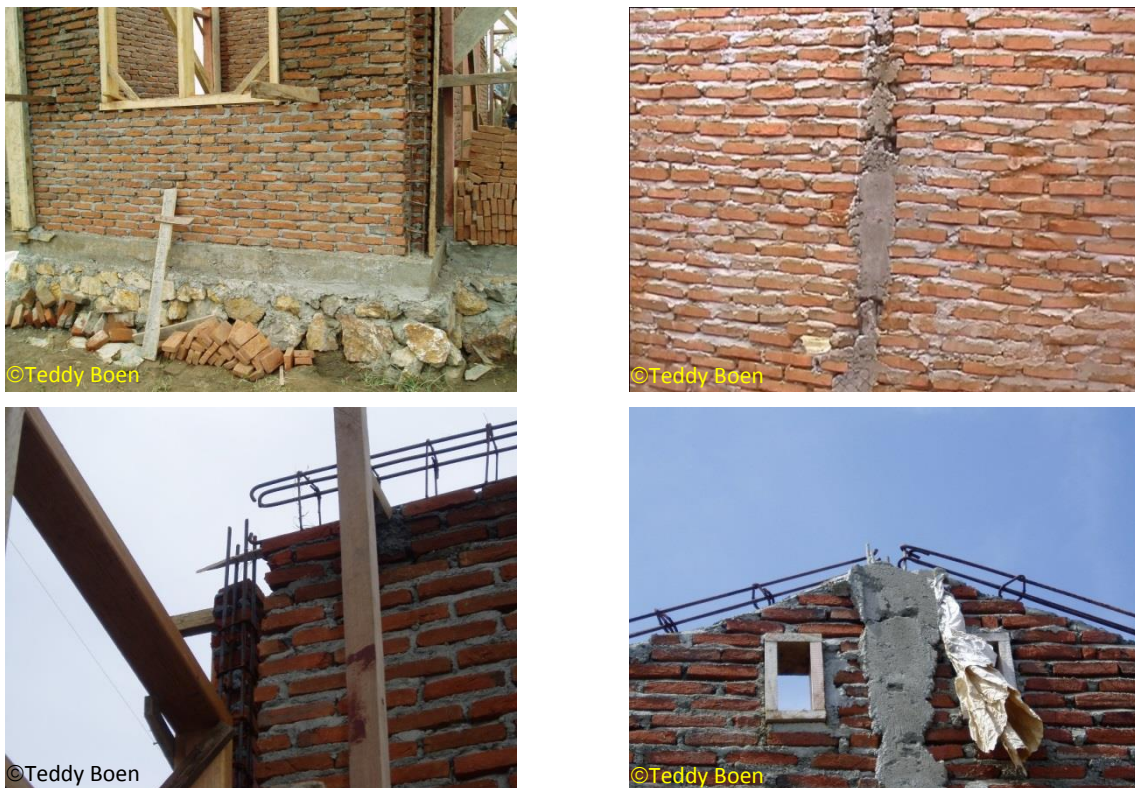
*Figure 10 – Houses under Construction in Aceh, Poor Quality Materials and Poor Workmanship*

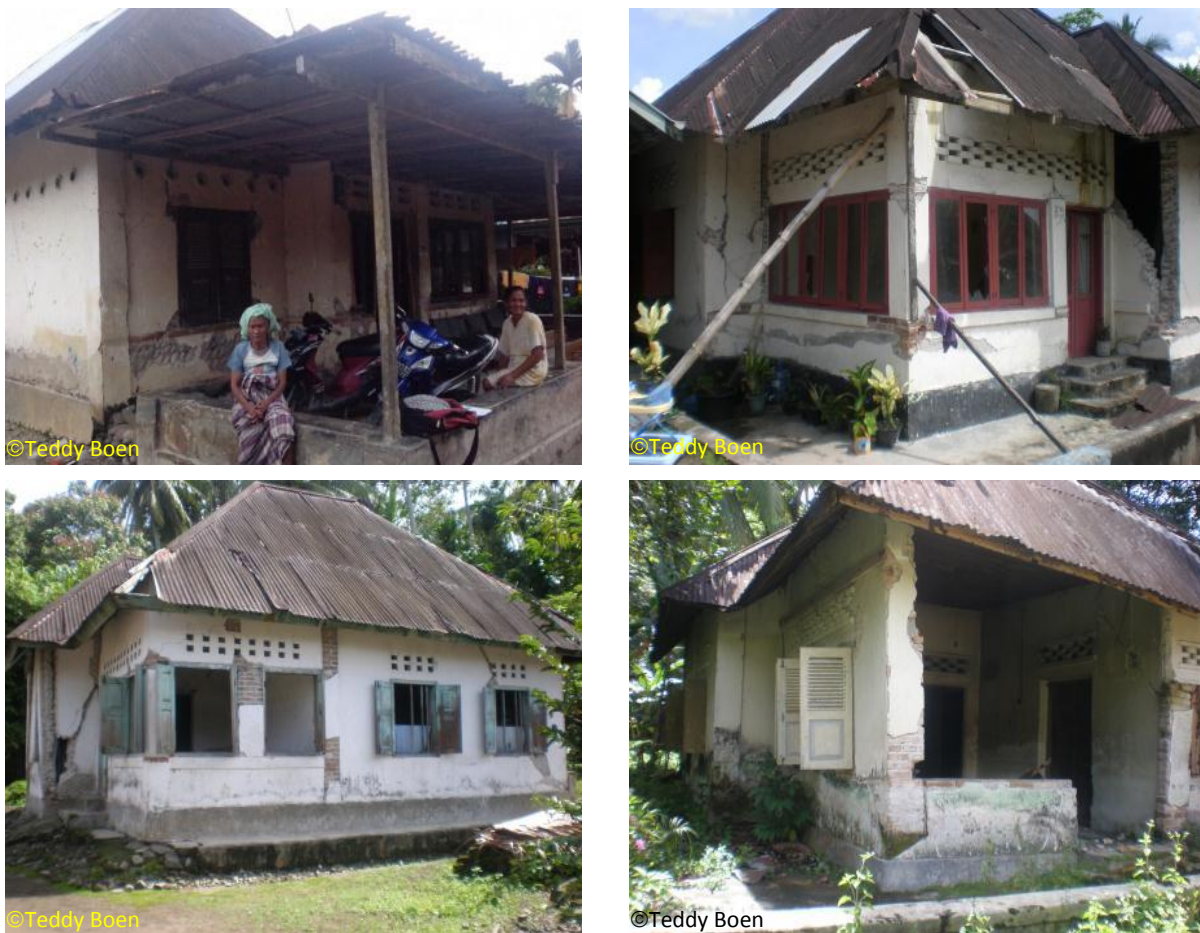
*Figure 11 – Abandoned Damaged Houses – Owners did not Retrofit Their Houses even though They Have Received the Funds – Picture taken February 2013*

disbursed in February 2013 and many complain that the payments were not the full amount and parts were “taxed” by facilitators as well as village chiefs. This was reported in the media. A clear indication of non-performance can still be seen today among others in Pariaman area (see Figure 11 taken in February 2013) where many of the house owners already received the full amount from the government BUT used for other purposes and their houses are still untouched and same damage condition as in September 2009. How can the owner receive payment while the installments can only be paid based on the progress of work?

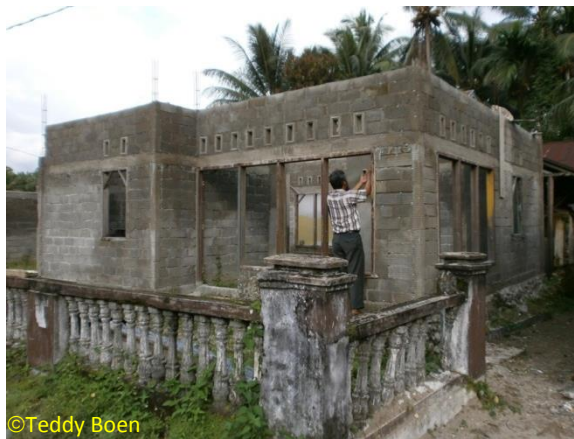
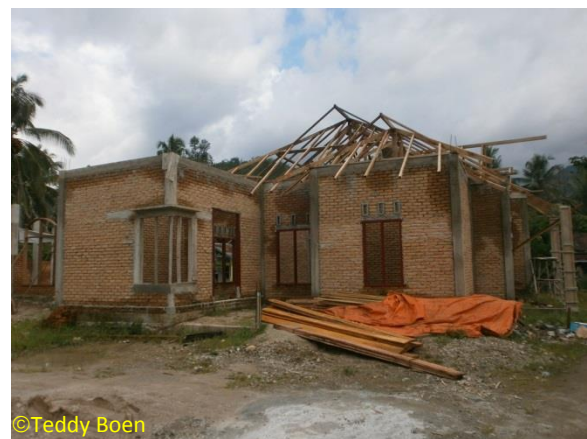
*Figure 12 – Lack of Damage Assessment: New Houses Built Bigger than the Damaged Houses due to Earthquake – Picture taken January 2013*

There was also a clear indication that the damage assessment was not done properly. Many of the damaged houses were demolished and the owners build new houses far bigger than before the earthquake (Figure 12); meaning that the owner has enough funds and does not need to be supported.

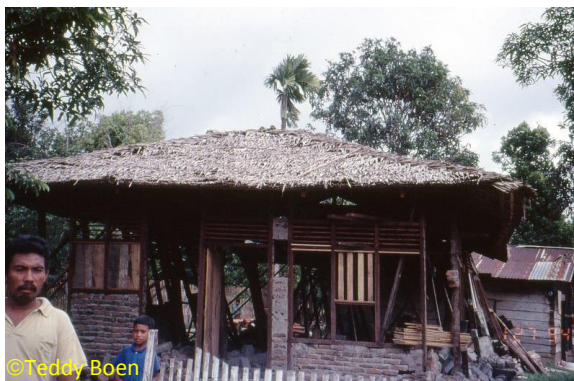
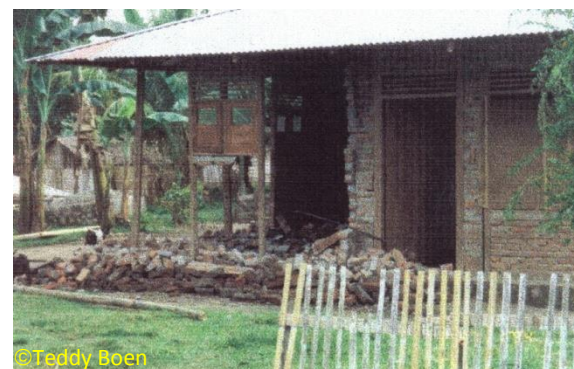
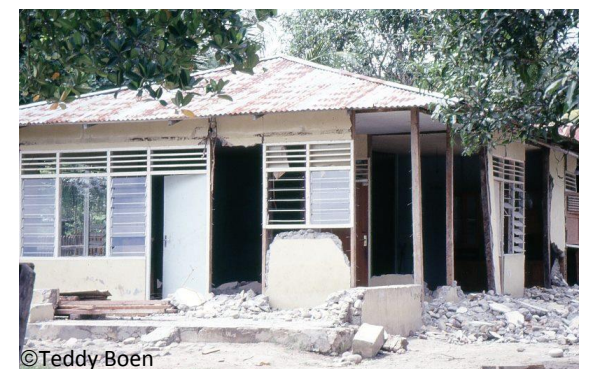
Besides using reinforced concrete “practical columns” and “practical beams”, half-brick-thick masonry buildings also can be confined using timber.

*Figure 18 – Masonry Buildings Confined with Timber Columns and Beams*

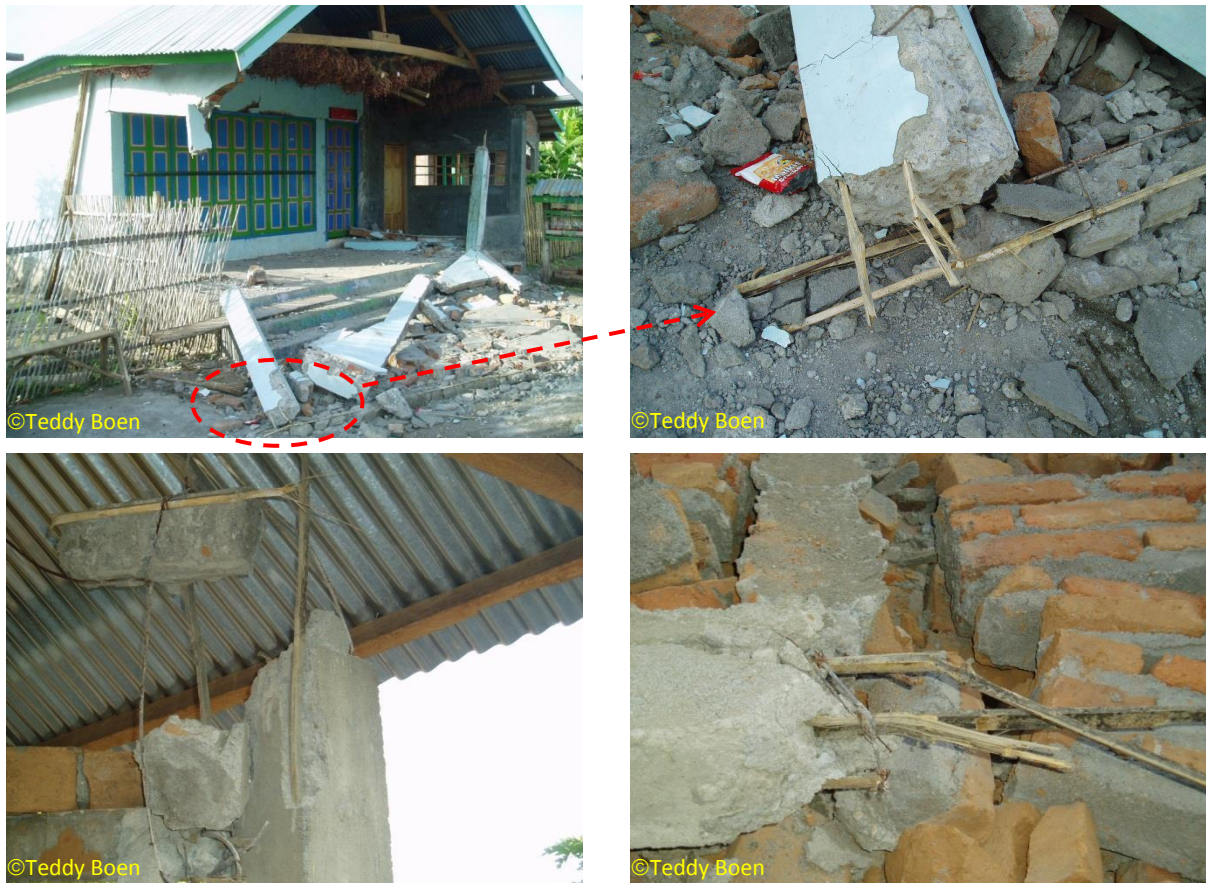
From survey of earthquake damages in the past 40 years, the author also found that in several places in Indonesia, masonry buildings are confined using reinforced concrete “practical columns and beams” with bamboo as reinforcement. Bamboo has a good characteristic to withstand tensile forces; therefore bamboo can be used as a substitute of reinforcing bars, if only the bamboo’s shrinkage can be reduced approximately equal to the concrete’s shrinkage. Bamboo also has a weakness and difficult to bend like steel bars and therefor the column - beam joint is not ductile. From past earthquake experiences, one of the failure modes of masonry buildings is caused by improper connection at joint of columns and beams.

*Figure 20 – Masonry Buildings Confined by “Practical Columns and Beams” with Bamboo as the Reinforcement*

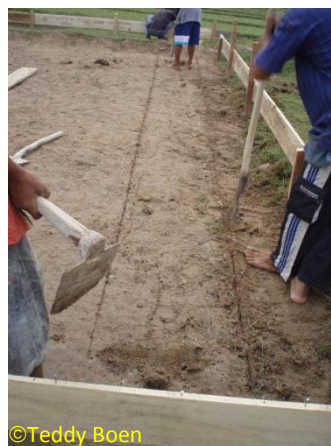
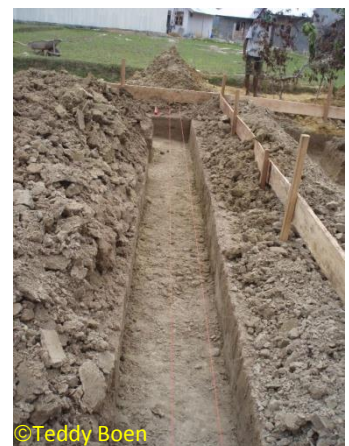
After all batter boards are constructed, the foundation excavation is done (Figure 29). The minimum depth and width is 80cm, and depends on the foundation dimension.

Figure 29 – Foundation Excavation

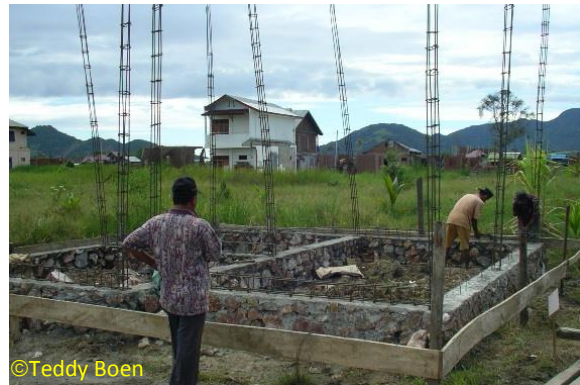
Foundations are built using rubble stone (Figure 30). Such rubble stone foundation was introduced by the Dutch. However, since several years ago, the author suggested to use continuous reinforced concrete inverted-T foundation (Figure 31).

Figure 30 – Rubble Stone Foundation

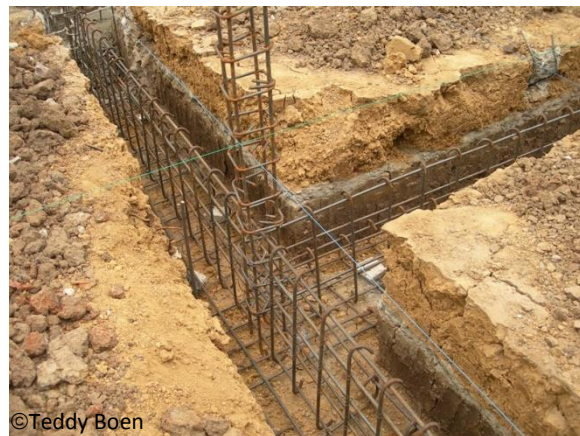
If the foundations are using continuous reinforced concrete inverted-T type, the foundation beams has integrated with the foundation. Therefore the column reinforcing bars should be assembled together with the foundation reinforcing bars.

Figure 31 – Reinforced Concrete Inverted-T Foundation

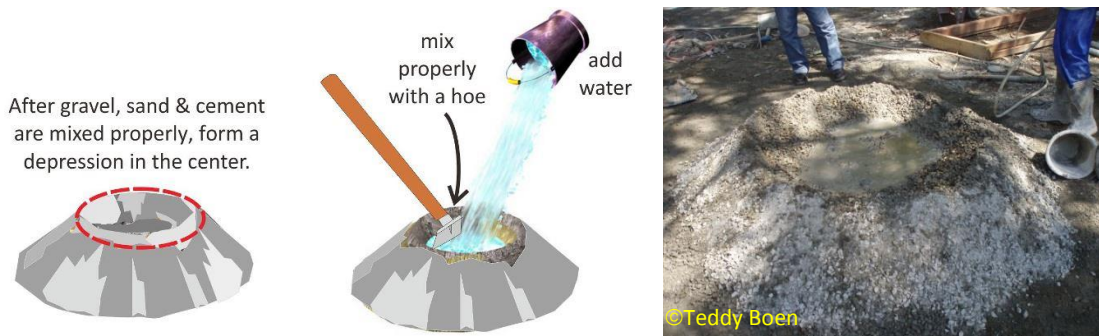
The ratio of water : cement : sand : gravel that meets standard requirement is 1:2:4:6 or  $\frac{1}{2}$ :1:2:3. Therefore material requirements for mix 1 m<sup>3</sup> of concrete are 0.125m<sup>3</sup> water, 0.250m<sup>3</sup> cement, 0.500 m<sup>3</sup> sand, and 0.750 m<sup>3</sup> gravel. The expected minimum compressive strength is approximately 150 kg/cm<sup>2</sup>. To test the concrete mix consistency, place the concrete in your hand. The appropriate concrete mix will be achieved if the concrete can be grasped by your hand (Figure 33 – left). However, if the water is too much, the concrete mix will be “melted” in your hand (Figure 33 – right).

Figure 32 – Preparing Concrete Mix

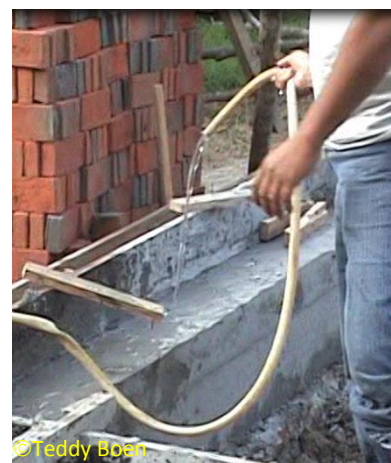
Curing of all reinforced concrete components must be done before and after the form work is removed. It must be sprayed routinely to prevent evaporation of concrete mix water. Lack of water in concrete may cause fissures that can reduce the concrete strength.

Figure 36 – Curing of Concrete

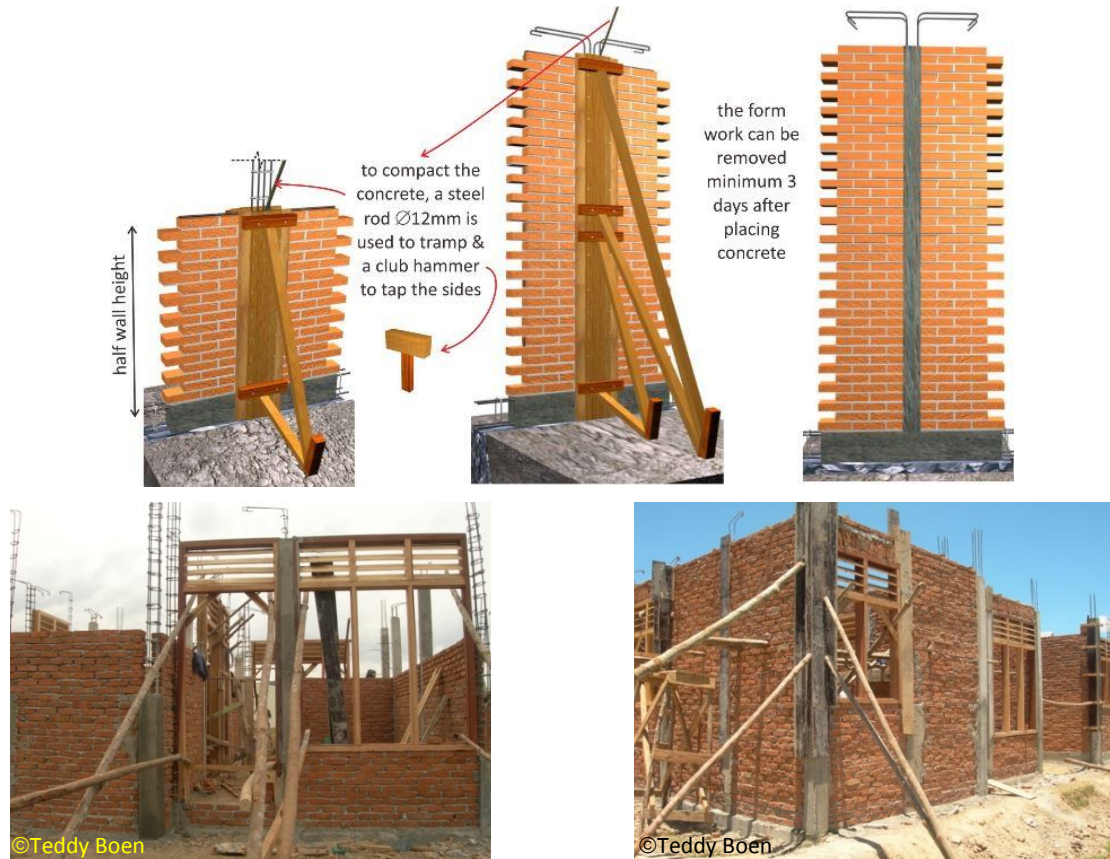
The reinforcing bar of columns shall be assembled coincide with the foundation reinforcing bars. However the concreting of columns can be implemented in two ways. The first is simultaneously with brick laying (Figure 37). The second is prior to brick laying (Figure 38). The columns are supported on four sides to warrant plumbness during placing of concrete. Wall anchors must be assembled before concreting columns. Placing concrete is done in one run and NOT IN STAGES.

Figure 37 – Concreting Columns Simultaneously with Brick Laying

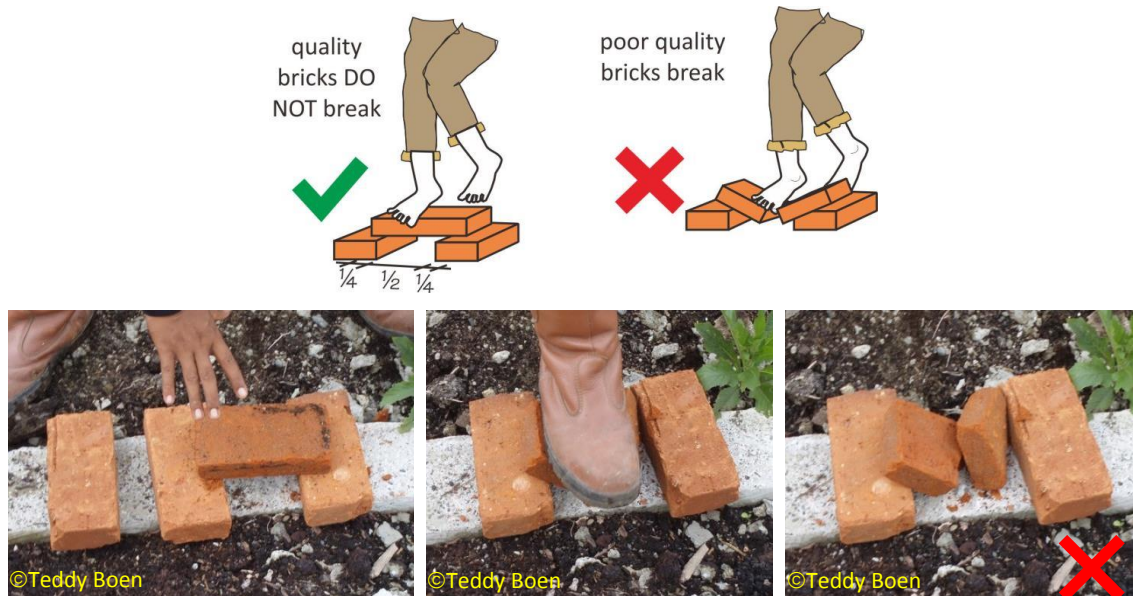
Burnt clay bricks are usually used to construct the walls. Simple method to check the quality of the bricks is shown in Figure 39. The brick-walls must be anchored to the columns using minimum  $\varnothing 10\text{mm}$  reinforcing bars with length minimum 40 cm, every 6 layers of brick. The bricks must be soaked in water minimum 10 minutes prior to laying and shall be laid immediately to prevent evaporation (Figure 40). When laying the bricks, a cord is used as a horizontal guideline (Figure 41). The ratio of cement and sand in mortar is 1 pc : 4 ps.

Figure 39 – Quality of Brick Testing

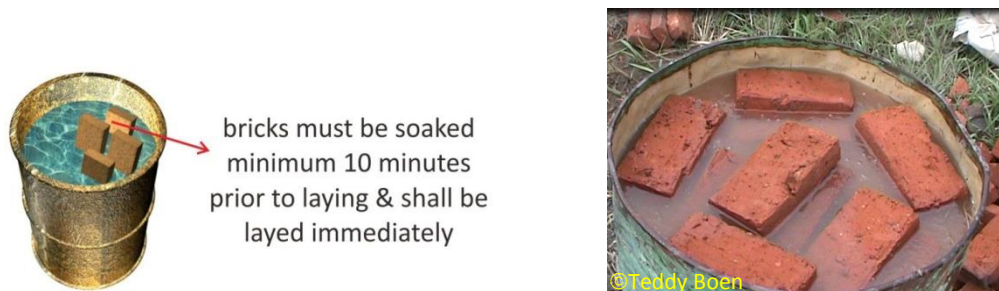
Figure 40 – Brick Soaked in Water

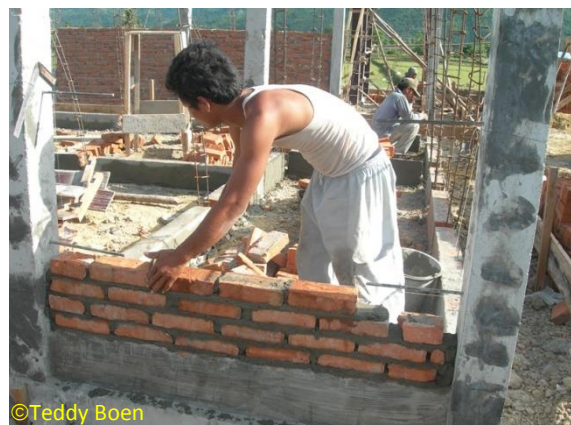
Figure 41 – Brick Laying

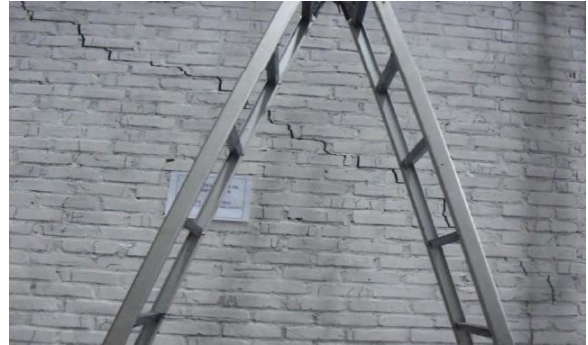
Figure 45 – Cracks Pattern of First Brick-Wall Panel with Good Quality of Bricks (Research Institute for Human Settlements & JICA, 2012)

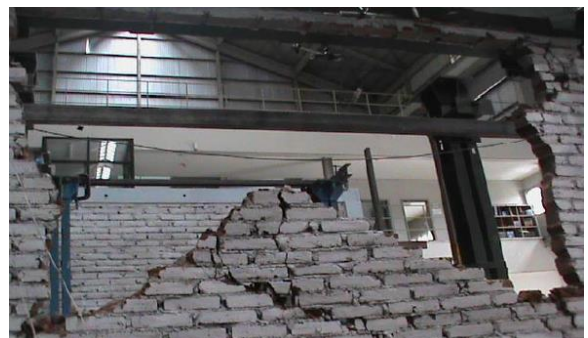
Figure 47 – Cracks Pattern of Second Brick-Wall Panel with Low Quality of Bricks (Research Institute for Human Settlements & JICA, 2012)

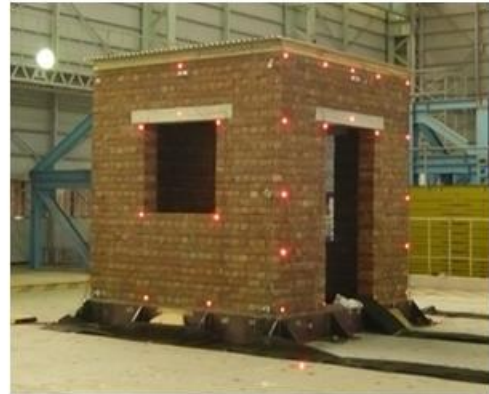
East wall, south wall and north wall have openings, but the west wall is without opening. The walls were built in accordance to English bond. Bricks of 230mm x 110mm x 70mm and 2.92kg were imported from Pakistan.

- Wall: 3000×3000 (mm)
- Brick: 230×110×70(mm)
- Finishing Mortar & Bond Mortar: Cement: Sand= 1:8

Figure 49 – Outline of Model Structure for Shaking Table Experiment of One Brick Thick Masonry Walls Construction (Narafu, 2010)

The length, width and height of the model structure was approximately 3 meters, fabricated on the shaking table at the National research Institute for Earth science and Disaster prevention (NIED) in Tsukuba. The bricks used for the model structure were imported from Pakistan. The ratio of cement to sand for mortar is one to eight to take account of the vulnerability of rural houses in developing countries. The joint mortar thickness is approximately 15mm (Minowa, et al., 2010).

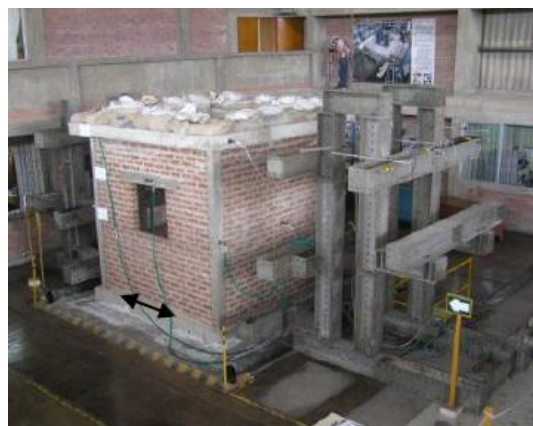
- Model A had no added reinforcement; it is similar to shaking table test conducted by NIED and Mie University as mentioned before in 3.5.3.
- Model B had a continuous reinforced concrete lintel beam over the door and windows openings, and also steel anchors between walls and columns at three positions. This model has the same concept with the Indonesian earthquake resistant masonry houses as can be seen in Figure 22, page 70 of this dissertation.
- Model C had an external wire mesh covering the surface of the walls, and a mortar cover was placed in East Wall. The wire mesh only wrapped the structure and did not act as ferrocement.

All of this 3 model of houses has dimension approximately 3m each in length and height with wall thickness 105mm. Sand bags were placed over the ring beams to simulate extra roof weight. Therefore the total load of each model was nearly less than 15ton, the limit load for PUCP shaking table. The models are based on Indonesian prevailing practice of non-engineered masonry construction.

*Figure 56 – Model Structure for Shaking Table Test of Confined Masonry Brick-Walls Construction with Additional Reinforcement (Minowa, et al., 2010)*

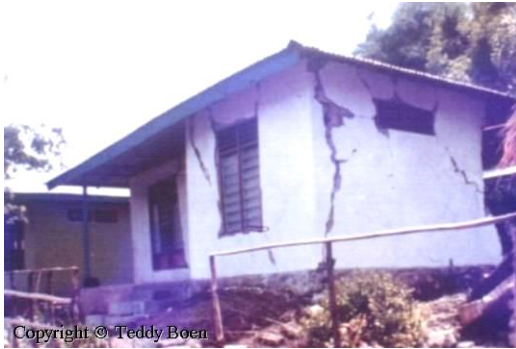
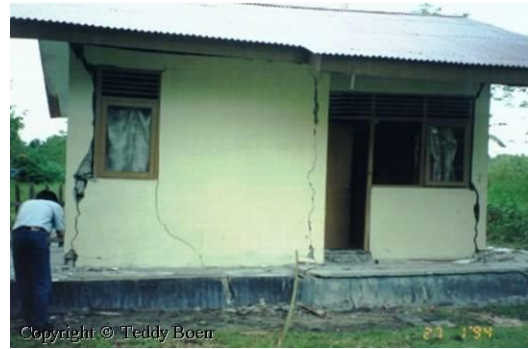
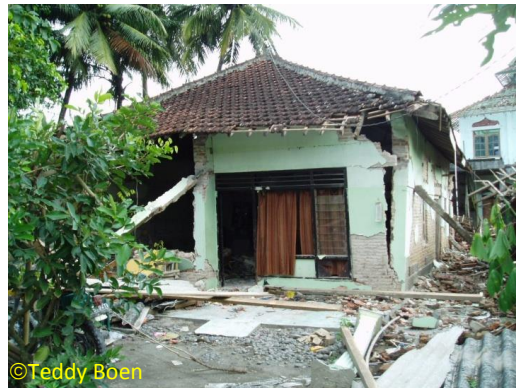
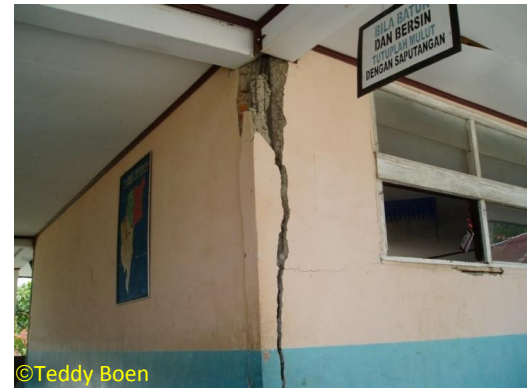
Figure 58 – Walls Tear Apart

1. Walls tear apart (Figure 58)
2. Failure at corner of walls (Figure 59)
3. Failure at corners of openings (Figure 60)
4. Diagonal cracks in walls (Figure 61)
5. Walls collapse (Figure 62)
6. Failure of connections (Figure 63)
7. Total damage (Figure 64)

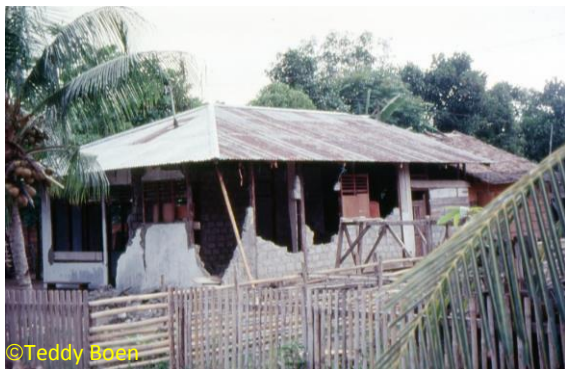
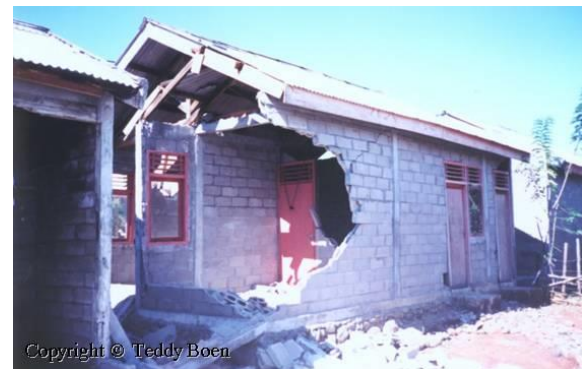
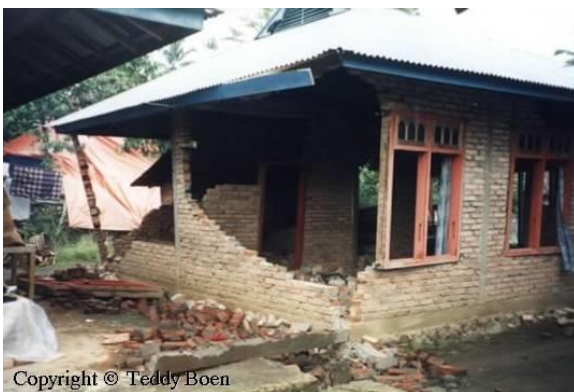
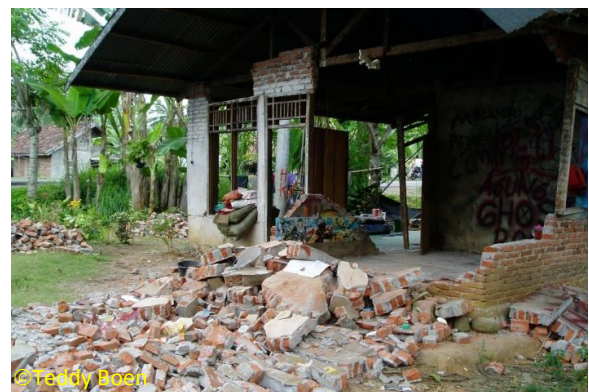
Figure 59 – Failure at Corners of Walls

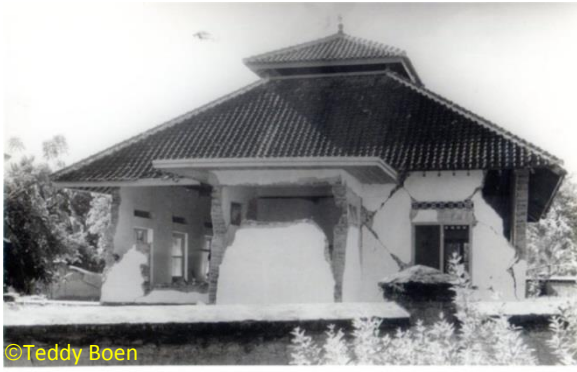
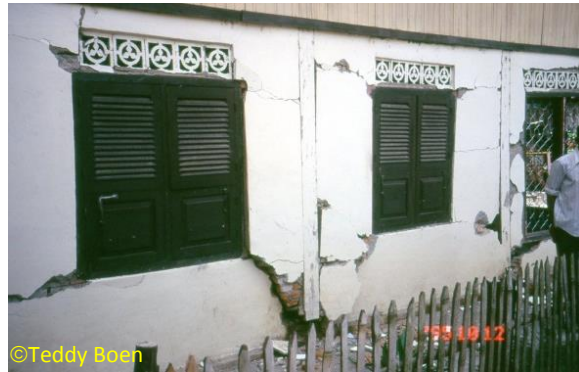
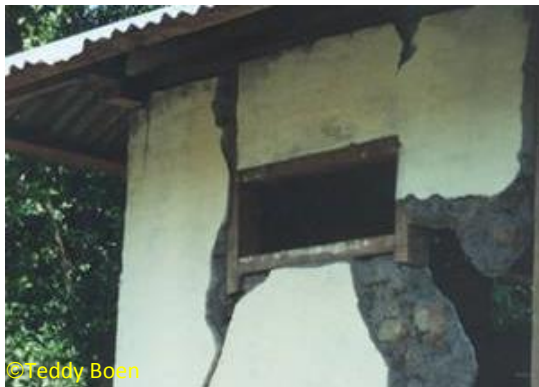
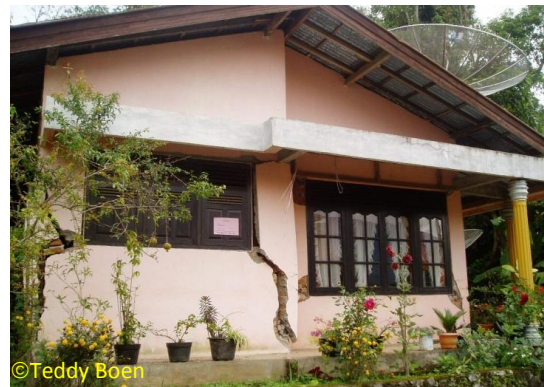
*Figure 60 – Failure at Corners of Openings*

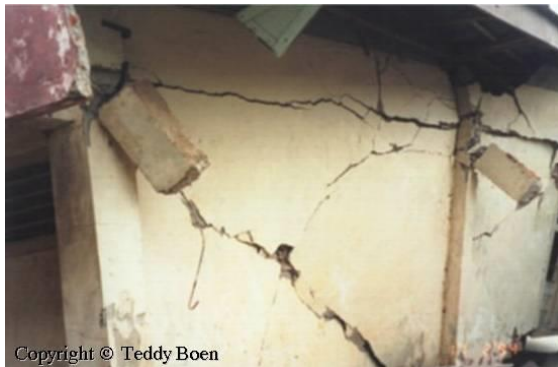
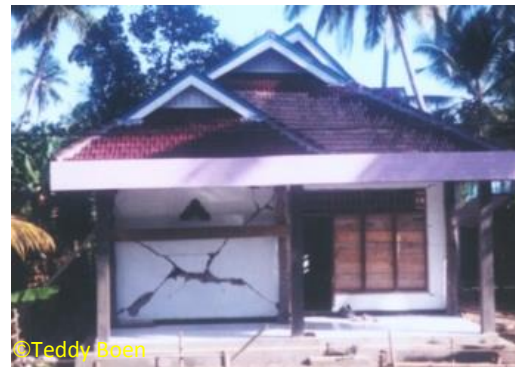
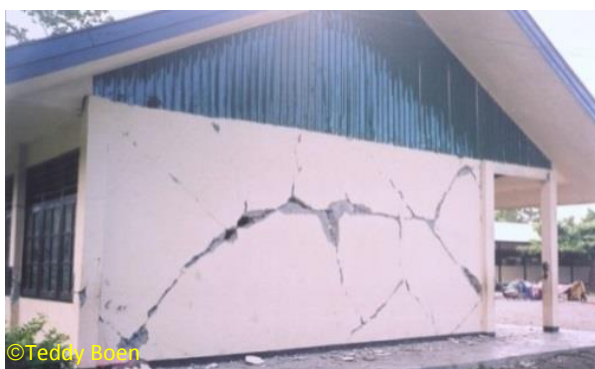
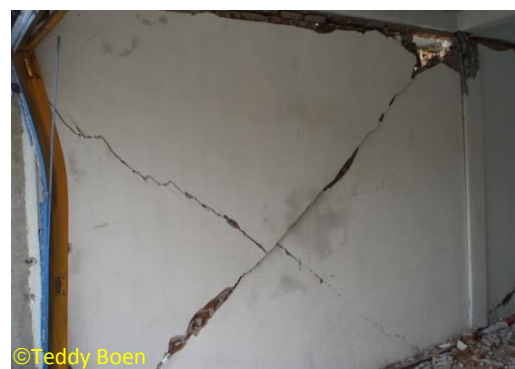
*Figure 61 – Diagonal Cracks in Walls*

- A shear or diagonal tension failure characterized by diagonal cracking
- A flexural or secondary compressive failure characterized by yielding of the tension steel and / or a compressive failure at the compression toe of the wall

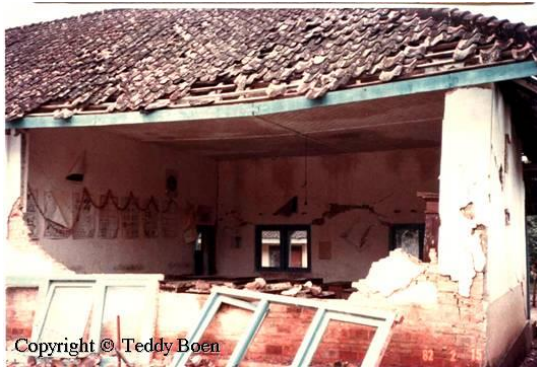
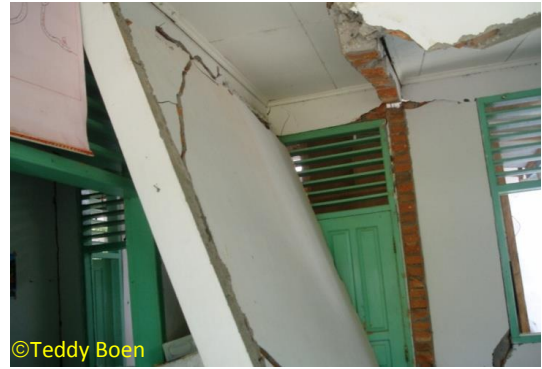
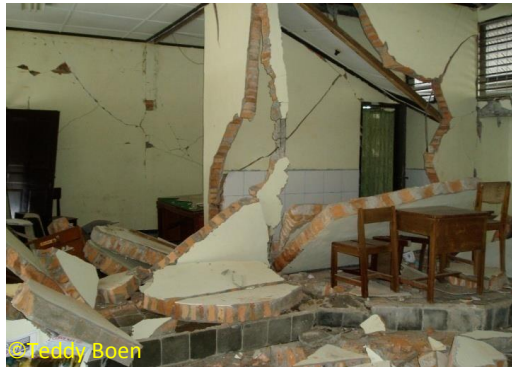
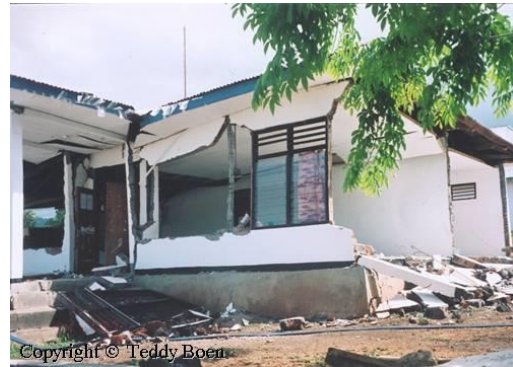
*Figure 62 – Walls Collapse*

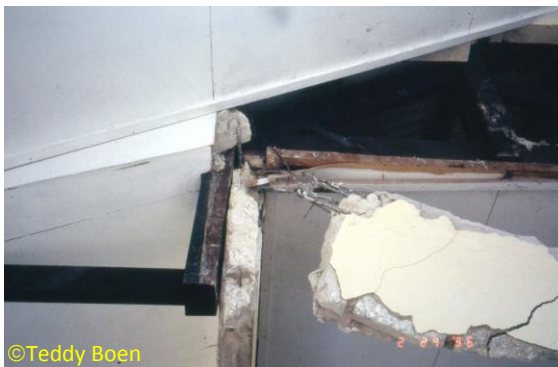
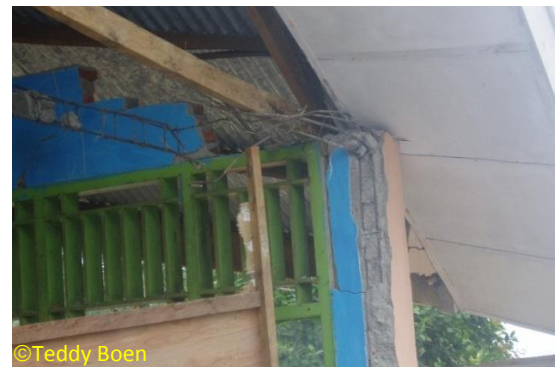
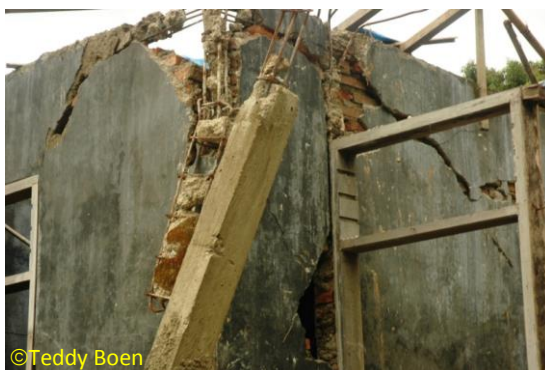
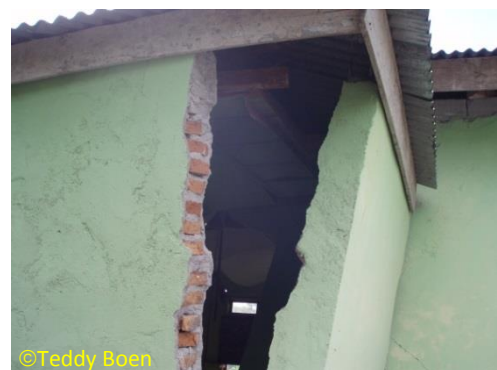
*Figure 63 – Failure of Connections*

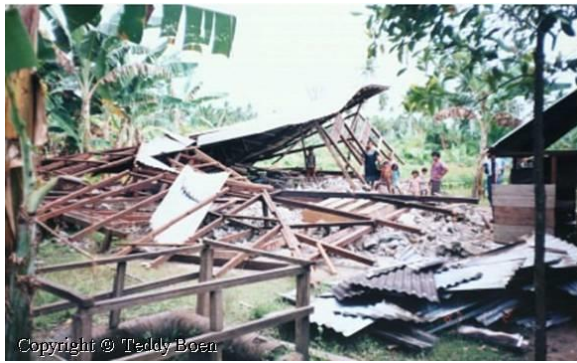
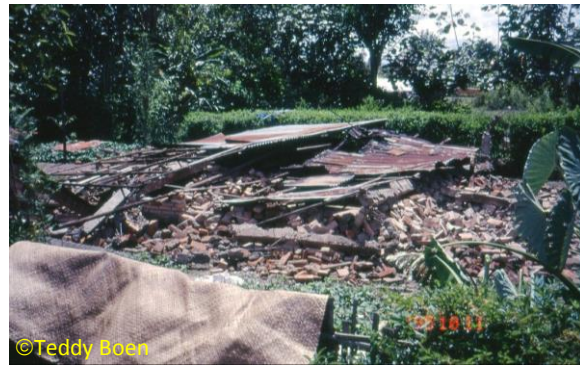
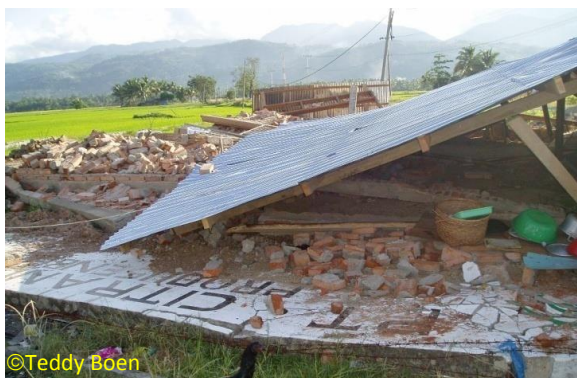
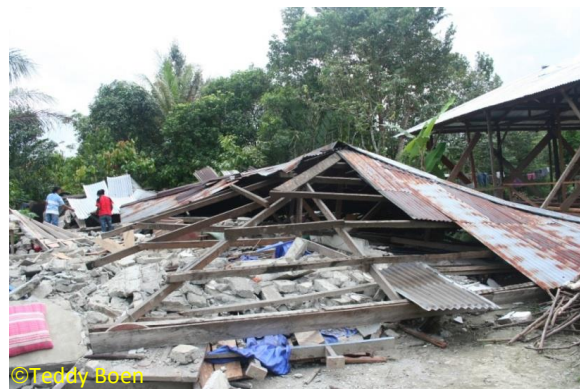
*Figure 64 – Total Damage*

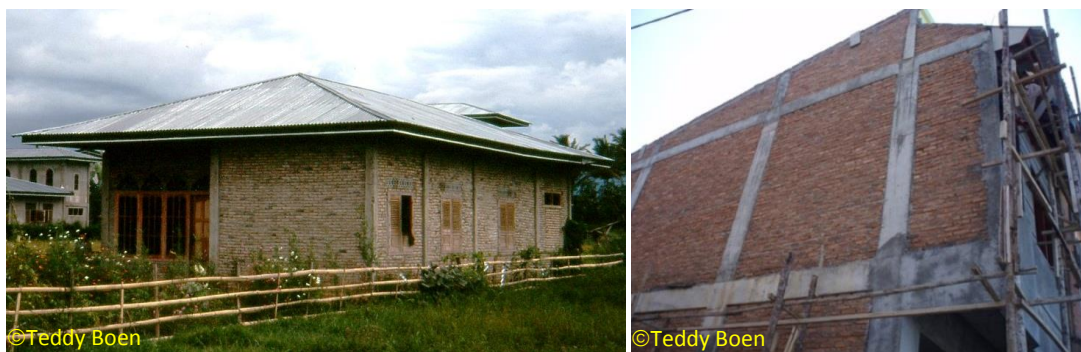
Figure 73 – Example of Bearing Wall (left) and In-filled Frame (right)

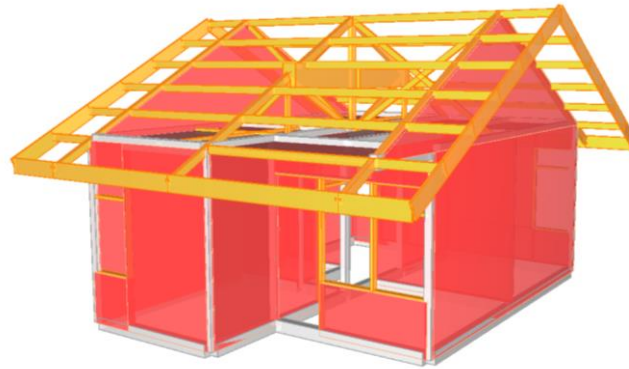
Figure 75 – 3-D Model Non-Engineered House with Practical Column

The analysis is elastic using response spectrum based on the Indonesian Seismic Code 2012 and ASCE7-10 Table 12.2-1 for Bengkulu area (Hard soil; PGA = 0.42g; Importance Factor = 1.0, R = 1.5).

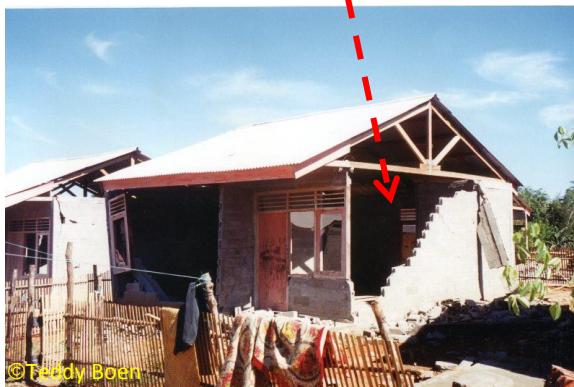
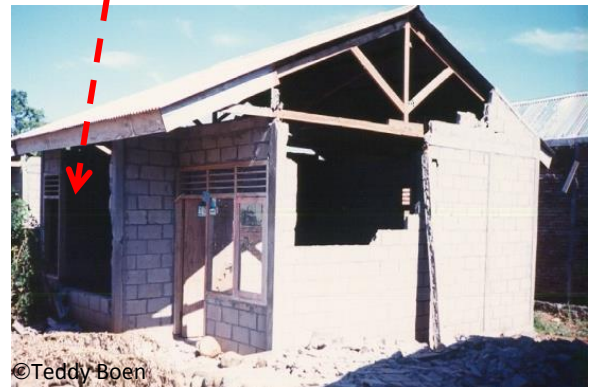
Figure 77 – Actual Damage – Bengkulu Earthquake (2000)

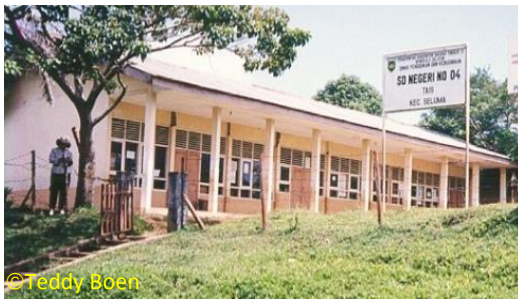
Figure 78 – Actual School Building and 3D Model for Analysis

The analysis is elastic using response spectrum based on the Indonesian Seismic Code 2012 and ASCE7-10 Table 12.2-1 for Bengkulu area (Hard soil; PGA = 0.42g; Importance Factor = 1.5, R = 1.5).

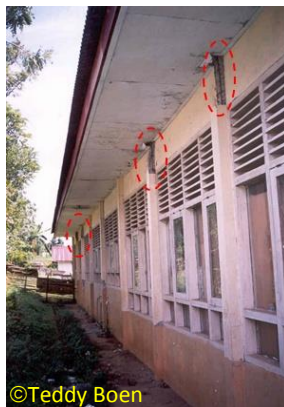
Figure 80 – (a) Actual Column Damage; (b) P-M Column Ratio from Analysis of 3D Model – Red Color Indicates Column Damage Possibility

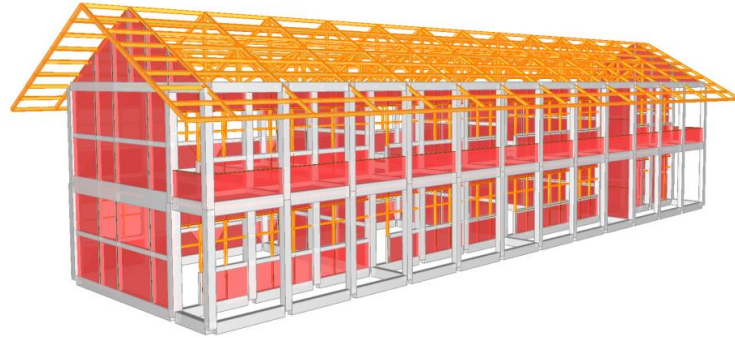
Figure 81 – 3D Model of Two Stories School Building with Confinement

The analysis is elastic using response spectrum based on the Indonesian Seismic Code 2012 and ASCE7-10 Table 12.2-1 for Bengkulu area (Hard soil; PGA = 0.42g; Importance Factor = 1.5, R = 1.5).

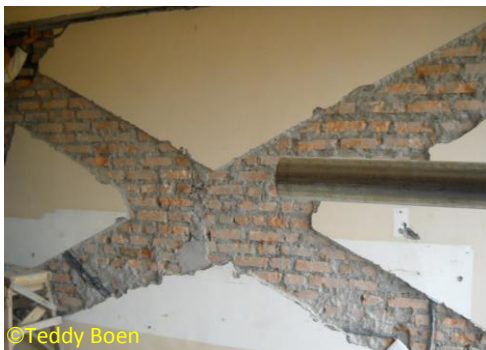
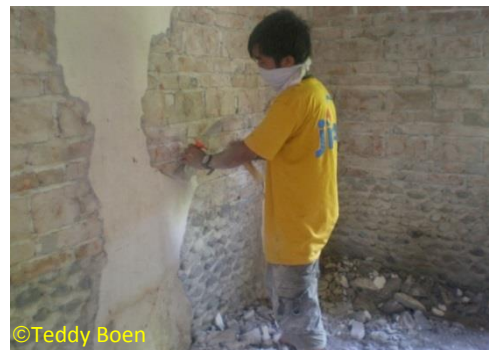
1. Remove the plaster layer around 30-50 cm width vertically and horizontally along corners of the wall and at the corner of openings Figure 89(a) on both inside and outside building. For wall without opening, remove the plaster layer diagonally Figure 89(b&c) on inside and outside as well. If the existing mortar is fragile, peel the whole building plaster layer Figure 89(d).

Figure 89 – Remove Plaster Layer on both Inside and Outside Building

As a variation and for economy in the use of materials, the covering may be in the form of vertical splints between openings and horizontal bandages over spandrel walls at suitable number of points only (IAEE, 1980). This method is applied as explained in Figure 89, p. 126 (Boen, et al., 2012).

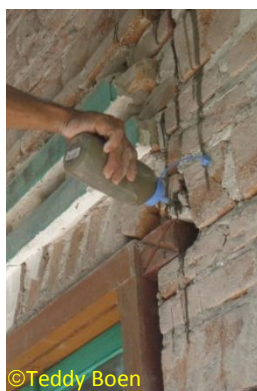
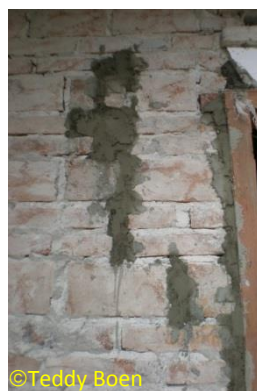
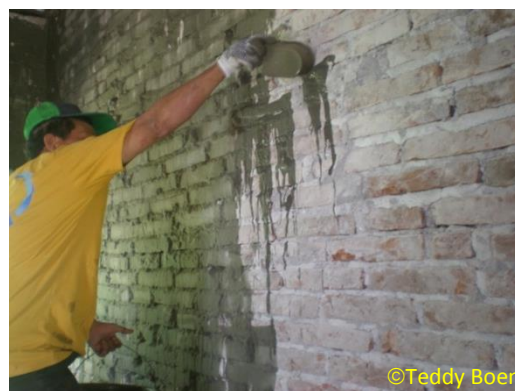
2. The cracks are sealed with cement and sand mortar (Figure 90). Spray the walls with water if the mortar consists of sand and cement. However, if the mortar of the existing walls consist of lime and sand or lime, red-brick powder and sand, without cement, it is better to inject cement water into the mortar.

Figure 90 – Cracks are sealed with Cement - Sand Mortar; Walls are sprayed with Cement-Water

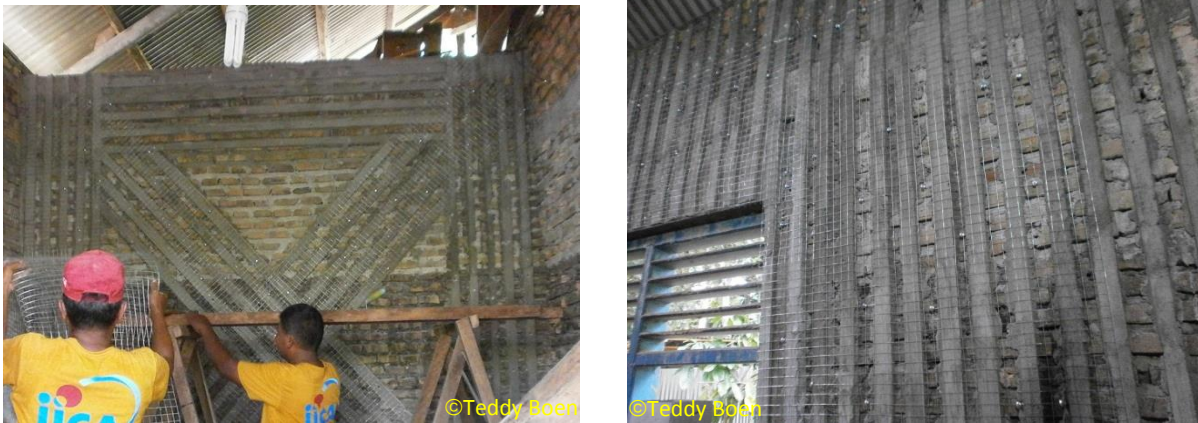
- b. Place the wire mesh at both sides of the wall; nail the wire mesh to the thin beds mortar in several places of the wall to keep the wire mesh in place and

does not shift (Figure 92). Give an extra overlap 15 cm at the wire mesh connections.

Figure 92 – Installation of Wire Mesh; Use Nails to Keep the Wire Mesh in Place

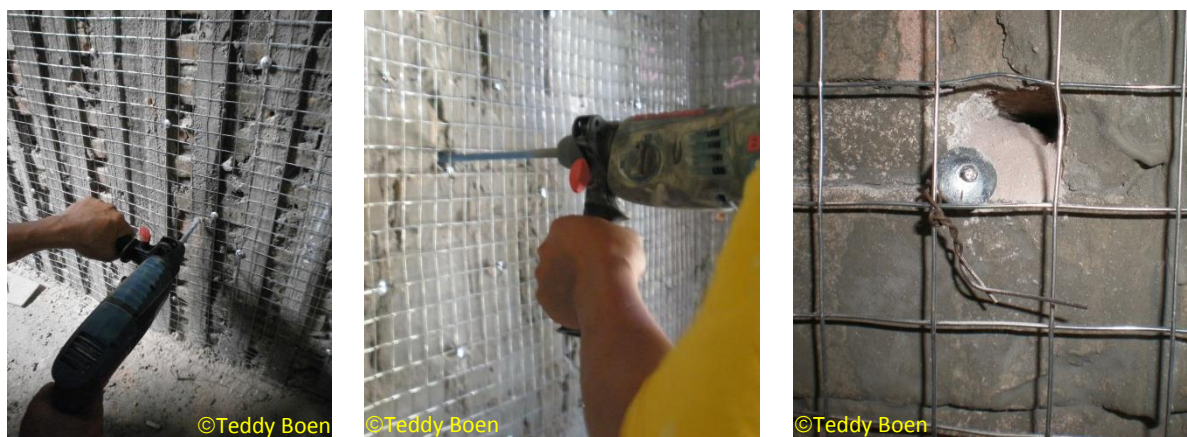
4. Make holes by drilling the masonry wall at the mortar layer, with spacing of approximately every 40 cm to stitch the wire mesh on the inner side of the masonry wall to that of the outer side (Figure 95). If the support is using thin bed mortar, the hole must be drilled on those thin bed mortar and not on the brick-wall.

Figure 95 – Drilling the Walls for Stitching

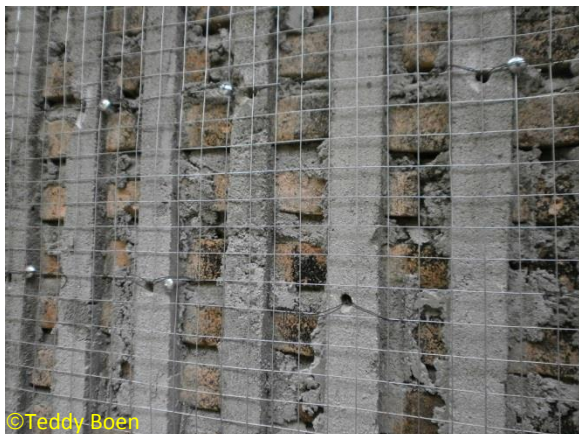
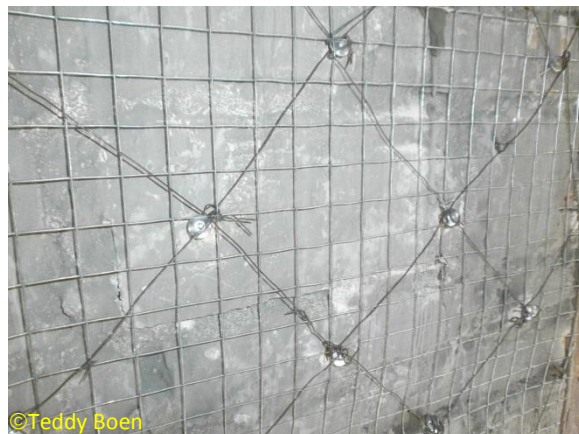
5. Insert tie wire into the holes and stitch the inside and outside wire mesh so that the ferrocement layers on two sides of the wall are tied to each other (Figure 96). The

ties are meant to strengthen bonding and also to make local buckling in the sandwich structures is unlikely.

*Figure 96 – Stitch the Inside and Outside Wire Mesh to Prevent Local Buckling*

As explained in Chapter 3.3 page 68, bonding between the masonry wall and cement mortar plaster is excellent and the ties enhance the bond between masonry and the ferrocement layer and also to make local buckling in sandwich structures for the proposed retrofitting method unlikely. Only material failure is a possibility.

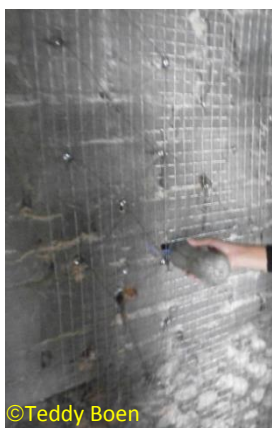
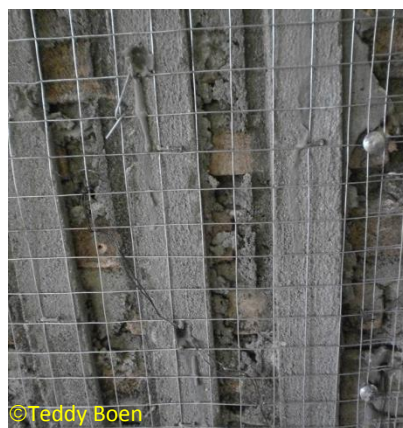
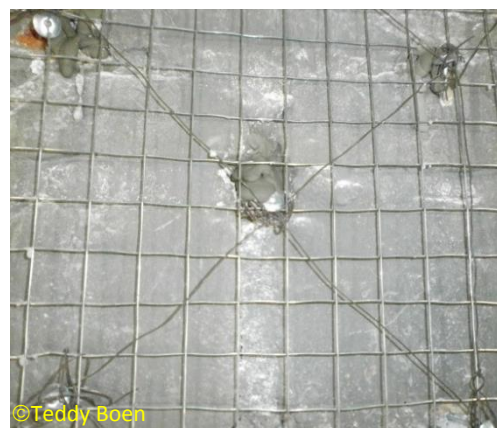
6. Grout the hole using cement paste as can be seen in Figure 97.

*Figure 97 – Grouting of Drill Holes Using Cement Paste*

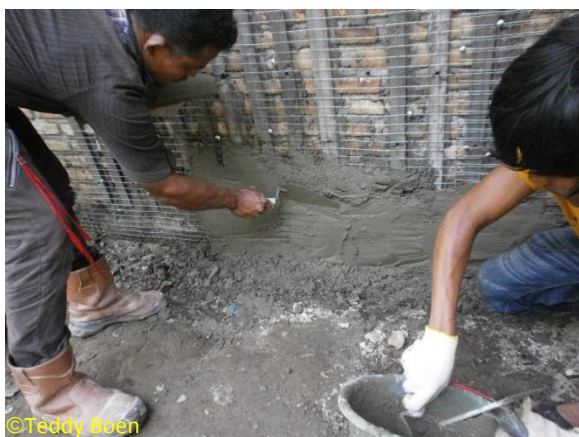
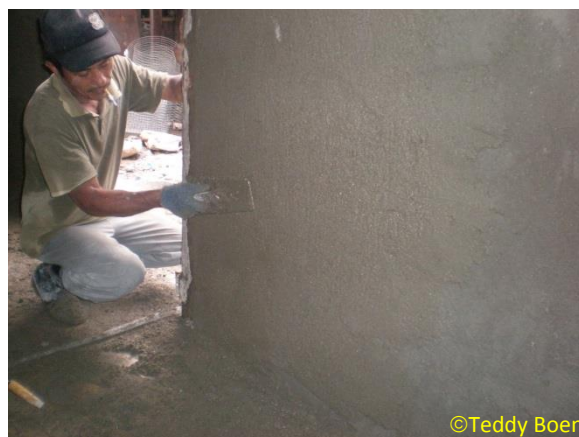
7. Plaster the wall using 1 PC : 4 sand mortar with thickness 1cm on top of the wire mesh (Figure 98). Therefore the ferrocement layer is 2 cm thick with the wire mesh encapsulated in the middle.

*Figure 98 – Re-plaster the Walls; Wire Mesh in the Middle of the Ferrocement Layers*
