# **Challenges and Potentials of Retrofitting Masonry Non-Engineered Construction in Indonesia**

**A Dissertation Submitted for the Fulfillment of  
Doctoral Program  
in Global Environmental Studies**

**Graduate School of Global Environmental Studies  
Kyoto University  
Japan**

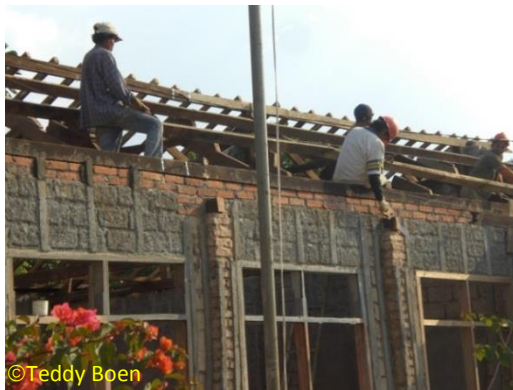
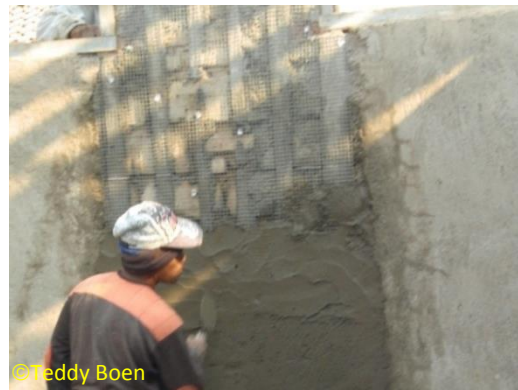
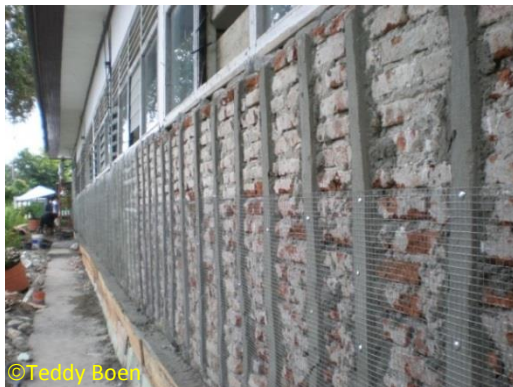
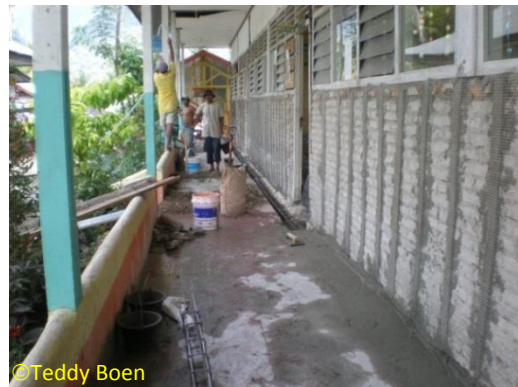
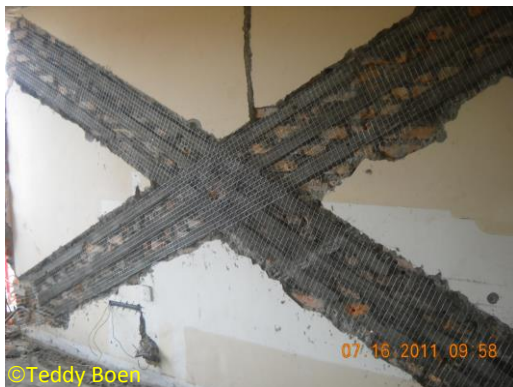
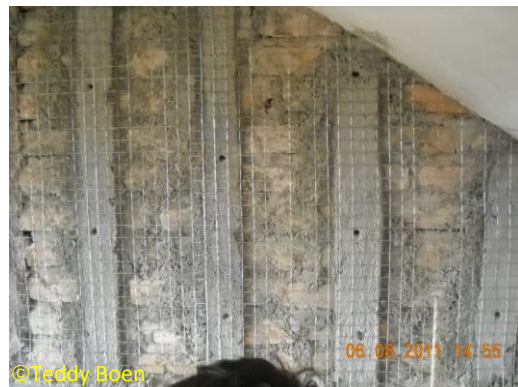
Such retrofitting method using ferrocement as strengthening layers was used when retrofitting two school buildings in Bandung, i.e. SDN Cirateun Kulon II in 2006 and SDN

Padasuka II Soreang in 2007 (United Nations Centre for Regional Development (UNCRD) & Center for Disaster Mitigation (CDM) ITB, 2007). The projects were a collaborative project to reduce the vulnerability of those existing school buildings in the corridor of School Earthquake Safety Initiative (SESI) project. After retrofitting, those school buildings survived the September 2, 2009, West Java earthquake without significant cracks.

Many retrofitting projects were also done using this proposed retrofitting method, especially after the September 30, 2009 West Sumatra earthquake, many school buildings and also an engineered building were retrofitted using this method.

*Figure 99 – Example of Retrofitting Buildings using Wire Mesh*

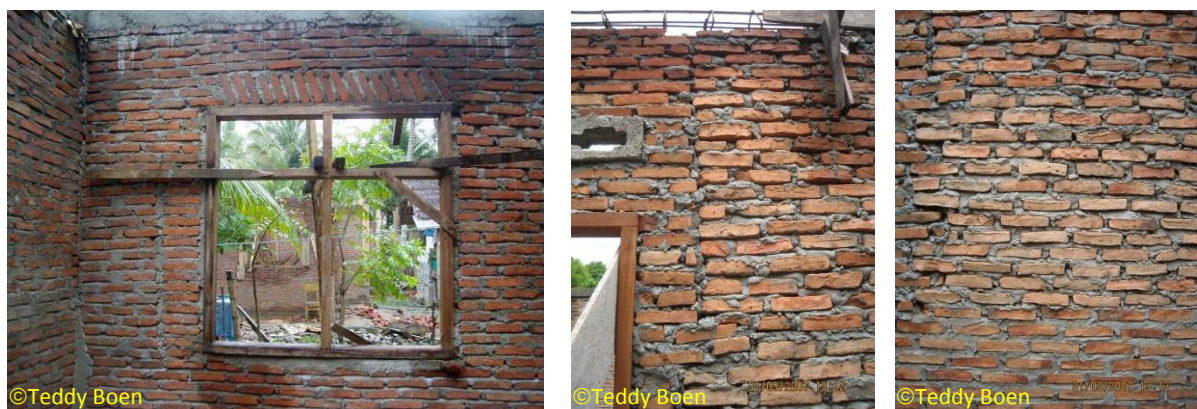
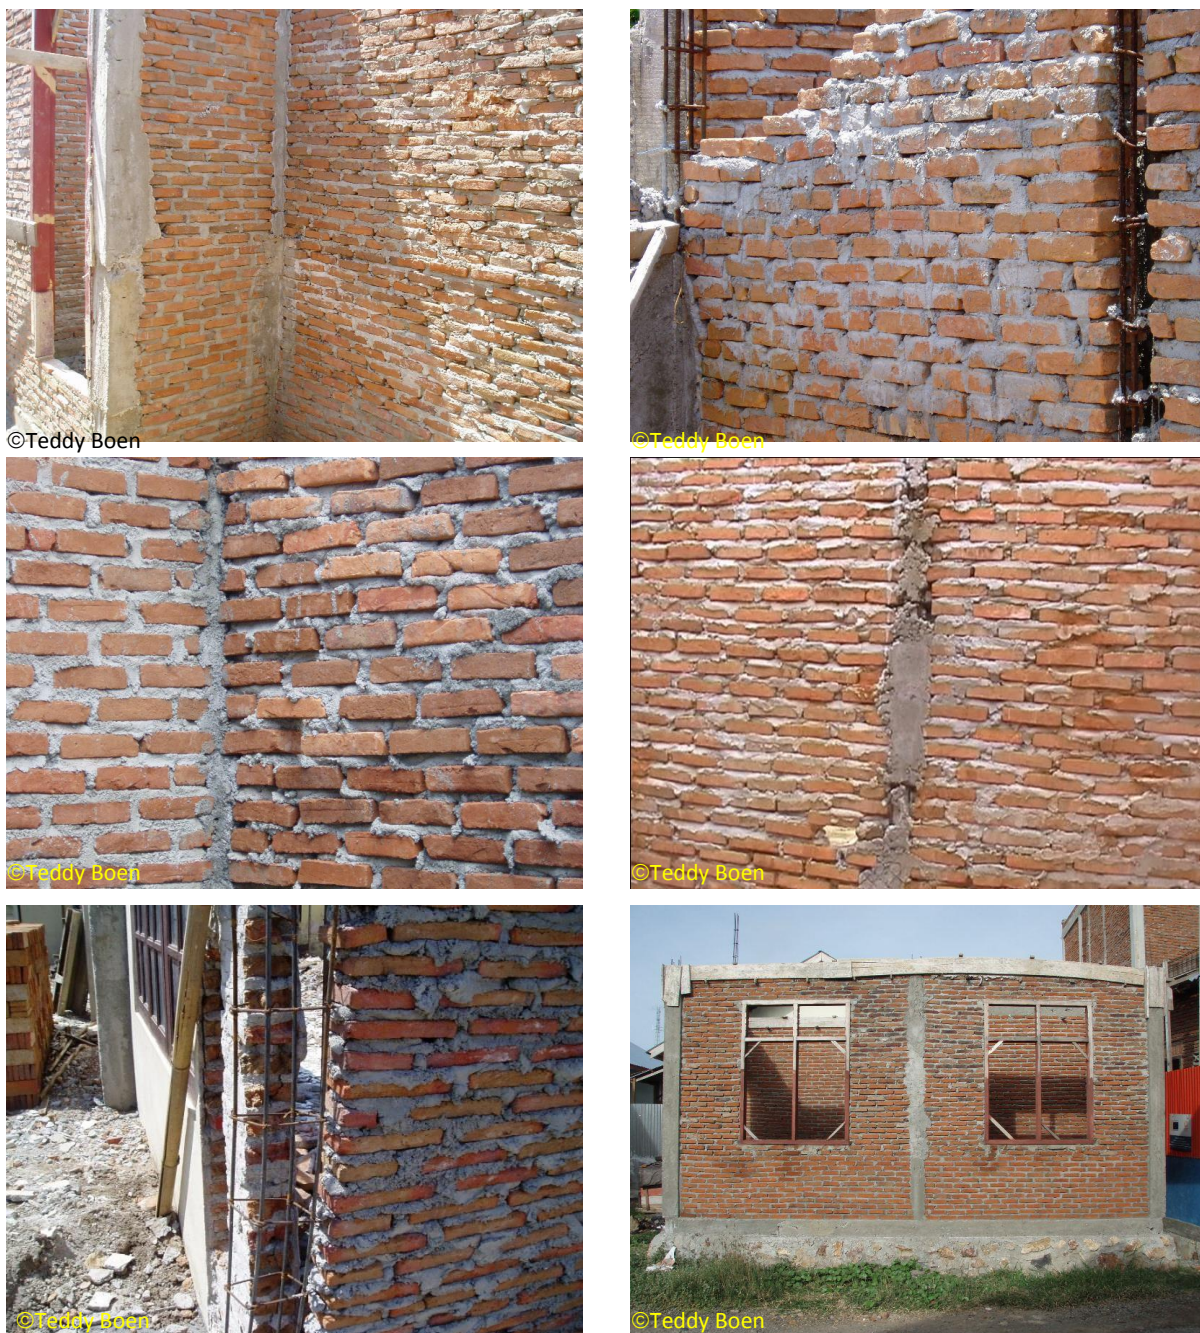
Figure 102 – Poor Workmanship Non-uniformities in Actual Brick Walls

*Figure 102 (cont'd) – Poor Workmanship Non-uniformities in Actual Brick Walls*

Based on observations for the past 40 years, surveys and tests which have been conducted by various agencies as mentioned in Chapter 3.6.1, in Indonesia, there are many variation of bricks dimension. The quality of brick-works also vary, from good enough until poorly brick-work, as can be seen in Figure 102.

Due to numerous uncertainties in the brick wall; such as the quality of brick, mortar's strength, workmanship, non-uniformity of mortar thickness in the joints, curing of the test piece, test procedure, method of loading and handling of specimen, etc. a quantitative analysis especially applying very sophisticated methods of analysis is considered as a waste of time and energy as can be seen in Figure 102. Application of simple algebra and strength

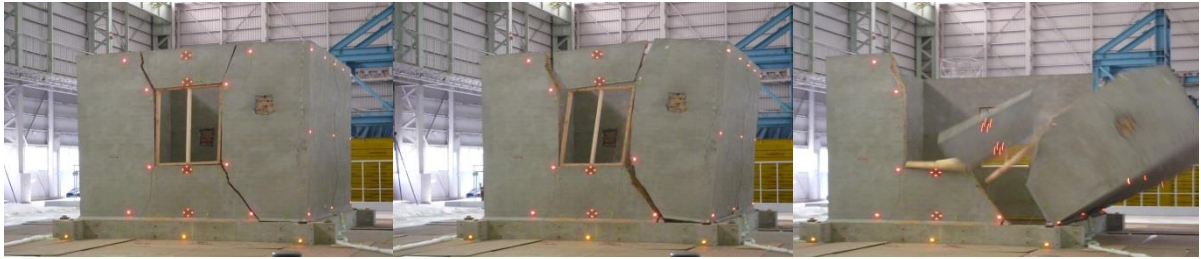
Figure 118 – Sequence Pictures of the Collapsed of Unreinforced Masonry Walls (Imai & Nakatani, 2012)

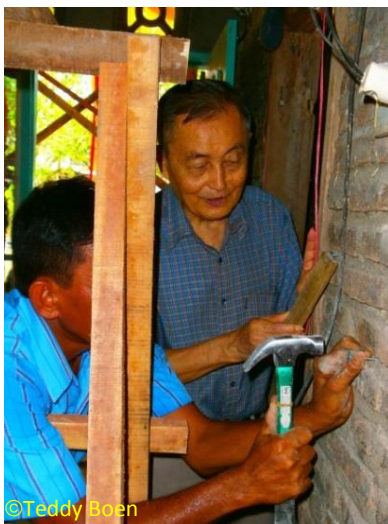
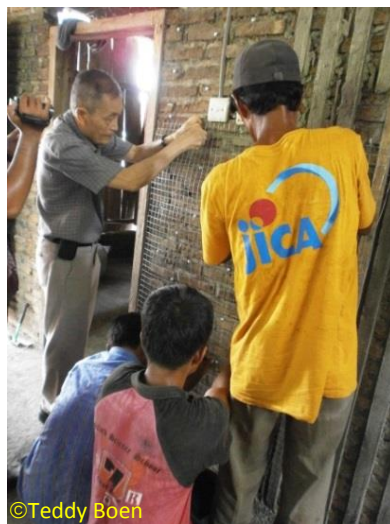
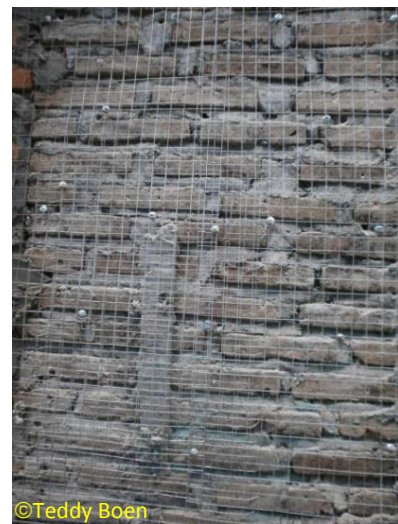
Figure 135 shows the sequence of retrofitting works in Tanjung Basung. The detail explanation of this proposed retrofitting method can be seen in Chapter 5.3 on page 122.

Installation Umbrella-Head-Roofing-Nail as Supports of Wire Mesh

Installation of Wire Mesh, Tie to Umbrella-Head-Roofing-Nail

Wire Mesh Installed and Fastened to Top of Umbrella-Head-Roofing-Nail

Figure 135 – Sequence of Retrofitting Works in Tanjung Basung

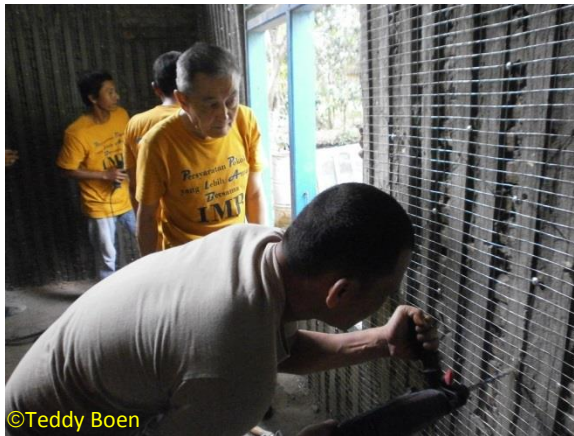
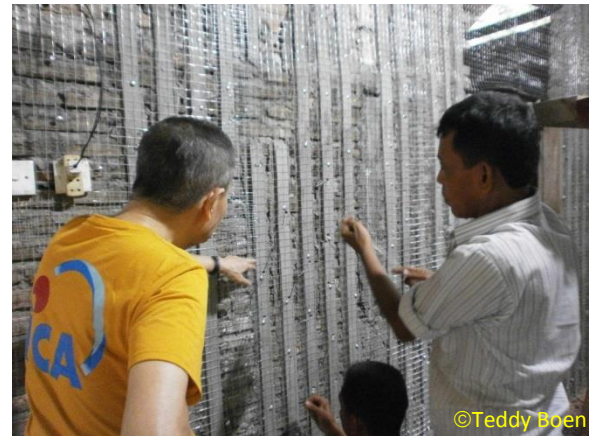
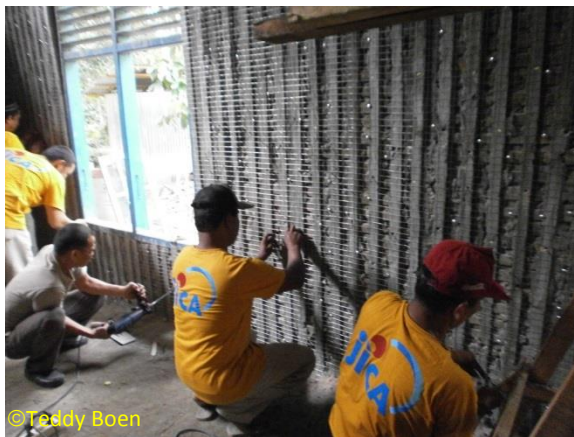
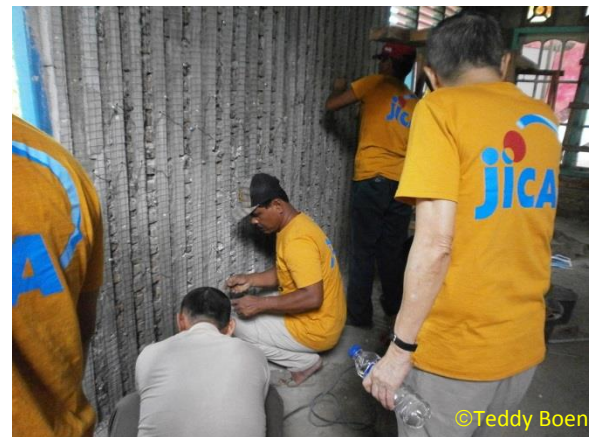
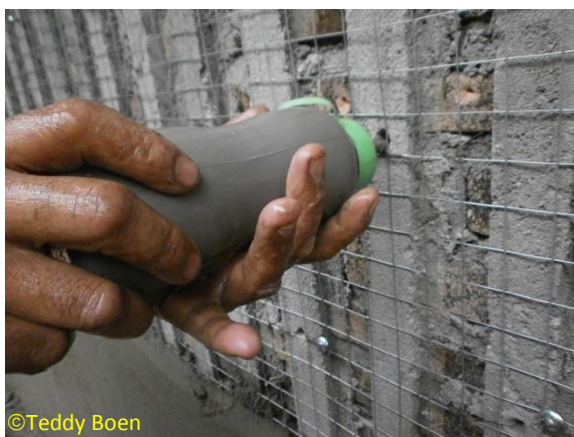
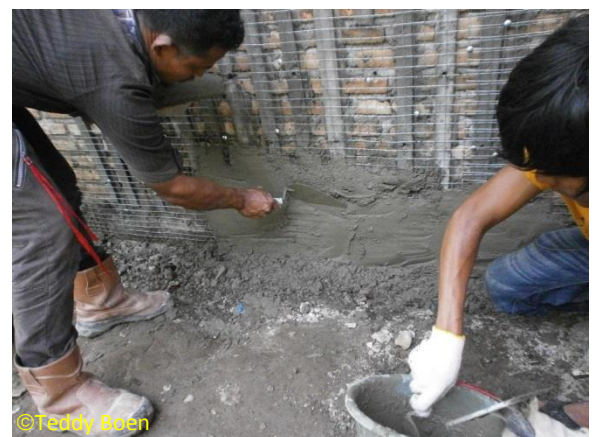
*Drilling the Walls for Stitching*

*Stitching the Inside and Outside Wire Mesh*

*Trained Local Masons Stitching the Inside and Outside Wire Mesh*

*Grouting of Drill Holes using Cement Paste*

*Re-plastering the Wall*

*Figure 135 (cont'd) – Sequence of Retrofitting Works in Tanjung Basung*

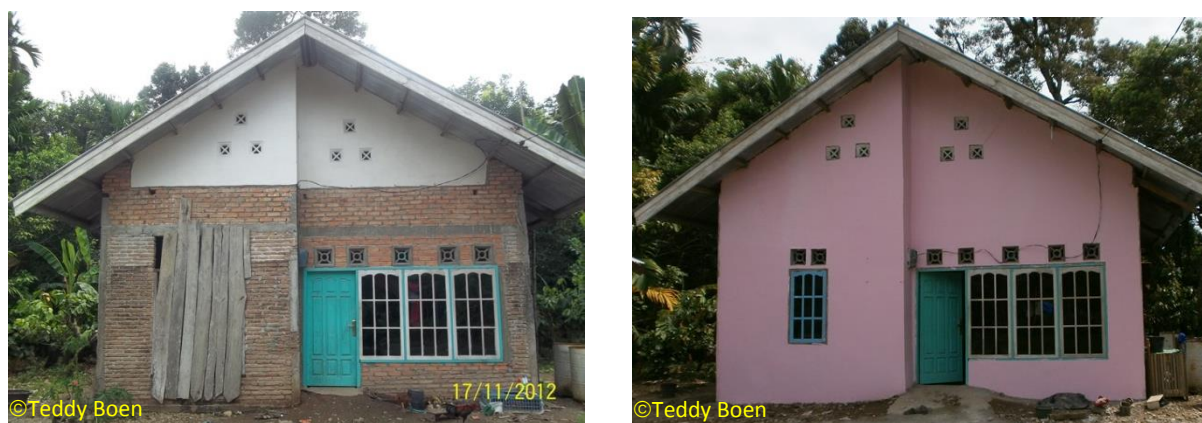
Figure 136 – Before and After Retrofitting, House in Tanjung Basung

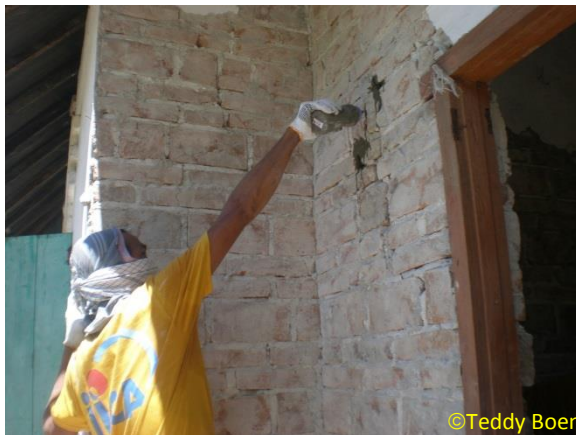
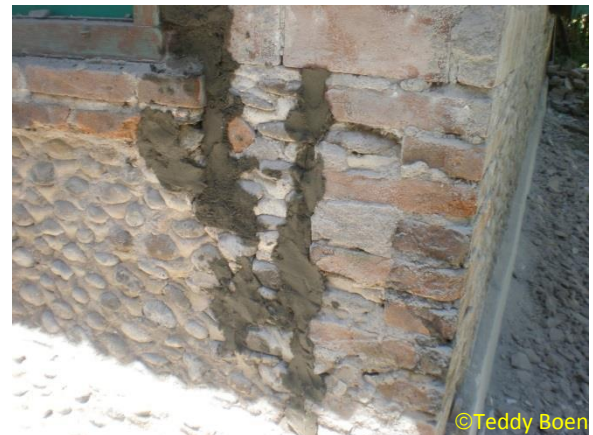
Sealing the Cracks with Cement - Sand Mortar

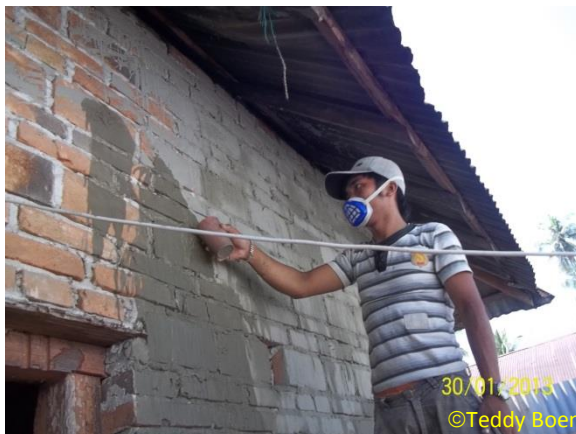
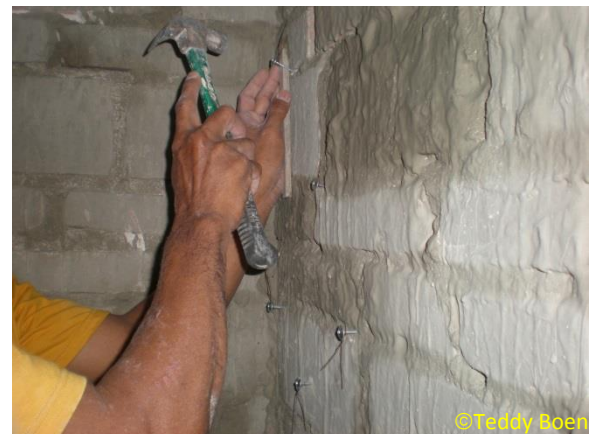
Figure 138 – Sequence of Retrofitting Works in Gadur

Spraying Walls with Cement-Water

Installation Umbrella-Head-Roofing-Nail as Supports of Wire Mesh

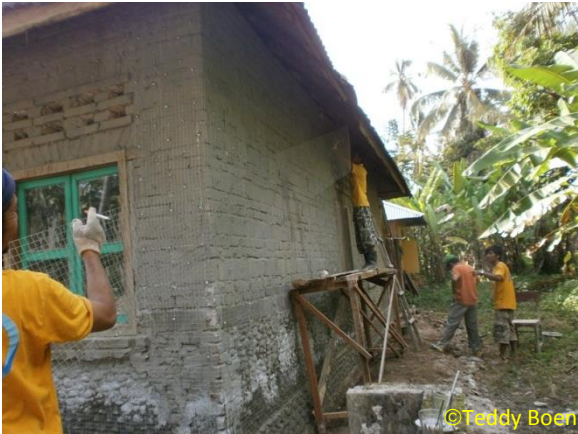
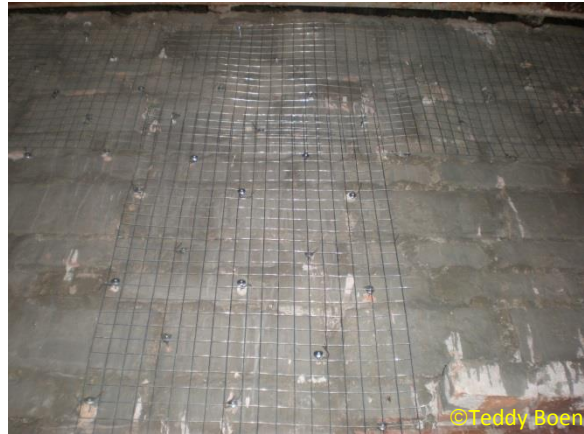
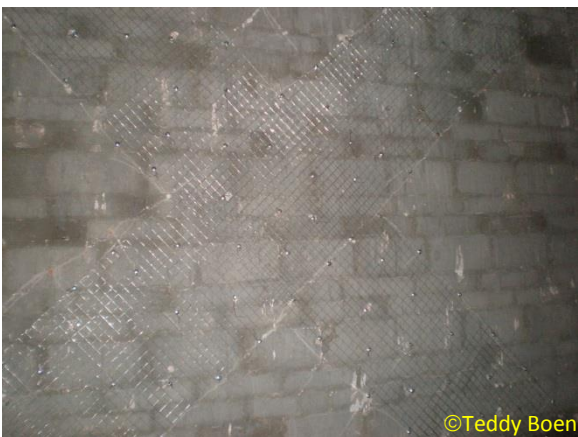
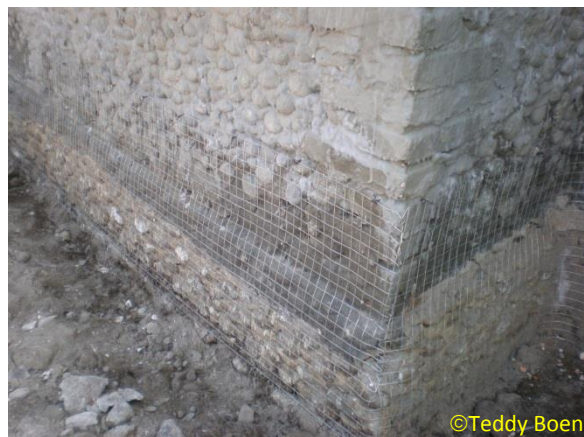
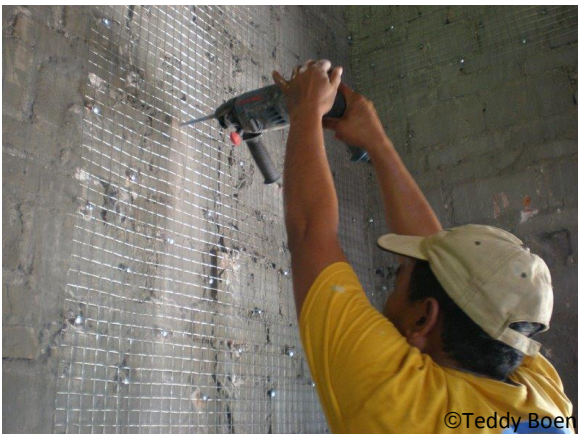
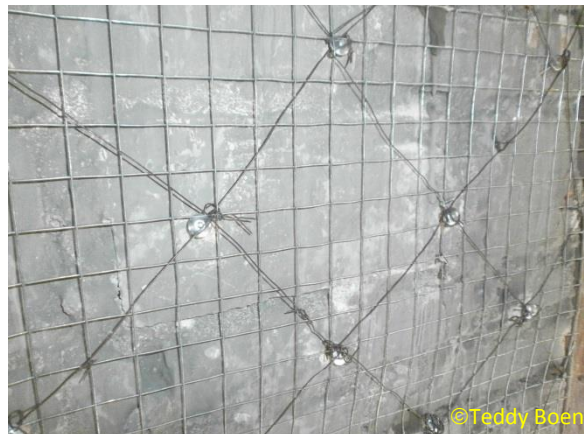
*Figure 138 (cont'd) – Sequence of Retrofitting Works in Gadur*

*Installation of Wire Mesh, Tie to Umbrella-Head-Roofing-Nail*

*Wire Mesh Installed and Fastened to Top of Umbrella-Head-Roofing-Nail*

*Diagonal Ferrocement Layer*

*Ferrocement as Foundation Beams*

*Drilling the Walls for Stitching*

*Stitching the Inside and Outside Wire Mesh*

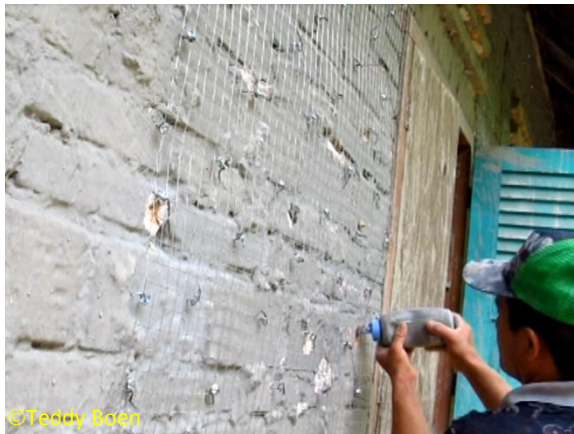
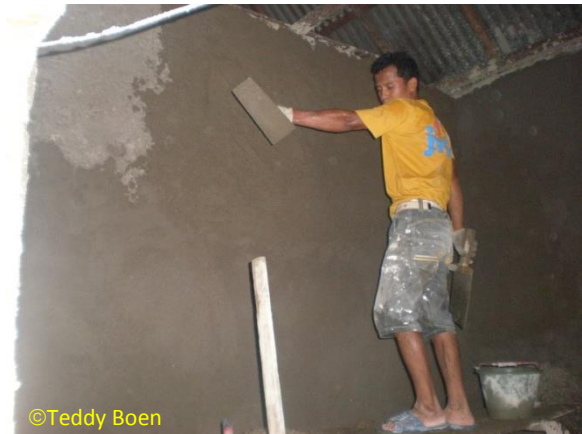
*Figure 138 (cont'd) – Sequence of Retrofitting Works in Gadur*

*Grouting of Drill Holes using Cement Paste*

*Re-plastering of Wall*

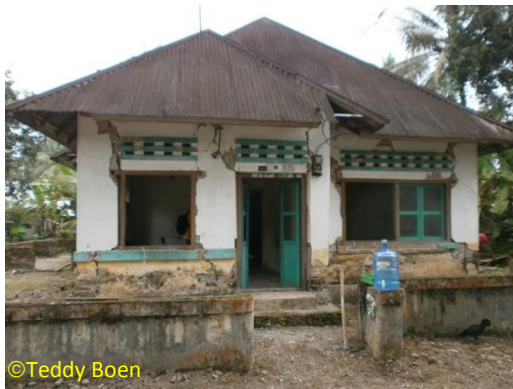
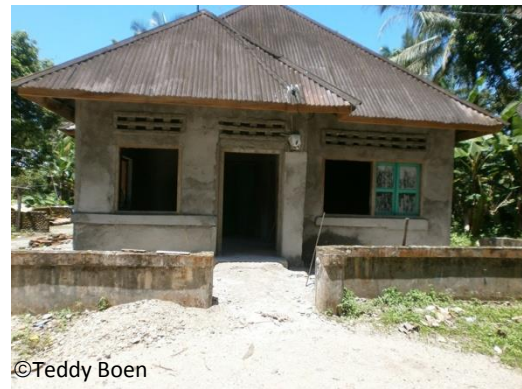
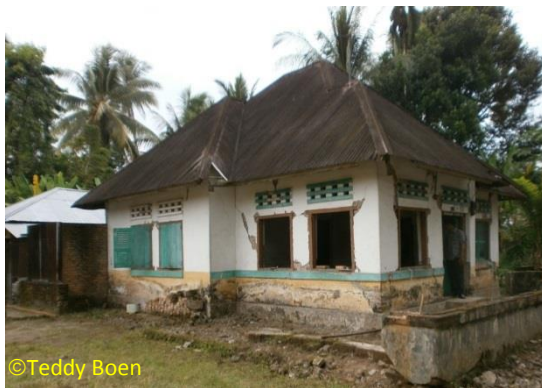
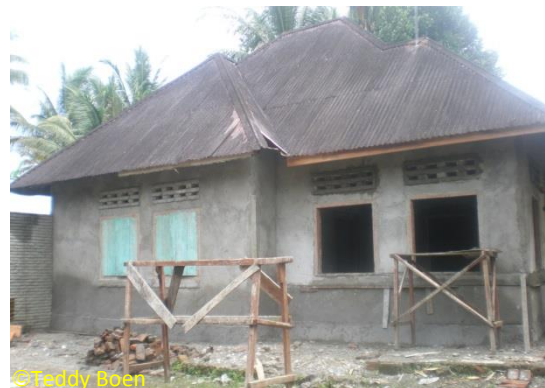
*Figure 139 – Before and After Retrofitting, House in Gadur*

In January 2013, once again JICA sponsored the retrofitting of a non-engineered masonry house in Gadur, Pariaman, West Sumatra using the proposed retrofitting method. Figure 137 shows the layout of the retrofitted house. The total footprint of the house is 61.6m<sup>2</sup>. The ferrocement layers were only applied as substitute of “practical” columns and “practical” beams 50cm width and diagonally. Figure 138 show the sequence of retrofitting works in Gadur. Local masons were also trained similar to that in Tanjung Basung, namely on how to install umbrella-head-roofing-nails and fastening the wire mesh. Similar to Tanjung Basung, the local masons can absorb what is being taught within several minutes only.
