# Seismic Response and Train-running safety of Two-Story Reinforced Concrete Viaduct with Seismically Repaired Middle Beams

**Abstract:** On March 16, 2022, a magnitude 7.4 earthquake, hereinafter referred to as the 2022 Fukushima EQ, struck off the coast of Fukushima Prefecture. The 2022 Fukushima EQ caused the derailment of a Tohoku Shinkansen bullet train and inflicted damage on seismically repaired middle beams of two-story reinforced concrete (RC) viaduct. This study evaluated the seismic performance and train-running safety of a two-story RC viaduct, specifically focusing on those with seismically repaired middle beams, using incremental dynamic analysis. To evaluate the impact of seismic repairs on train-running safety, we adopted a method that calculates the spectral intensity (SI) of the acceleration response time history at the top of the viaduct during seismic events. This study defines the SI value derived from the acceleration response at the top of the viaduct as  $SI_{top}$ , distinguishing it from the commonly used SI value, which describes the intensity of seismic waves. The numerical model representing the as-built condition of the viaduct was labeled the 'As-bui

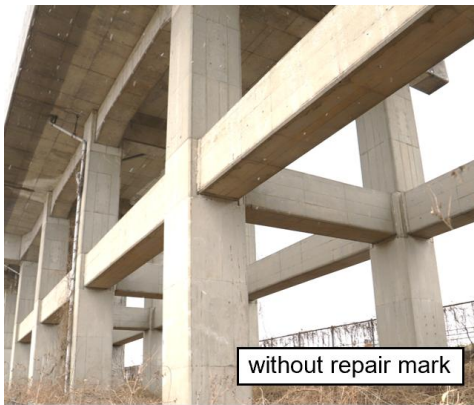
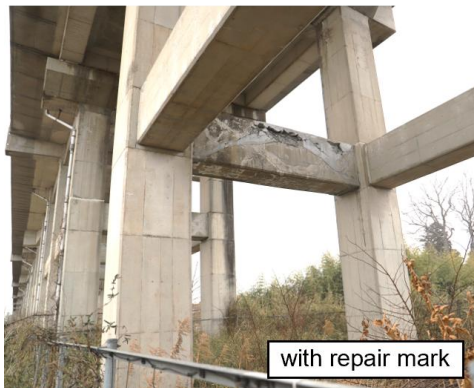
**Fig. 1.** Damage to middle beams with repair mark, photographed on 18 March 2022.

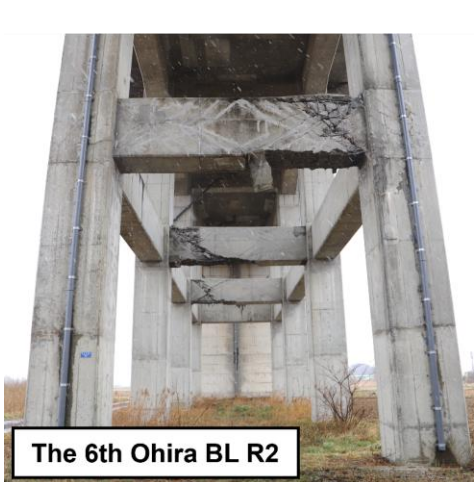
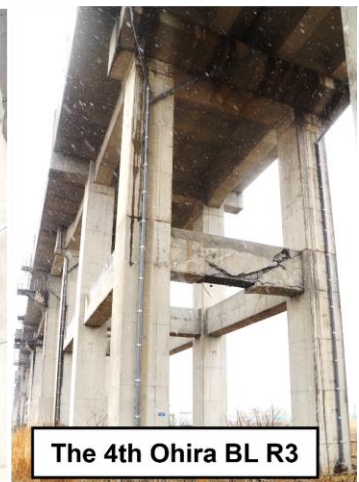
**Fig. 2.** Damage to two-story RC viaduct at the site of the bullet train derailment, photographed on 18 March 2022.

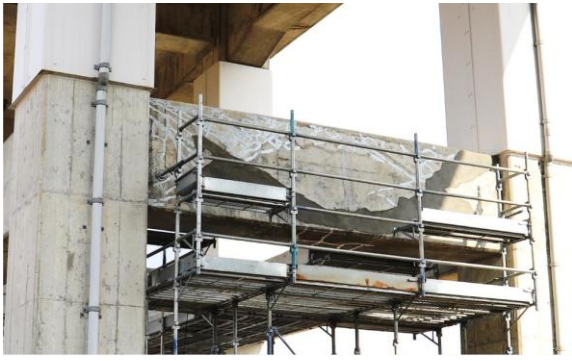
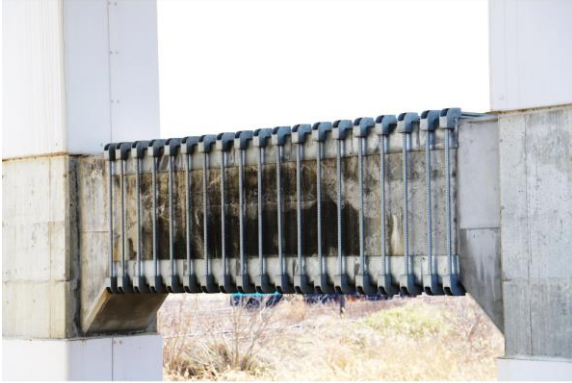
**Fig. 14.** Repair method for middle beams of real-life two-story RC viaducts, photographed on 20 February 2021: (a) resin injection method and cross-sectional restoration using mortar; and (b) RB method.

When an earthquake damages middle beams of two-story RC viaducts on Tohoku Shinkansen Line, resin injection is commonly employed to repair the resulting cracks (**Fig. 14 (a)**). When concrete spalling occurs, cross-sectional restoration using mortar is also utilized. In certain instances, RB method is applied for shear retrofitting of the middle beams (**Fig. 14 (b)**). This method involves adding external transverse reinforcements around the existing RC members, with the four corners secured by L-shaped steel plates.

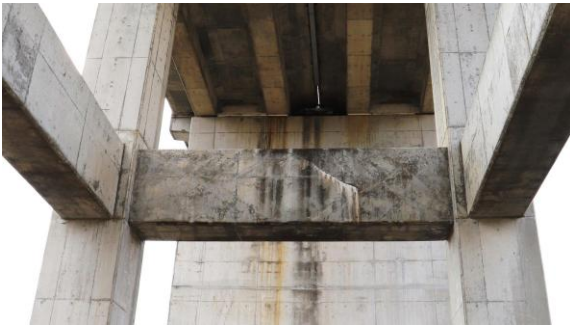
**Fig. 16.** Actual repair conditions on the middle beams of two-story RC viaduct at the site of bullet train derailment, photographed on 20 February 2021.
