# Micro-Process of the Tilting Motion of Ground and Structures

Yoshiro Itō

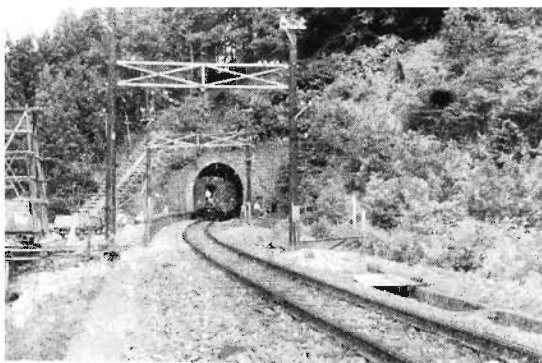
Fig. 12a.

The railway tunnel concerned is an old tunnel of Jōetsu Line in Niigata Prefecture constructed about 20 years ago. (see Fig. 12a)

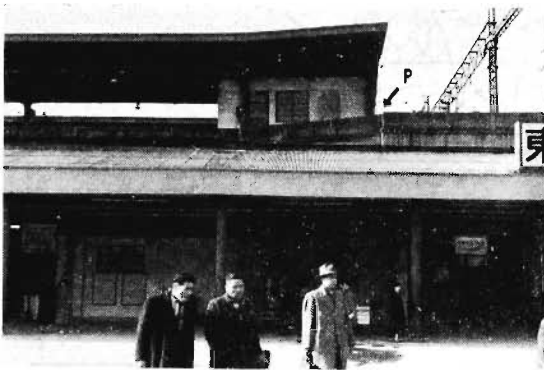
Fig. 20. Photograph of a part of Osaka Station.  
P corresponds to P in Fig. 19.

ferent piles. The amount of sinking during 10 years after the establishment in 1934 was measured as shown in the lower figure in Fig. 19, reaching a surprisingly large amount of 100 cm in 10 years, and its effect is clearly seen in the photograph in Fig. 20.

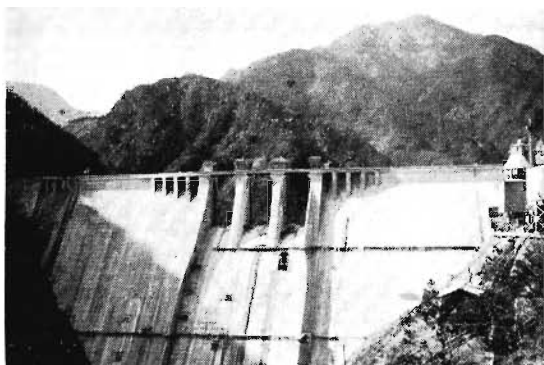
Fig. 31a. Photograph of Miyagawa Dam.

The Miyagawa Gravity Dam is situated at the upper stream of River Miya in Mie Prefecture. Its height, length and volume are 88.5 m, 225 m and 380,000 m<sup>3</sup> respectively of which construction was initiated in 1953 and completed in December, 1956. The foundation rock is tight diabase, and no remarkable fault is found around the dam foundation. The capacity of impounding reservoir (pool) is about 64,000,000 m<sup>3</sup>, and the traverse and longitudinal sections are respectively represented in Figs. 31a and 31b.
