# Hammering sound of concrete with defects and spalling risk

## Abstract

*Keywords:* Plain concrete, Spalling defects, Hammering test, Maintenance, Sound

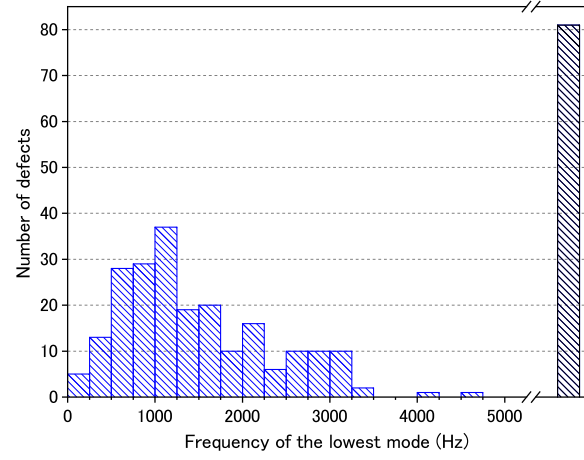
Figure 1: Distribution of lowest mode frequency in defect area rated as  $\beta$  in unreinforced concrete sections of tunnels.

The low-frequency vibrations of the defects are less likely to be transmitted to the air as sound pressure. Moreover, the human ear is less sensitive to such low-frequency sounds. Hence, low-frequency vibration may not affect the hammering sound. The presence or absence of defects can be distinguished by the hammering sound. However, the spalling risk cannot be accurately evaluated from the sound alone. This is one of the main reasons for spalling risk overestimation by human inspectors, as shown in Figure 1.

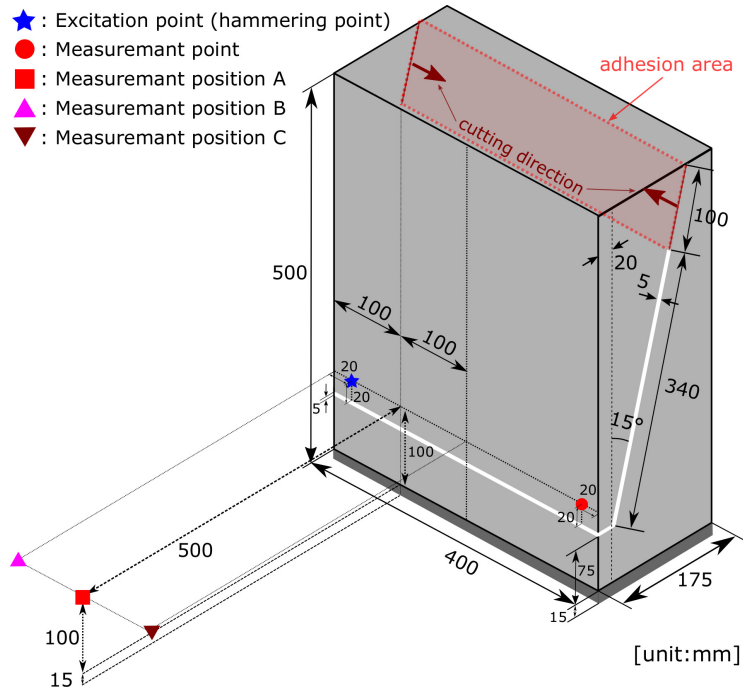
Figure 2: Dimensions of concrete specimen with vibration excitation and measurement points, and positions of sound pressure measurement.

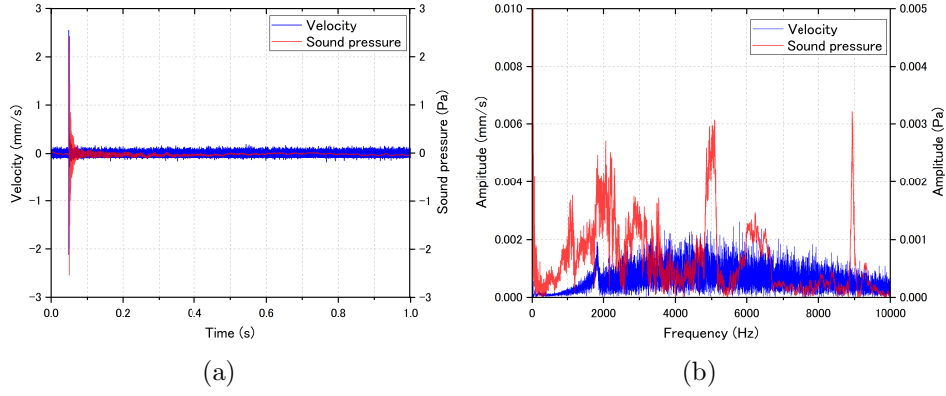
Figure 3: Vibration and sound in good concrete: (a) time history waveforms; (b) Fourier spectra of waveforms.

In the hammering test on good concrete, there is no correlation between the spectra of the vibration and sound, as shown in Figure 3. The hammering sound is considered to have been generated by the vibration of the

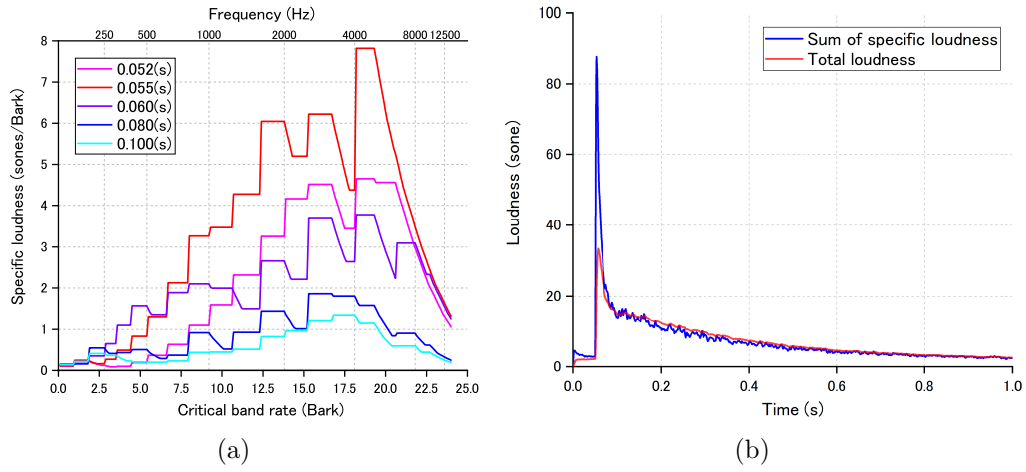
Figure 4: Loudness of hammering sound in good concrete: (a) specific loudness; (b) total loudness.

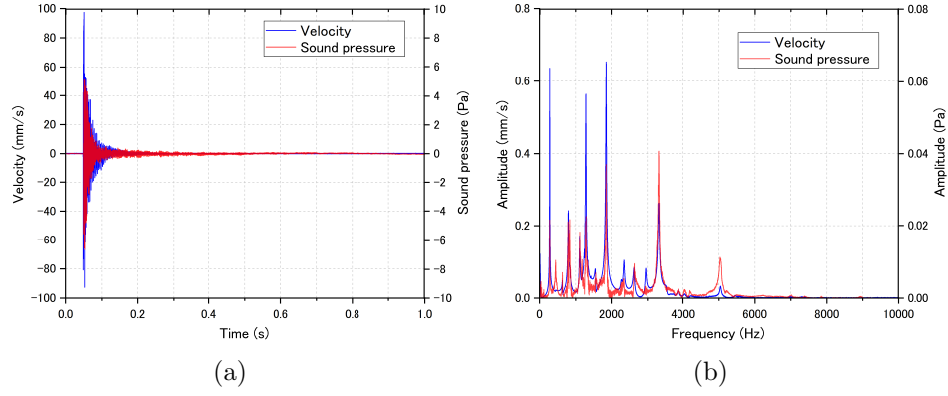
Figure 5: Vibration and sound in specimen before cut: (a) time history waveforms; (b) Fourier spectra of waveforms. The sound was measured at position A.

hammer itself. In contrast, in the hammering test on concrete with defects, the spectra of the vibration and sound are correlated, as shown in Figure 5. The hammering sound was mainly generated by the natural vibration of the defects. The vibration sound of the hammer itself was almost inaudible in the hammering test on the concrete with defects because the sound pressure was relatively small and drowned out by that induced by the defect vibration. This can be confirmed by comparing Figures 3 (b) and 5 (b). The peak value of the spectrum with defects is more than ten times larger than that of the spectrum without defects.

By comparing the results in Figures 5 (b) and 7 (a), it can be found that the specific loudness below 250 Hz was relatively small for the amplitude of the sound pressure spectrum. In contrast, the specific loudness in the vicinity of 3000 Hz was relatively large. The human auditory characteristics can also be confirmed for other cases by comparing Figures 8 and 9. The results are consistent with the equal-loudness contour characteristics defined in ISO 226. Low-frequency sounds, whose wavelength is much longer than the size of the human head, are relatively hard to hear.

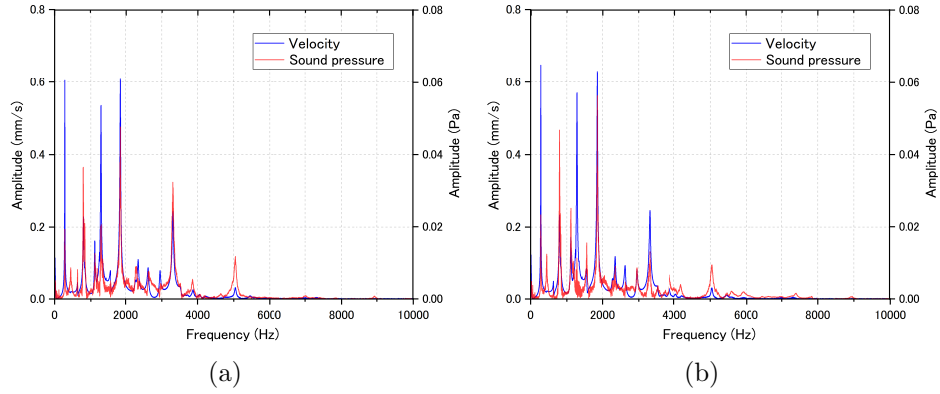
Figure 6: Fourier spectra of vibration and sound in specimen before cut. The sounds were measured at (a) position B and (b) position C.

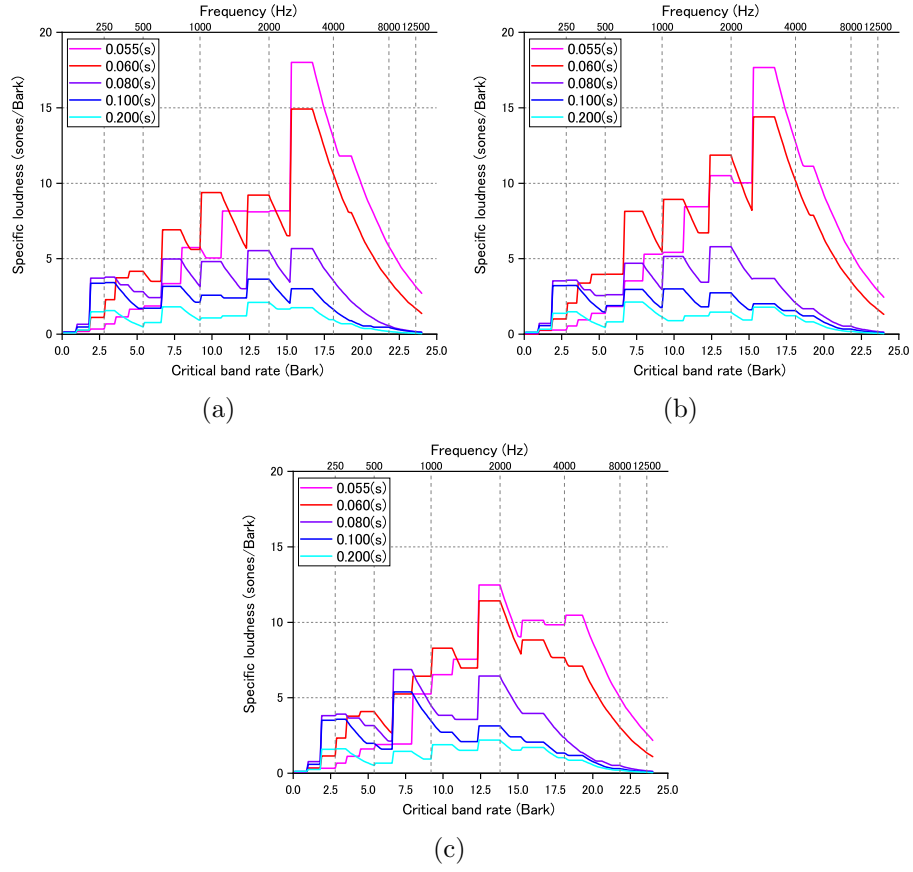
Figure 7: Specific loudness of hammering sound in specimen before cut. The sounds were measured at (a) position A, (b) position B, and (c) position C.

The hammering sound was slightly different depending on the measurement position, as shown in Figure 7. The specific loudness corresponding to the range below 250 Hz was the same at all three points. The reason for this is that the wavelength of low-frequency sound waves is long compared with the difference of the measurement positions. For example, the wavelength of the 250 Hz sound wave is approximately 1.4 m, which is 14 times larger than the difference at the position of 10 cm.

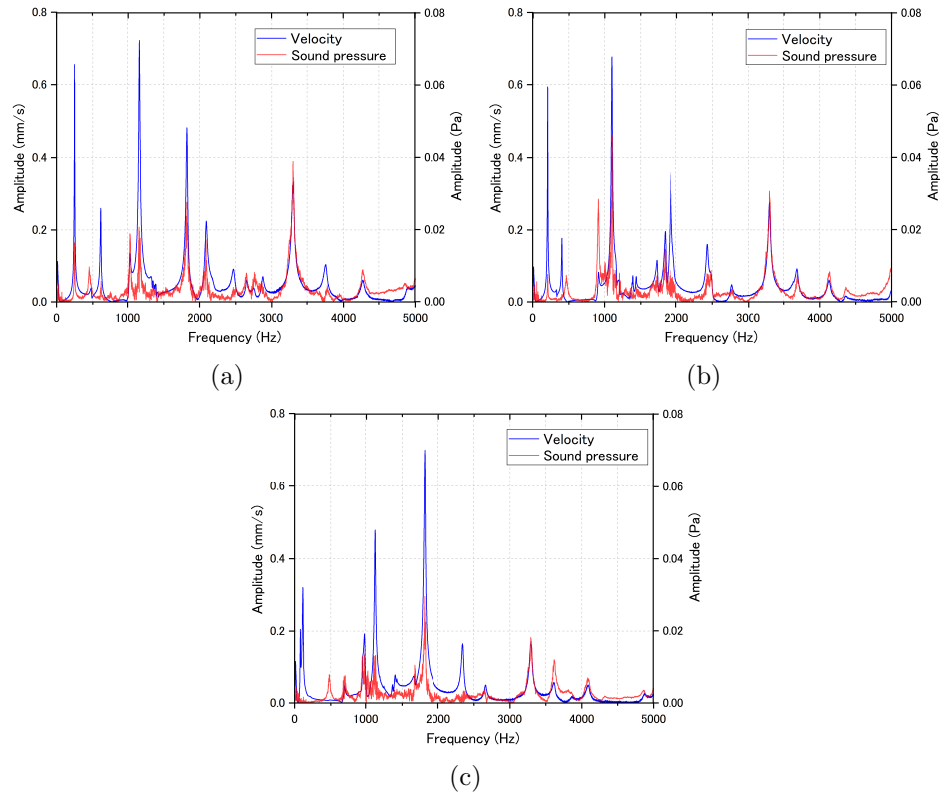
Figure 8: Change in Fourier spectra of vibration and sound with increase of cut length. The sound was measured at position A. The cut length was (a) 20 cm, (b) 30 cm, and (c) 38 cm.

As shown in Figure 8, a spectral peak of sound that is different to the natural frequency of the concrete defects was observed around 500 Hz. This was caused by the air resonance generated in the gap of the detachment, as predicted from Figures 12 and 15. Such sounds may even occur in actual gaps such as cracks and openings.

As the cut length of the specimen increased, the sound pressure of the low-frequency vibration decreased, as shown in Figure 8. This result is consistent with the numerical results, as shown in Figures 12 and 16. This decrease was because the low-frequency vibrations of the defects that are lower than a certain threshold are less transmitted to the air as sound pressure. The radiation efficiency of a baffled beam, which is the ratio of the sound power radiated from a structure to that of a piston with the same size moving with the same average velocity, decreases for frequencies well below the critical frequency (Wallace, 1972a). The critical frequency is the frequency for which the wavelength of the standing wave on the beam is equal to the wavelength of the radiated acoustic wave. Similar results have been obtained for a plate (Wallace, 1972b; Berry et al., 1990). The specimen and actual defects have

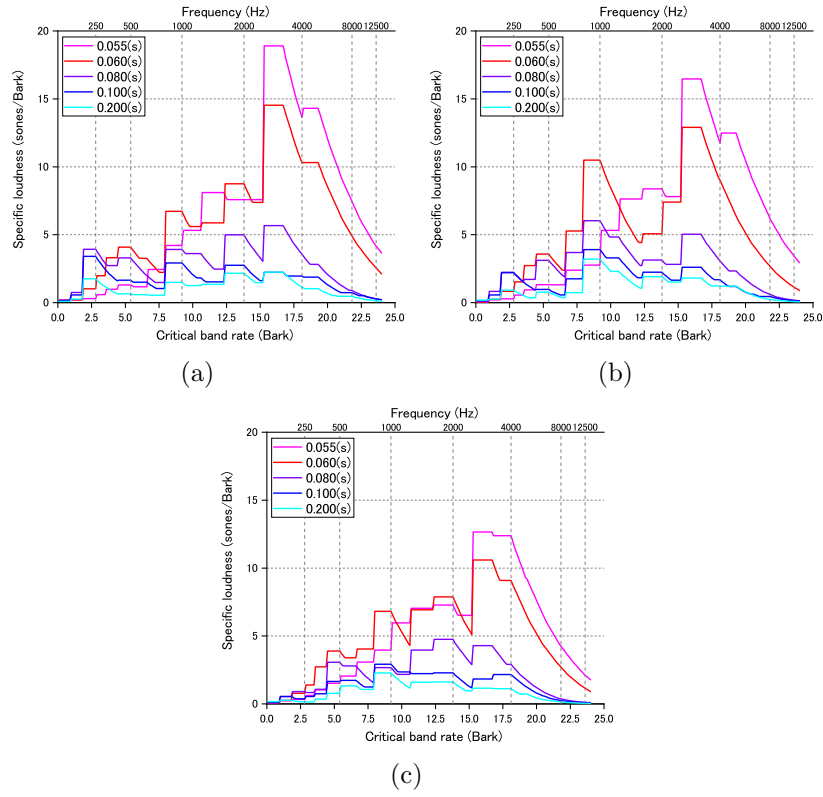
Figure 9: Change of specific loudness of sound with increase of cut length. The sound was measured at position A. The cut length was (a) 20 cm, (b) 30 cm, and (c) 38 cm.

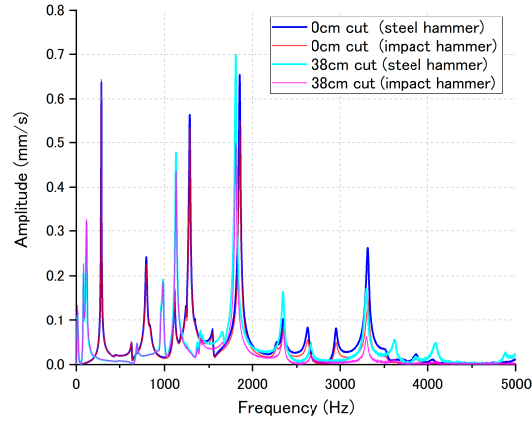
Figure 10: Comparison between Fourier spectra of vibration induced by steel hammer and Fourier spectra of vibration induced by impact hammer.

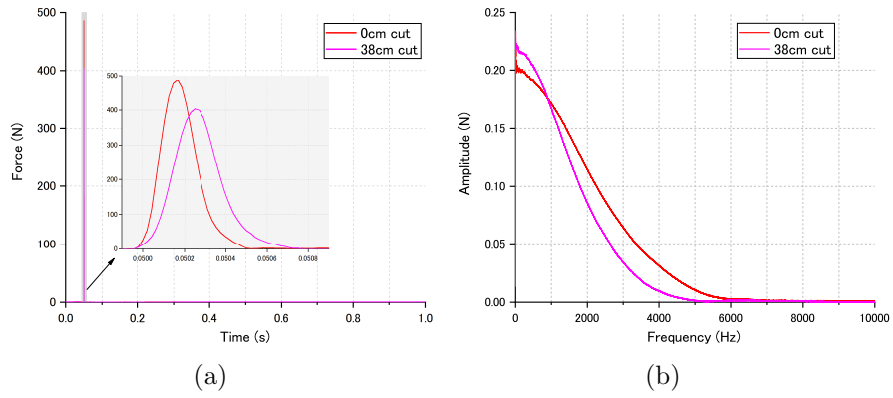
Figure 11: Force signals induced by impact hammer: (a) time history waveforms; (b) Fourier spectra of these waveforms.

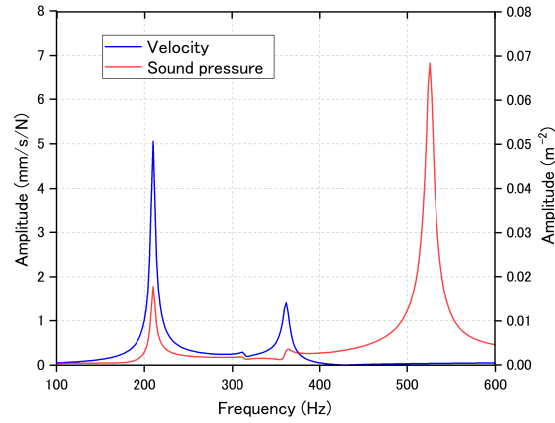
Figure 12: Frequency response functions obtained in specimen after cut of 30 cm, as obtained by numerical analysis. The sound was measured at position A.

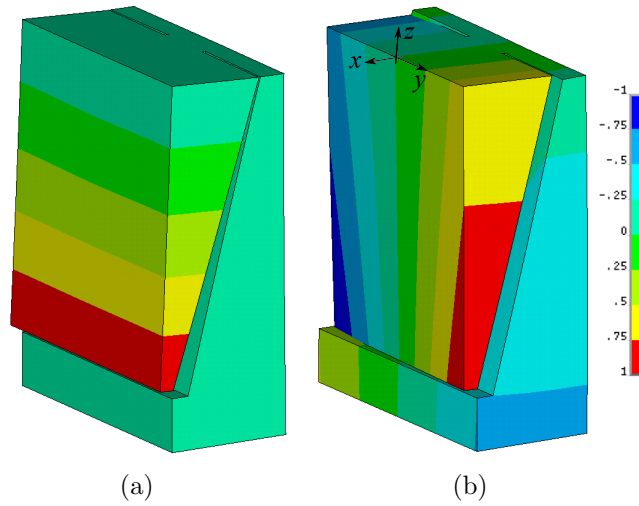
Figure 13: Deformation in  $x$ -direction of low-order vibration modes in specimen after cut of 30 cm. The natural frequency was (a) 210 Hz and (b) 362 Hz.

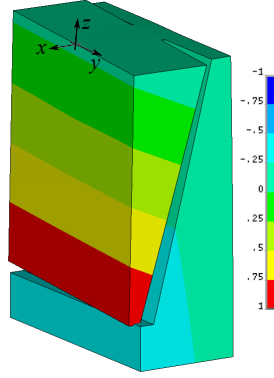
Figure 14: Deformation in  $z$ -direction of low-order vibration modes in specimen after cut of 30 cm. The natural frequency was 314 Hz.

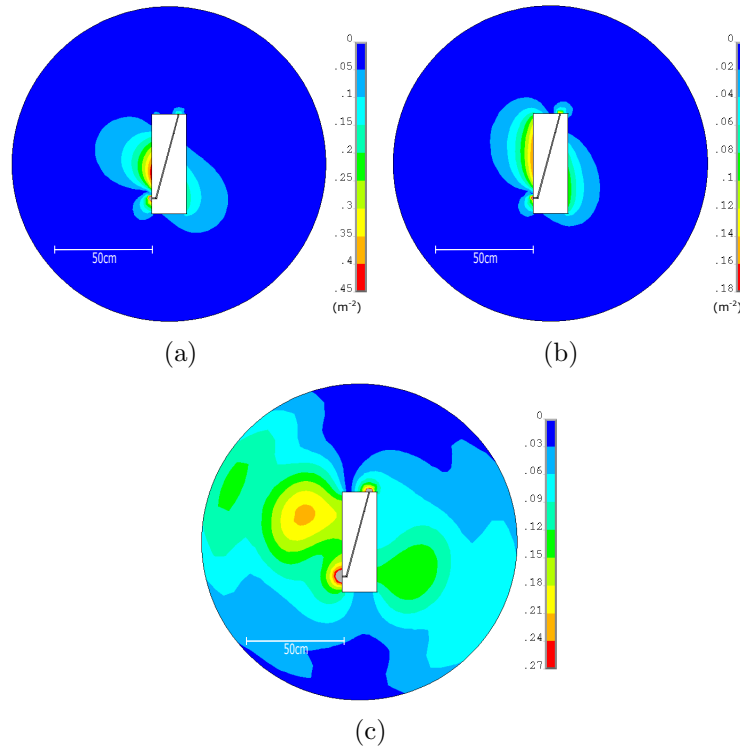
Figure 15: Spatial distribution of maximum sound pressure in specimen after cut of 30 cm on cross-section  $y = -10$  (cm). The vibration frequency was (a) 210 Hz, (b) 362 Hz, and (c) 526 Hz.

section  $y = -10$  (cm) at 98 Hz and 152 Hz. Compared with the 30 cm cut shown in Figure 15, the magnitude of the sound pressure on the specimen was reduced. Moreover, the sound pressure decayed faster as the distance from the specimen increased.

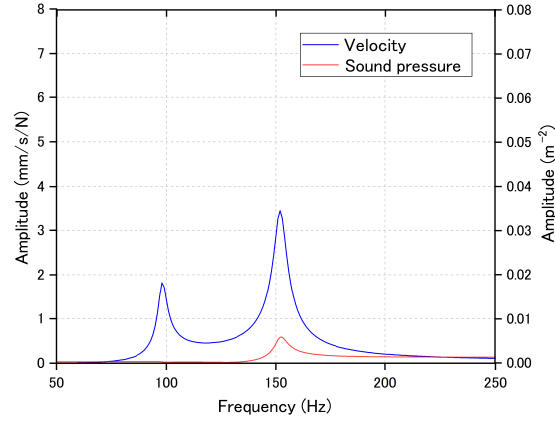
Figure 16: Frequency response functions in specimen after cut of 38 cm, as obtained by numerical analysis. The sound was measured at position A.

Figure 16 shows the frequency response functions in the specimen after a cut of 38 cm. The results were calculated in the range of 50–250 Hz in 1.0 Hz increments. The alpha damping and beta damping values were 15 and  $2.5 \times 10^{-5}$ , respectively. The damping ratio in the range of 100–150 Hz was approximately 2 %. Large velocity responses were observed at 98 Hz and 152 Hz. In contrast, there was almost no sound pressure response at 98 Hz. The deformation with the natural frequencies of 98 Hz and 152 Hz was similar to that shown in Figure 13 (b) and (a), respectively. Figure 17 shows the spatial distribution of the maximum sound pressure on the cross-

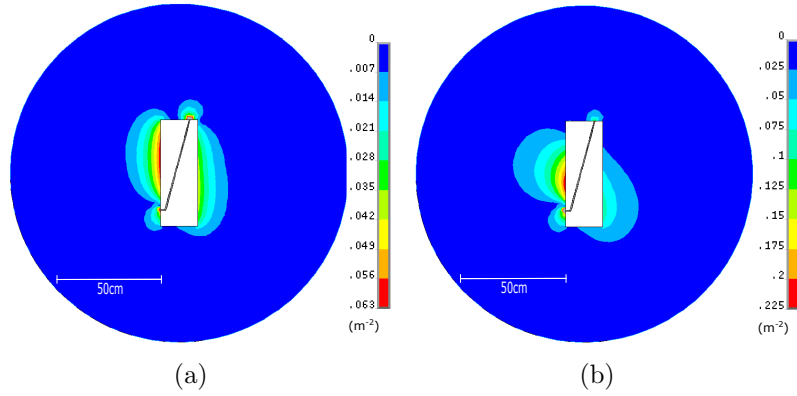
Figure 17: Spatial distribution of maximum sound pressure on cross-section  $y = -10$  (cm) in specimen after cut of 38 cm. The vibration frequency was (a) 98 Hz and (b) 152 Hz.

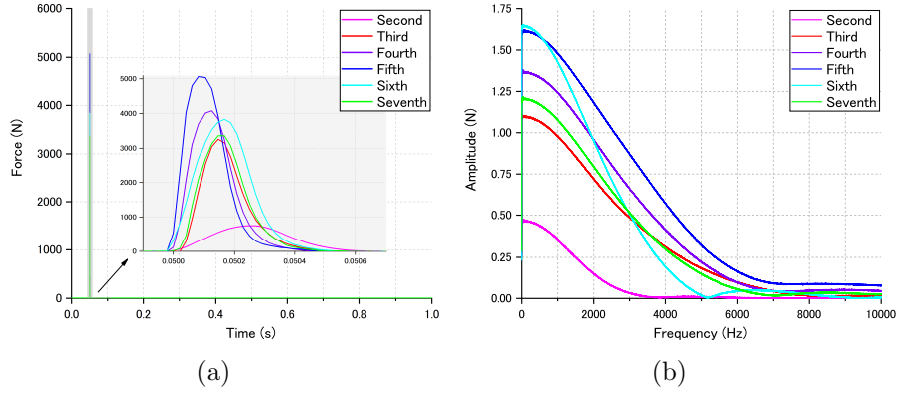
Figure 18: Force signals induced by impact hammer. The cut length was 38 cm: (a) time history waveforms; (b) Fourier spectra of these waveforms.

The hammering sound before and after spalling was investigated by blowing the specimen after a 38 cm cut was made by an impact hammer (086D05, PCB). Figure 18 shows the force signals. The hammer excitation force gradually increased until spalling occurred on the sixth impact. Immediately after the impact, the concrete block dropped by 20 mm directly below owing to its own weight, which corresponded to the gap of the detachment. The spalled concrete block was stable in that state. The seventh impact was performed by hammering the concrete block. As the excitation force increased, the excitation time became shorter and the excitation frequency increased. The maximum excitation force before spalling was approximately 5000 N. Figure 19 shows the Fourier spectra of the vibration and sound. Because of the spalling, the position of the vibration measurement of the seventh impact was higher by 20 mm compared with the other impacts. The peak vibration frequencies of the fifth impact were slightly lower than those of the third impact. This decrease was caused by the progress of the destruction of the adhesion area. By comparing the third and seventh impact, where the exciting force was approximately the same, it was found that there was little change in the peak frequencies, regardless of spalling. However, the damping rate of the vibration increased after spalling and the peak value of the spectrum decreased. Figure 20 shows the specific loudness. There was no noticeable difference between the third and fifth impact, although the vibration around 3000 Hz was damped faster in the fifth impact. Immediately after vibration excitation, the specific loudness of the seventh impact was not very different to that of other impacts. However, owing to the rapid damping of the vibration, the large excitation at a particular frequency disappeared faster compared with the other impacts.

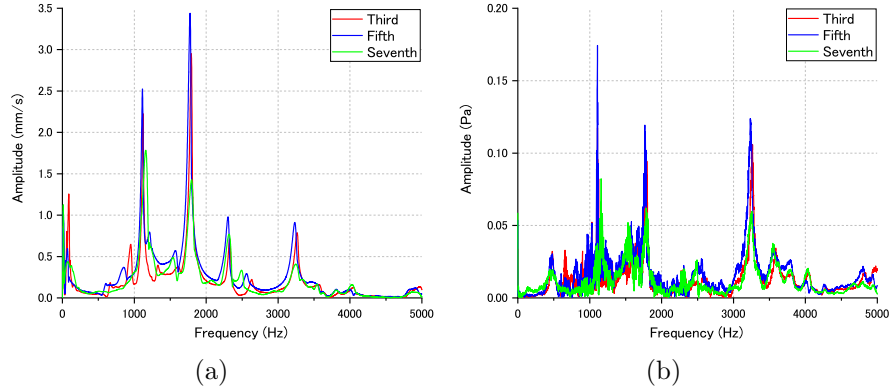
Figure 19: Fourier spectra of (a) vibration and (b) sound induced by impact hammer. The cut length was 38 cm. The sound was measured at position A.

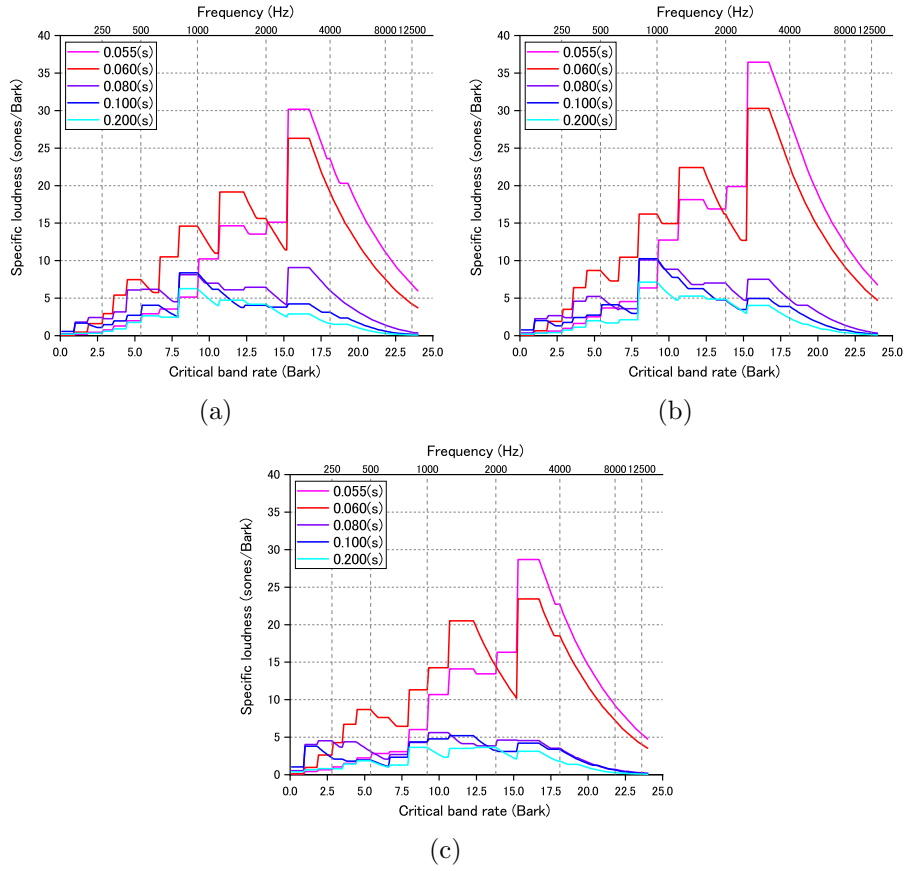
Figure 20: Specific loudness induced by impact hammer: (a) third impact; (b) fifth impact; (c) seventh impact. The cut length was 38 cm. The sounds were measured at position A.

As the risk of spalling increased, high-frequency sounds were relatively hard to hear, as shown in Figure 20. Because there was no clear sign of spalling, it was difficult to evaluate the spalling risk only based on the hammering sound. The hammering sound of the spalled concrete block was heard as a dull sound compared with the sound before spalling. This is attributed to the rapid damping of the vibration, which is caused by the increase of the area of contact with the surroundings. Therefore, it is considered that the hammering sound is heard as a dull sound when a particular frequency is not strongly excited or the excitation time is short.
