Procedia Environmental Sciences 28 (2015) 587 - 594

The 5th Sustainable Future for Human Security (SustaiN 2014)

Shear strength reduction in progress of shear displacement on the landslide near dam reservoir

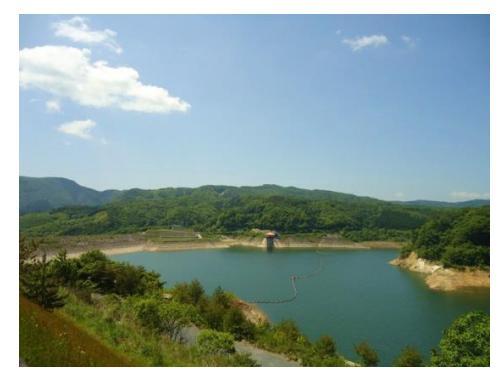
Fig. 1. Aratozawa dam and reservoir in Miyagi Prefecture of Japan (photo taken in June 2013)

The Aratozawa dam (Fig. 1) is located in the southeast of Mount Kurikoma in the Iwate-Miyagi Prefecture of Japan. The height of Aratozawa dam is 74.4 m and length of about 414 m with the geographical position at 38°53'4.98'' of north latitude and 140°51'42.93'' of east longitude.

According to Ministry of Land, Infrastructure and Transport of Japan, this dam was built in 1983 and categorized as rock-fill dam with central core. The main purpose of the Aratozawa dam and reservoir are flood control and

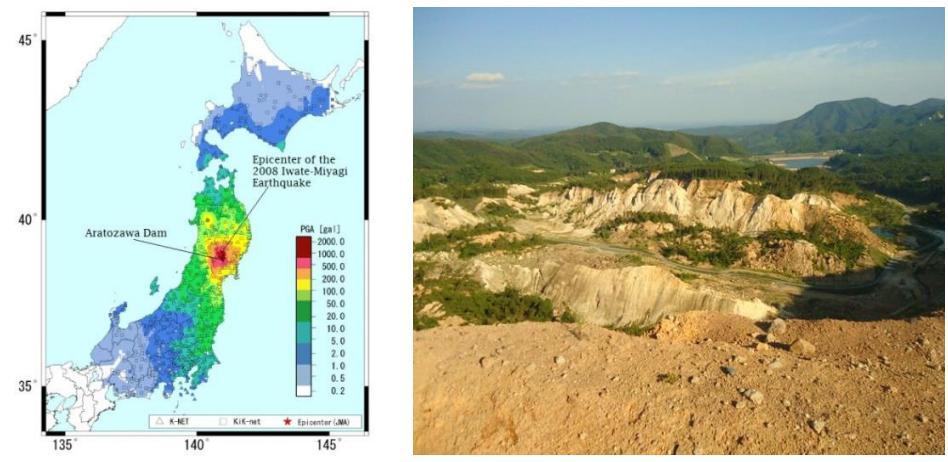
Fig. 2. Distribution of peak ground acceleration of the 2008 Iwate-Miyagi Nairiku earthquake (K-Net and KiK-Net data from NIED, Japan) and view of Aratozawa landslide from head scarp (photo taken in June 2013)

The deep-seated large-scale landslide on the upstream of Aratozawa reservoir occurred shortly after the Iwate-Miyagi inland earthquake of magnitude 7.2 hit the Ohu Mountains on 14 June 2008. Aratozawa landslide has gentle gradient of about 2-4 degree at a depth varied from about 150 m near the head scarp (crown) to 70 m at the main body slide^{2.4}. In addition, Aratozawa landslide resulted in the movement of massive blocks and ridges of 1,300 m in length and 900 m wide with sediment volume of more than 67 million cubic meters that slipped about 320 m. The toe part of landslide was directed into the dam reservoir and caused tsunami wave of about 2.4 m³. Because of the geometry and sediment volume, the landslide near Aratozawa dam was stated to be the largest catastrophic landslide in the last 100 years in Japan⁴.

Aratozawa landslide was mainly triggered by an earthquake with the seismic peak ground acceleration of more than 1,000 gal as reported by several researchers. However, the possibility of reactivated landslides in surrounding terrains near Aratozawa reservoir as the dynamic-geomorphologic movement in Ohu mountainous area within a period of a hundred years⁵ is strongly relevant with water fluctuation in the reservoir as other triggering factors. Based on the observed data provided by Ministry of Land, Infrastructure and Transport of Japan, the daily elevation of Aratozawa reservoir since it began to operate in 1998 up to 2011 can be seen as provided Fig. 3. It could be stated that the fluctuation rate of Aratozawa reservoir is significant in terms of dam purpose.

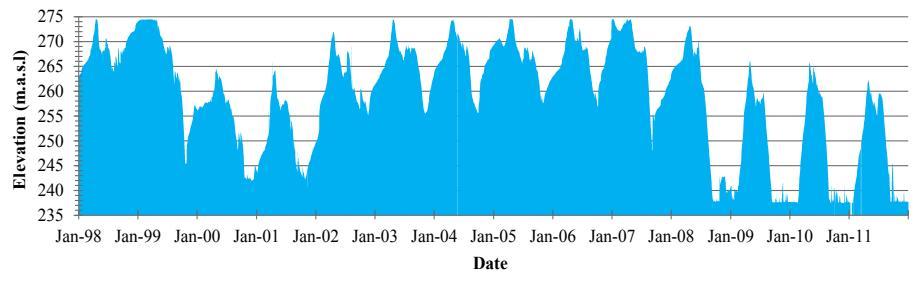
Fig. 3. The daily elevation of Aratozawa reservoir in 1998-2011

Since November 2007 until June 2008, where landslide occurred, the inflow-outflow difference observed in the positive trend where the water elevation in the reservoir had increased continuously of about 20 m up to elevation

273 m. The cumulative different of inflow-outflow discharge rate impounded in the reservoir reached 90 m³/s (7.77 million cubic meters) in May 2008 just about one month before landslide event occurred. However, there was drawdown discharge of the reservoir in early June that made the discharge rate decreased to 50 m³/s (4.32 million cubic meters) with water elevation stands about 268 m.

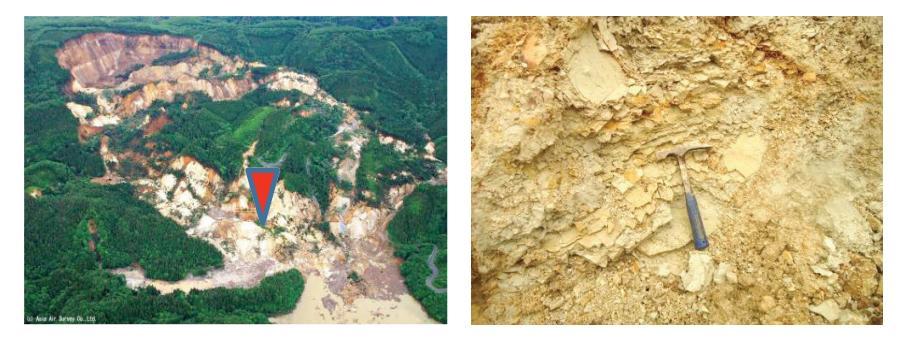
Fig. 4. Sample location (aerial photo from Asia Air Survey Co. Ltd., sampling taken in Nov 2012)

The site investigation was conducted in autumn 2012 and summer 2013. Disturbed samples were taken from Aratozawa landslide area to be tested in laboratory using ring shear apparatus. From the observation and grain size distribution test result, sample from the secondary collapse zone (Fig. 4) was considered as the finest layer from overall Aratozawa landslide samples. The finest soil sample is the key to study the shear strength reduction of suspected slip surface in progress of shear displacement of Aratozawa landslide.

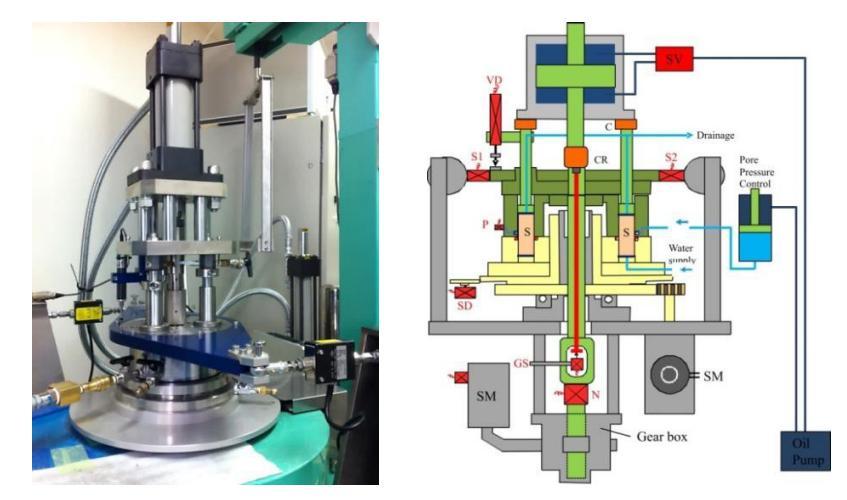
Fig. 5. Structure of the undrained ring shear box ICL-2 and its loading system (Sassa et al. 2014)

The ring shear apparatus ICL-2 has five components: (1) Undrained ring shear box and loading system; (2) Main control unit; (3) Monitoring control unit; (4) Separated servo generator with back pressure unit; and (5) Vacuum pump de-aired water system. The loading concept of ICL-2 does not incorporate loading frame. The central axis pulled by loading piston which is controlled by servo valve (SV) using feedback signal from load cell (N) through servo amplifier (SA) (Fig.5). The installation of back pressure machine for pore-water pressure was integrated with the servo generator controlled with oil pump like normal stress loading system⁴.

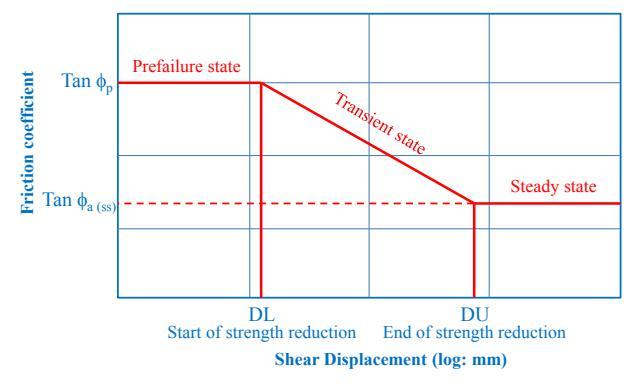
Fig. 6. Concept of shear strength reduction in progress of shear displacement (Sassa et al. 2010)

The concept of shear strength reduction in progress of shear displacement⁵ is introduced to observe the critical state of landslide mass from the beginning of collapse, sliding and deposition stage. The shear strength reduction consists of four stages: (1) initial state, (2) pre-failure state, (3) transient state and (4) steady state. As shown in Fig. 6, the initial state represents the state when the soil stability stood under the peak friction coefficient (tan ϕ_p). The pre-failure state occurs when shear resistance reached peak friction coefficient due to heavy rainfall, groundwater rise, rapid drawdown, seismic loading from earthquakes or the combination of both. The critical shear displacement in the pre-failure state (DL) indicates the soil or slope failure and landslide occurrence.

The following stage is called the transient state which is transition from failure point to steady state. The pore pressure generation together with shear strength reduction will proceed in progress of shear displacement in transient state. The final stage called steady state in which the landslide mass still moves without any strength reduction. The transition stage from transient to steady state is marked with the critical shear displacement at the end of shear reduction (DU). All stages are assessed from the friction coefficient of landslide mass. In the condition of constant normal stress, the friction coefficient is represented as the shear resistance during shear loading.

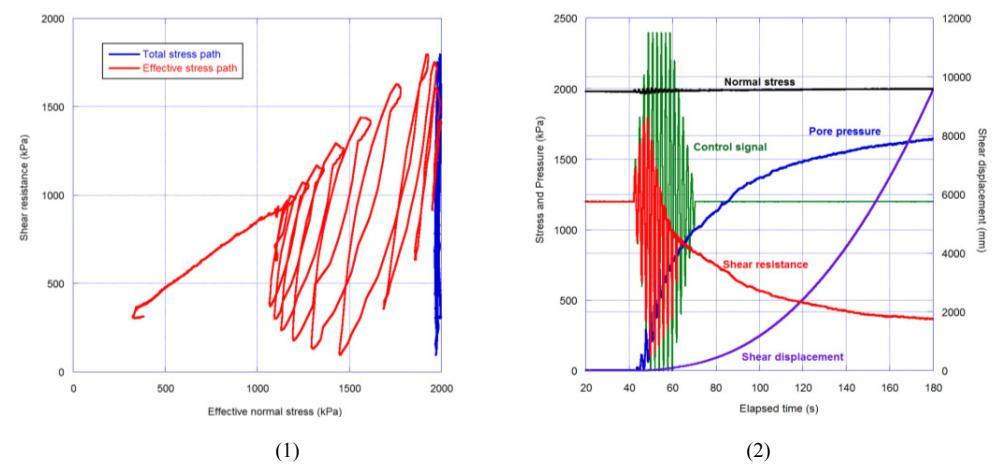
Fig. 7. Cyclic load of secondary collapse zone of Aratozawa landslide: (1) Effective stress path (2) Time series

The cyclic shear test in undrained condition was conducted in order to observe the pore pressure generation and initiation of failure motion due to the cyclic shear load like earthquake-pattern in a slow speed. Through cyclic shear load, the shear displacement pattern and shear strength reduction of Aratozawa samples from pre-failure state to steady state could be obtained. Fig. 7 shows the result of the undrained cyclic loading test for secondary collapse zone sample. The cyclic loading was conducted with 300 kPa of initial amplitude, 4 cycles of amplification, 5 constant cycles and 5 cycles of attenuation. Pore-water pressure was generated more than 1000 kPa during constant cycles where shear resistance rapidly lost its strength. When the pore pressure reached about 1650 kPa, the shear displacement was accelerated in terms of shear strength reduction. The shear displacement reached above 8 m because at elapsed time of 180 second, the shear resistance decreased on the transient stage.

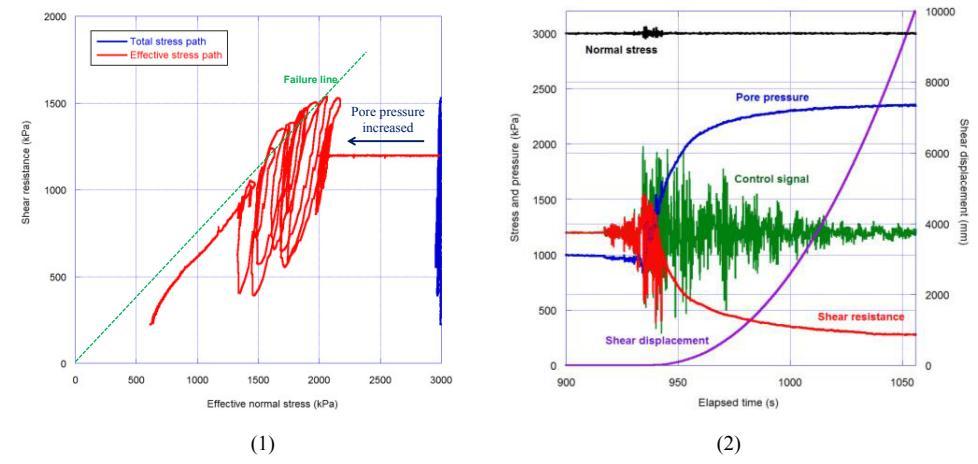
Fig. 8. The 2008 Iwate-Miyagi earthquake load of secondary collapse zone of Aratozawa landslide: (1) Effective stress path (2) Time series

The Iwate-Miyagi Nairiku inland earthquake was applied to the undrained shear box with the assumed slip surface about 22 degree. The effective stress path and wave time series of combined test applied in Atzw SCZ secondary collapse zone is shown in Fig. 8. It can be seen that pore water pressure increased rapidly due to wave loading and reached its peak of about 2300 kPa while the shear strength decreased rapidly in progress of mobilized shear displacement. The steady state shear resistance was reached after 10 m moving displacement when the pore pressure seems to be constant in a high value.

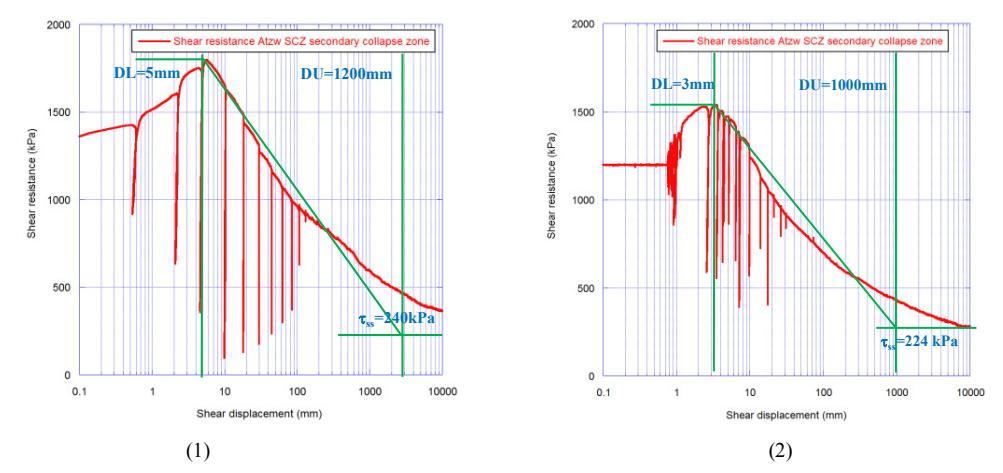
Fig. 9. Shear strength reduction of secondary collapse zone of Aratozawa landslide: (1) Cyclic load (2) The 2008 Iwate-Miyagi earthquake load

The effective stress reduction during Iwate-Miyagi inland earthquake in 2008 is the key issue of Aratozawa landslide³. Fig. 9 shows the graph of shear strength reduction during cyclic loading on sample from exposed collapse zone. The transient state started at DL = 5 mm and ended at DU = 1200 mm or more with the steady state shear resistance started from 240 kPa. This implies that the collapse zone has vulnerable in acceleration motion and long traveling shear displacement. Even at 10 m height in shear displacement, the trend of shear resistance was likely to diminish in several meters until there was a constant steady state shear resistance.
