## **High-speed non-contact defect imaging for a plate-like structure**

**Abstract** Images of defects in a plate-like structure can be obtained from amplitude distributions measured using the scanning laser source technique. This paper discusses high-speed non-contact imaging for defects in a plate. Fundamental experiments conducted using a contact piezoelectric transducer as a receiving device revealed the effect of the generated wave shape and measurement speed on the defect images. Generating tone-burst waves consisting of multiple frequency components and averaging the images obtained in multiple frequency bands (frequency image averaging, FIA) gave clearer defect images in which noisy effects due to low signal-to-noise ratio and spurious images due to multiple reflections in high-speed imaging were reduced. Moreover, FIA was shown to be effective for high-speed non-contact imaging using a laser Doppler vibrometer.

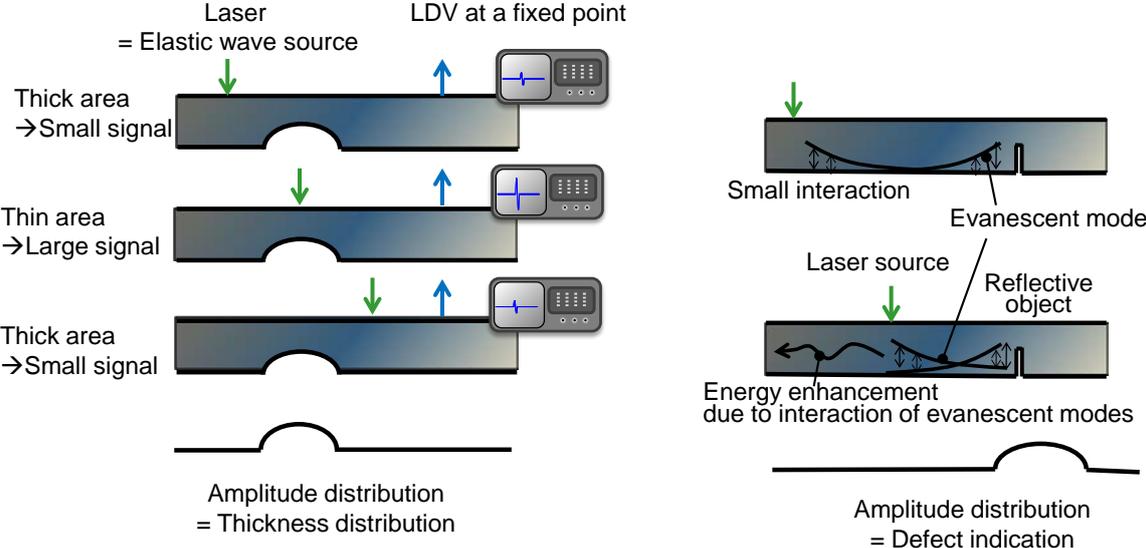
Fig. 1 Principle of defect imaging using the SLS technique

(a) A widely spread defect

(b) A non-volume crack

Before showing experimental results of high-speed imaging, this section describes the principle of the defect imaging for plate-like structures. In the defect imaging technique, the laser source of elastic wave is rastered by galvano mirror scanners and then distributions of an amplitude peak or a Fourier spectrum peak are obtained from the waveforms at all rastering points. Then generation energy of flexural vibration was enhanced when a laser source is located on a defect or in the vicinity of a defect and distributions of the vibration energy correspond to a defect image. The authors analyzed the energy enhancement using semi-analytical finite element calculations and normal mode expansion theory [8, 13]. Figure 1 shows the schematic figure of the principle: (a) for a plate with a widely spread defect like erosion and corrosion and (b) for a plate with a non-volume crack stretching in the thickness direction. In (a), when the laser beam is irradiated on an intact thick area, small flexural vibration is generated, whereas, if the laser source is located at a thin defected area, the detected signals at the LDV become large. It is shown in ref. [8] that this phenomenon appears at the frequency range below the cut-off frequency of A1 mode. In (b), if laser beam is irradiated in the vicinity of a reflective object like a crack, the interaction of a pair of evanescent waves from the laser source and

the reflection object generates extra vibration energy, whereas if the laser source locates far from the reflection object, the interaction of the evanescent waves becomes small and the energy enhancement cannot be seen. The energy enhancement caused by the interaction of evanescent modes was discussed in ref. [13].

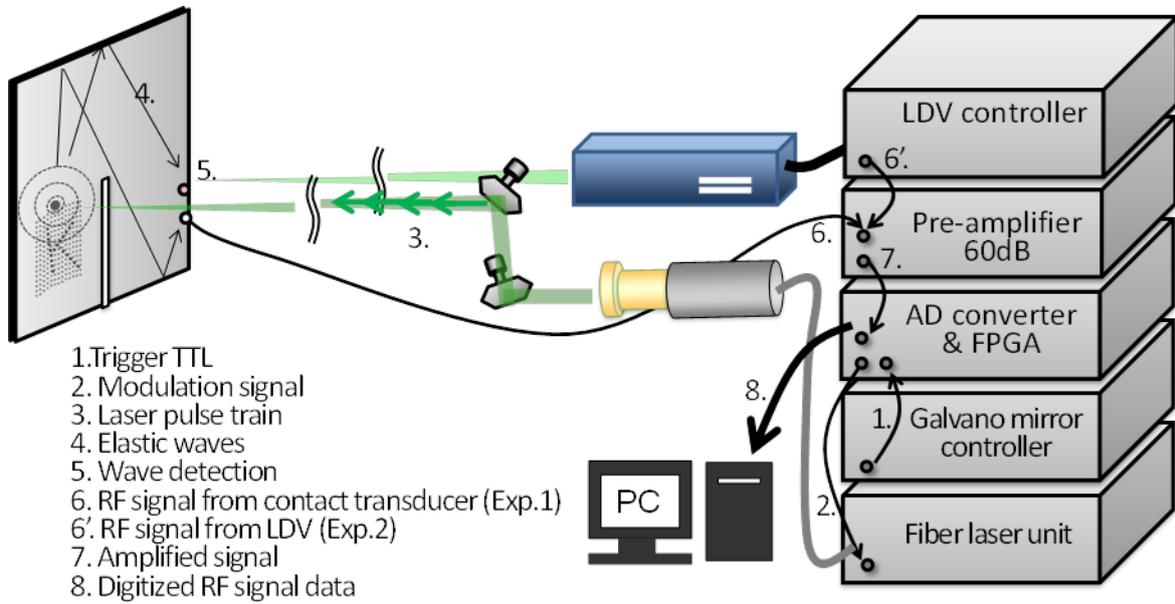
Fig. 2 Experimental setup

Figure 2 shows the experimental setup used in this study. A fiber laser with a maximum output of 50 W (SPI laser, G4-HS) was used for generating elastic waves. The laser equipment could emit pulse trains with a high repetition rate of over 100 kHz and could control the laser output by external modulation signals. In this study, pulse trains at a repetition rate of 540 kHz were modulated by the external signals shown in Fig. 3, where the laser would output and stop at high and low levels of the modulation signal, respectively; consequently, intermittent loading and unloading were repeated at the laser spot. The generation of narrowband burst waves with laser pulse trains and modulated laser output can be referred to [12], [22], and [23].

An LDV was used as a receiving device instead of a piezoelectric transducer, as shown in Fig. 2, and elastic waves were detected at the position shown in Fig. 5. Defect images with multi-frequency tone-burst FIA are shown in Figs. 15 and 16. Because the frequency components between 6 kHz and 8 kHz could not be measured with the LDV, the modulation tone-burst square waves at frequencies of 9 kHz, 11 kHz, and 13 kHz were adopted, and images at different frequencies were obtained by taking the maximum values in the corresponding frequency bands. Figures 15 and 16 show defect images with FIA using pulse wave and tone-burst waves, respectively, with three frequency components. The images obtained by pulse waves (Fig. 15) exhibited the sandstorm effect owing to low SNR, whereas the images obtained by tone-burst waves (Fig. 16) gave apparently clearer defect images. These results show the effect of multi-frequency tone-burst FIA more obviously than the case of Fig. 14. In addition, they show that non-contact measurement with LDV is feasible for defect imaging at high speeds.

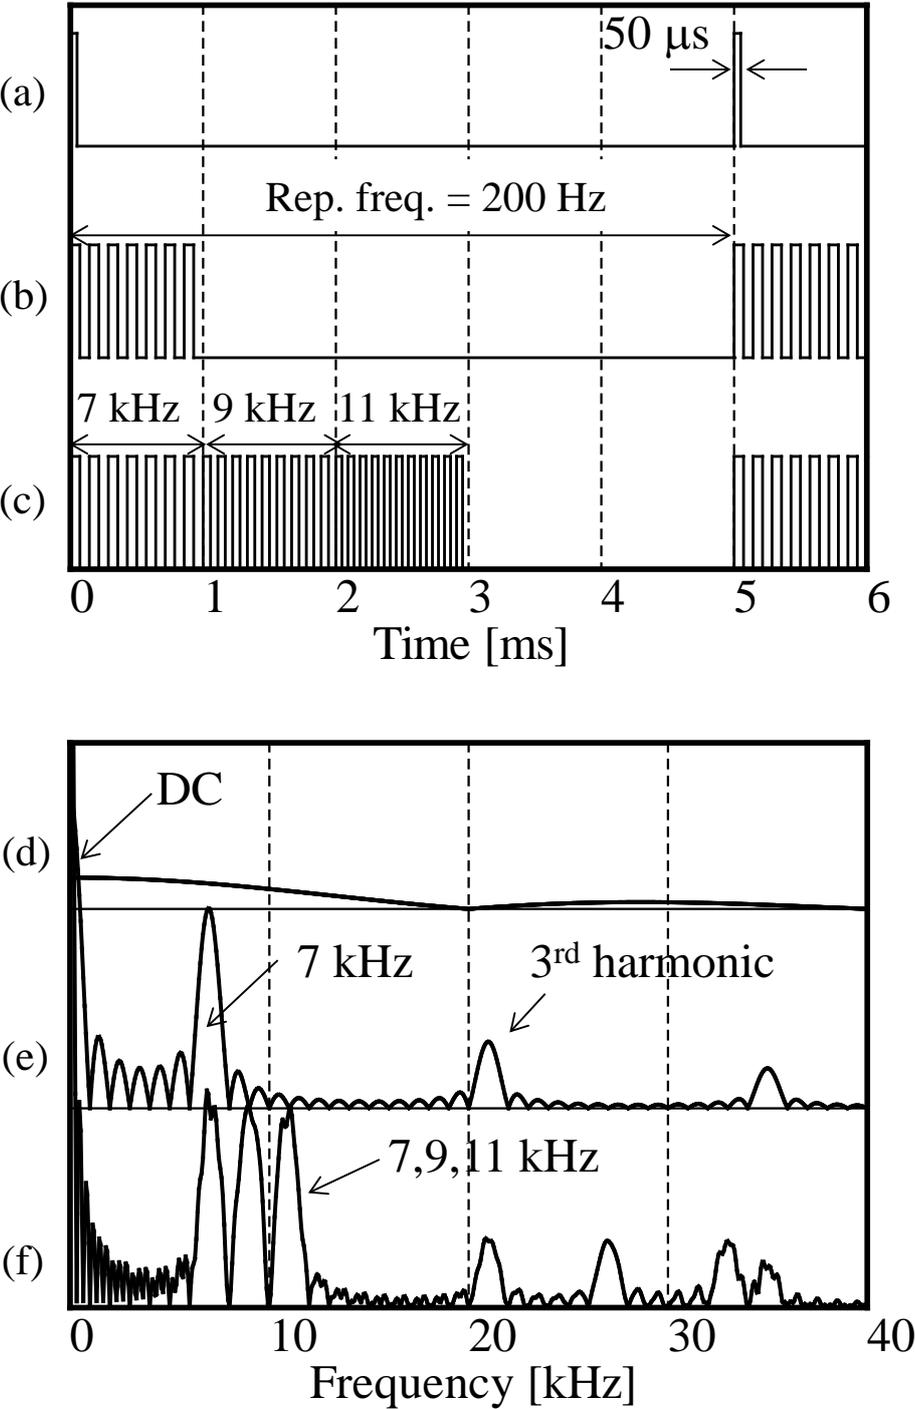
Fig. 3 Typical modulation signals and their Fourier spectra for generation of (a)(d) broadband pulse waves, (b)(e) narrowband tone-burst waves, and (c)(f) multi-frequency narrowband tone-burst waves.

As shown in Fig. 3 (a), one square wave for one trigger TTL from the galvano mirror controller was used for generating a pulse wave. Multi-cycle square waves, shown in Fig. 3 (b), were used for generating narrowband tone-burst waves. Figure 3 (c) shows a modulation waveform formed by the connection of square waves of three different frequencies. This will be used in Section 5.2 to generate narrowband tone-burst waves having three frequency components. Figures 3 (d)–(f) are frequency spectra for the modulation signals shown in Figs. 3 (a)–(c), respectively. These frequency spectra show

that one square wave (a) and multi-cycle square burst waves consist of broadband and narrowband frequency components, respectively, and (c) contains three distinct peaks at the desired frequencies (7, 9, and 11 kHz), together with DC components and 3rd and 6th harmonic components. The external modulation signals were generated by the field-programmable gate array (FPGA) module (National Instruments NI FlexRIO) at the trigger TTL from the galvano mirror controller. At the trigger timing, the galvano mirror moved to the next rastering point repeatedly, i.e., the scanning speed increased as the trigger TTL was repeated at a higher repetition rate.

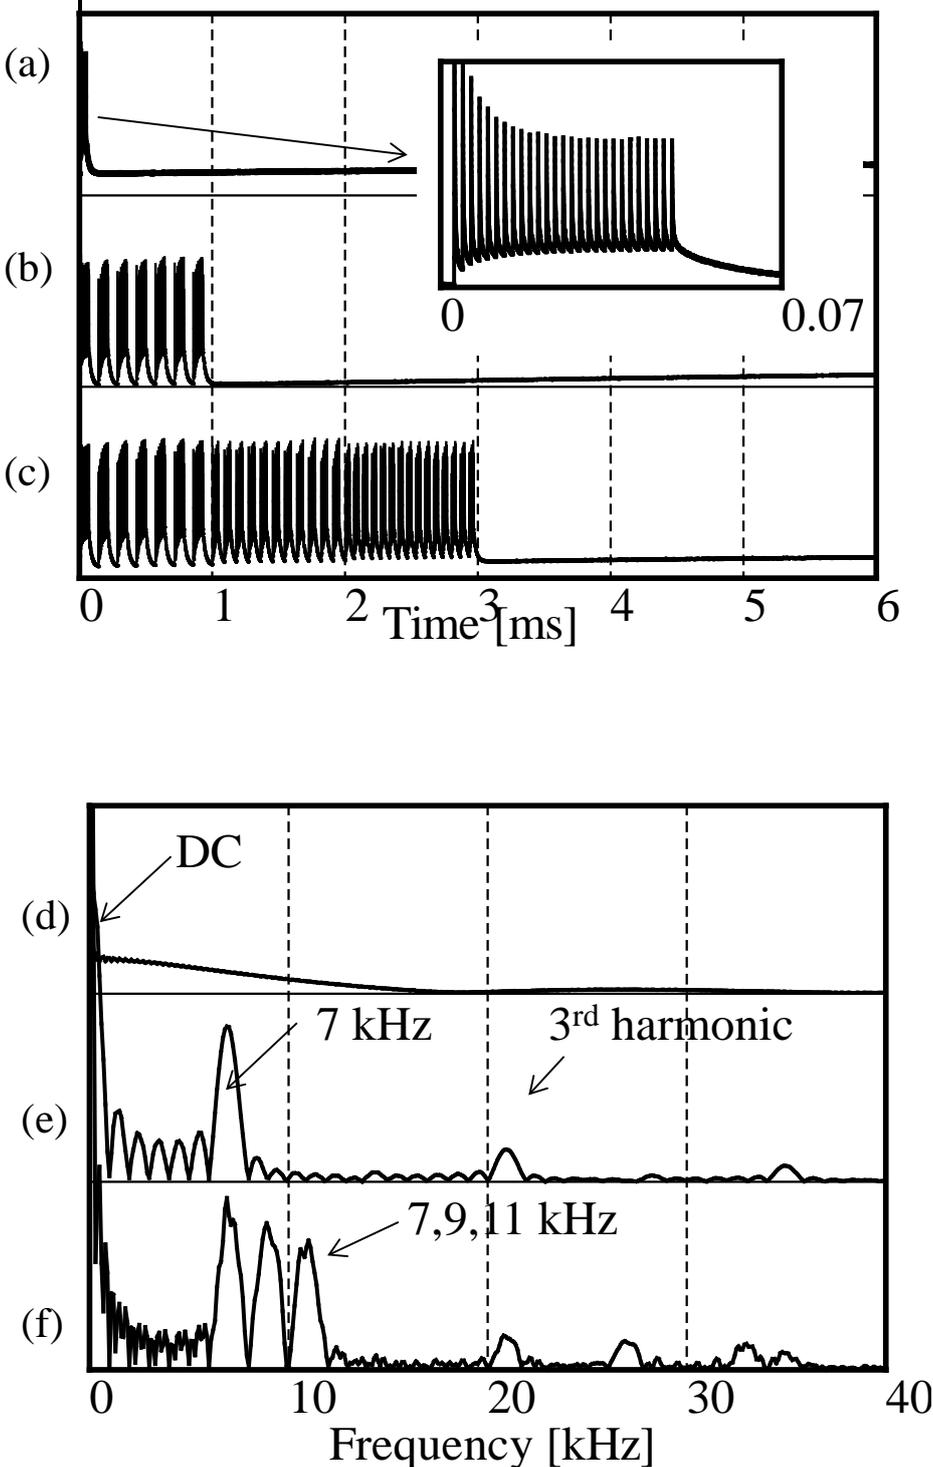
Fig. 4 Light intensities detected by a photo detector and their frequency spectra. (a) - (c) are intensities for the modulation signals shown in Figs. 3 (a) - (c), and (d) - (f) are the frequency spectra of Figs. 4 (a) - (c), respectively.

Figure 4 is light intensities scattered at the surface of a specimen and detected by an amplified photo detector. Figures 4 (a)–(c) correspond to the laser intensities for the modulation signals shown in Figs. 3 (a)–(c), and Figs 4 (d)–(f) are their Fourier spectra. The light intensities and the Fourier spectra agree well with the modulation signals as shown in Fig. 3, which proves that the laser pulse trains were irradiated following the modulation signals. The zoomed figure of (a) in the inset of Fig. 4 show that the pulse trains are comprised of small laser pulses at the repetition frequency of 540 kHz.

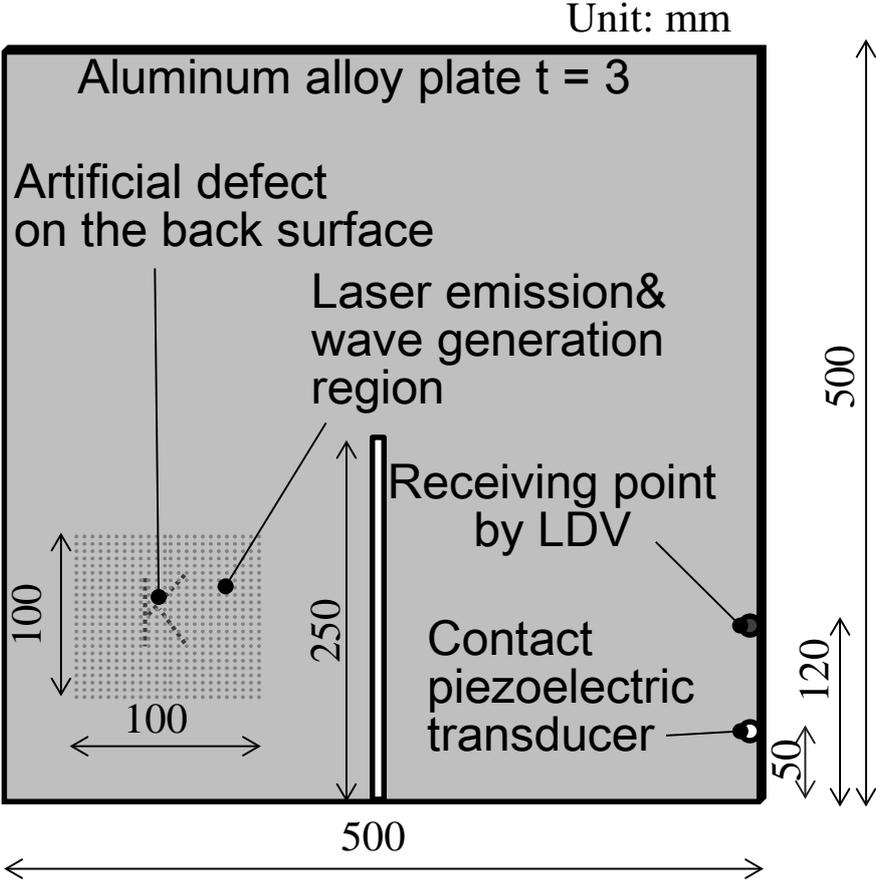
Fig. 5 Specimen used in this study.

Figure 5 shows the dimensions of the aluminum alloy plate used and the positions of the

laser emission region and receiving points. A thru notch was sawed at the center of the aluminum alloy plate (A5052) measuring  $500\text{ mm} \times 500\text{ mm} \times 3\text{ mm}$ . Laser pulses were emitted for elastic wave generation in the left region measuring  $80\text{ mm} \times 80\text{ mm}$ . The thru notch disturbed the straight path between the laser sources and the receiving points, and the received signals consisted of only waves passing through detour paths by diffraction and reflection. It has been shown that defect images can be obtained even for a plate with complex geometries using the same plate specimen [12]. An artificial defect, i.e., the letter "K", was engraved to a depth of 1.5 mm behind the laser emission region. A piezoelectric transducer was attached to the plate surface at 50 mm above the right bottom corner, and a receiving point with an LDV was set at 120 mm from the right bottom corner, where a retro-reflective marker was attached to improve the detectability of the scattered laser beam from the surface.

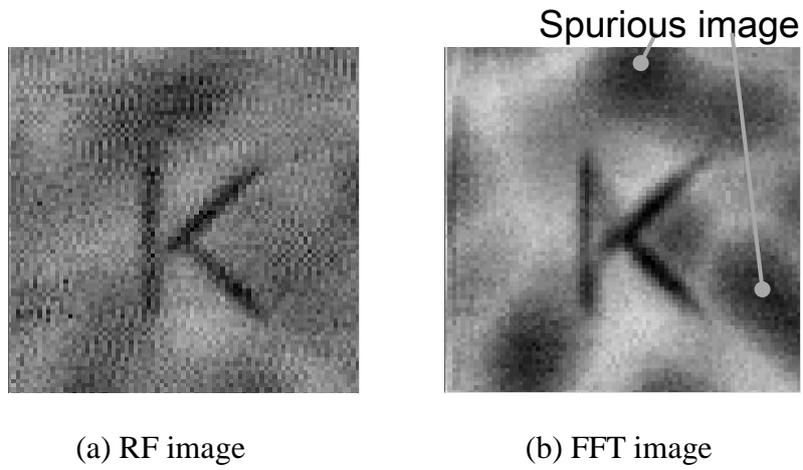
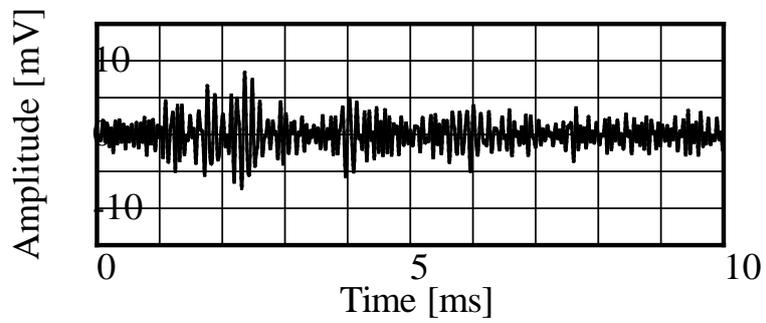
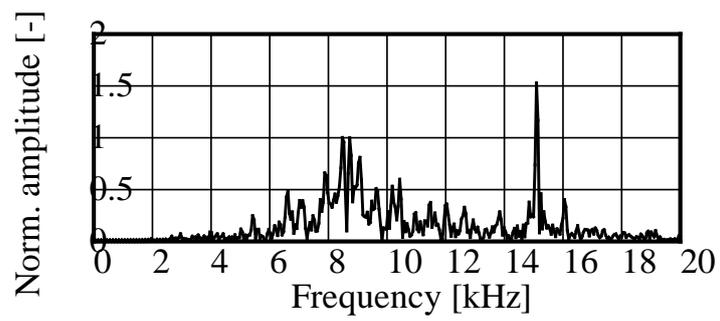
Fig. 6 Results for pulse wave generation at low scanning speed (repetition rate: 20 Hz).

First, high-speed imaging was examined using the modulation signal for pulse wave generation, as shown in Fig. 3 (a). Figures 6 (a) and (b) show examples of defect images at low speed, where the repetition rate of the trigger TTL in the experimental system described above was set to 20 Hz. On the other hand, Figures 7 (a) and (b) show defect images in high-speed measurements at a repetition rate of 200 Hz. The galvano mirrors moved to the next rastering point at the trigger timing and the laser source was scanned over the region. Here, the laser source was rastered along one line from left to right at 1-mm increments and then moved up to the next line at 1-mm increments. Repeating the scanning over the  $80\text{ mm} \times 80\text{ mm}$  region yielded two-dimensional distributions of the

signals. Consequently, laser emission and mirror rotation were repeated every  $1/20 \text{ Hz} = 50 \text{ ms}$  and  $1/200 \text{ Hz} = 5 \text{ ms}$  for  $81 \times 81$  points and it took around 328 s and 33 s, respectively, to measure the signals. It should be noted that the laser spot seemed to move continuously in one line because the laser scanning was sufficiently fast. Therefore, the laser spot might suffer from small position errors.

Figure 6 (c) shows the waveform detected when the laser was emitted at the center of the laser emission region at a repetition rate of 20 Hz. The figure shows a waveform for an interval of 10 ms after the AD converter received the trigger TTL. Although the signals are not clear owing to low SNR, a received waveform seems to appear after around 1 ms. The frequency spectrum of the waveform for 10 ms is shown in Fig. 6 (d). This spectrum is normalized by the peak value between 8 kHz and 10 kHz, and then, the frequency spectra are also normalized by the same value for comparison of intensity. The large peak at 15 kHz is the intrinsic noise of the pre-amplifier; the noise occupies the major part of the waveform in Fig. 6 (c). Figure 6 (a) shows the distribution of the maximum value of the radio frequency (RF) waveform for 10 ms (RF image), and Fig. 6 (b) shows the distribution of the peak value of the frequency spectrum between 8 kHz and 10 kHz (FFT image). In both figures, the intensity is shown with a gray scale in which black and white represent the maximum and minimum values, respectively. In Fig. 6 (a), we can see a non-smooth sandstorm distribution because random noise in the waveforms has a strong effect owing to low SNR. Meanwhile, in Fig. 6 (b), the sandstorm effect is reduced but the number of spurious images around the defect image increases. This is the effect of multiple reflections contained in the waveforms for the interval of 10 ms. Multiple reflections have been discussed in detail in previous studies [11, 12].

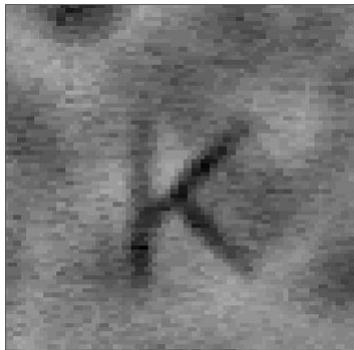
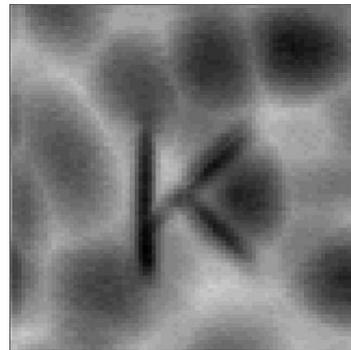
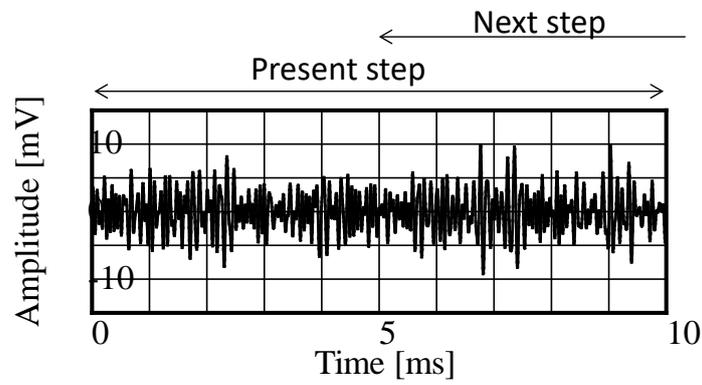
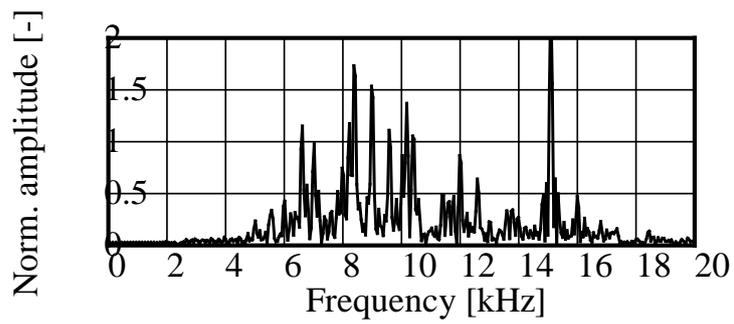
Fig. 7 Results for pulse wave generation at high scanning speed (repetition rate: 200 Hz).

(a) RF image

(b) FFT image

(c) Typical waveform

(d) Typical frequency spectrum

Figures 7 (a) and (b) show RF and FFT images for a repetition rate of 200 Hz. These images were also obtained from the maximum values of the RF signals and frequency

spectrum peaks between 8 kHz and 10 kHz, as in the case of Figs. 6 (a) and (b). However, at the high repetition rate, the waveforms were not recorded at every laser emission spot; recording started at the left edge and one waveform was recorded continuously until the right edge. Then, we extracted waveforms corresponding to all the laser spots and constructed the images using the extracted waveforms. Figure 7 (c) shows the extracted waveforms for the interval of 10 ms from the moment when the laser was located at the center of the laser emission region. Because the laser emission was repeated every 5 ms ( $=1/200$  Hz) at slightly different positions, the current extracted waveform also contains waveforms generated by the next laser emission. A comparison of the waveforms in Fig. 6 (c) and Fig. 7 (c) shows that the signal level slightly increases in Fig. 7 (c) because multiple reflected waves and waves generated by the previous laser shot were superposed at the high repetition rate. Consequently, the sandstorm effect caused by low SNR was reduced, as seen by comparing Fig. 7 (a) with Fig. 6 (a). Meanwhile, spurious images increased, as seen by comparing Fig. 7 (b) with Fig. 6 (b), because at the high repetition rate, the image was more strongly affected by the resonances of multiple reflections and high-repetition wave generation.

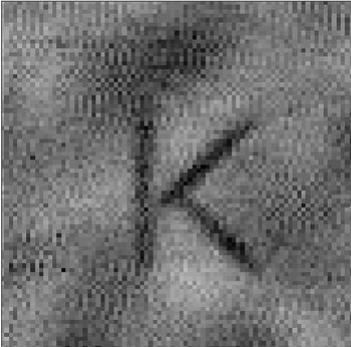
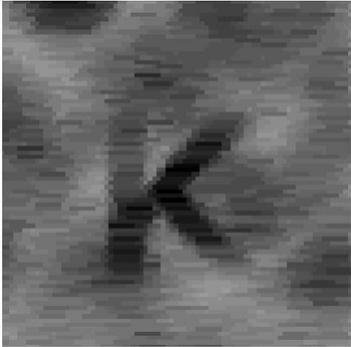
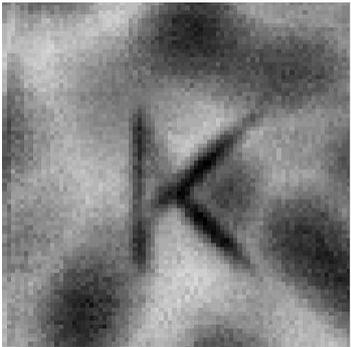
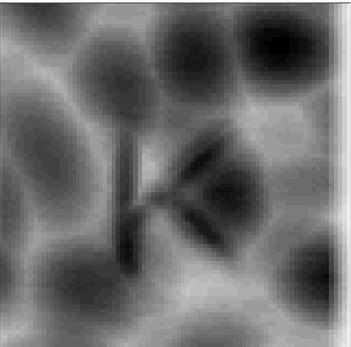
Fig. 8 Images showing differences in interval of extracted waveforms. Repetition frequency: 200 kHz.

(a) RF image for 1 ms

(b) RF image for 30 ms

(c) FFT image for 1 ms

(d) FFT image for 30 ms

In Figs. 7 (a) and (b), all the signals from the left edge to the right edge were recorded at one time, and then, the images were obtained from waveforms extracted for the time interval of 10 ms. Because the extracted waveforms varied with multiple reflections and repetitions of laser emission, we could infer that the interval of the extracted waveform affects the images. To evaluate the effect of the interval, Fig. 8 shows RF and FFT images for intervals of 1 ms and 30 ms, where the repetition rate is set to 200 Hz. As seen in the waveform of Fig. 6 (c), propagation from the laser emission spots to the transducer took

around 1 ms. Therefore, for a short extraction time interval of 1 ms, the images shown in Figs. 8 (a) and (c) were constructed using waveforms generated in the previous laser emissions. The RF image in Fig. 8 (a) shows the sandstorm effect owing to low SNR, but the artificial defect is obtained appropriately. In the FFT image shown in Fig. 8 (c), the sandstorm effect is reduced, but spurious images appear owing to multiple reflections. For the time interval of 30 ms, the extracted waveforms contained waves generated by six laser emissions at six laser spots. Because the maximum value among the waves at the six laser spots is plotted in Fig. 8 (b), the defect image appears stretched in the scanning direction. The FFT image shown in Fig. 8 (d) contains significant spurious regions because the waveforms for 30 ms consist of a large number of multiple reflections.

In summary, the short interval of the extracted wave causes the sandstorm effect in an RF image owing to low SNR, and the long interval causes deformation of defect images in an RF image as well as spurious images in an FFT image owing to multiple reflections and multiple laser emissions. Hereafter, in high-speed imaging at a repetition rate of over 200 Hz, the interval of the extracted waveform was set to twice the repetition period.

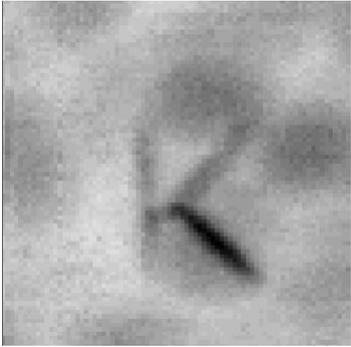
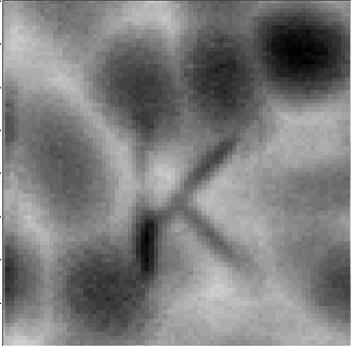
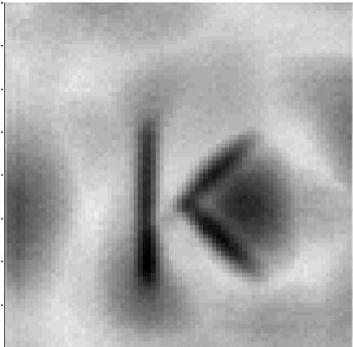
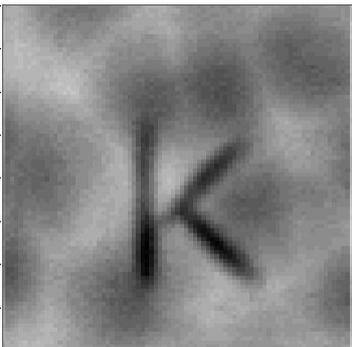
Fig. 9 Images for different frequency bands and their averaged image. Repetition frequency: 200 Hz. Extracted waveform interval: 10 ms.

(a) 6–8 kHz

(b) 8–10 kHz

(c) 10–12 kHz

(d) Average

Although we used a pulse wave in this case, unlike the approach followed in [12], FIA was applied to reduce spurious images by taking images in three frequency bands (6–8 kHz, 8–10 kHz, and 10–12 kHz) in which the frequency components were distributed as shown in Fig. 7 (d). Figures 9 (a), (b), and (c) show the distributions of the maximum values of the frequency spectra at the frequency bands, and Fig. 9 (d) shows their average. The repetition rate and the interval of the extracted waves were 200 Hz and 10 ms, respectively, as in Fig. 7. Spurious images were appropriately reduced. Figure 9 (d) shows the defect more clearly than Figs. 7 (a) and (b). This proves that FIA works well for broadband pulse waves.

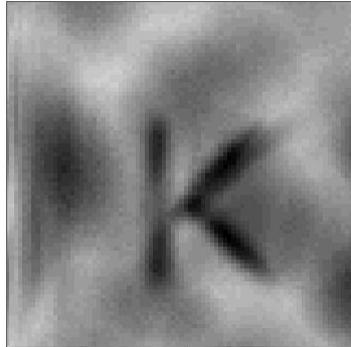
Fig. 10 Frequency averaged images for high-speed scanning using broadband pulse wave.

(a) 600 Hz (11 s)

(b) 1000 Hz (6.6 s)

(c) 2000 Hz (3.3 s)

Imaging speed can be increased by employing a higher repetition rate. This subsection discusses the effect of high-speed measurements on defect images. Figures 10 (a)–(c) show defect images using FIA at repetition rates of 600 Hz, 1000 Hz, and 2000 Hz (repetition periods of 1.67 ms, 1 ms, and 0.5 ms), respectively. As in Fig. 9, three images at three frequency bands were averaged. As described in Section 4.2, the waves were recorded at one line from left to right continuously, and the waves at each laser spot were extracted for the double interval of the repetition period. The required times to obtain the images were around 11, 7, and 4 s, respectively. As the imaging speed increased, the images of the artificial defect, i.e., "K", were more distorted, mainly because of multiple reflections at the high repetition rate. The longitudinal patterns were caused by the jump from the right end to the left edge during laser scanning. Waveforms for laser sources near the left edge consisted of multiple reflected waves generated near the right edge before laser beam jumping. Therefore, significant changes in multiple reflected waves cause such longitudinal noise in the images.

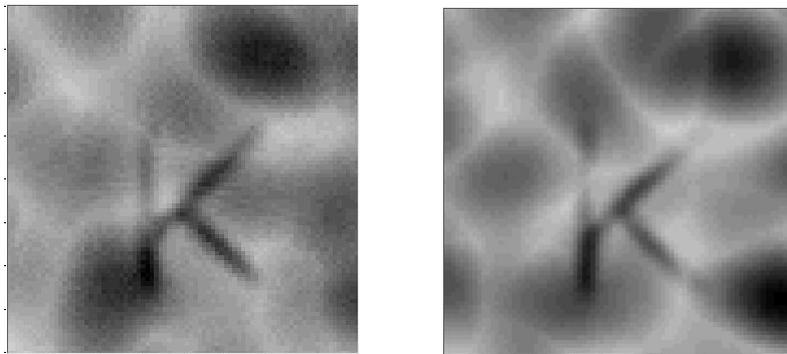
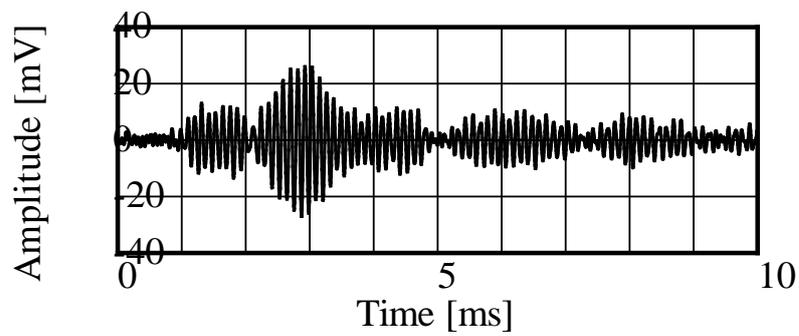
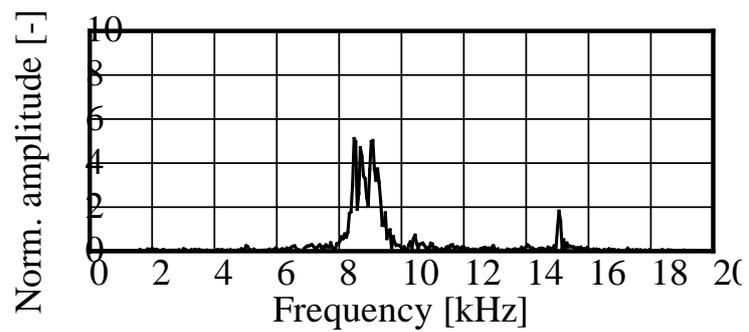
Fig. 11 Results for tone-burst wave generation at low scanning speed (repetition rate: 20 Hz).

(a) RF image

(b) FFT image

(c) Typical waveform

(d) Typical frequency spectrum

Figures 11 (a) and (b) show RF and FFT images obtained from 10-ms waveforms at the low repetition rate of 20 Hz using the modulation signals; the frequency was 9 kHz, duration time was 1000  $\mu$ s, and duty ratio was 50%, as shown in Fig. 3 (b). The images obtained for the tone-burst waves correspond to Figs. 6 (a) and (b) for the pulse waves. Figure 11 (c) shows the waveform when the laser was emitted at the center of the scanning region, and Fig. 11 (d) shows its frequency spectrum. The intensity of the frequency components can be compared with Fig. 6 (d) and Fig. 7 (d) because the frequency spectrum is normalized by the same value. Thus, the frequency spectrum clearly shows that the use of tone-burst wave significantly improves the SNR in the frequency domain. Moreover, wave packets appear after around 1 ms in Fig. 11 (c), which is the minimum travelling time from the laser spot to the receiving transducer. Because the SNR was improved in both the time domain and the frequency domain, the sandstorm effect in Figs. 11 (a) and (b) was reduced, as compared with Figs. 6 (a) and (b). Spurious regions can be seen even in the RF image because the long duration of the elastic wave causes multiple reflections to a greater extent.

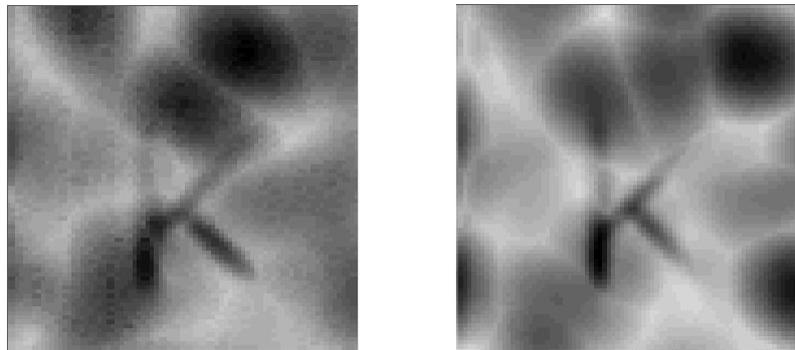
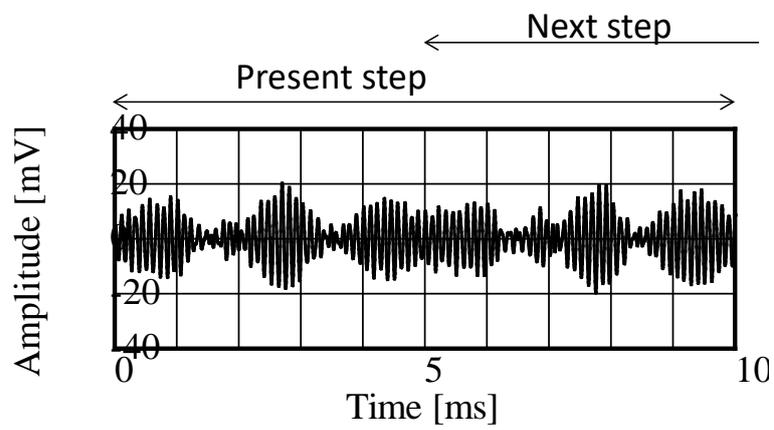
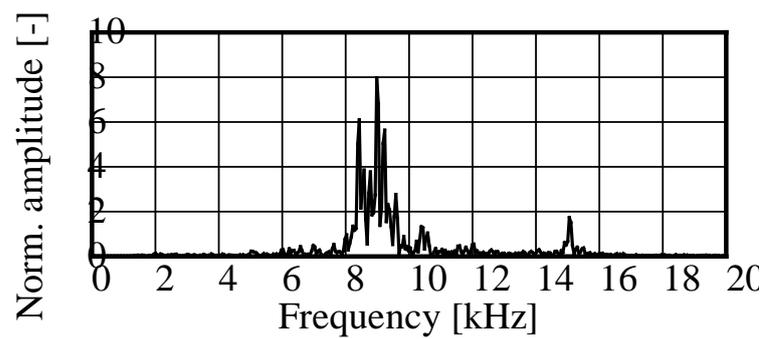
Fig. 12 Results for tone-burst wave generation at high scanning speed (repetition rate: 200 Hz).

(a) RF image

(b) FFT image

(c) Typical waveform

(d) Typical frequency spectrum

Figures 12 (a) and (b) show defect images at the high repetition rate of 200 Hz. Figure 12 (c) shows the waveform when the laser was emitted at the center of the scanning region,

and Fig. 12 (d) shows its frequency spectrum. The waveform shown in Fig. 12 (c) seems to repeat at the repetition rate of 5 ms because the received signals are superposed by the waves generated in the previous laser shots owing to the high repetition rate. Spurious regions slightly increase in Figs. 12 (a) and (b) as compared with Figs. 11 (a) and (b), which indicates that the images at high scanning speed are affected by multiple reflections as well as waves generated at the previous laser shots.

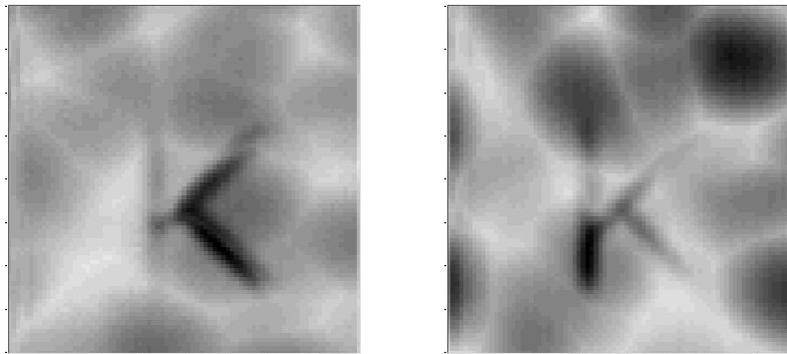
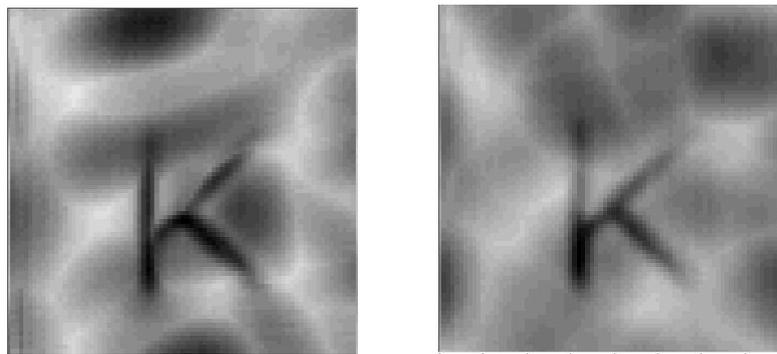
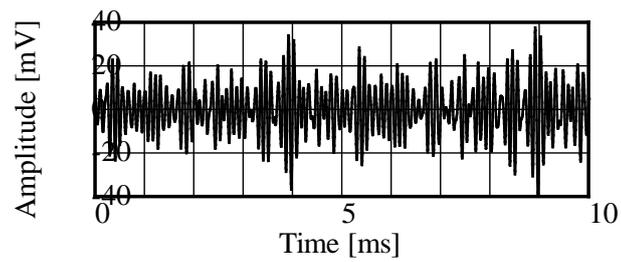
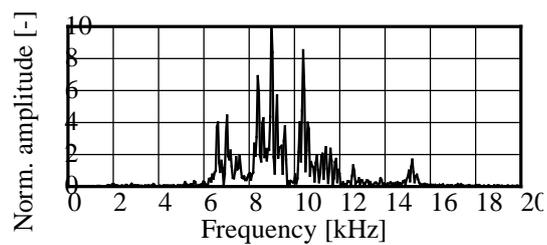
Fig. 13 Images in different frequency bands, their averaged image, typical waveform, and its frequency spectrum. Multi-frequency tone burst modulation signals are used. Repetition frequency: 200 Hz. Extract waveform interval: 10 ms.

(a) 6–8 kHz

(b) 8–10 kHz

(c) 10–12 kHz

(d) Average

(e) Typical waveform

(f) Typical frequency spectrum

Here, defect imaging with FIA was examined for tone-burst wave generation. To generate tone-burst elastic waves with multiple frequency components, we used the modulation signals shown in Fig. 3 (c), in which three square waves with different frequencies are connected. Figures 13 (a)–(d) show distributions from the frequency spectra when the modulation signal is set to square tone-burst waves at frequencies of 7, 9, and 11 kHz with a duration of around 1 ms each. The distributions (a), (b), and (c) were obtained from the maximum value of the frequency spectrum in the frequency bands of 6–8 kHz, 8–10 kHz, and 10–12 kHz, respectively. Further, Fig. 13 (d) shows the average of Figs. 13 (a), (b), and (c). Figure 13 (e) shows the waveform at the center of the region and Fig. 13 (f) shows its frequency spectrum. The frequency spectrum shown in Fig. 13 (f) is significantly large as compared to the frequency spectrum for pulse generation shown in Fig. 7 (d). Moreover, it has frequency components not only in the frequency band of 8–10 kHz but also in the frequency bands of 6–8 kHz and 10–12 kHz, as compared with Fig. 12 (d), which shows the generation of a tone-burst wave with a single frequency component. Therefore, the sandstorm effect was reduced in these images, as compared with Fig. 9. In addition, Fig. 12 (b), which shows an image for a single-frequency tone-burst wave generation, is nearly the same as Fig. 13 (b). This indicates that an image separated in a

specific frequency band can be obtained appropriately by taking frequency spectrum peaks in the frequency band. In the average image, i.e., Fig. 13 (d), spurious regions were reduced as compared with Fig. 12 (b), which shows that FIA using tone-burst waves with multiple frequency components works effectively.

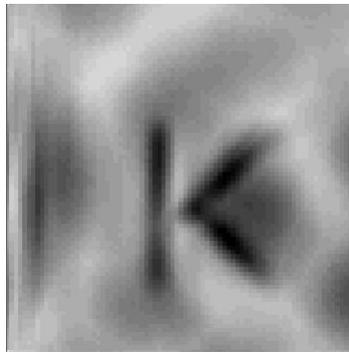
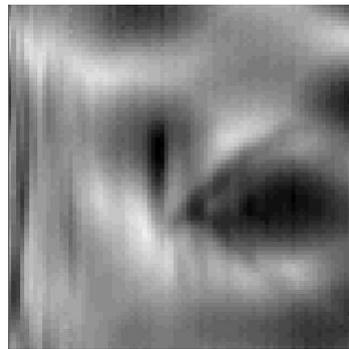
Fig. 14 Frequency averaged images for high-speed scanning using multi-frequency tone-burst waves.

(a) 600 Hz (11 s)

(b) 1000 Hz (6.6 s)

(c) 2000 Hz (3.3 s)

As in the case of pulse wave generation, defect images can be obtained by increasing the repetition rate of laser emission even in the case of tone-burst wave generation. However, when using tone-burst waves, it is necessary to check that the duration of the modulation signal is within the repetition period. For example, when the repetition rate of 600 Hz (repetition period of 1.67 ms) is used and the modulation signal contains three frequency components as shown in Fig. 3 (c), the total duration of the square waves must be less than 1.67 ms. Now, the duration of each square wave is set to 1/3 of the repetition period, i.e., the duration of each frequency component is around 0.55 ms, 0.33 ms, and 0.16 ms for repetition frequencies of 600 Hz, 1000 Hz, and 2000 Hz, respectively. Figure 14 shows the average images of the three frequency images for the repetition frequencies of 600 Hz, 1000 Hz, and 2000 Hz, which can be compared with Fig. 10 for pulse wave generation. At 600 Hz, the sandstorm effect was reduced because the use of narrowband tone-burst wave improved the SNR. However, for 1000 Hz and 2000 Hz, the images obtained by pulse wave generation (Figs. 10 (b) and (c)) and tone-burst wave generation (Figs. 13 (b) and (c)) were nearly the same, because the tone-burst durations at the high repetition rate had to be short (less than a few cycles) and the images showed similar tendency to the case of one-cycle pulse generation.
