Hydraulic and Morphological Consequences of Bank Protection Measures along the Jamuna River, Bangladesh

Synopsis

Keywords: Brahmaputra/Jamuna River, bank protection, channel stabilization, field investigation, Bandal, spur dyke

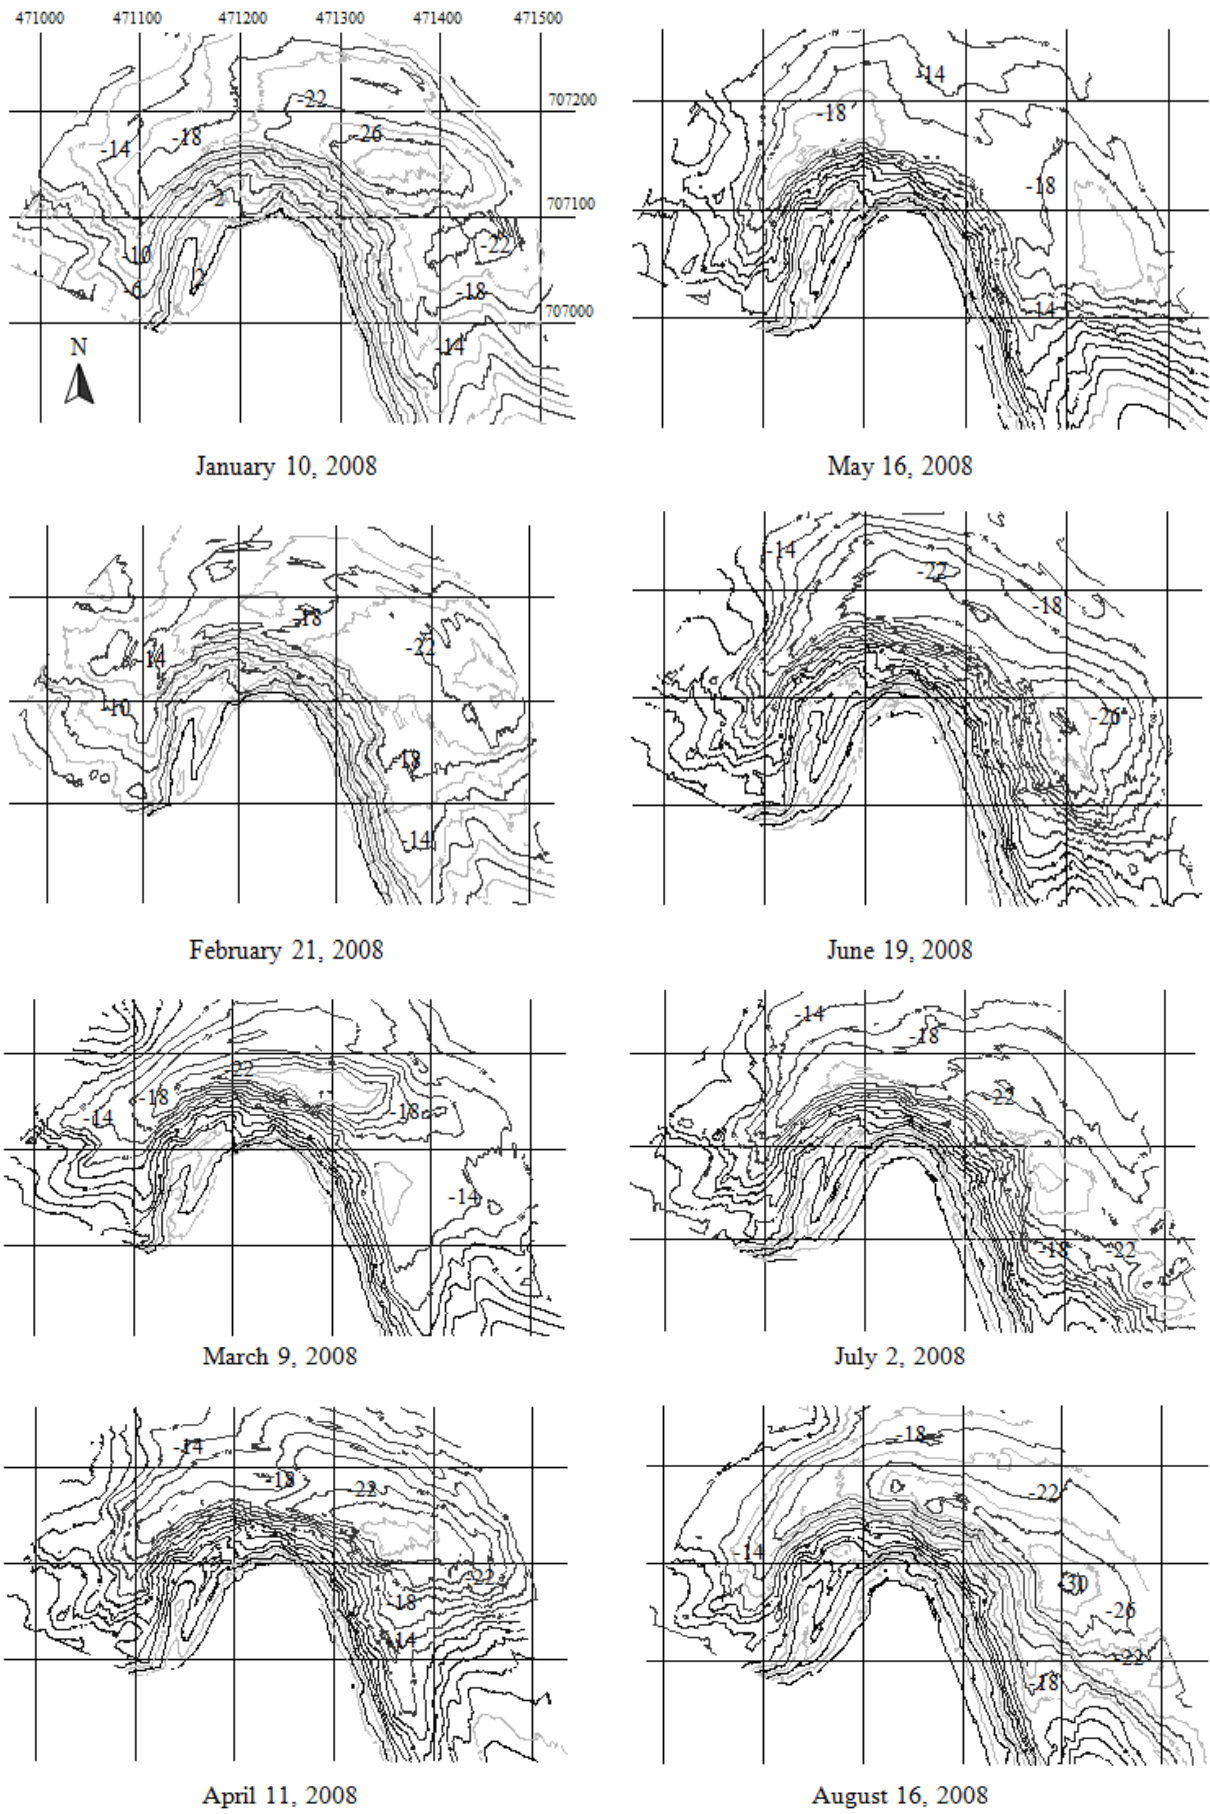
Fig.6 Bed level change at termination

The monthly change of the bed elevation around the upstream termination of the Sirajganj Hardpoint from January 2008 to February 2009 was plotted in Fig.6. The plot series provided valuable information on the bed evolution characteristics in the proximity of the termination. Basically, the bed morphology around the termination was dominated by a scour hole and the hole changed its shape as well as its bottom elevations almost all the time even in the dry season. The similarities in the scour geometry and the fluctuations in the maximum scour depth from January to the beginning of July indicated that the transport of bed forms played an important role in the bed evolution during the low flow season.

The scour hole exhibited significant changes during the flood as shown in the plots in August and in September. In particular, the maximum scour depth was dramatically increased and the location of the deepest point also shifted a bit to the downstream of the termination. After the flood, the scour hole area was refilled with sediment and the maximum scour hole depth returned to the pre-flood level as obviously shown from the plots after October. Although the 2008 flood enlarged the scour hole, the final scour hole in January of 2009 was even much smaller and shallower than that in January of 2008. It has to be mentioned that the termination partially failed in September of 2008 during the flood. The severe scour at the toe of the termination resulted in stability problems of the termination, i.e. the sliding of the apron and the sand materials beneath it took place. The observations suggested that the mitigation of the scour due to flood and the enhancement of the termination against scour were probably the keys to ensure the effectiveness of the Sirajganj Hardpoint.

The horizontal velocity vectors near the water surface were shown in Fig.7 and Fig.8, together with the sketches of major sandbars based on field investigations and satellite images. In 2008, the approach flow channel was diverted into two parts by two sandbars. The flow attacked the termination of the hardpoint and resulted in two circulation flows in front of and behind the termination, respectively. In 2009, the west part of the big sandbar on the east was washed away and the width of the approach flow channel was significantly enlarged. On the other hand, a small sandbar appeared in the approach flow channel just in front of the termination. These changes affect a lot on the flow structure near the termination. The two circulations remained in 2009, but became much weaker than those in 2008. The flow in 2009 was further divided into two parts after passing the hardpoint due to the detachment of the downstream sandbar from the embankment. If one took a look at the velocity field in the vertical direction passing the termination in Section P as shown in both Fig.8 and Fig.9, the differences in the flow structure could be evidently distinguished. A vortex occupied the scour hole in front of the termination in both years, but the one in 2008 was much stronger than that in 2009. As this vortex was the major engine for the local scour around the termination, it was then easily understandable that the scour depth in 2009 was smaller than that in 2008 as have been confirmed by the bathymetry data in Fig.6.

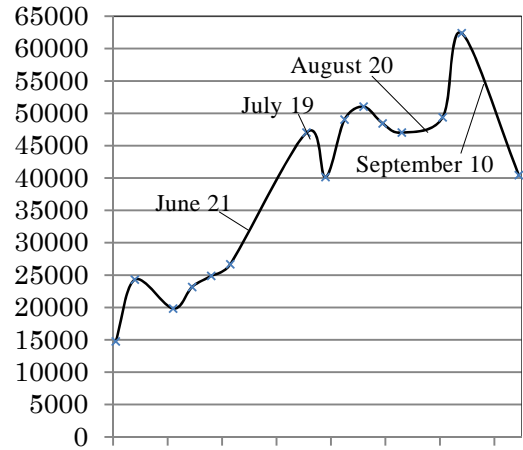
Fig.12 Discharge in 2008 monsoon at Bahadurabad

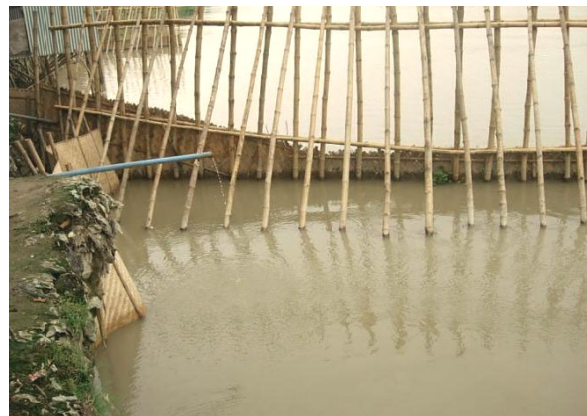
the water course with a length of about 10m and made an angle of 50°-60° to the bankline. The Bandal was made of groups of vertical bamboo piles with a spacing of 46cm. The diameters of the bamboo piles ranged from 6cm to 9cm. The piles were connected with each other by cross bamboos with a vertical spacing of around 75cm. Moreover, inclined bamboos were set at an angle of 45° to the bamboo piles to enhance the stability of the Bandal structure. The upper part of the Bandal was closed with bamboo thatch while the lower part is open. The Bandals were arranged in a group along the secondary channel of the river as show in Fig.2. The distance between two consecutive Bandals is around 32m. The details of one of the Bandals are shown in Photo1 which was taken during the field investigation in July, 2008. On the other hand, Photo2 demonstrates the sediment deposition behind the Bandal structure along the bank and the photo was taken in July 2009, one year after the first field trip. It is found that a large area of land is created behind the Bandal within only one year. The two photos give visible evidence on the deposition-promoting performance of the Bandals.

Photo 5 Randhunibari Bandal (July, 2008)

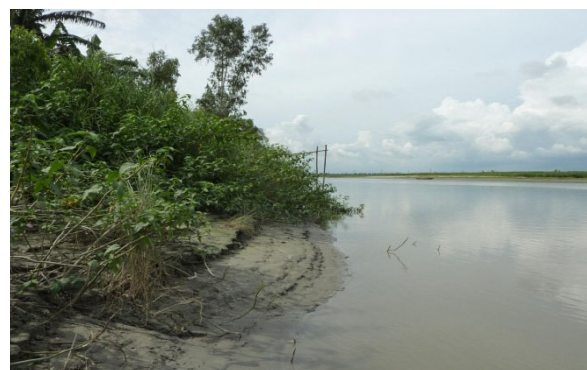
Photo 6 Randhunibari Bandal (July, 2009)
