Necessity of new paradigm for conquest the millennium / compound class disaster

Toyohiko MIYAGI (Tohoku-Gakuin University, Sendai, Japan)

Out line of the East Japan Great Earthquake 3.11, 2012

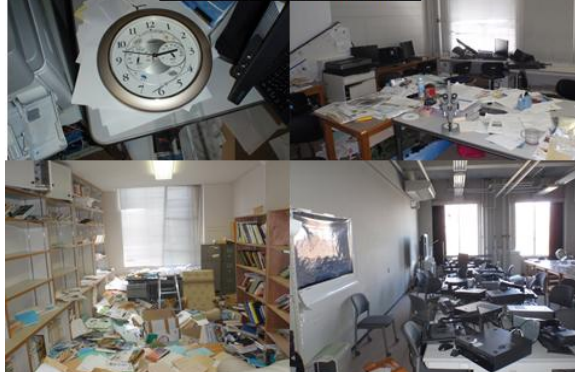
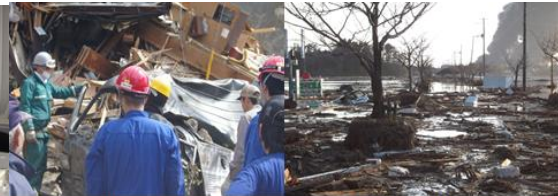
1. Introduction the tsunami disasters in Miyagi Prefecture Earthquake Damages in my office

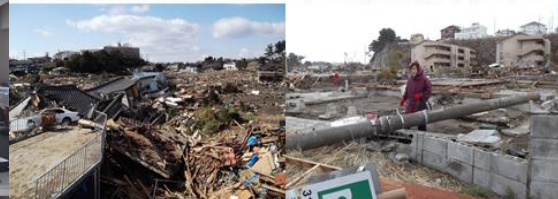
Tsunami disasters around my house, Shichigahama, Miyagi, Japan

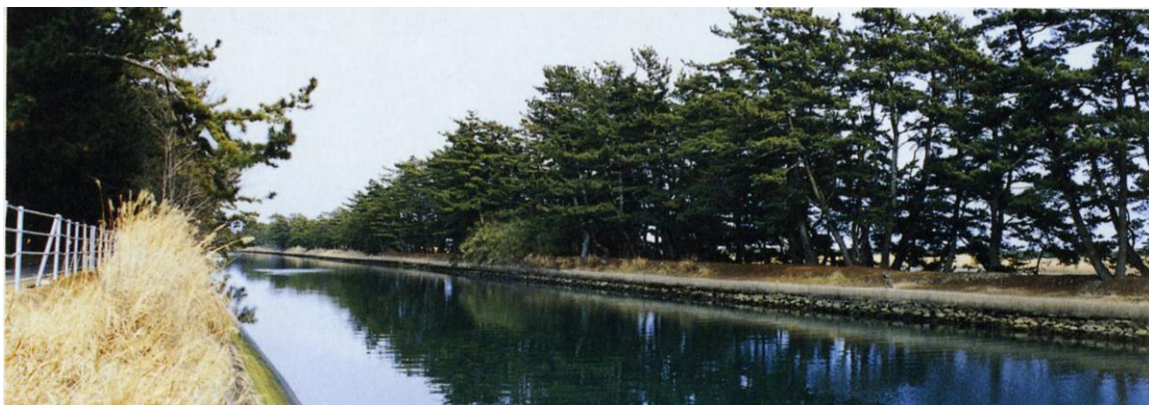
Teizan canal and the pine trees

Artificial treatments were added to the land to which the initial condition was set by beach ridges and formation of the back marsh. Then, change of a land natural system was started. (1) The drainage system and de-salt by excavation of Teizan canal. (2) Banking of both banks by excavation of Teizan canal. (3) Reduction of sand dust accompanying attenuation of the wind velocity by forestation, and deposition into a forest. (4) Creation of the ecosystem by forestation, etc. This change became the foundation of new reclamation of a rice field, and built the “original scenery of Japan” called “white sand and green pine forest”. The secondary ecosystem as an autonomous forest structure progressed also inside the forest.

In the Sendai coastal plains, human work, such as establishment of Teizan canal and afforestation of a pine trees, worked by the fine geographical feature environment of coastal beach ridges and the back marsh, and a rich scene and ecosystem were built by it. In detail, the afforestation to a ground condition and the place not suiting would also be performed. A present earthquake and tsunami will bring various destructions to such complicated land and vegetation. It seems that the hint about construction of a coastal forest strong against tsunami is also contained from various kinds of destruction. Probably, one of them is the relation between foundation quantity (groundwater level) and tree destruction. The groundwater level is considered to result in change to the style of destruction, and can reduce generating of a drift tree greatly by raising a little foundation at a low place. It cannot be overemphasized that padding of foundation quantity links with attenuation of tsunami directly. It seems that trees will bend and crease destruction will hardly be produced due to the fluid power of tsunami, and trees destruction if the depth of inundation is 4 m or less. Can the foundation quantity and afforestation measure based on tsunami attack prediction be created in the near future based on the knowledge acquired from this occasion?

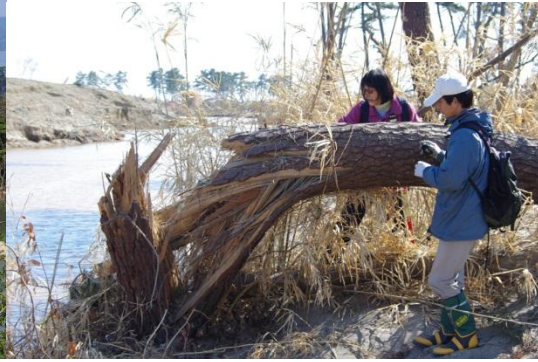
Tsunami damage of pine tree

It is thought that the diameter of trees is so thin that the flow velocity and depth of water are large when it assumes that destruction of trees arises according to the fluid power of tsunami that such big destruction occurs. Therefore, if both relations can be quantified, the relation between tsunami power and trees destruction will become clear. When the attack wave quantity of tsunami and the depth of inundation which were measured in various parts of a coast and the forest, and trees bent and writers found the relation of destruction, the place in which it bends and crease destruction excels was a little higher of the foundation quantity which the ground dried mostly.

If tsunami and trees bend and the relation between collapse destruction is found for the depth of inundation and a diameter, in 3 m or less of the depth of inundation, destruction will hardly produce trees 10 cm or less in diameter, either. At the place which intense tsunami which destruction begins to actualize from about the depth of inundation 4m, and exceeds 8 m invaded, a diameter exceeds 40 cm that survival ratio exceeds 50%.

Isn't it realistic as for destruction of a coastal forest to think that there were 1; foundation and groundwater conditions, destruction related to a shock, and 2; related the fluid power of the tsunami and the destruction related to the intensity of trees?

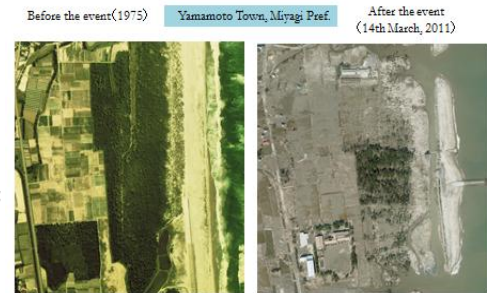
Although woods were destroyed by tsunami, there is also a part which remained
津波によって森が破壊されたが、残存した箇所もある。

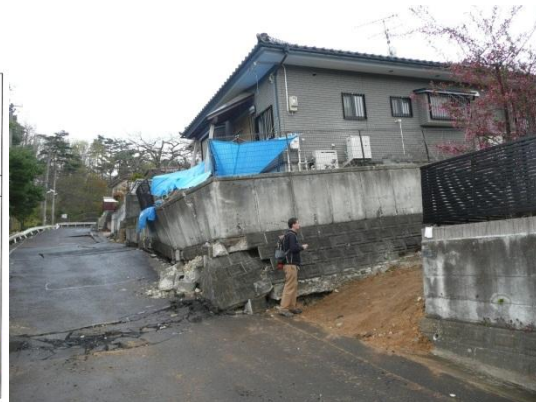
Typical view of the land deformation.
