Original Paper

Mechanical properties of wall soils for predicting damage to the substrate of *Hiten* wall paintings in the Horyu-ji Temple main hall caused by humidity fluctuation: Measurements with mock-up materials

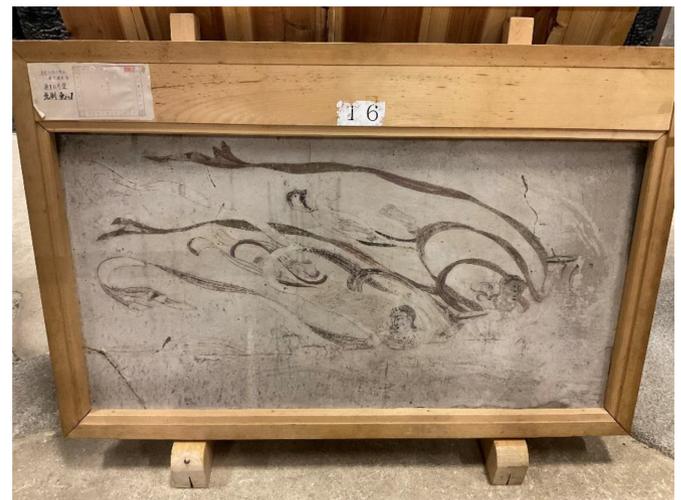
FIGURE 1 One of *Hiten* wall paintings in the storehouse of the main hall of Horyu-ji Temple photographed by an author (K. Ishikawa) on December 1, 2021

Figure 1 shows present *Hiten* wall painting (No. 16), and Figure 2 shows the constituent materials of the wall paintings inferred from previous research on the wall paintings in Horyu-ji Temple.^{16–19} The wall paintings have soil wall substrates composed of various types of wall soil (*Kabe-tsuchi*). The thicknesses of the upper-, middle-, and under-coat soil layers were based on the research of Aoyagi and Hayashi,¹⁹ in which they estimated the dimensions of various parts of the burned wall paintings based on the documents stored at Horyu-ji Temple. Note that the assumption of the materials and composition of *Hiten* wall paintings presented in Figure 2 are based on studies of the burned wall paintings, which were originally the first-story walls in the main hall of Horyu-ji Temple. The main focus of this study is *Hiten* wall paintings, which were not burned, and their materials and compositions have not been clarified. We assumed that the materials and

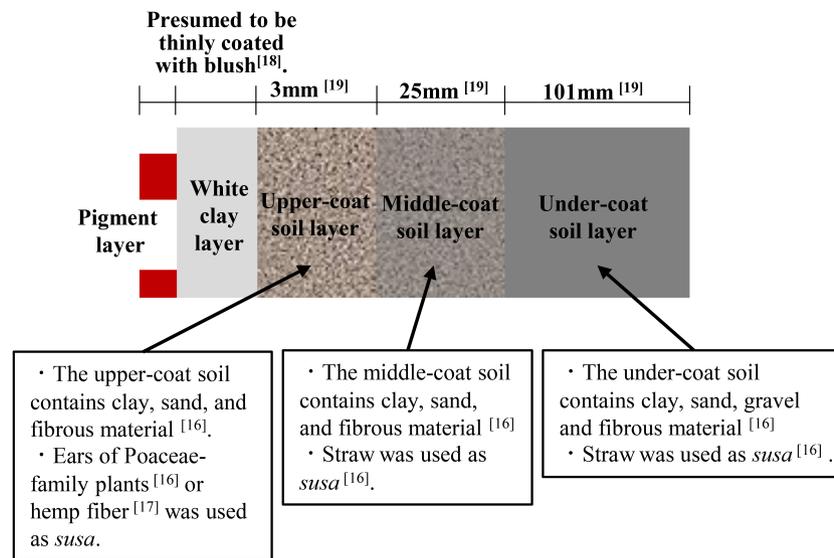
FIGURE 2 Assumption of materials and composition of *Hiten* wall paintings

As shown in Figure 2, the substrates of the wall paintings comprised soil walls with multiple layers, and white clay was used as the substrate layer for the pigment.¹⁸ The upper-coat soil positions just beneath the white clay, and the middle-coat soil does beneath the upper-coat soil layer. Previous reports^{16,19} identified or estimated the component materials and soil grain sizes of the upper- and middle-coat soils of the burned wall paintings using a water-sieving technique. Based on these reports, the materials, including the grain size of the soils, and composition for the mock-up wall soils were

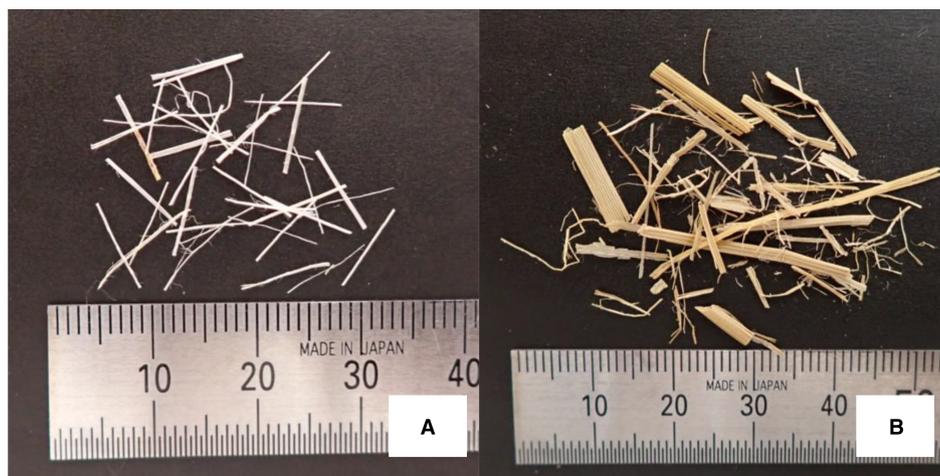
FIGURE 3 (A) Hemp and (B) straw fibers used to fabricate the mock-up wall soils

than 75 μm) were dried in an oven at 80°C. Figure 3A,B show the hemp and straw fibers used to fabricate the mock-up upper- and middle-coat soils, respectively. The width of the hemp fibers was less than 0.5 mm, and the length was approximately 10 mm for the most part, where the longest was 18 mm. The width of the straw fiber was in the range from less than 0.5 mm to approximately 4 mm, and the length was less than 40 mm. The length and diameter can affect the physical properties of the wall soils. However, the fibers added to the specimen were not sorted by their dimensions in this study. A further problem is clarifying the effects of fiber dimensions on the physical properties of the upper- and middle-coat soils.

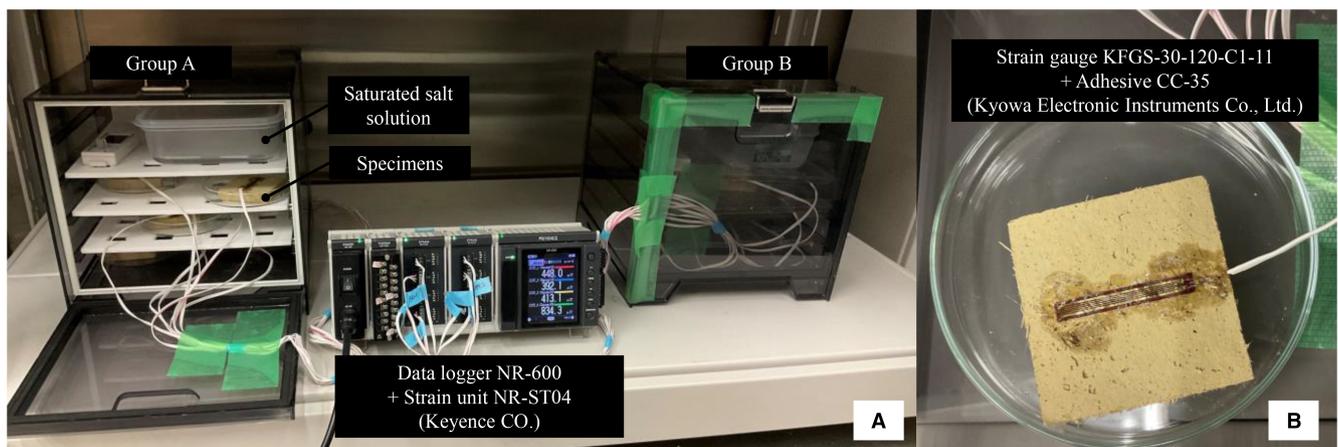
FIGURE 4 Measuring equipment of humidity-induced strain

Figure 4 shows the measuring system for the humidity-induced strain measurements. The strain measurement system comprised an NR-600 logger and NR-ST04 (Keyence Co.) (Figure 4A). Strain gauges and gauge glue were KFGS-30-120-C1-11 and CC-35 (Kyowa Electronic Instruments Co., Ltd.) (Figure 4B), respectively. The measurements were conducted in a thermostatic room at 23°C. Each specimen was placed on a glass dish in a humidity-conditioned desiccator with a saturated salt solution at the reference relative humidity. The strain at equilibrium was set to zero. The salt solution was replaced to dry/humidify the desiccator, and the strains of the specimens caused by a difference in RH between the reference and new relative humidities were recorded. The reference humidity was 53% RH, and the humidities under drying and humidifying conditions were 33% and 84%, respectively. Owing to the limited logger-connection capacity, the specimens were divided into two groups (A and B) and placed in different desiccators. Each group contained three specimens of

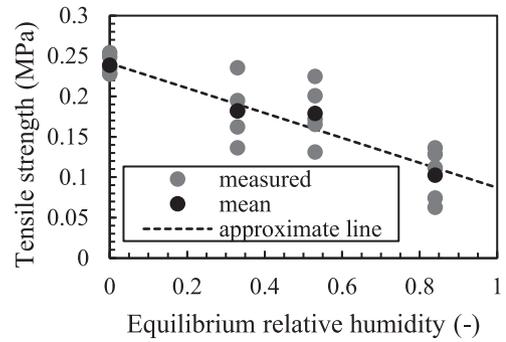
FIGURE 6 Relationship between the tensile strength of the upper-coat soil and equilibrium RH

Figure 6 shows the measured and average tensile strengths relative to the equilibrium RH. The average tensile strength

ranged from 0.103 MPa to 0.239 MPa. The average tensile strength decreased with increasing equilibrium RH over the entire measured humidity range. We consider the relationship between tensile strength and relative humidity is not necessarily linear because it depends on the meniscus formation in the upper-coat soil. Notably, the measured tensile strengths of specimens at 33% and 53% equilibrium RH had similar ranges, and the average tensile strengths were not significantly different. However, the test results were insufficient to approximate a suitable curve and coefficients reflecting the relationship between mechanical properties, including tensile strength and relative humidity, owing to the limited humidity range used in the tests. Thus, the tensile strength σ_{ten} (MPa) was approximated as a linearly decreasing function of equilibrium RH h (-), expressed as follows:

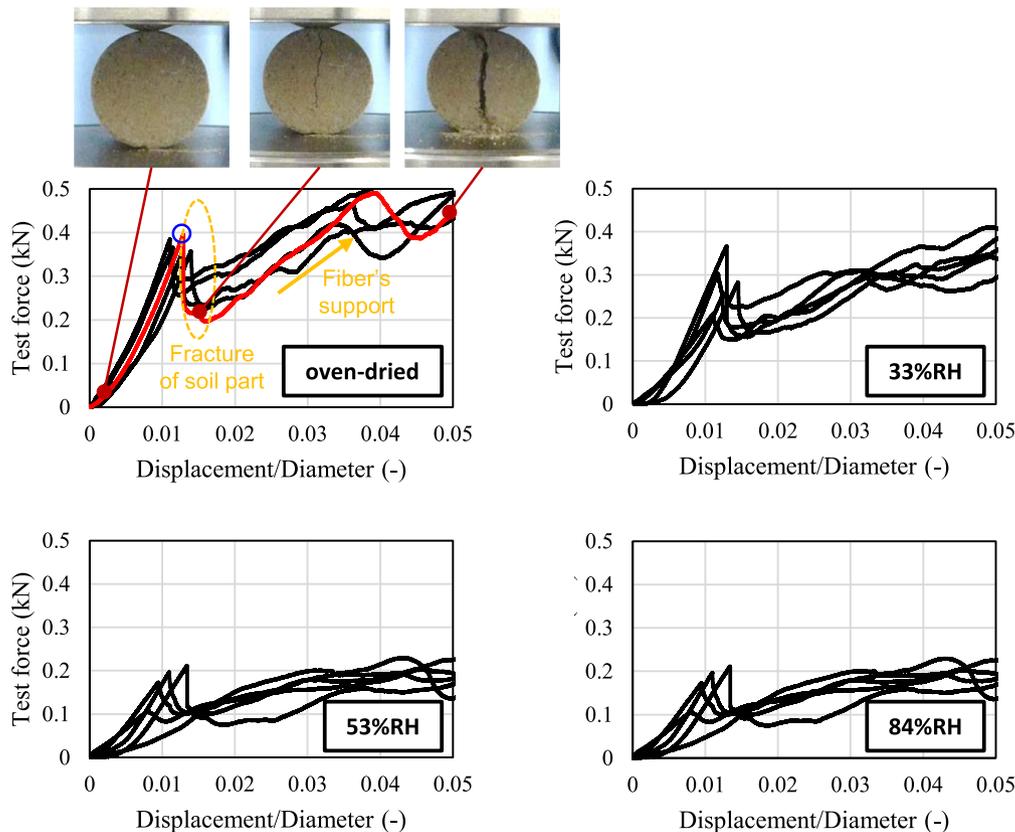
FIGURE 5 Test force–displacement/diameter relationship of the upper-coat soil during the splitting tensile test

Figure 5 shows the relationship between the test force and ratio of the displacement to the specimen diameter during the splitting tensile test at each equilibrium humidity. As a typical example of the failure process, the appearance of a specimen base (red line) during the test is shown in Figure 5. The test force linearly increased with the displacement-to-diameter ratio at every equilibrium RH, reaching a local maximum value before the ratio reached 0.02. It is considered that the initial increase in the slope was attributed to the increasing surface area supporting the applied force with increasing displacement when the side surface of the specimen was rough. For most specimens, the test force decreased immediately after reaching the local maximum value. Subsequently, the test force tended to increase until the end of the test for all specimens, although the base had already cracked. We expect that the first maximum value was attributed to the bonding of the soil and sand, and the subsequent increase in the test force was attributed to the support provided by the hemp fiber against tensile force. As discussed in the Introduction, the occurrence of cracks in cultural artifacts leads to a loss in value, despite their capability to withstand tensile forces. Therefore, the tensile strength was obtained from the local maximum value of the test force (blue circle in Figure 5; red line).

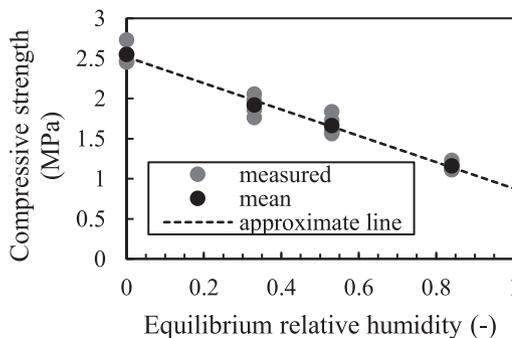
FIGURE 8 Relationship between the compressive strength of the upper-coat soil and equilibrium RH

Figure 8 shows the measured and average compressive strengths relative to the equilibrium RH. The average compressive strength ranged from 1.16 MPa to 2.55 MPa. The compressive strength at the same humidity was 9.30–11.3 times greater than the tensile strength, confirming that upper-coat soil was weaker in tension. The average compressive strength decreased with increasing equilibrium RH. The relationship between the mechanical properties and equilibrium humidity is not necessarily linear when the meniscus formation influences the mechanical properties. However, in contrast to tensile strength, a clear linear relationship between compressive strength and equilibrium humidity was observed. The compressive strength σ_{com} (MPa) is expressed

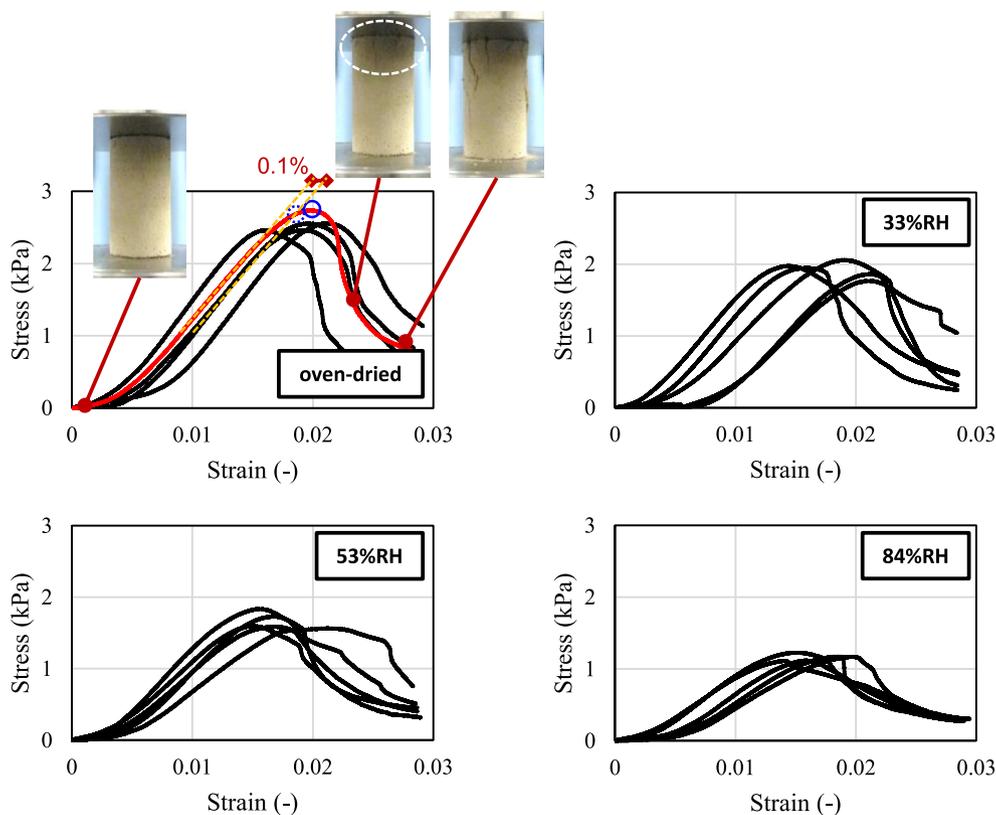
FIGURE 7 Stress–strain relationship of the upper-coat soil during the compressive test

Figure 7 shows the stress–strain relationship observed during the compressive test for each equilibrium RH. As an example of the failure process, the change in the appearance of a specimen is shown in red line. For every equilibrium RH, the slope of the stress–strain curve initially increased within the range of 0.0–0.3 kPa. In the compressive test, it was considered that the initial increase in the slope was larger when the base of the specimen was a rough plane, with the rough part subsequently flattened by the compressive force. After the initial slope increase, the stress relative to the strain increased linearly. The maximum stress was reached after the slope decreased. Subsequently, the stress rapidly decreased. Similar to the red-line specimen, for every compressive test, side cracks were visually observed on the specimen after the stress decreased. Therefore, the compressive strength (blue solid circle in Figure 7) was determined as the maximum stress of the entire stress–strain relationship. Because the stress–strain relationship deviates from linearity before reaching the maximum stress, a proportional limit was also determined as the maximum stress to which Young’s modulus can

Young's modulus was obtained from the slope of the stress–strain relation shown in Figure 7. The stress ranges where Young's modulus was obtained were 1.0–2.0 kPa for specimens oven-dried at 105°C, 0.7–1.2 kPa for 33% RH and 53% RH, and 0.3–0.8 kPa for 84% RH. In addition, the stress at which the corresponding strain deviated by 0.1% from the linear relationship of the slope of Young's modulus was determined as a proportional limit (blue dotted circle in Figure 7). Figures 9 and 10 show the measured and average Young's moduli and proportional limit relative to the equilibrium RH, respectively. The average Young's modulus and proportional limit ranged from 0.115 GPa to 0.209 GPa and 1.10 MPa to 2.49 MPa, respectively. Both values decreased with increasing equilibrium RH. Young's modulus E (GPa) and proportional limit σ_{pro} (MPa) were approximated as decreasing linear functions of equilibrium RH h (–), respectively.

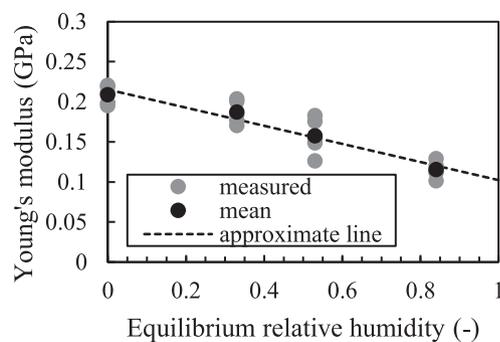
FIGURE 9 Relationship between Young's modulus of the upper-coat soil and equilibrium RH

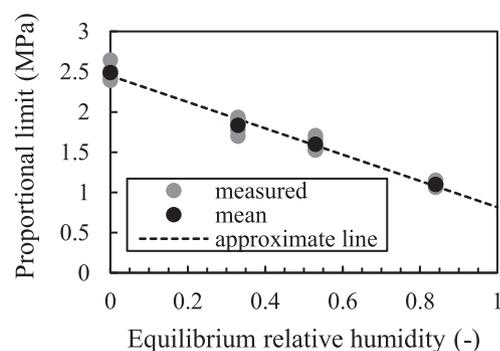
FIGURE 10 Relationship between the proportional limit of the upper-coat soil and equilibrium RH

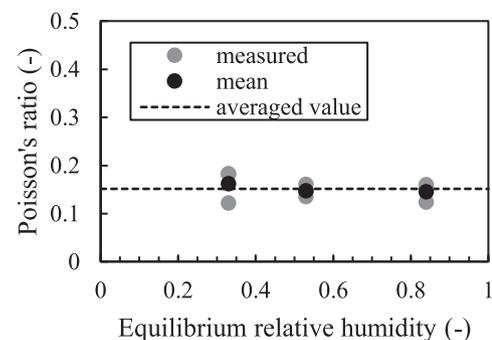
FIGURE 11 Relationship between Poisson's ratio of the upper-coat soil and equilibrium RH

Figure 11 shows the measured and average Poisson's ratios relative to the equilibrium RH. The average Poisson's ratios at each equilibrium RH were approximately 0.162, 0.147, and 0.146 (–) for 33, 53, and 84% RH, respectively. The average of the three values was 0.152 (–), and the mean absolute error was 0.018 (–) when the average value was regarded as the approximate Poisson's ratio.

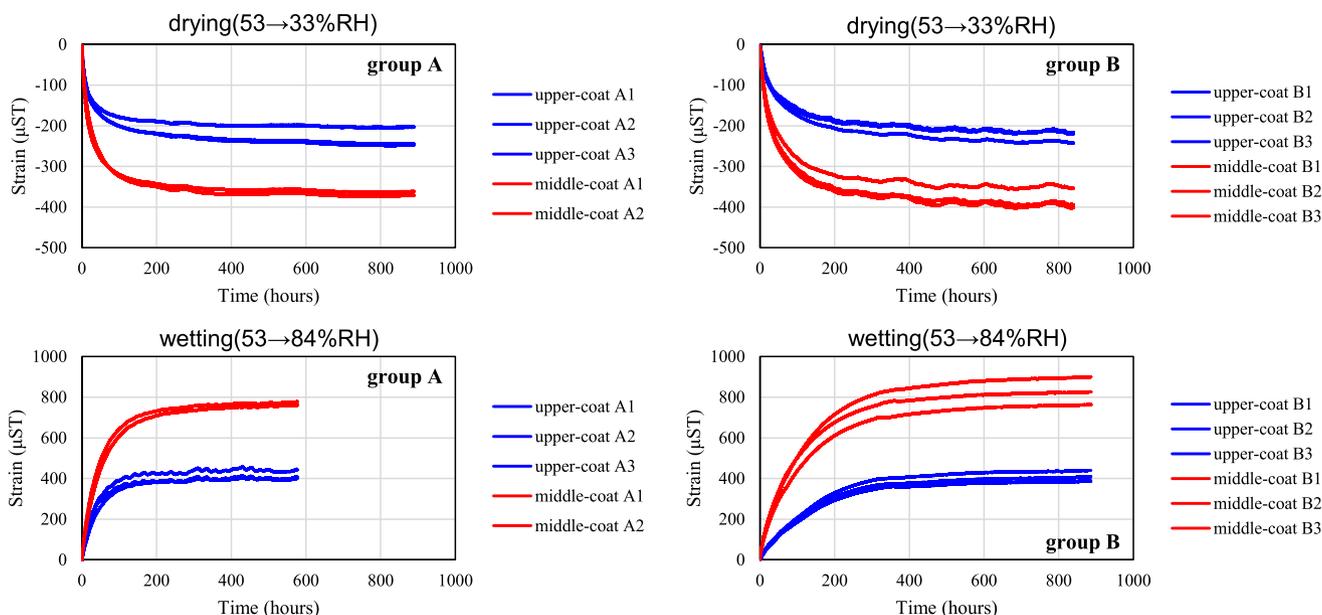
FIGURE 12 Strain decreasing/increasing over time

Figure 12 shows the strain in each measurement group during drying and wetting. For all specimens, the strain increased during wetting and decreased during drying, and the change over time became smaller and nearly constant. Figure 13A,B show the time-averaged strain values during 500–550 h for dry and wet conditions for the upper- and middle-coat soils, respectively. The time-averaged strains of the upper- and middle-coat soils were approximately 372.3–434.8 μ ST and 738.6–869.3 μ ST at 84% RH and –238.9 to –199.2 μ ST and –390.3 to –347.7 μ ST at 33% RH, respectively. For each soil, the relationship between strain ϵ (μ ST) and equilibrium humidity (–) was expressed as a linear function, with the strain at 53% RH was 0 μ ST.

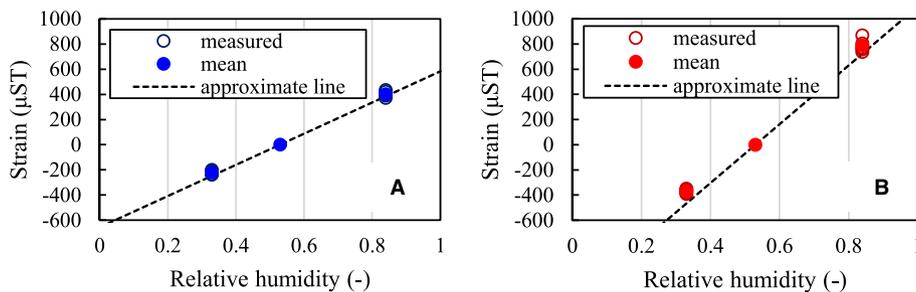
FIGURE 13 Humidity-induced strains of the upper- and middle-coat soils
