## **Necessity of new paradigm for conquest the millennium / compound class disaster**

***Toyohiko MIYAGI (Tohoku-Gakuin University, Sendai, Japan)***

# Out line of the East Japan Great Earthquake 3.11, 2012

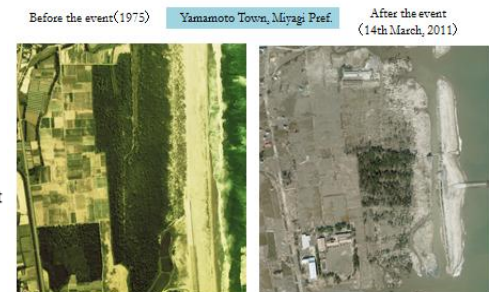
## Field evidence: forest made mitigate tsunami energy

森林が津波浸水深を低減させた可能性

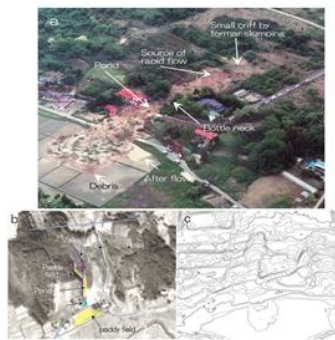
Rapid flow landslide at the artificial reclaimed area by the trigger of earthquake on May 26, 2003 Miyagi Prefecture.

- a: An overview of landslide area just after the disaster.
- b: The landslide occurred at the reclaimed small valley. The land modification completed 35 yrs ago for agricultural use. The former topography and land cover such as pond and paddy field shows highly potential of ground water.
- c: The 1 meter contour map shows the clear landslide topography.

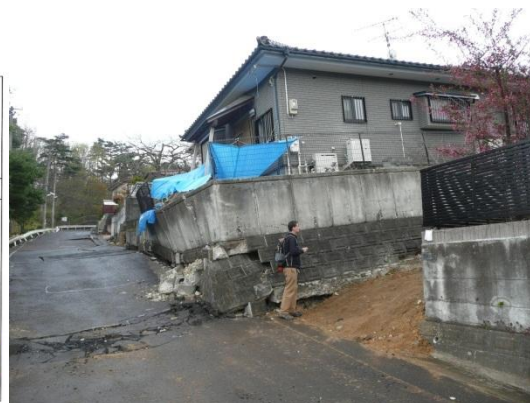
### Types of modification at Oritate area.

Typical view of the land deformation.
